## TECHNICAL NOTE: PRELIMINARY BAT ROOST ASSESSMENT

<b>SITE NAME &amp; ADDRESS</b>	2 Harewood Avenue, Simonstone, BB12 7JB
<b>DEVELOPMENT PROPOSAL</b>	Two storey extension
<b>DATE</b>	29 September 2025
<b>AUTHOR</b>	Ryan Knight BSc (Hons) MCIEEM - Principal Ecologist

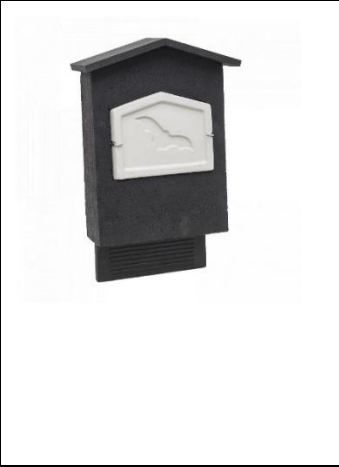
<p>These boxes are manufactured from WoodStone, a breathable and insulating material made from concrete and FSC Certified wood fibres. Woodstone is designed to be robust and hard-wearing, providing a warm and stable temperature for summer bat roosts.</p> <p>Available from: <a href="https://www.nhbs.com/">https://www.nhbs.com/</a></p>
	Beaumaris Woodstone Bat Box

BAT BOX		
<b>Locations and positioning</b>	The box can be fitted on the walls of the renovated dwelling at a height of at least 3m from the ground (ideally just under the roof eaves and away from any windows). Any aspect is suitable.	
<b>Bat box models and purchasing</b>	Bat box models along with the locations for purchasing are provided below. There can be a considerable waiting time for delivery for certain models, therefore, two options have been provided.	
	Low Profile WoodStone Bat Box (Vivara Pro)

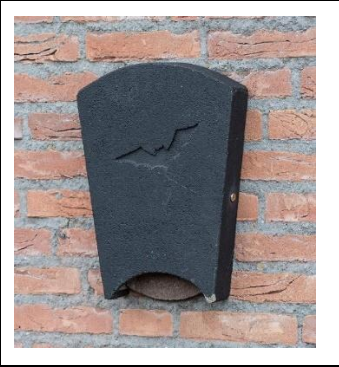
<p>These bat boxes are also made entirely from WoodStone. The Beaumaris box has a single narrow cavity which makes it suitable for crevice roosting bats such as common pipistrelle. Available from: <a href="https://www.nhbs.com/">https://www.nhbs.com/</a></p>

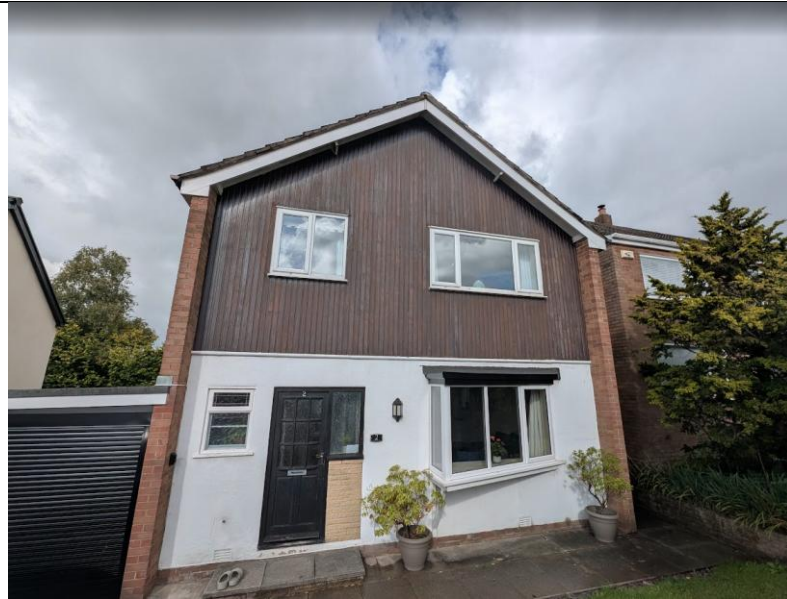
**Photo 1.**  
Front (east)  
elevation.

The property comprises a brick-built, detached dwelling with a flat-roofed side garage. The dwelling features a pitched gable roof clad with interlocking concrete tiles. The pointing mortar at the roof verge on the frontage appeared intact and well-sealed, with no gaps observed. No suitable bat roosting features were identified within the roof structure, including around the chimney.

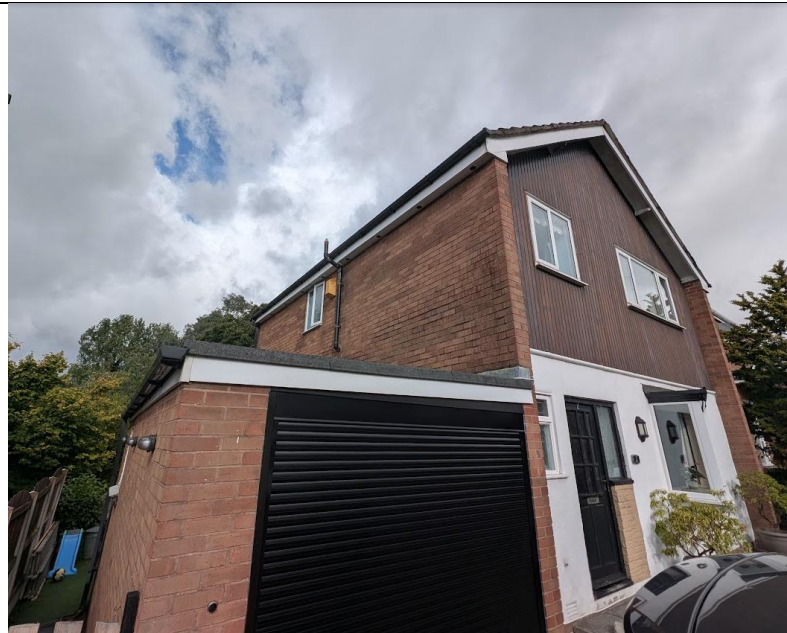
**Photo 2.**  
Front and side  
elevation (area of  
extension).

The upper frontage was clad with timber panelling, while the lower section was rendered. The remaining brickwork was in good repair throughout. The fascia board on the garage was also tight-fitting, and no potential roost features were noted.

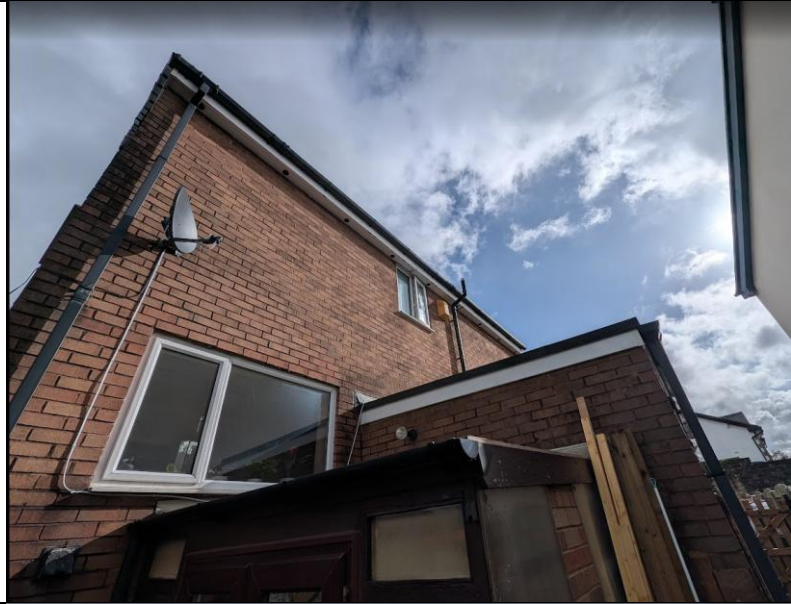
**Photo 3.**  
Further view of side elevation (south).

Fascias and soffits were present on the front and side elevations. These appeared to be in good condition and tightly sealed to the walls, offering no access points for bats. The rear roof verge was

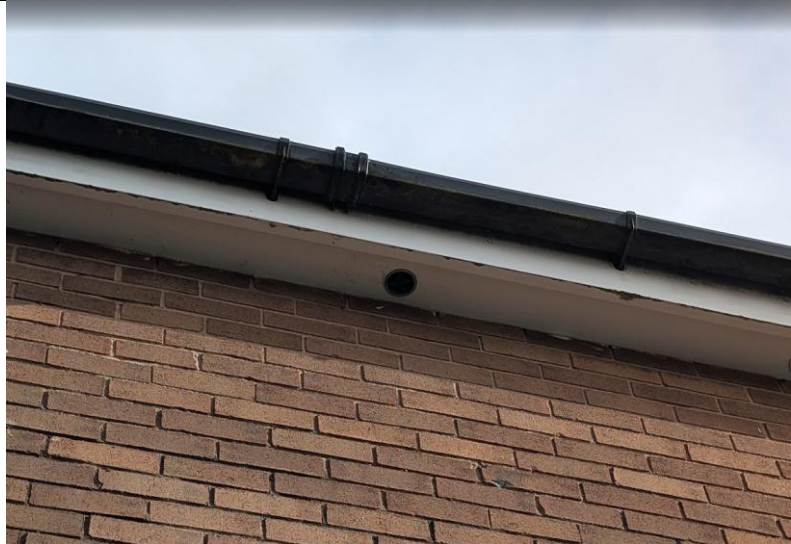
**Photo 4.**  
Example of soffits well sealed to the walls.

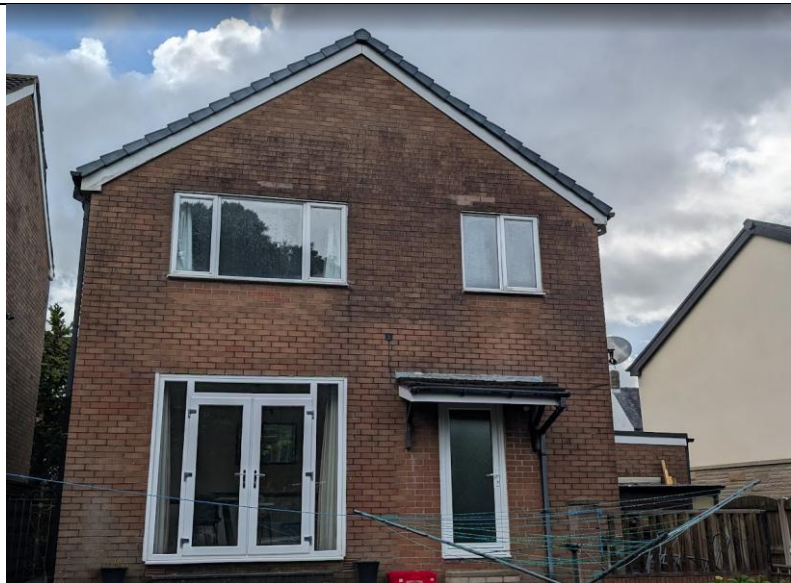
**Photo 5.**  
Rear (west) elevation.

fitted with a modern plastic verge system, and the fascia board was flush with the wall, further limiting roosting potential.

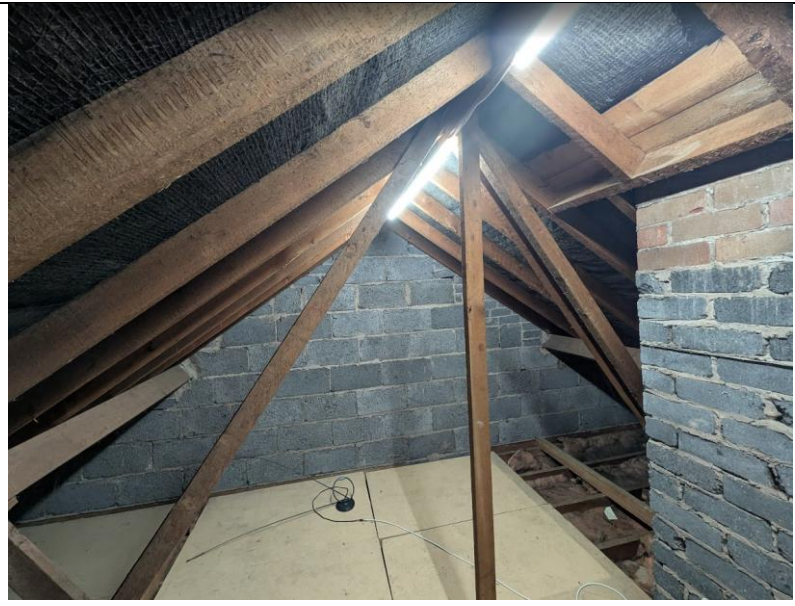
**Photo 6.**  
Loft area.

Internally, the loft space was fully boarded and fitted with strip lighting along the ridge. The roof was lined with traditional bitumen-based underfelt. The loft floor was clear, and no evidence of bat access or roosting features was recorded. Daylight was visible at the roof verges; however, this originated from ventilation vents within the soffits and did not indicate gaps or entry points.
