**BAT SURVEY AT -  
PROMETHEOUS  
THE VILLAGE HALL  
BROCKHALL VILLAGE  
BB6 8AY**

REFERENCE NO. 6020

Extension upwards of the building to form 2no further storeys of office accommodation.

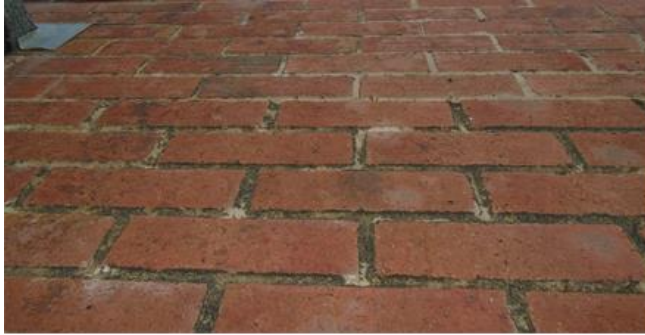
The walls are brick, assumed to be cavity construction.

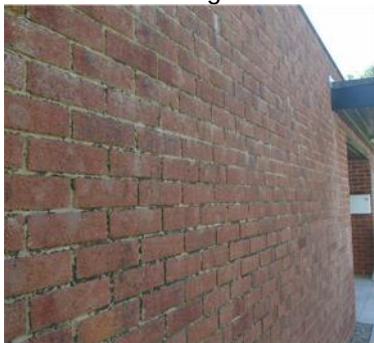
The brick work and pointing are in excellent condition with no access points, cracks or crevices suitable for bat ingress.

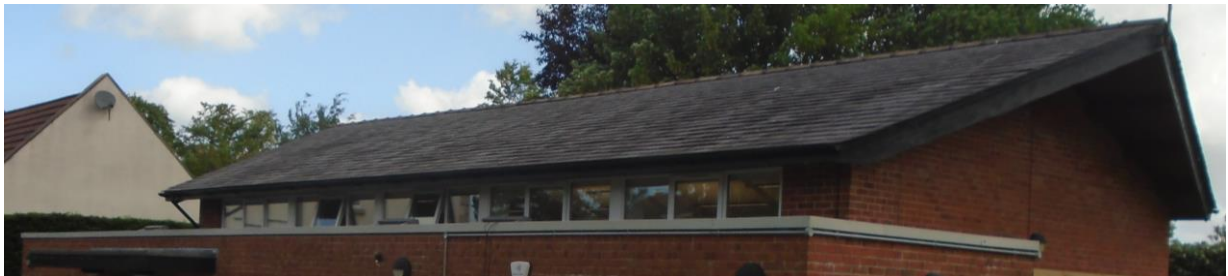
Felt flat and Pitched roof

The main roof is pitched with projecting boarded gable overhangs and barge boards. Eaves overhangs are also present with boarded soffits.

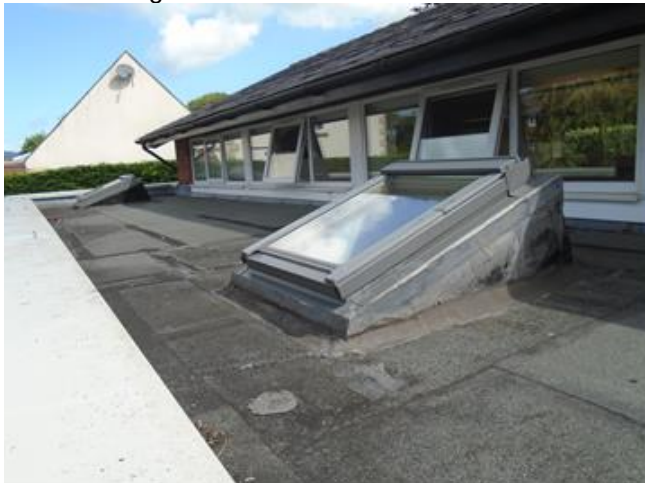
Flat roof with parapet wall

The felt flat has a parapet wall to the perimeter and flashed upstand to the adjoining wall and the raised roof lights.

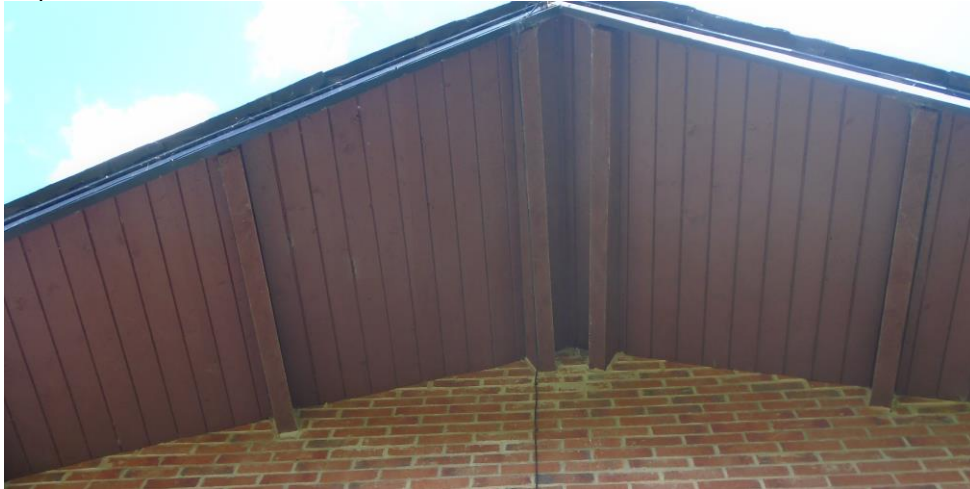
The boarded soffits to the gable overhangs are in excellent condition with no decay or gaps in the boards, barge boards or abutments with the walls. The south gable being particularly closely inspected from the flat roof.

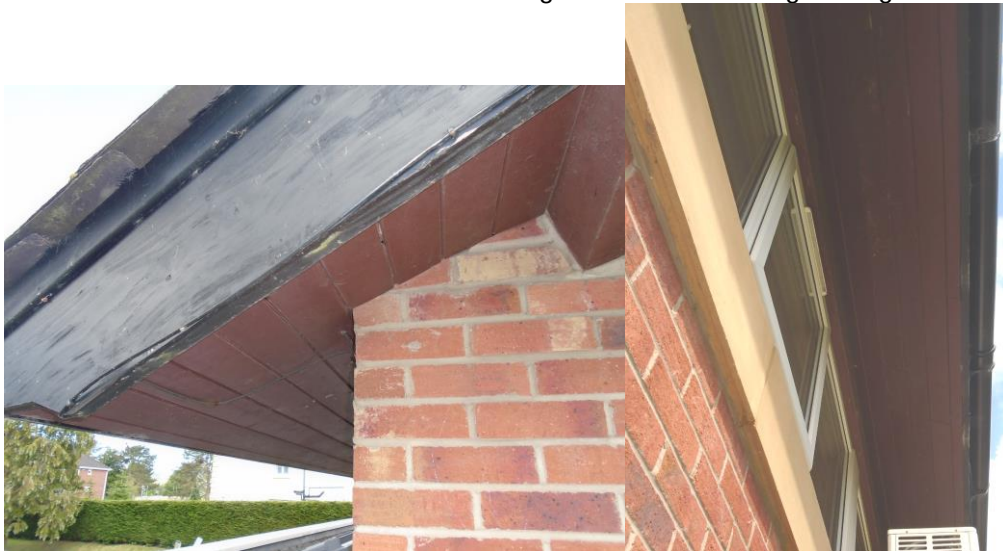
The boarded soffits on the west elevation were examined very closely from the flat roof and with the aid of binoculars on the east side. All were in good condition and tight fitting.

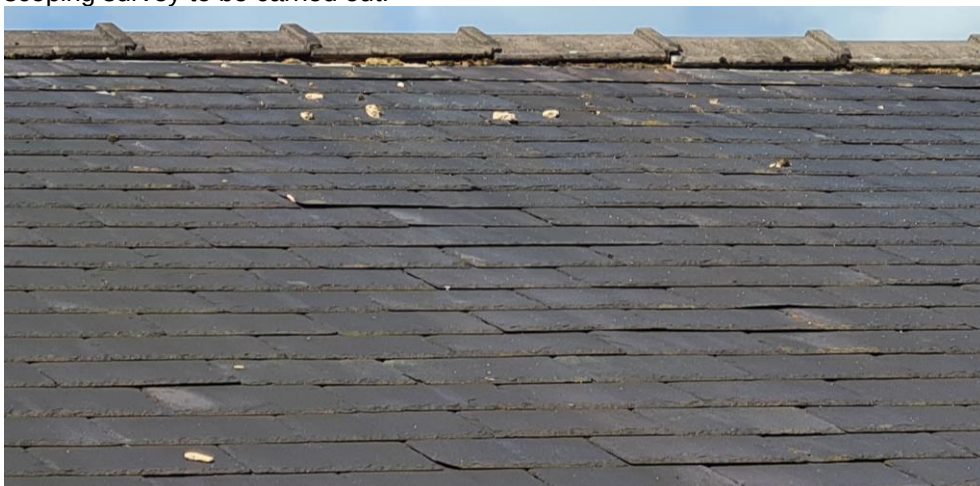
The blue slate roof finish to the pitched roof having been previously in very good condition has deteriorated since the 2022 scoping survey. The ridge pointing to the east elevation has degraded and dislodged forming crevices which have the potential to be accessed by bats, thus necessitating a scoping survey to be carried out.

The building generally lacks potential access points or crevices however the deterioration of the ridge pointing has provided some potential access points. The scoping and emergence survey paid particular attention to the ridge. No visible evidence or emergence from the building was noted. The disruption to the roofs will not impact adversely on any local bat population nor is it likely that any bats will be uncovered or disturbed during the slate removal.

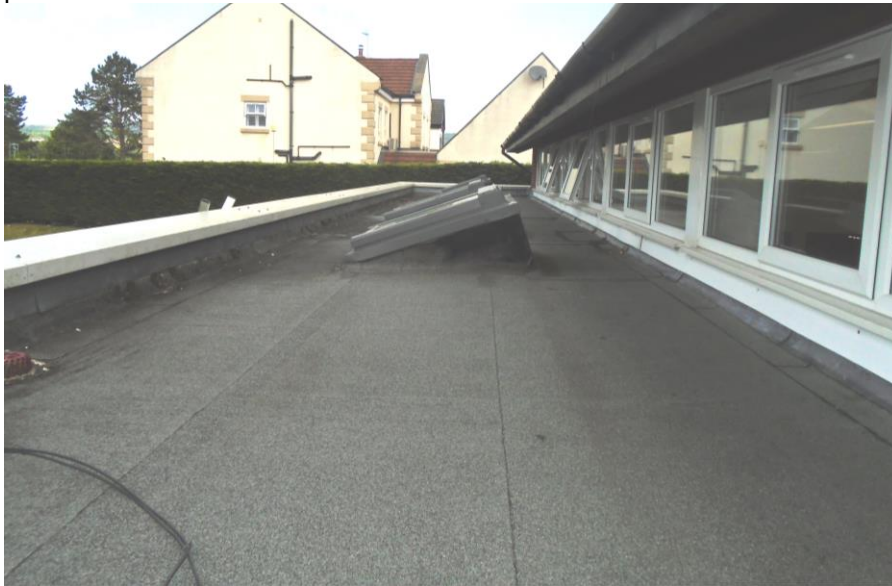
The felt on the flat roof was in perfect condition as were all the upstand flashings No possible access points were found.

The roof did not provide any potential access points to the interior nor any crevices suitable for Bat ingress.

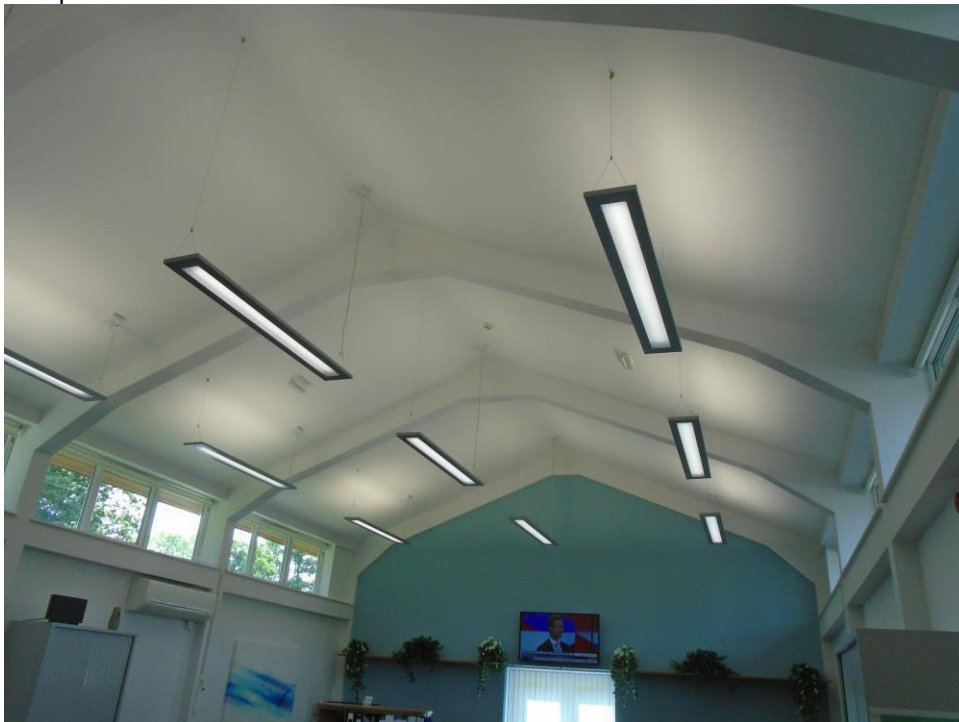
There is no enclosed roof void present in this building, the rafter structure is lined to the underside with plaster board.
