**BAT SURVEY, AT -**  
**PRIMROSE BUSINESS PARK**  
PRIMROSE ROAD  
CLITHEROE

REFERENCE NO 6981

Demolition of industrial building.

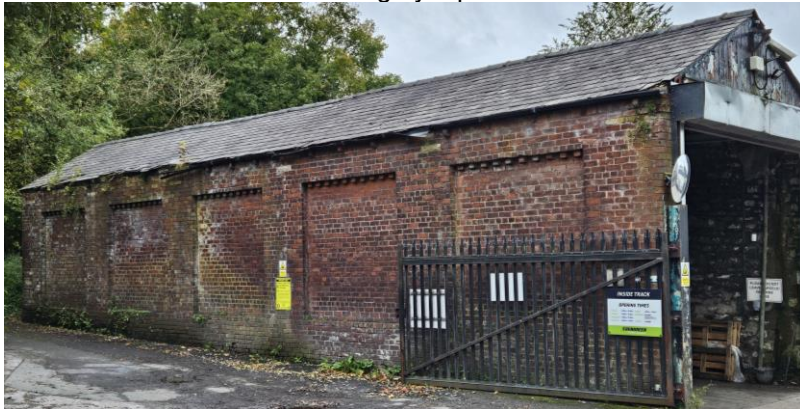
The building probably dates from the early 1900's it forms one of the units in Primrose business park. The building is formed by 1no brick wall parallel to the wall of an existing stone-built mill building. It is open to each end the apex formed by the pitched roof has a timber boarded infill over. The wall is attached to the main mill building by a pitched roof.

Side Elevation

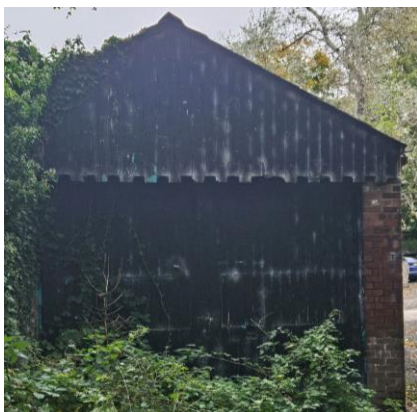
Rear Elevation

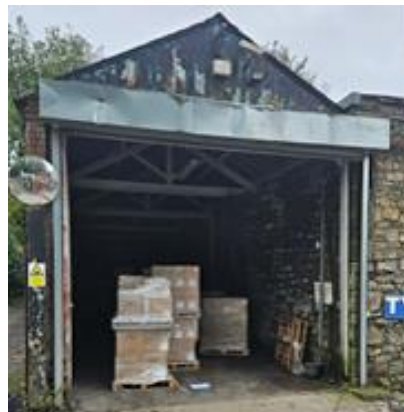
Front Elevation

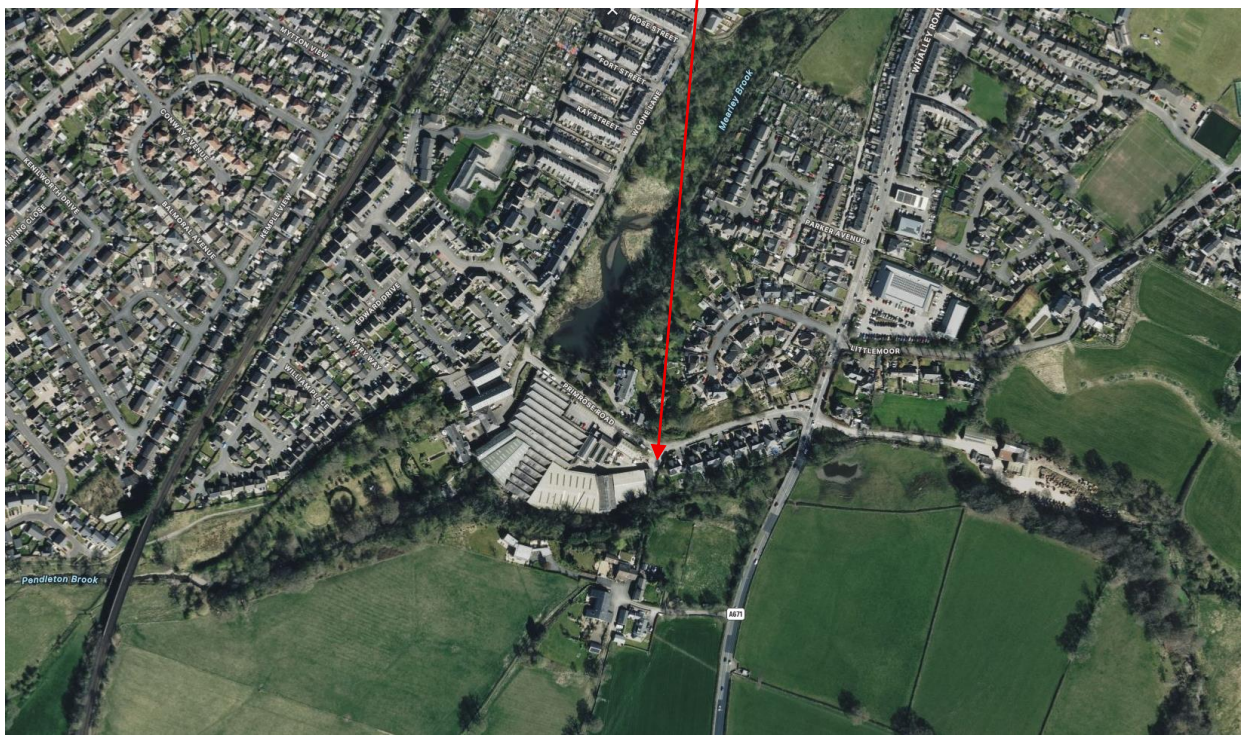
The building is part of Primrose Business Park. It is on the east edge of the site at the entrance accessed directly off Primrose Road. The site is on the southern edge of the settlement area of the town.

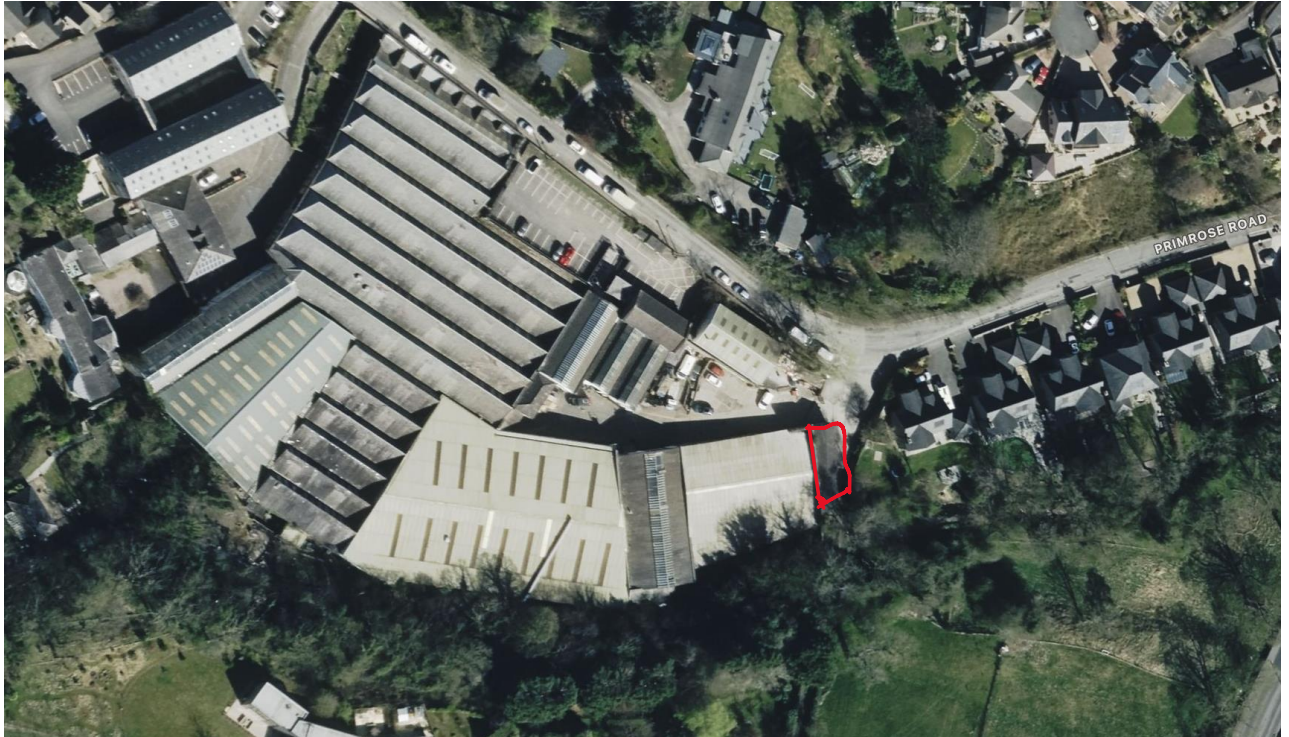
Whilst the building is adjacent industrial units it is also adjacent to pastureland immediately to the south. Pendleton Brook borders the site which is lined with mature trees. This line of trees extends to the west, east and north forming extensive connection to the greater locality. The location is considered to provide optimal forage potential.

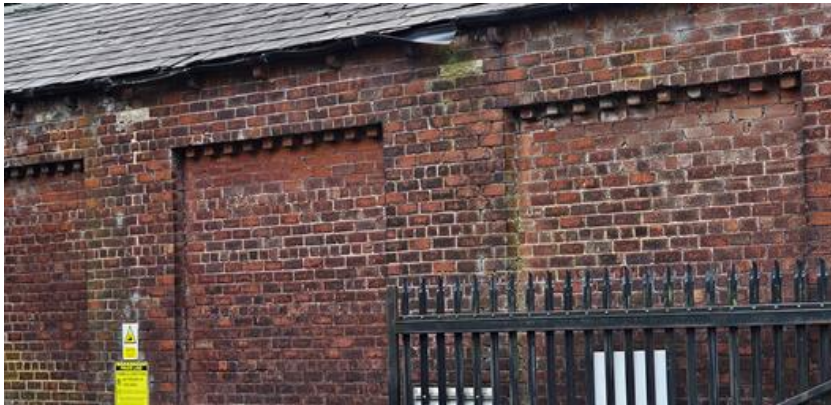
The wall is a solid brick wall.

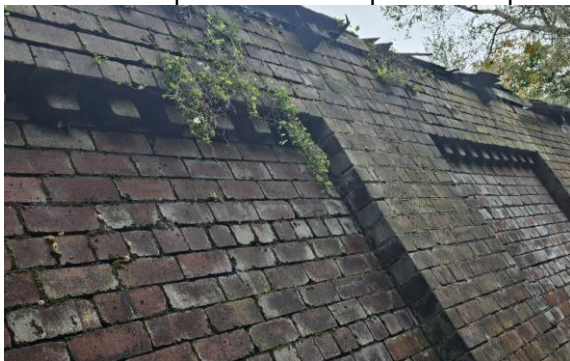
The wall is in reasonable condition with only small sections of degraded pointing. No cracks or crevices were present with the potential to provide bat roost habitat.

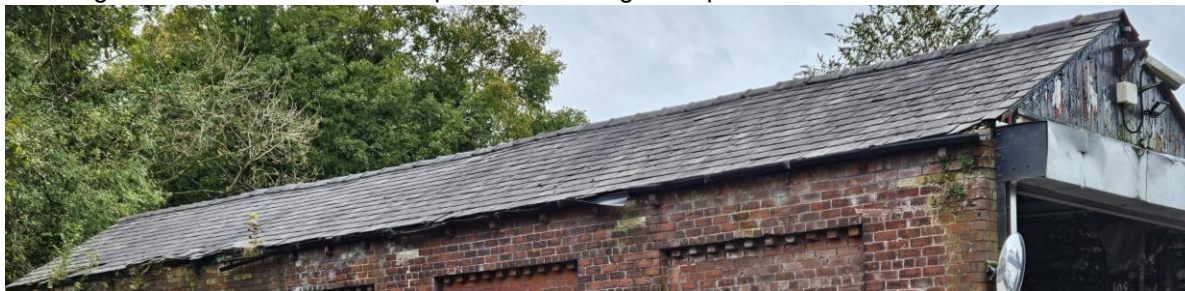
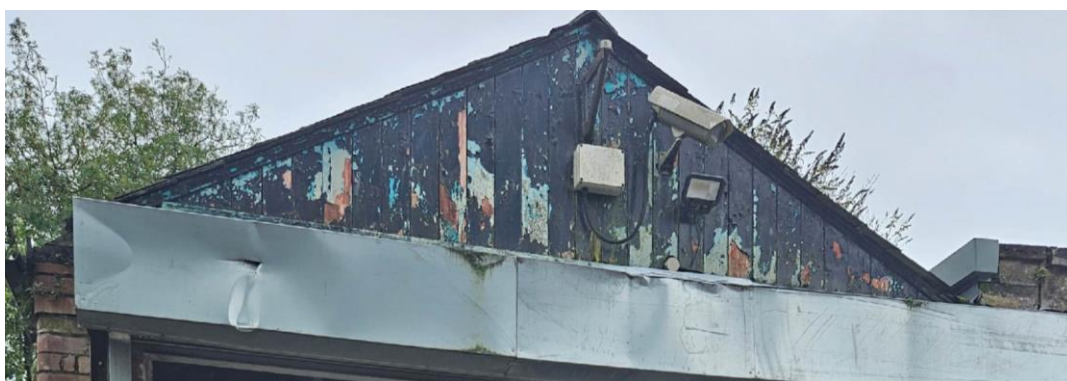
The pitched roof is blue slate with ridge slates. A valley gutter is present at the abutment with the stone mill wall. The fascia fixed to the brick wall is in poor condition with sections missing. Timber boarding over a timber frame infill is present to both gable apices.

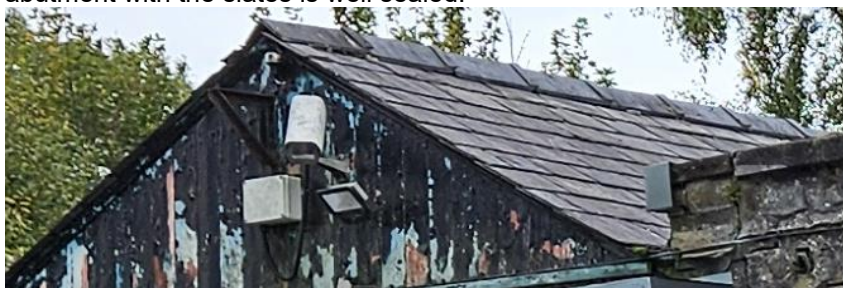
The painted timber boarding has flaking paint however there is no rot present in the timber and the abutment with the slates is well sealed.

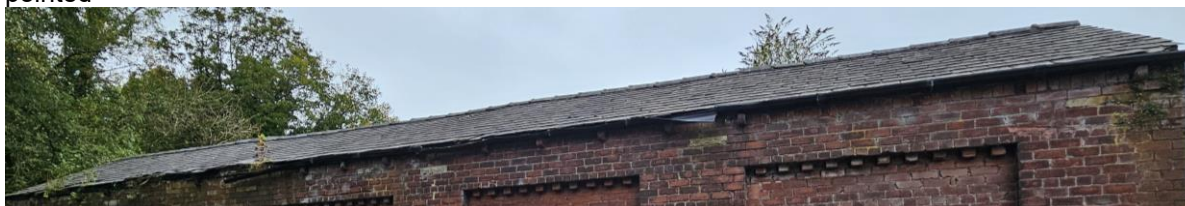
The slates are in good condition all visible slates are tight fitting. The ridge slates appear to be well pointed

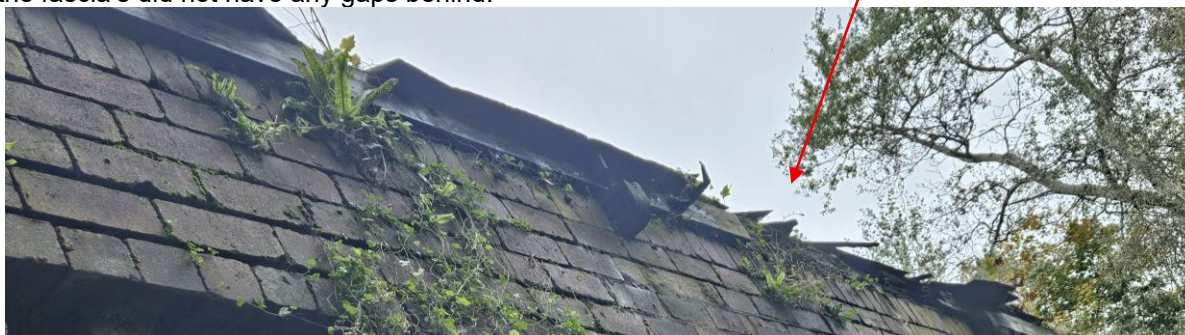
Some slates at the eaves of the brick wall where the fascia is missing have slipped. Where present the fascia's did not have any gaps behind.

It is suggested that an emergence survey be carried out between April - Sept prior to the removal of the roof to ensure no bats are present.

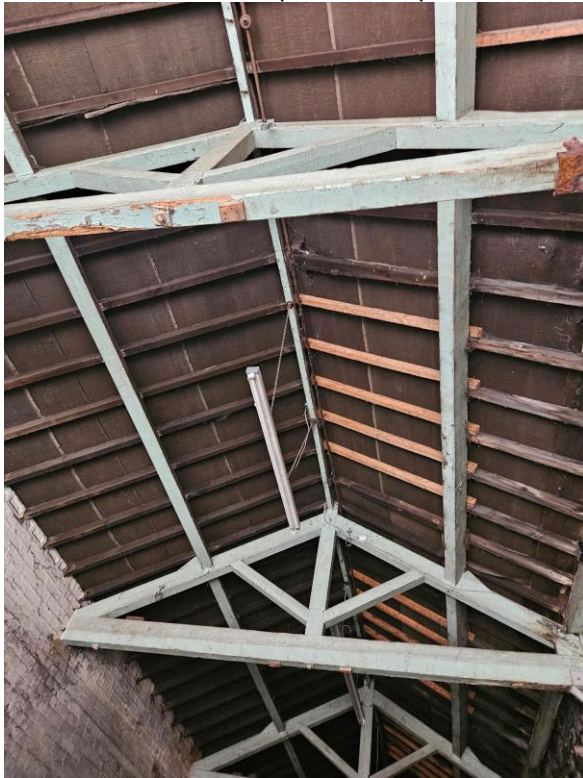
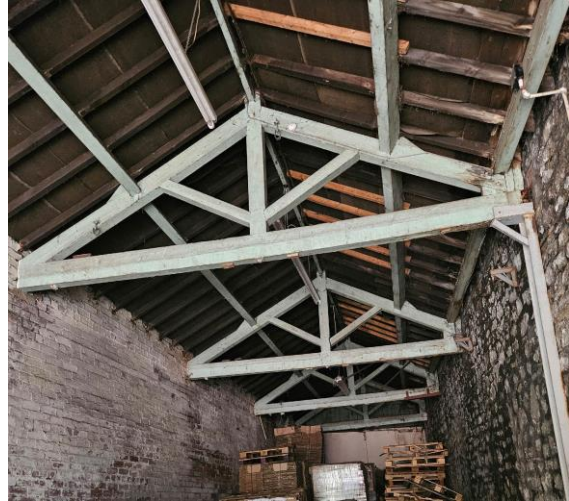
There was no enclosed roof void in the building. The timber trusses, purlins and rafters are all in reasonable condition with no signs of rot, cracks or crevices. Felt underlay is present which is in good condition with sealed laps and no rips or tears.

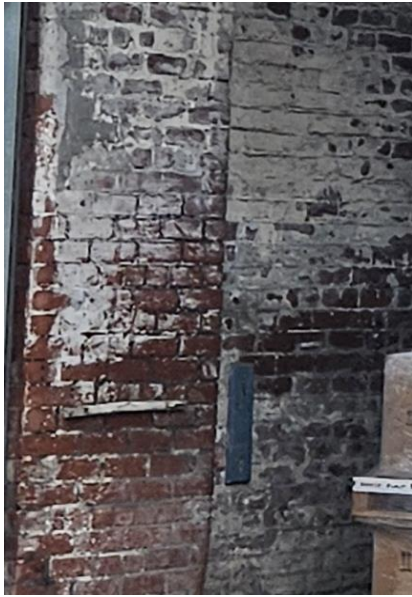
Both walls were examined internally for any crevices or cracks with the potential to provide roost habitat. The Brick wall was well pointed with a whitewash finish in some areas. The stone wall which will be re-exposed after the removal of the brick structure is well pointed. Neither wall provides any roost habitat for bats.

Brick wall internal

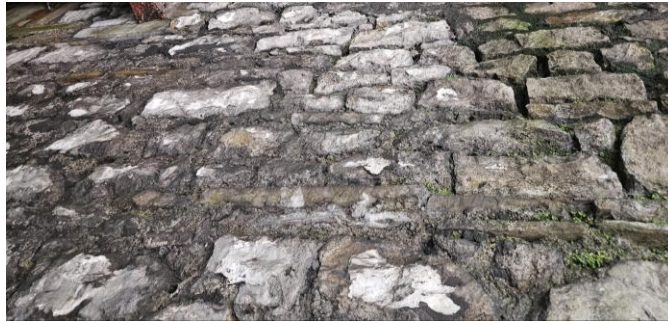
Stone mill wall (retained)
