**BAT SURVEY, AT -
18 Accrington Road
Whalley**

REFERENCE NO 7261

Demolition of former Motor services garage prior to construction of new office development.

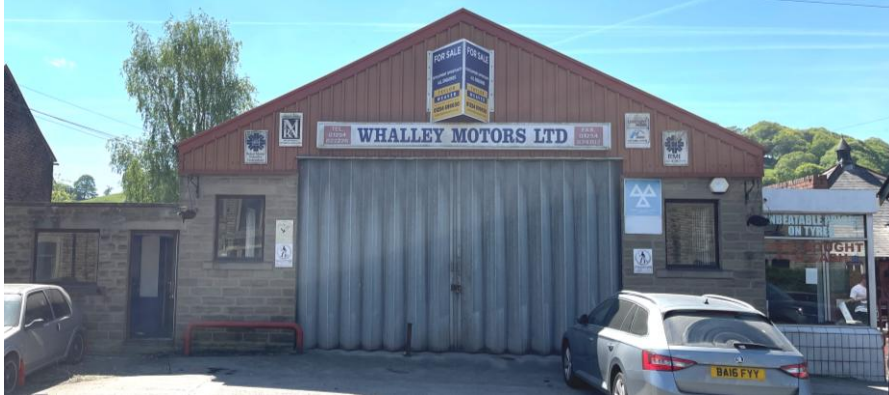
The front (north facing) elevation is single storey.

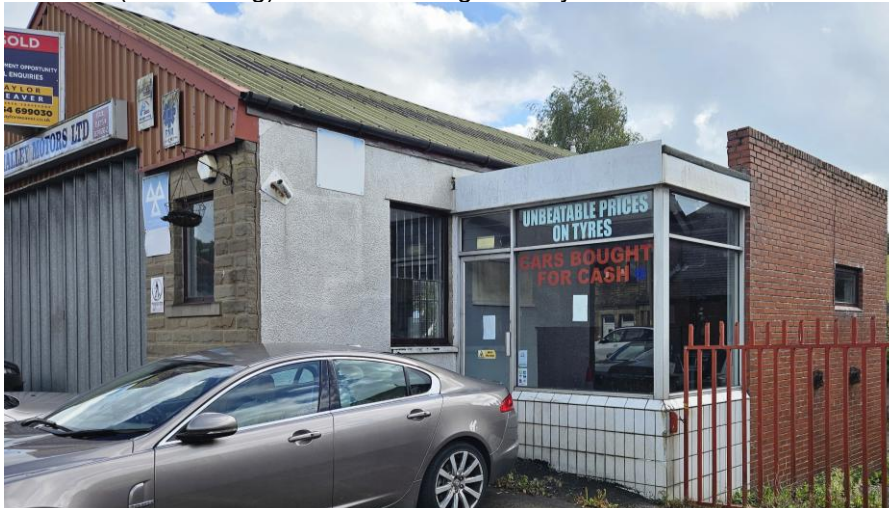
Part side (west) elevation

The site slopes to the rear allowing for 2 storeys' (restricted height). A small single storey mono pitch roof extension is present to the rear elevation.

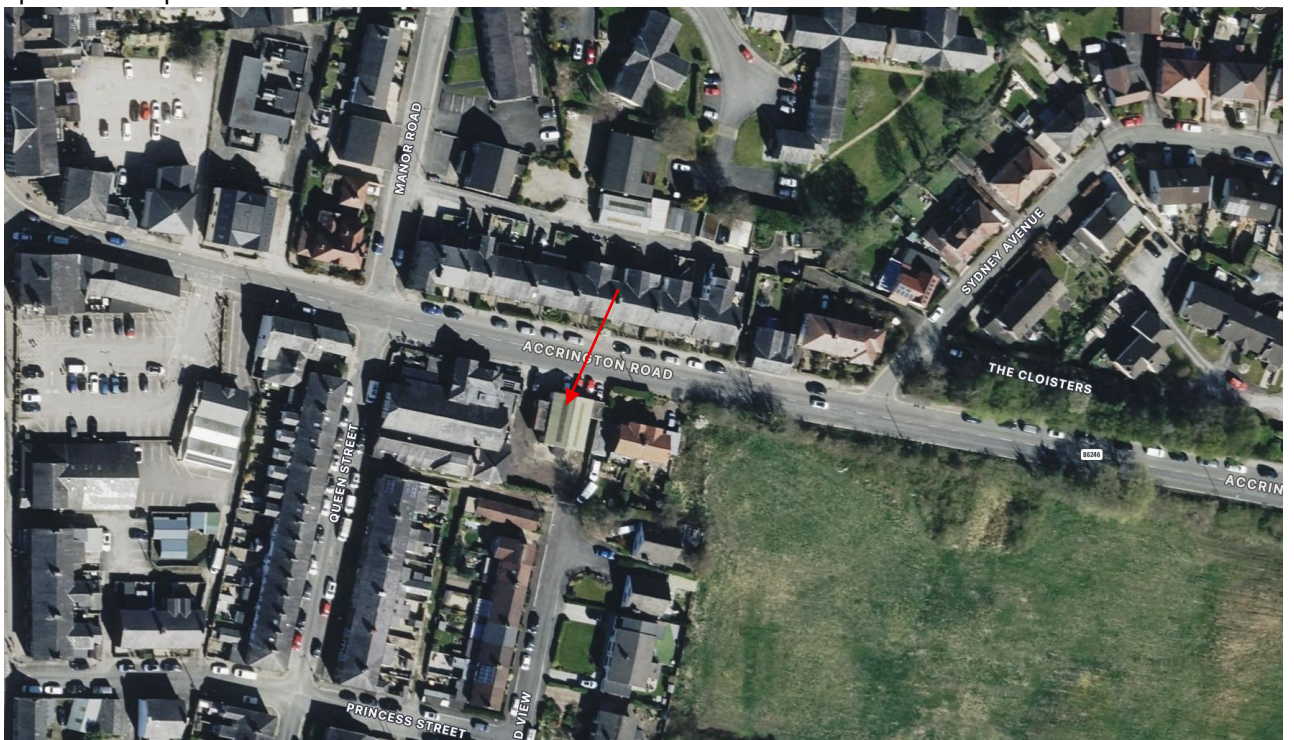
The building is located directly on Accrington Road on a plot of land which is all hardstanding. It is located between 'The Aviary Bar' to the west and a semi-detached dwelling to the east. Directly to the rear (south) there are further residential properties, and the village commercial centre is to the west. A field is 31m to the east which is bound adjacent to the road with a hedgerow extending towards a wooded area 242m to the west which borders the river Calder which is 185m to the south. Whilst the greater locality has a good level of forage potential, the immediate locality provides sub optimal roost potential.

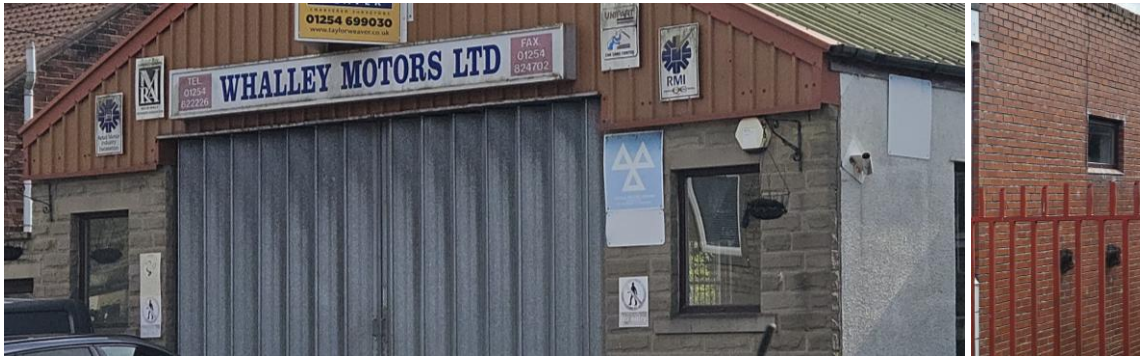
The walls are brick with a rough cast render finish to the sides and rear. The front has been partially clad with artificial stone and corrugated steel to the gable. A brick wall is present to the west side elevation.

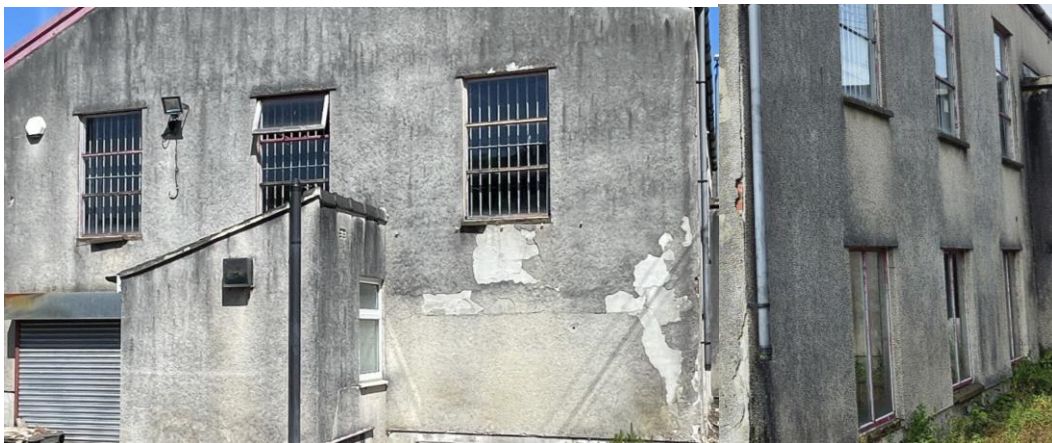
Whilst the walls are aged the render did not provide any cracks or crevices with the potential to provide bat roost habitat. The brick wall is in good condition and does not provide any access points for bats.

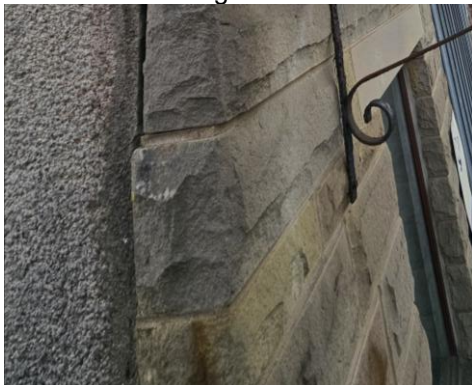
The stone cladding is reasonable condition with no gaps or crevices;

However the northeast corner has pulled away from the wall slightly it was closely examined and was found to not provide roost potential. The abutment of the steel cladding with the wall is very tight fitting.

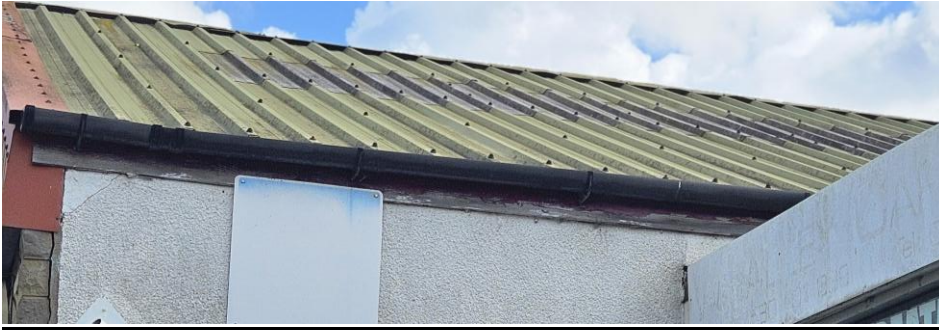
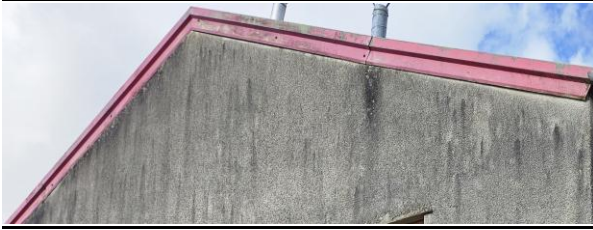
The main pitched roof is corrugated steel sheet with a clear upvc sections, a timber fascia board fixed flush to the wall. There is a steel verge trim to the front and rear gable.

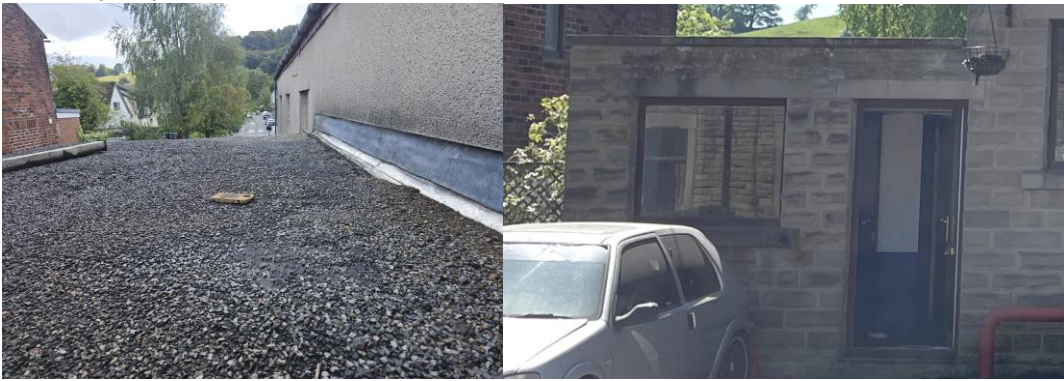
The flat roof to the east side is felt with a gravel finish with lead flashing at the abutment with the wall and the parapet wall to the front elevation.

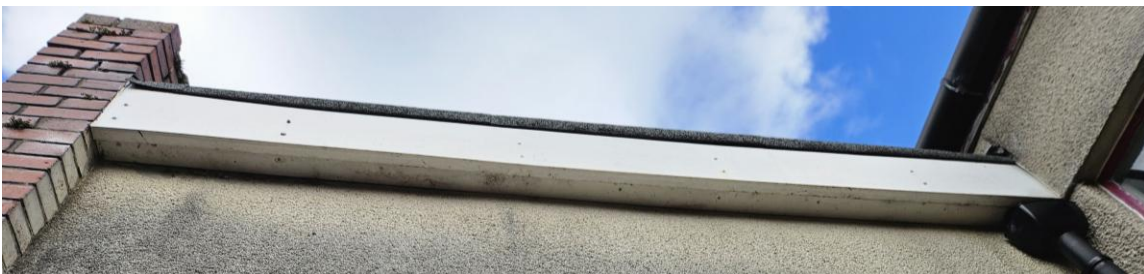
West side flat roof extension has a felt roof covering with upvc fascia's to the front and rear.

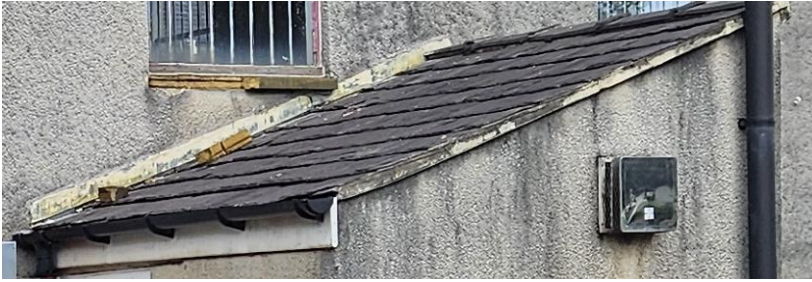
The small extension to the rear has a mono pitch slate **roof** with pointed verges, flashings and ridge tiles Flush fitting fascia's to the eaves

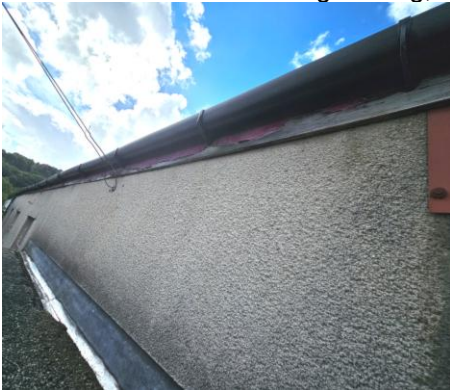
Main roof - the eaves are tight fitting, no gaps present behind the fascia's

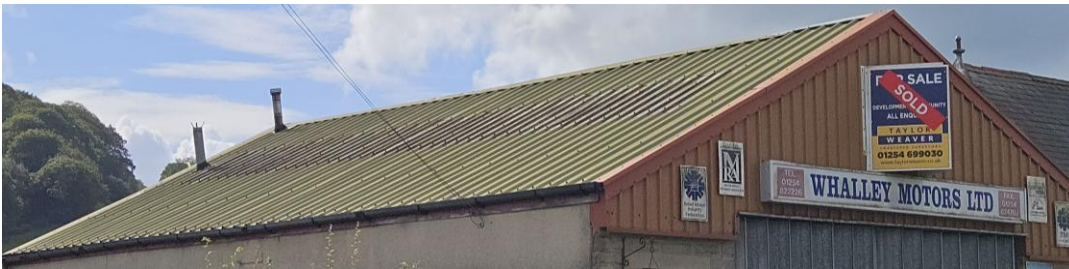
The roof sheeting is in excellent condition as are the ridge and verge trims .no access points were observed.

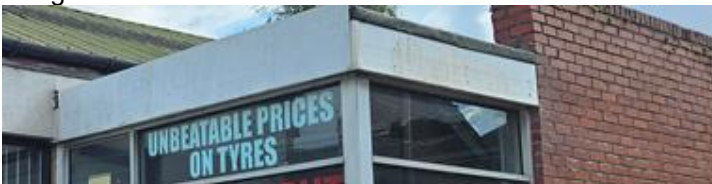
The flashings to the flat roof abutments were in good condition as was the felt no access points, cracks or crevices present. The upvc fascias to the west flat roof are in good condition and very tight fitting.

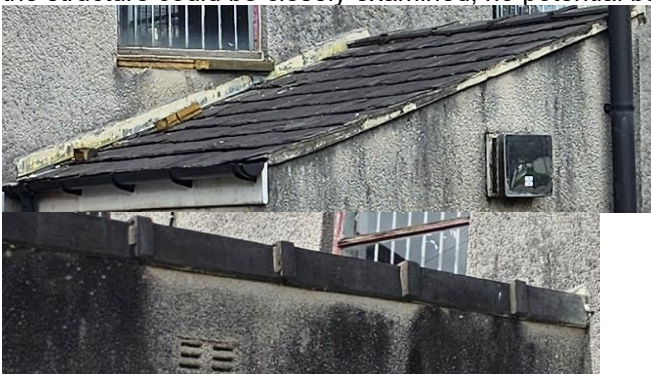
The mono roof is in average condition, the slates are in reasonable condition with no significant gaps the structure could be closely examined, no potential bat roost habitat was found.

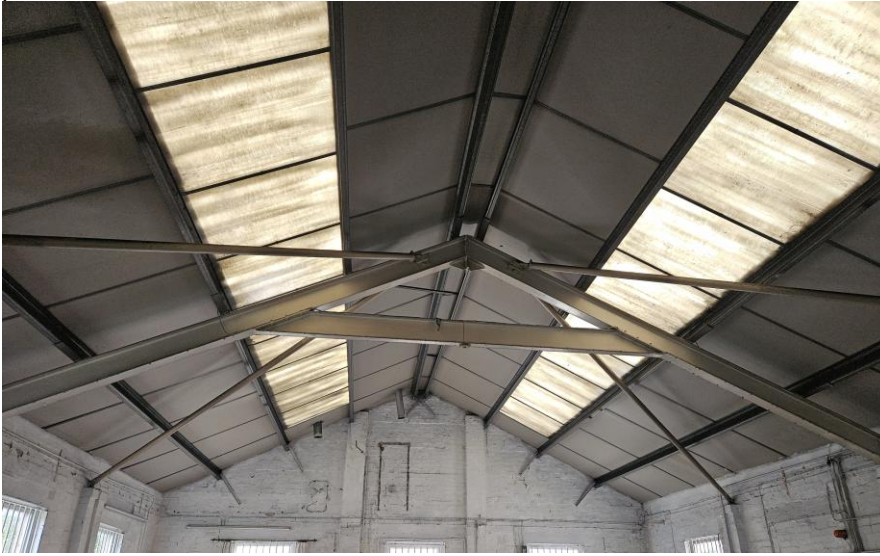
Main roof void Steel structure with insulation cut tight between the structure. Clear panels to allow light. The structure was examined from the ground with Binoculars. The structure did not provide any potential for bats to roost.

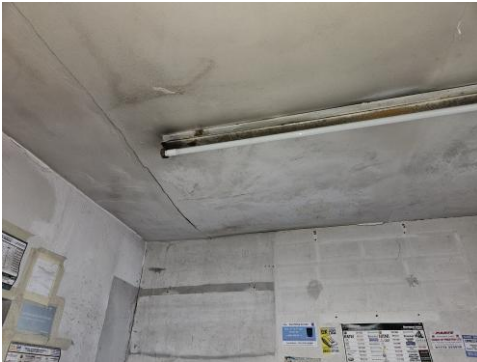
East flat roof section internal

Both flat roof sections have boarded ceilings. The west roof has a section removed it was possible to look between the joists no bat presence found.

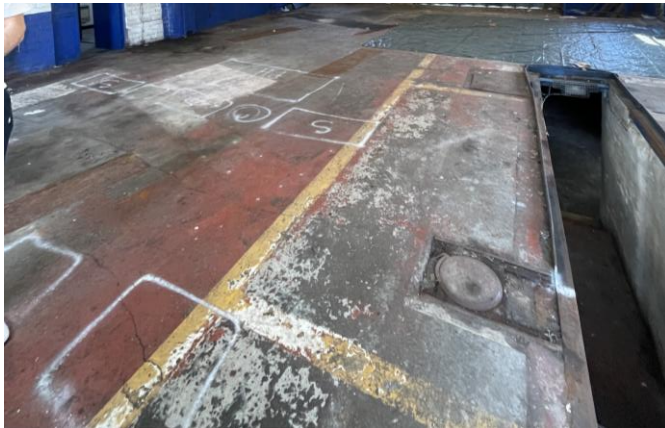
The main building was inspected; the concrete floor was clean with none of the above listed evidence found. The space was devoid of roost potential.

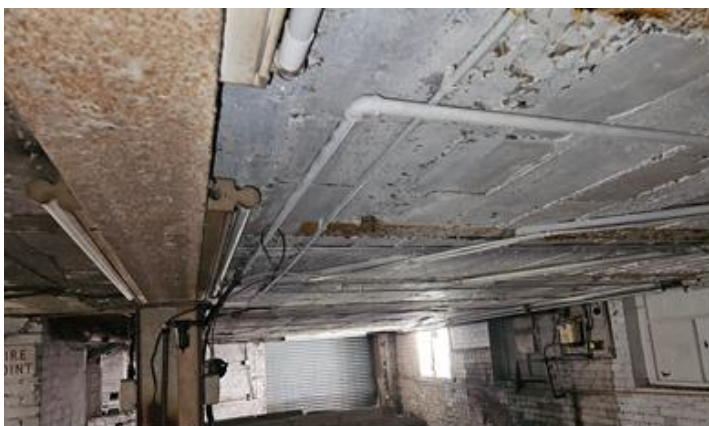
The basement to the building had a concrete ceiling/floor the space was easily examined. The result was negative. The space was devoid of roost potential.

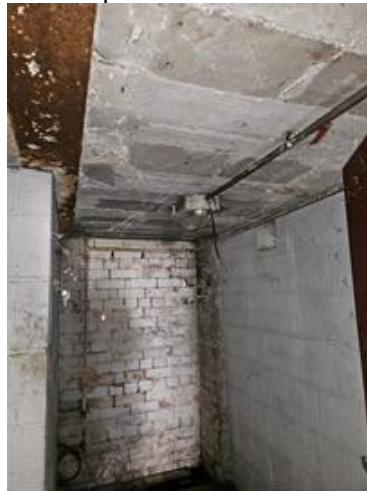
The rear extension interior was inspected for any potential roost habitat. The result was negative no roost habitat present

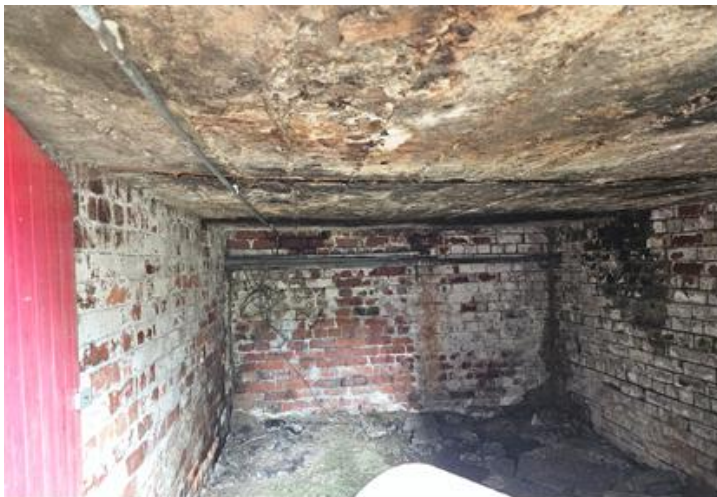
There is an open void under the east side extension which is accessed from the rear. The interior was examined for any cracks or crevices providing any roost potential. The space provided sub optimal roost potential being draughty and damp.
