Bat Survey Report and Method Statement European Protected Species (Bats)

Reasonable Avoidance and Mitigation Measures

**Leagram Mill Farm,
Dinkling Green Lane,
Leagram,
PR3 2QS**

19.10.2025

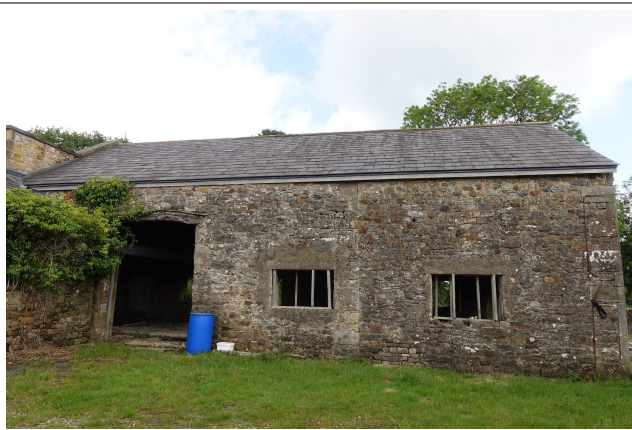
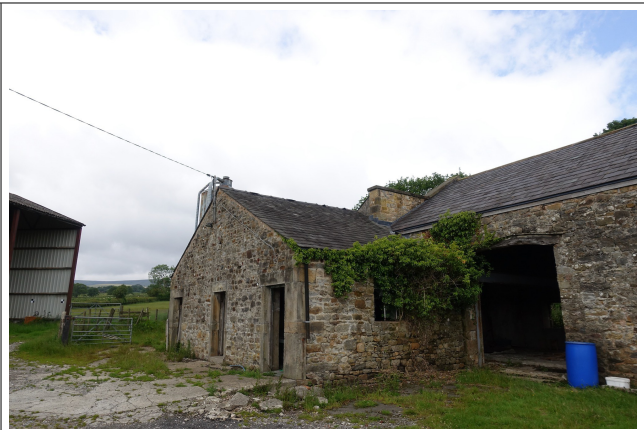
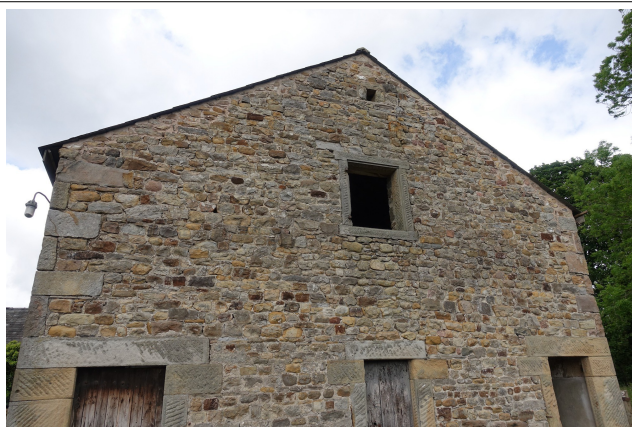
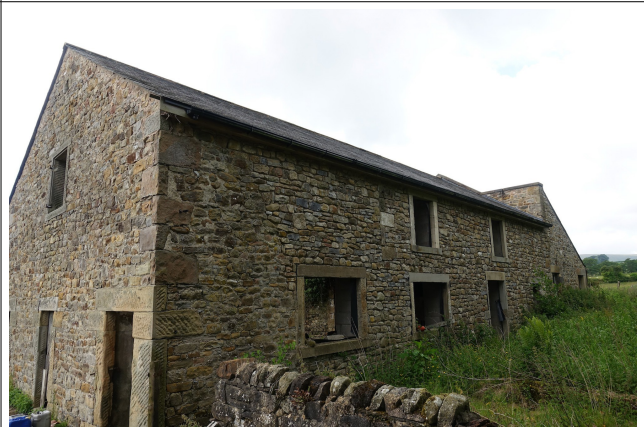
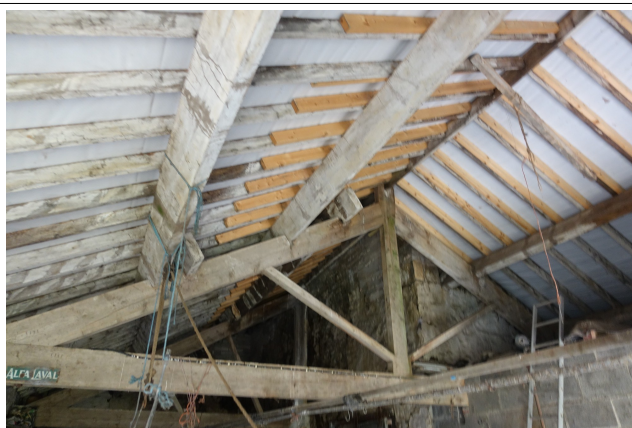
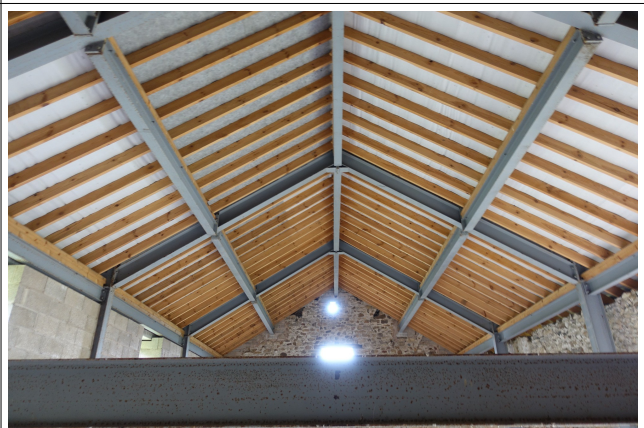
The building consists of a detached stone built barn with double pitched slate roofs.

External walls are generally well pointed, however cracks, gaps and crevices were observed on external facades. The building has open windows, door ways and breathe holes allowing access to the interior. The main barn has modern steel frame and concrete block interior wall suggesting recent renovation works. Roof slates are generally close fitting and well sealed. Roof slates are lined with a modern breathable membrane resulting from reroofing works in 2018. The roof is exposed to the interior, with open windows and doorways allowing illumination to the interior.

The building was assessed as offering moderate potential for roosting bats when condition of the building and location were taken into consideration.

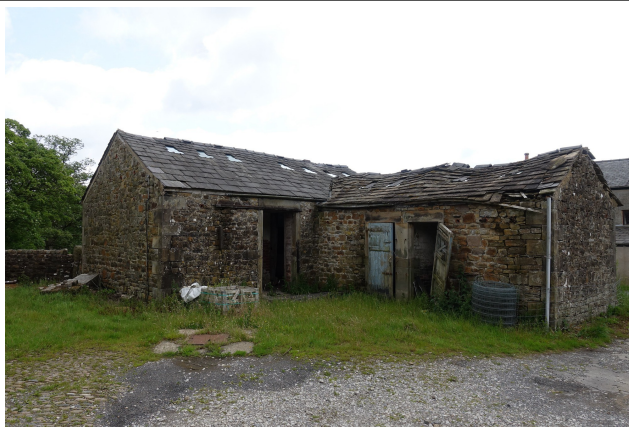
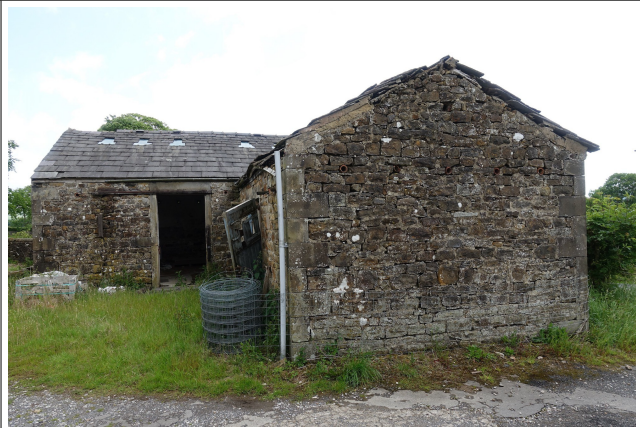
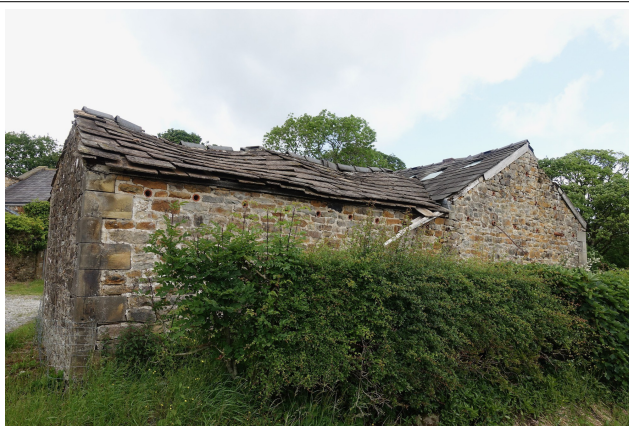
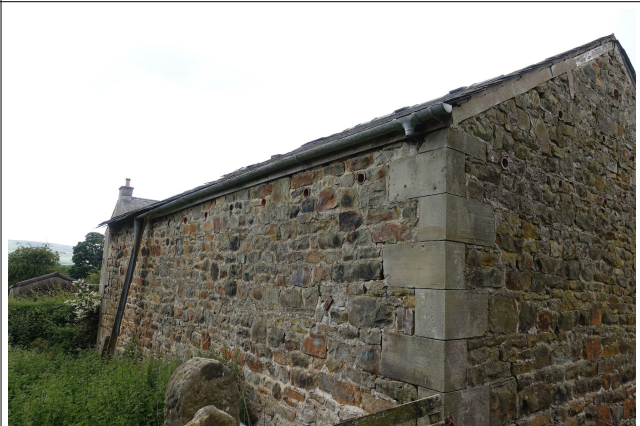
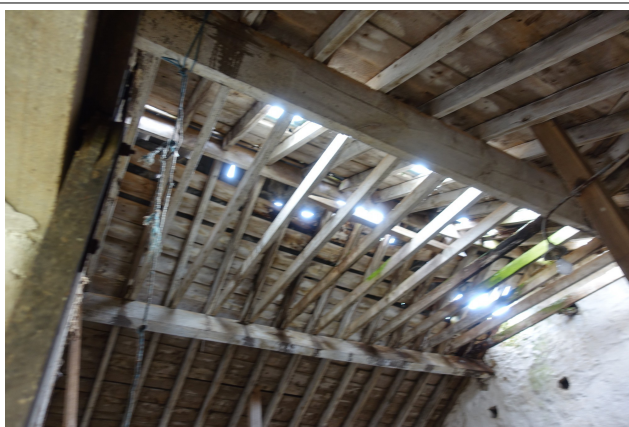
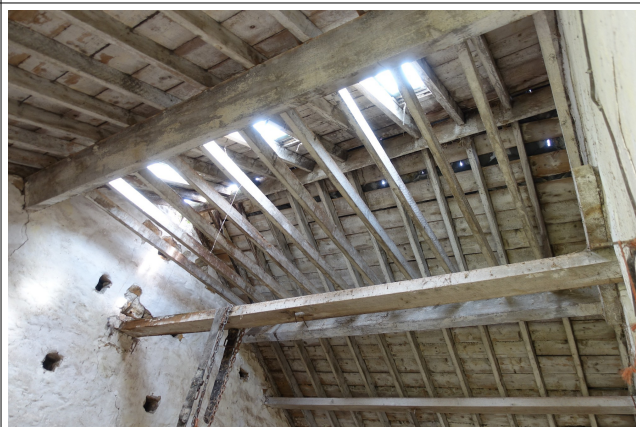
Outbuilding.

An L shaped stone built single storey outbuilding with double pitched slate roofs is present to the south of the main barn.

External walls are generally well pointed and sealed, however gaps were noted on the west facing gable end. Roof slates are in poor condition with areas of slumping and slipped and missing slates resulting in weather and light penetration to the interior. Timber sarking is present below roof slates.

The outbuilding was assessed as offering low potential for roosting bats..
