**BAT SURVEY, AT -  
2 TINTERN CLOSE  
SIMONSTONE**

REFERENCE NO 10-32

Two storey side extension. extension to existing house. And removal of existing single storey rear outshot.

The property is a detached 1 ½ storey House possibly dating from the 1960 /70s

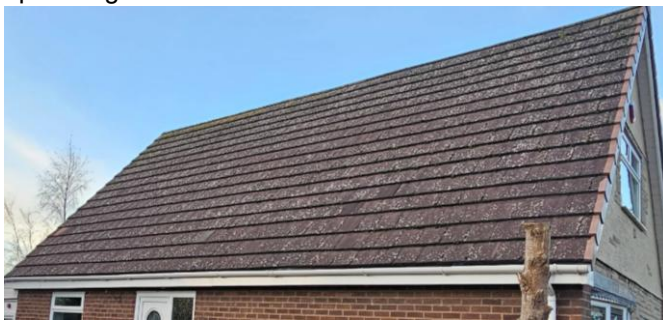
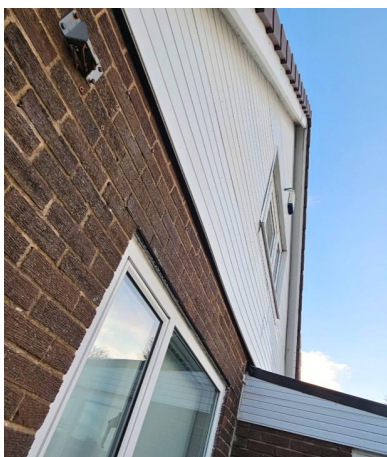
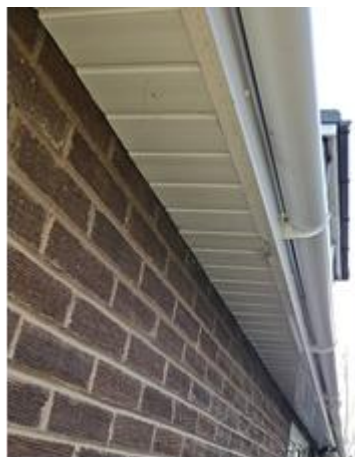
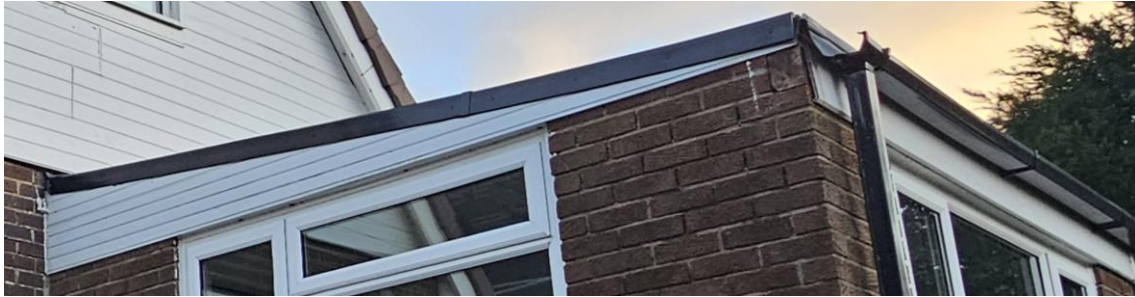
The roof is pitched with a tile finish and ridge tiles. Upvc fascia and barge boards project slightly from the walls with a boarded effect upvc soffit. The dormer roof present on the west elevation and the single storey flat roof both have a membrane finish with flush fitting upvc fascias. The gables have a upvc verge trim.

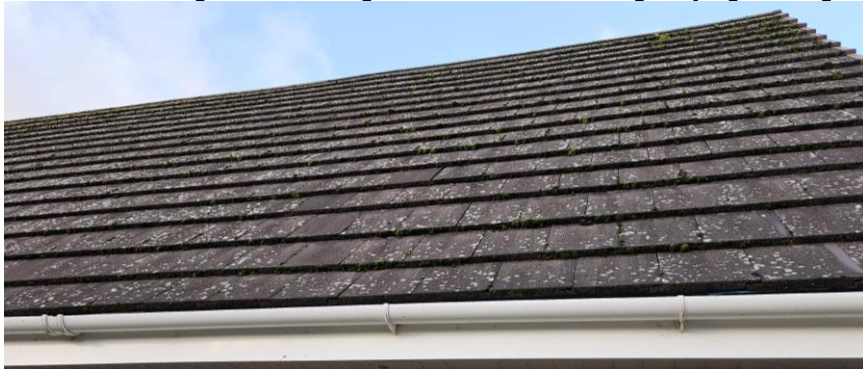
The tiles and ridge tiles are in good condition, all being very tight fitting with no slipped slates or gaps.

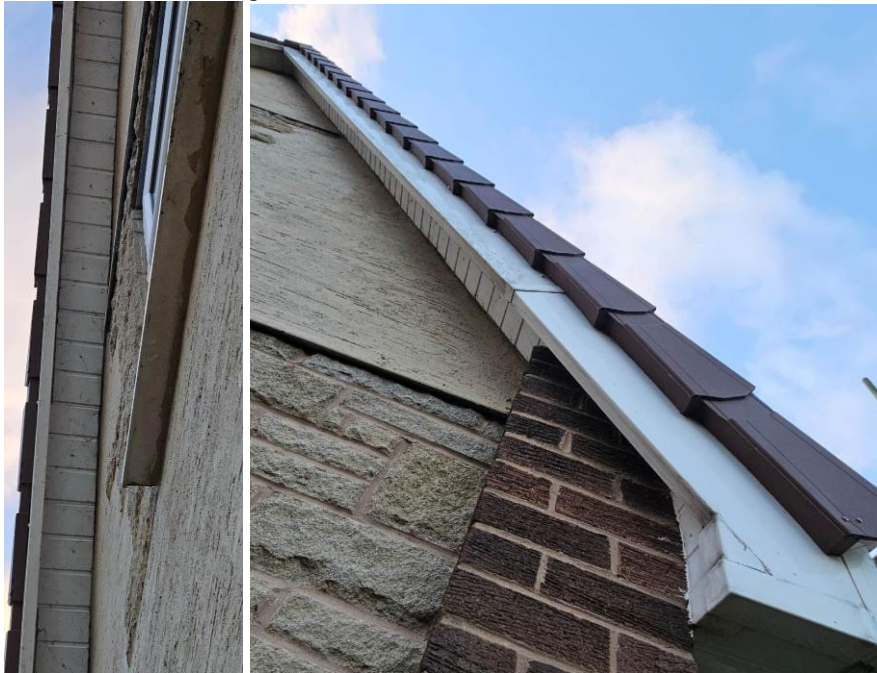
The soffits to the barge boards and fascias are in excellent condition and very tight fitting.

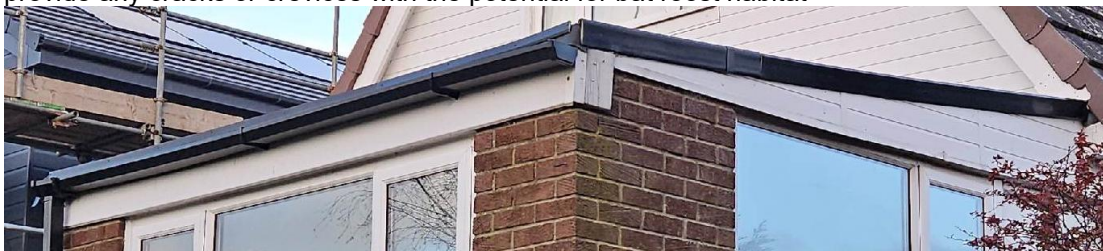
The upvc trim to the gable verge is in good condition and does not provide any access points. The flat roof structure was in excellent condition and could be closely inspected, it was found not provide any cracks or crevices with the potential for bat roost habitat

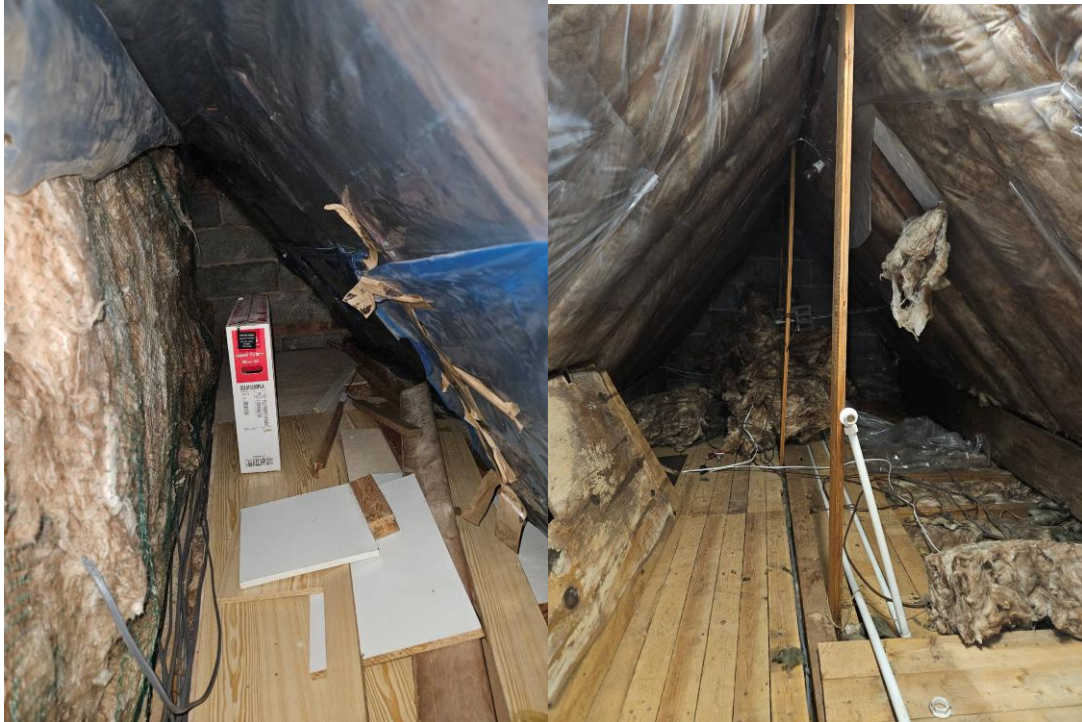
Three roof voids were present in the building, all were accessible. Ceiling access to the under-ridge void, the rafters have quilt insulation between, quilt is also present between the ceiling joists. The space is clean the boarding to the floor is free of any droppings or insect remain feeding evidence.

The two eaves' voids were accessed via wall hatches, insulation etc as before. The space is clean the boarding to the floor is free of any droppings or insect remain feeding evidence. The voids had no evidence of current or historic bat presence. They did not provide any potential habitat for void roosting bats
