BAT SURVEY, AT -

4A WISWELL LANE
WHALLEY

DATE AND TIME OF VISIT
9th Oct 2025 10.00am

REFERENCE NO 7302

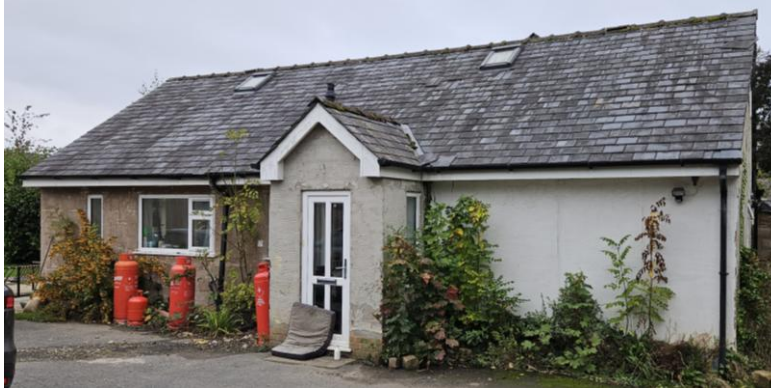
East Elevation

The building is a bungalow with a lined-out roof space for storage built around 20 years ago. It is attached at right angles to an adjacent house with a pitched roof on the west elevation.

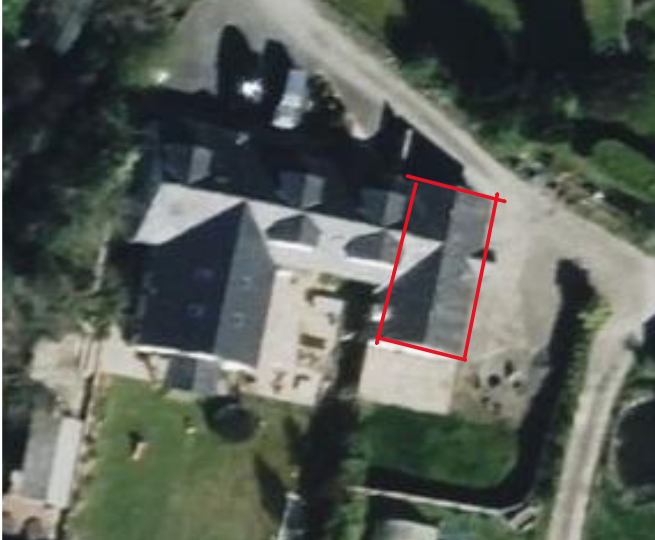
The section of roof affected by the proposed extension.

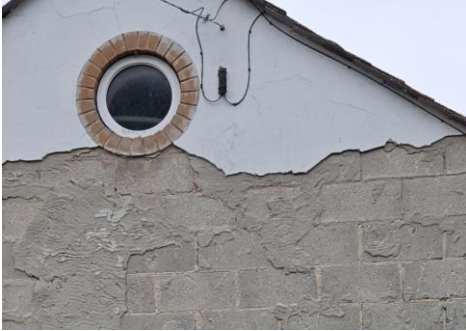
Being a relatively new construction the walls are concrete block with a smooth white painted render finish. Some of the render has been removed very recently.

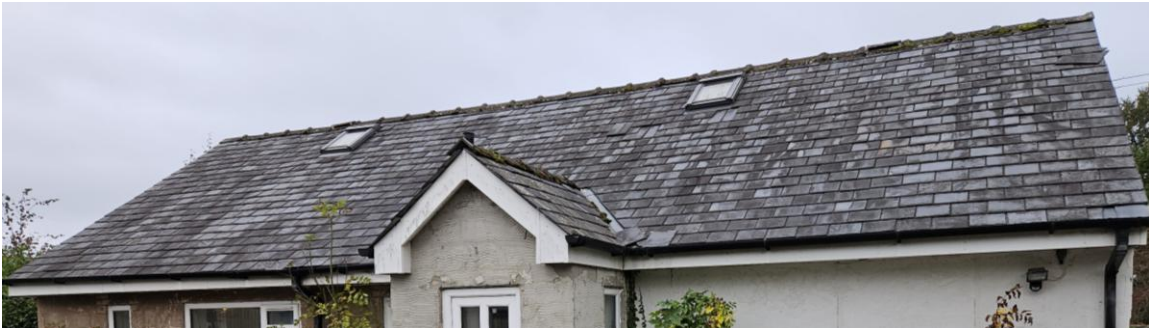
The roof is blue slate pitched with a small, pitched roof to the front (east) elevation porch. There is a pitched connecting roof on the rear (west) elevation. Roof lights are present in the east pitch. Upvc soffits and fascia's are present at the eaves. The gable verges are pointed.

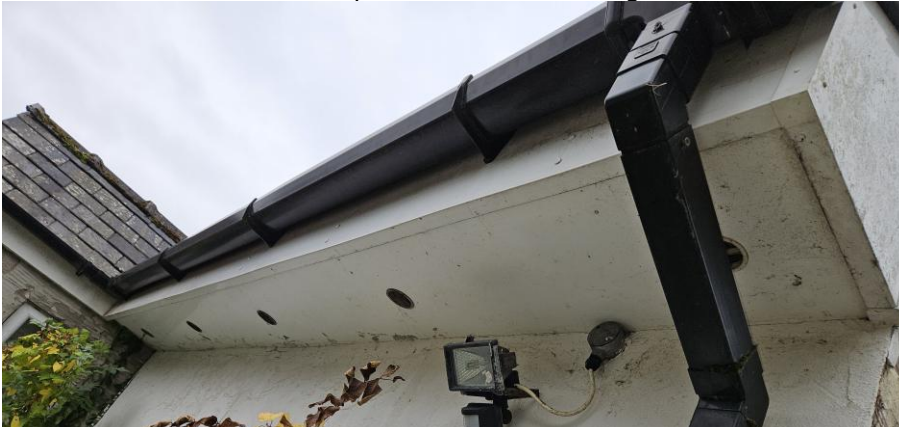
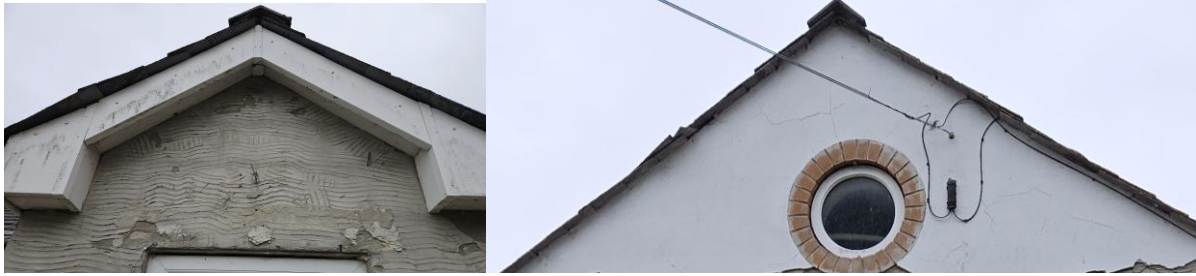
The blue slates are in good tight-fitting condition. The pointing to the ridge tiles was in good condition. The fascia's and soffits are in perfect condition with tight abutments. The verges are tight fitting.

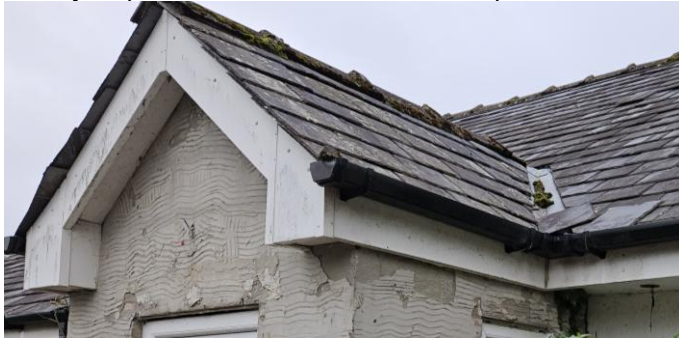
There is a single slipped slate at the abutment of the porch roof with the main roof, it was possible to closely inspect with the aid of an endoscope. No current or historic bat presence was evident.

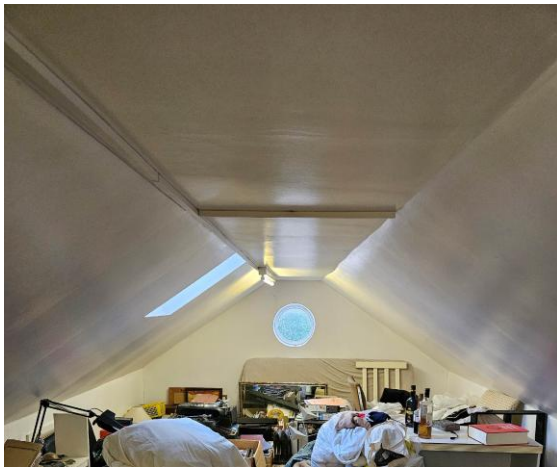
The roof space of the property is plaster boarded, and floor boarded with windows to the gables and roof windows in the east pitch. Small voids are present at the eaves which could be inspected from hatches.

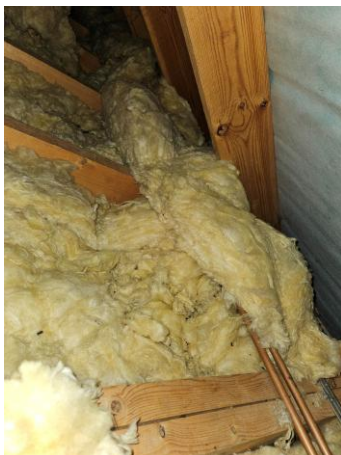
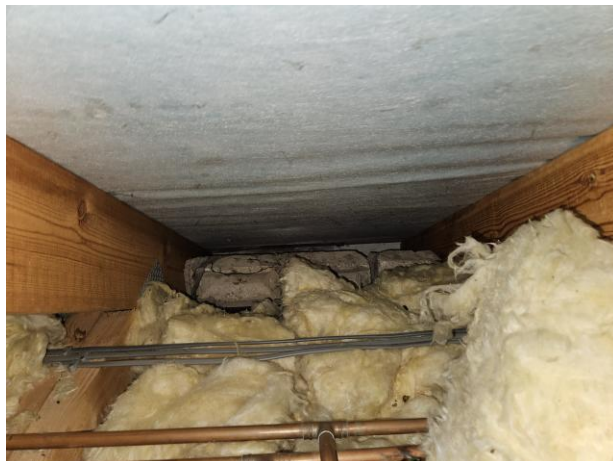
The eaves voids timber structure was in excellent condition as was the underlay which was clean. No evidence of bat presence was found.
