Phase 2 Intrusive Site Investigation

17 November 2025

Parsonage Farm, Church Street, Ribchester, PR3 3YE

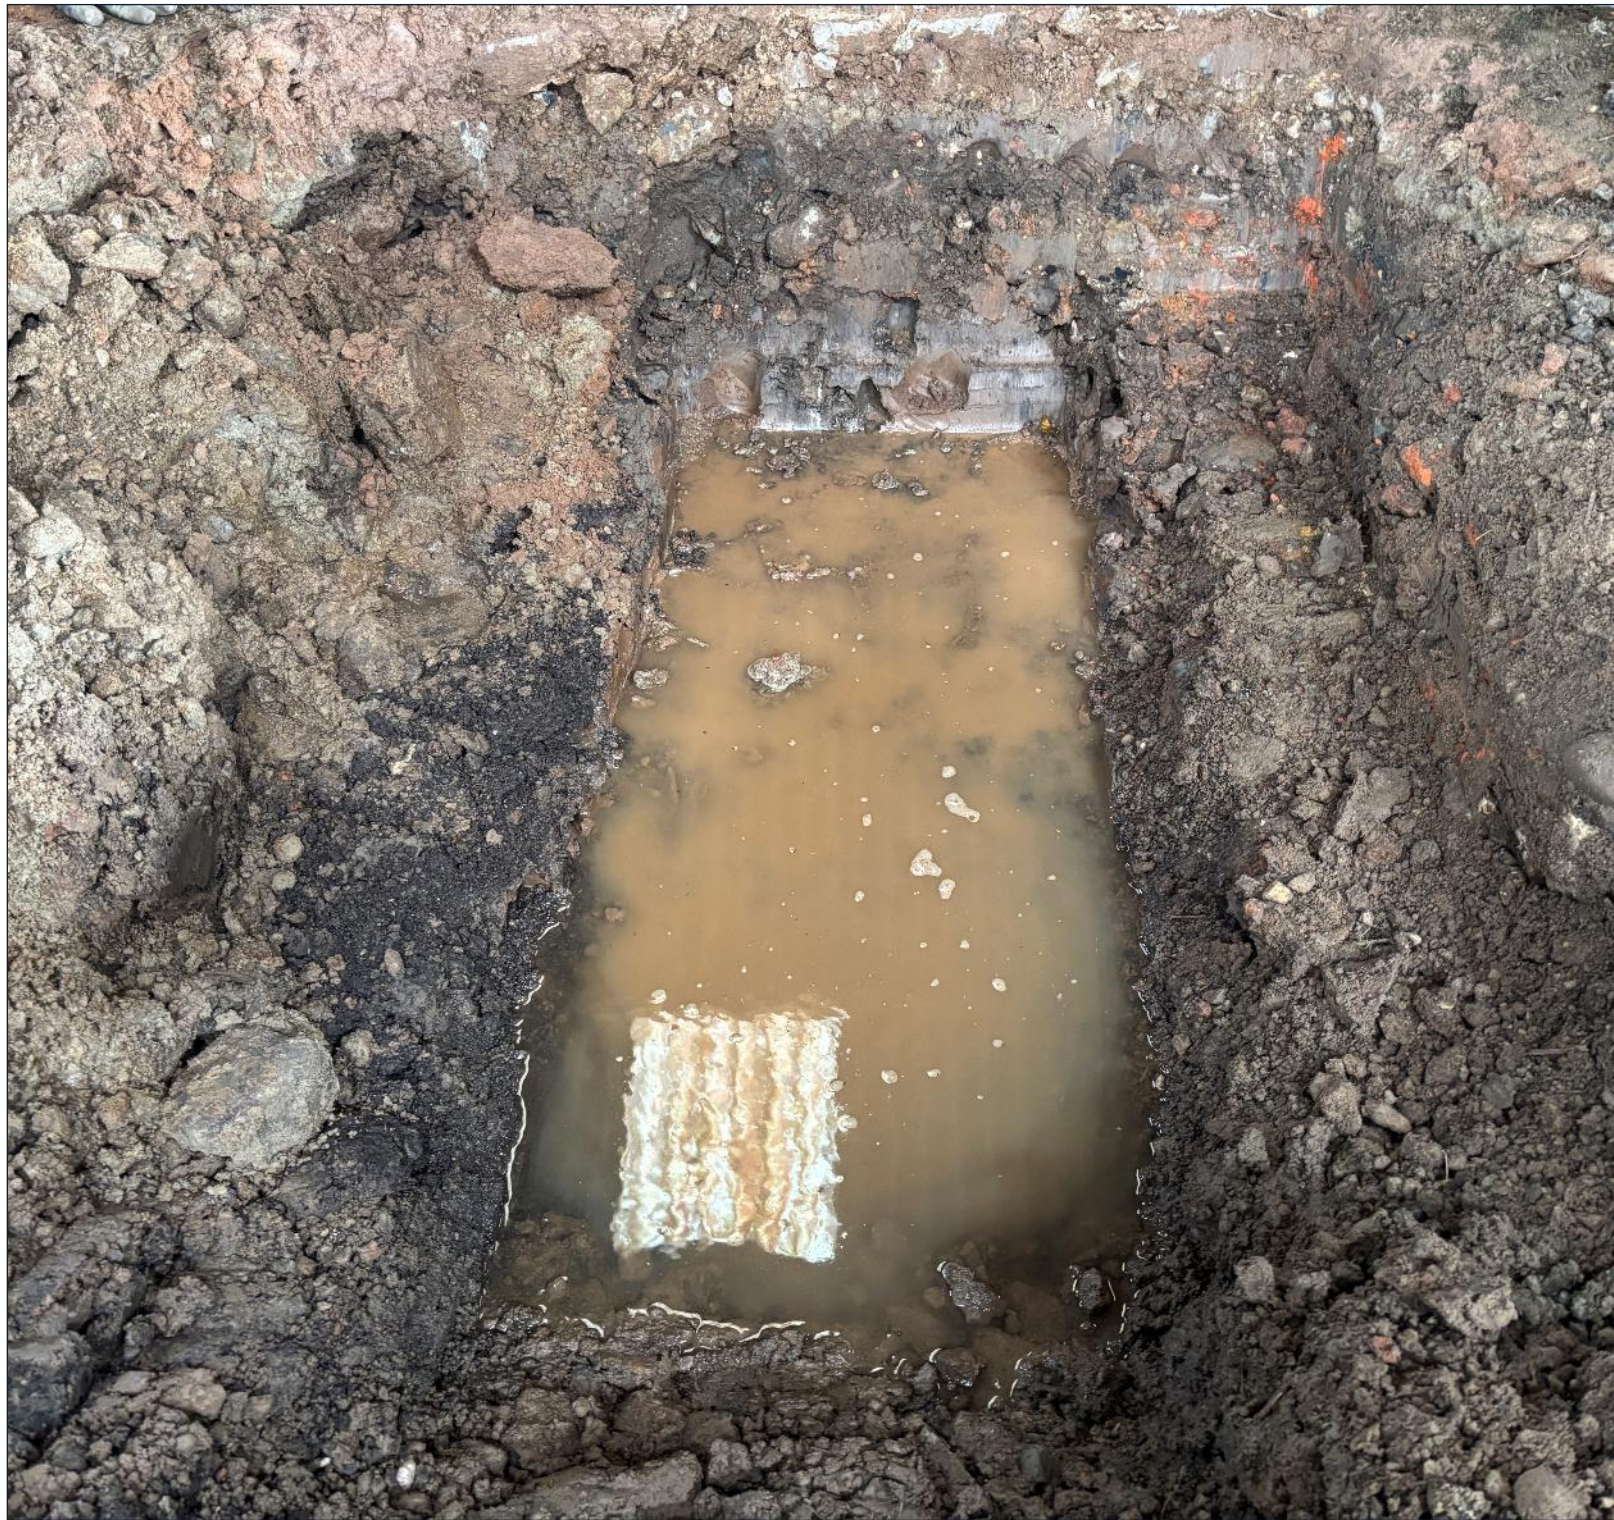
Ground conditions identified in trial pits TP01 and TP02 comprised concrete overlying made ground to a depth of 0.40m and medium brown clay with occasional gravel to the bottom of the trial pit at 0.70m.

Appendix - Site Photos
Description
Photo showing trial pit TP01
Sources
Oakshire Environmental

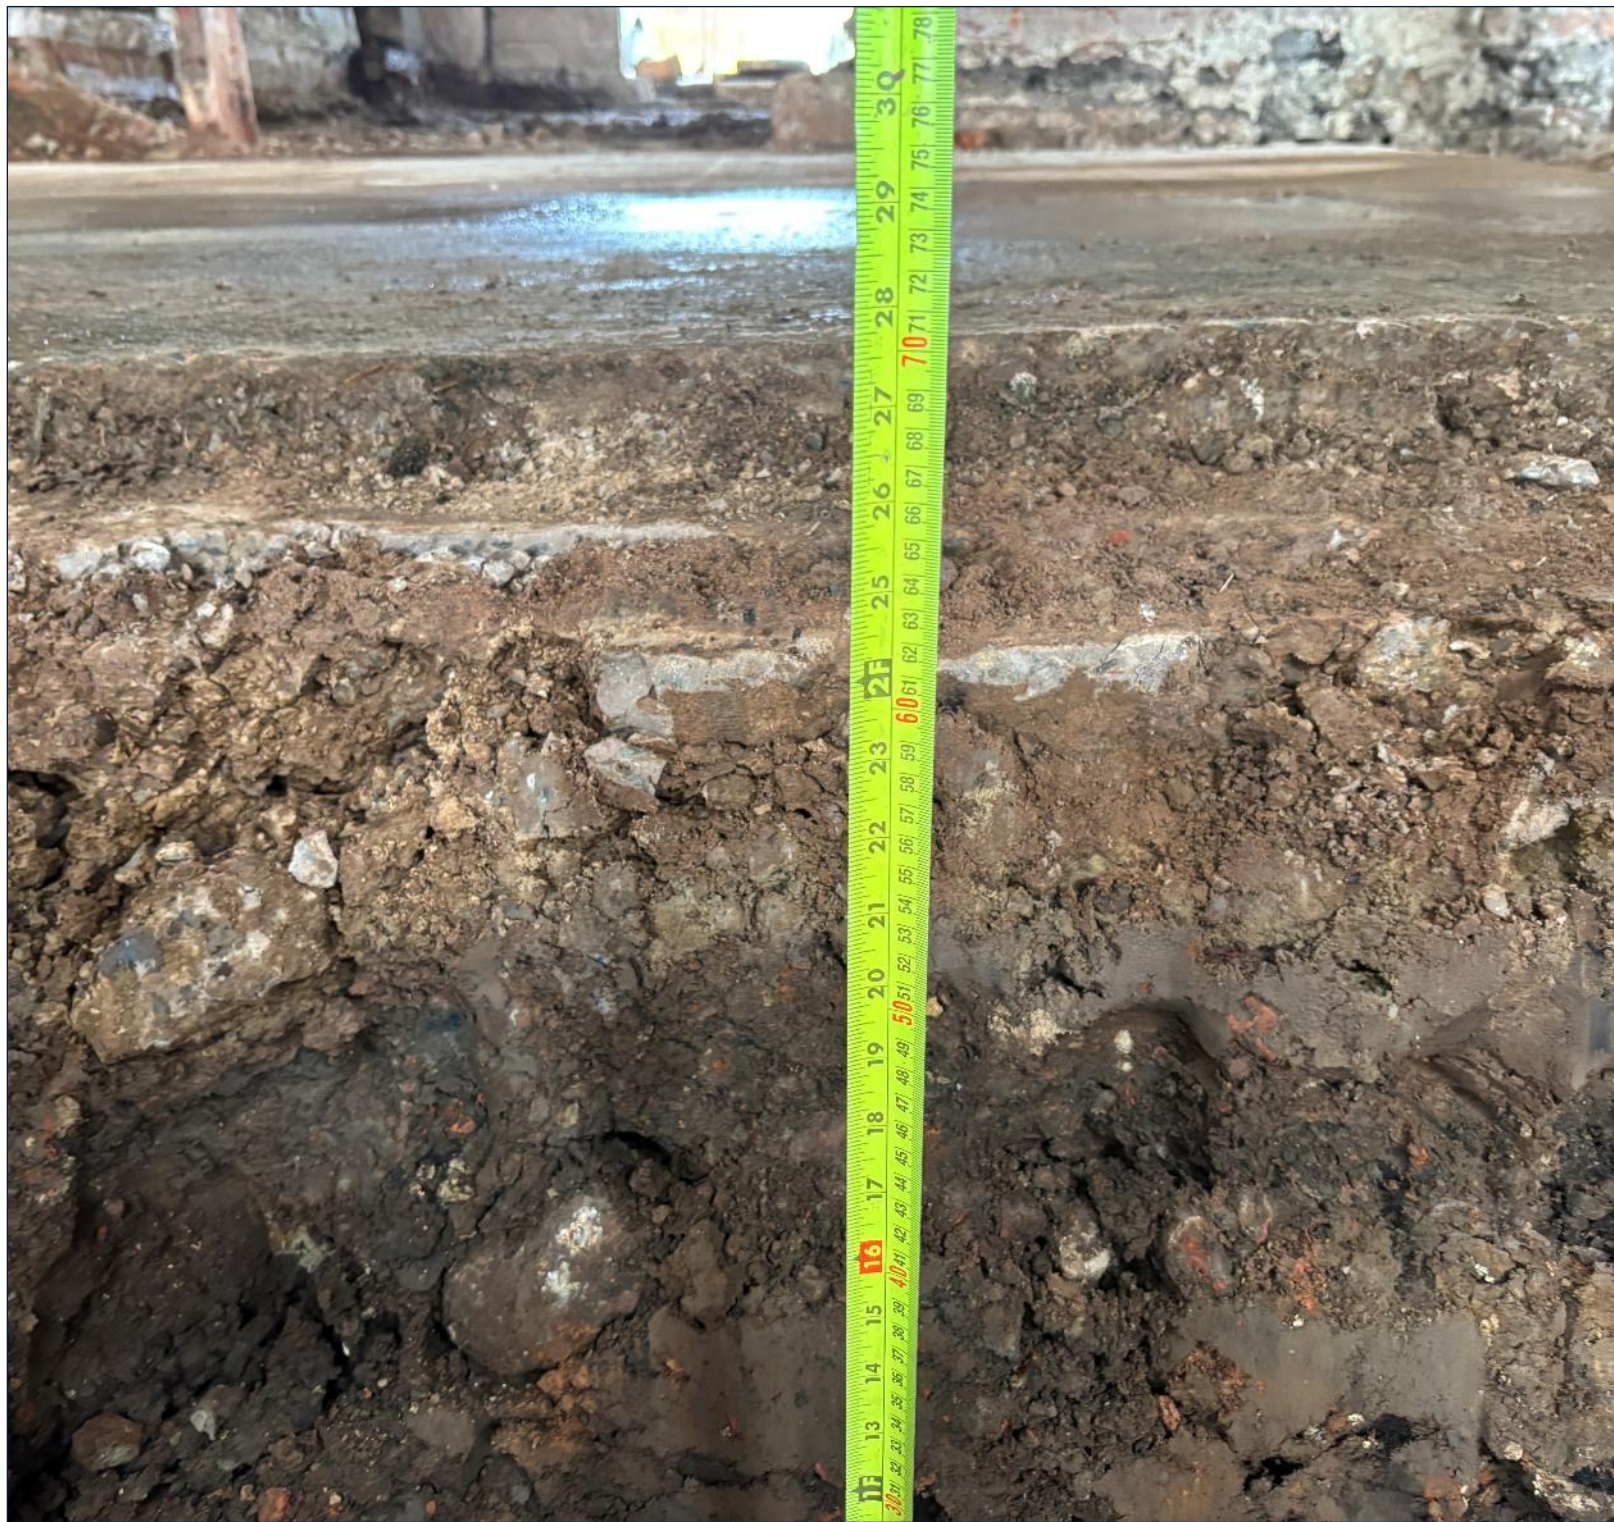
Appendix - Site Photos	
Description	
Photo showing the depth of trial pit TP01	
Sources	
Oakshire Environmental

Site	Parsonage Farm, Church Street, Ribchester, PR3 3YE		Reference	TP01	Appendix - Ground Conditions		
Samples		Description of Strata		Thickness (m)	Depth (m)	Symbol	
Depth (m)	ID						
0.20	S01	Concrete		0.10	0.10		
		Dark brown sandy CLAY with gravel and brick, concrete and wood fragments (MADE GROUND)		0.40	0.40		
0.60	S02						
		Medium brown CLAY with occasional gravel		0.30	0.70		
Remarks and comments							
Surface water pooling, no groundwater identified

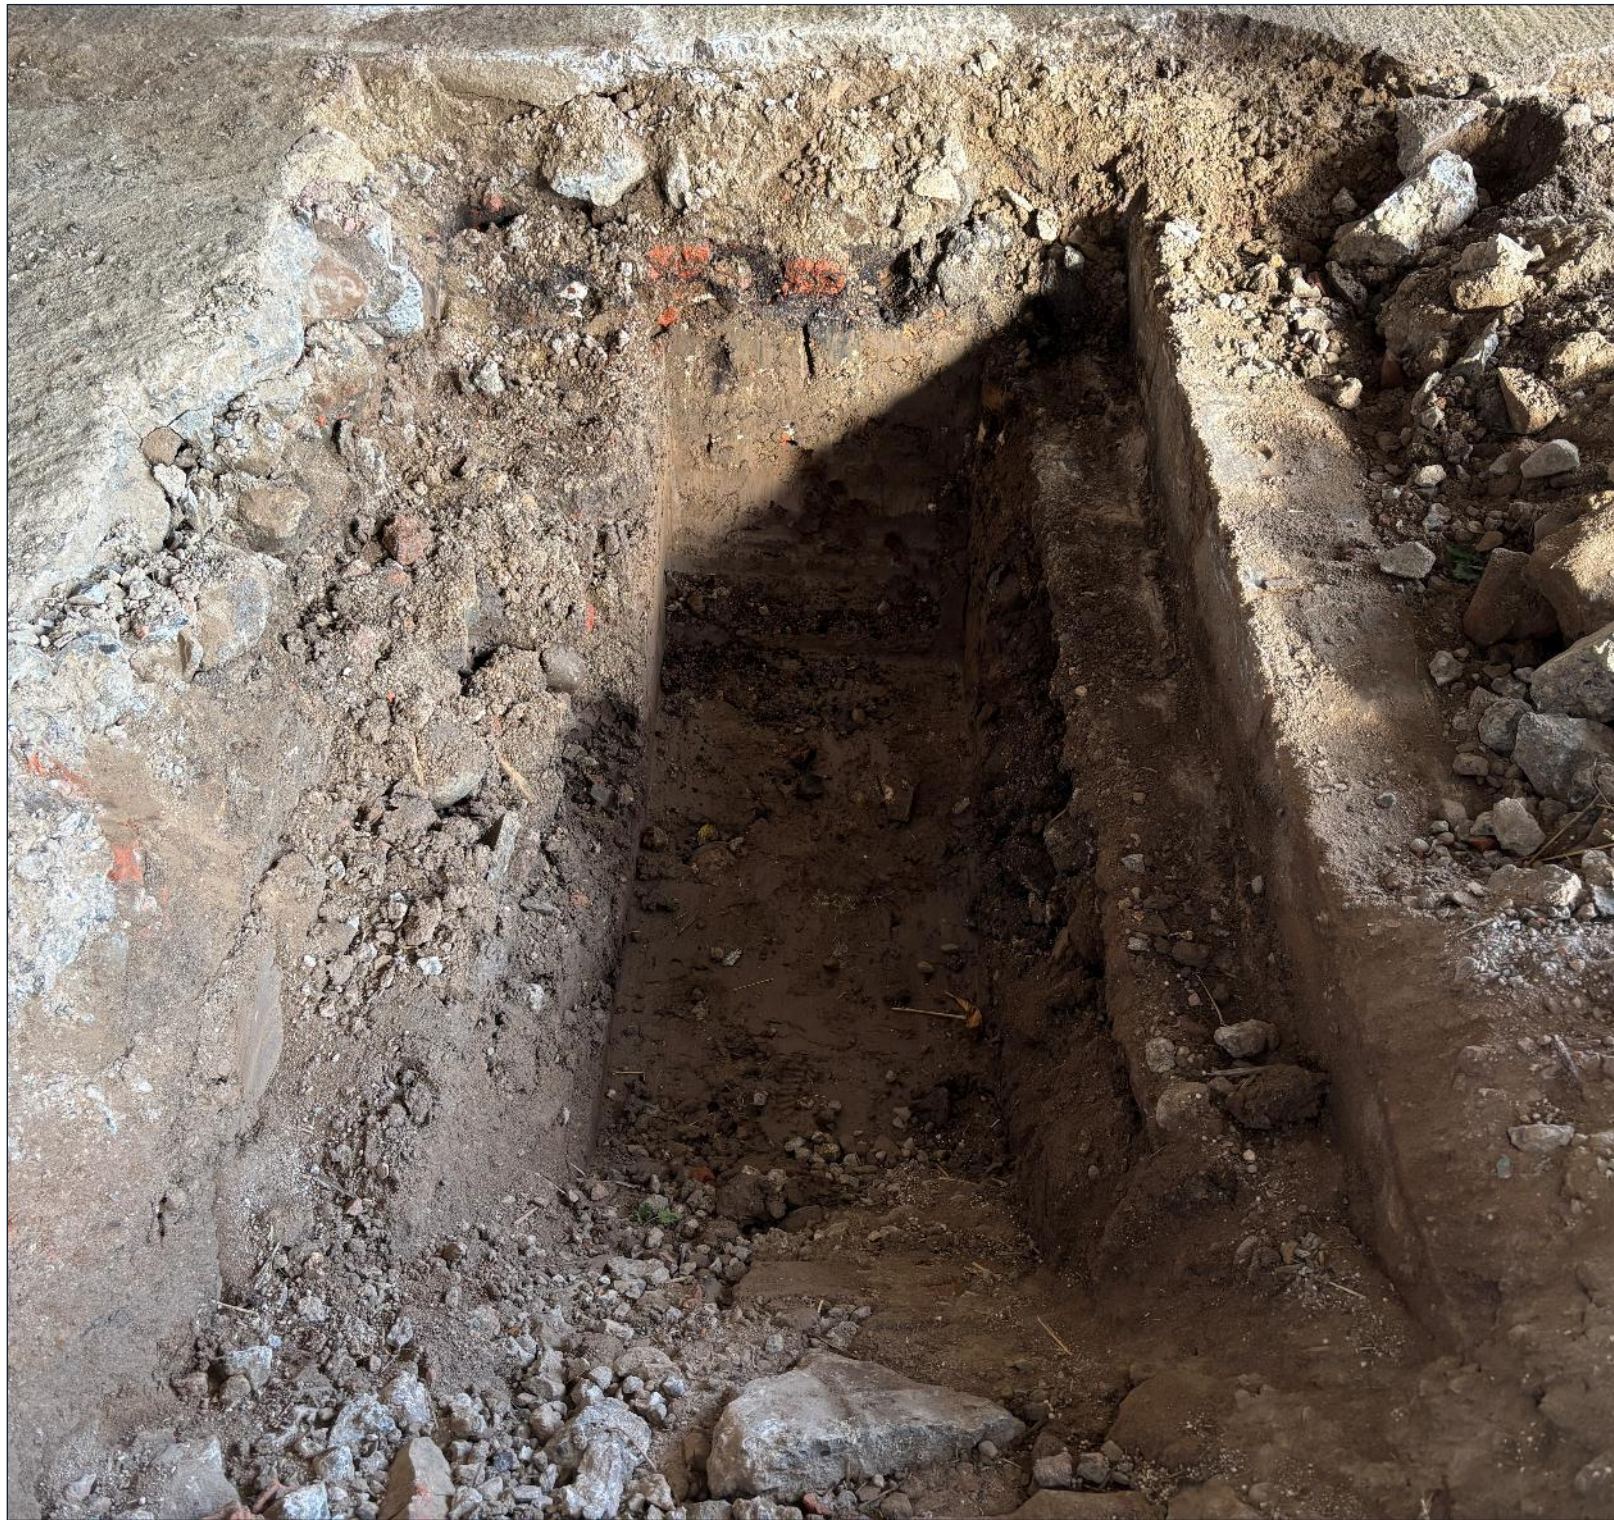
Appendix - Site Photos
Description
Photo showing trial pit TP02
Sources
Oakshire Environmental

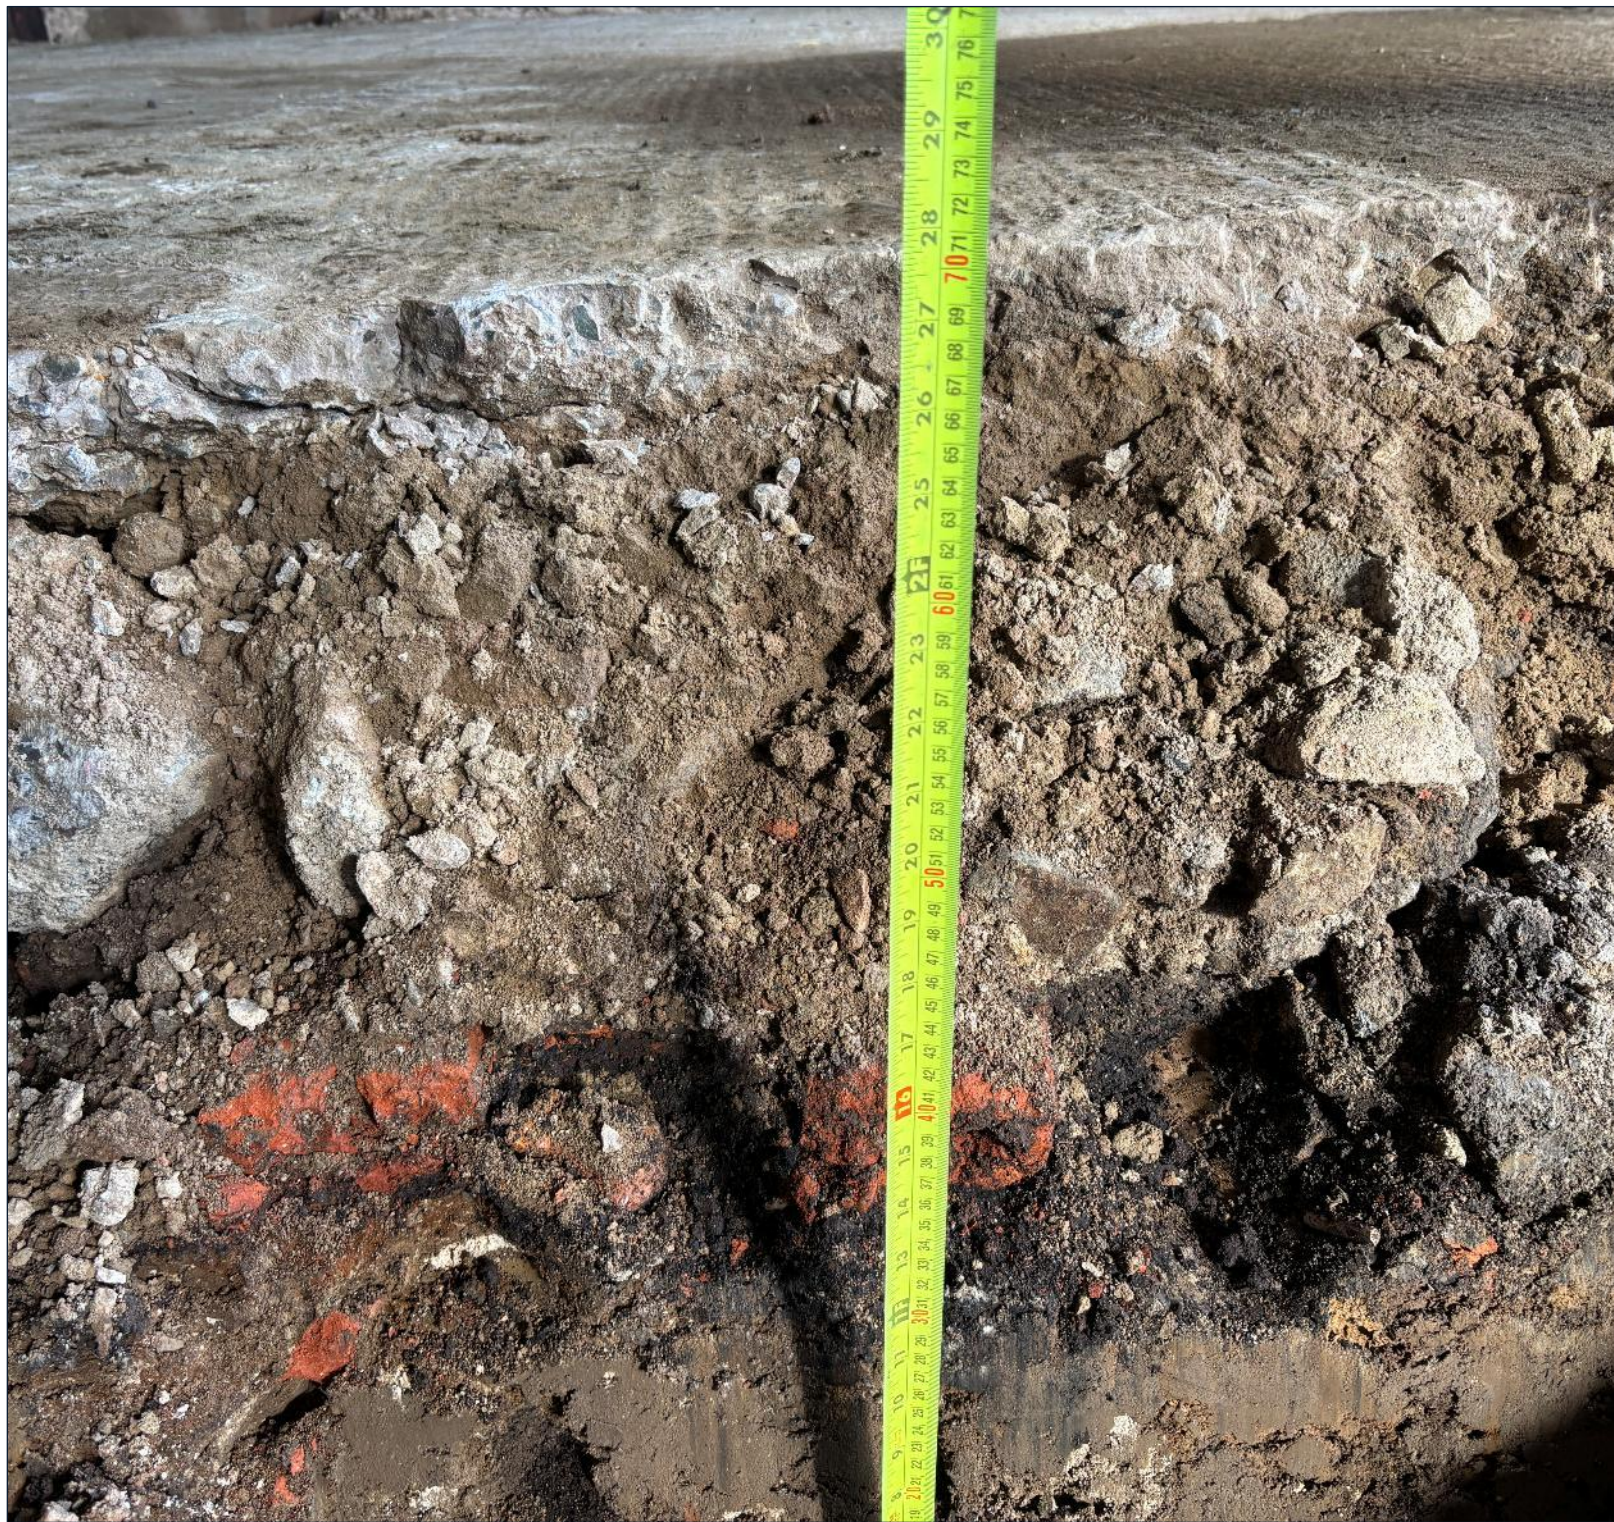
Appendix - Site Photos	
Description	
Photo showing the depth of trial pit TP02	
Sources	
Oakshire Environmental

Site	Parsonage Farm, Church Street, Ribchester, PR3 3YE		Reference	TP02	Appendix - Ground Conditions		
Samples		Description of Strata		Thickness (m)	Depth (m)	Symbol	
Depth (m)	ID						
0.20	S03	Concrete		0.10	0.10		
		Dark brown sandy CLAY with gravel and brick, concrete and wood fragments (MADE GROUND)		0.40	0.40		
0.60	S04						
		Medium brown CLAY with occasional gravel		0.30	0.70		
Remarks and comments							
Surface water pooling, no groundwater identified

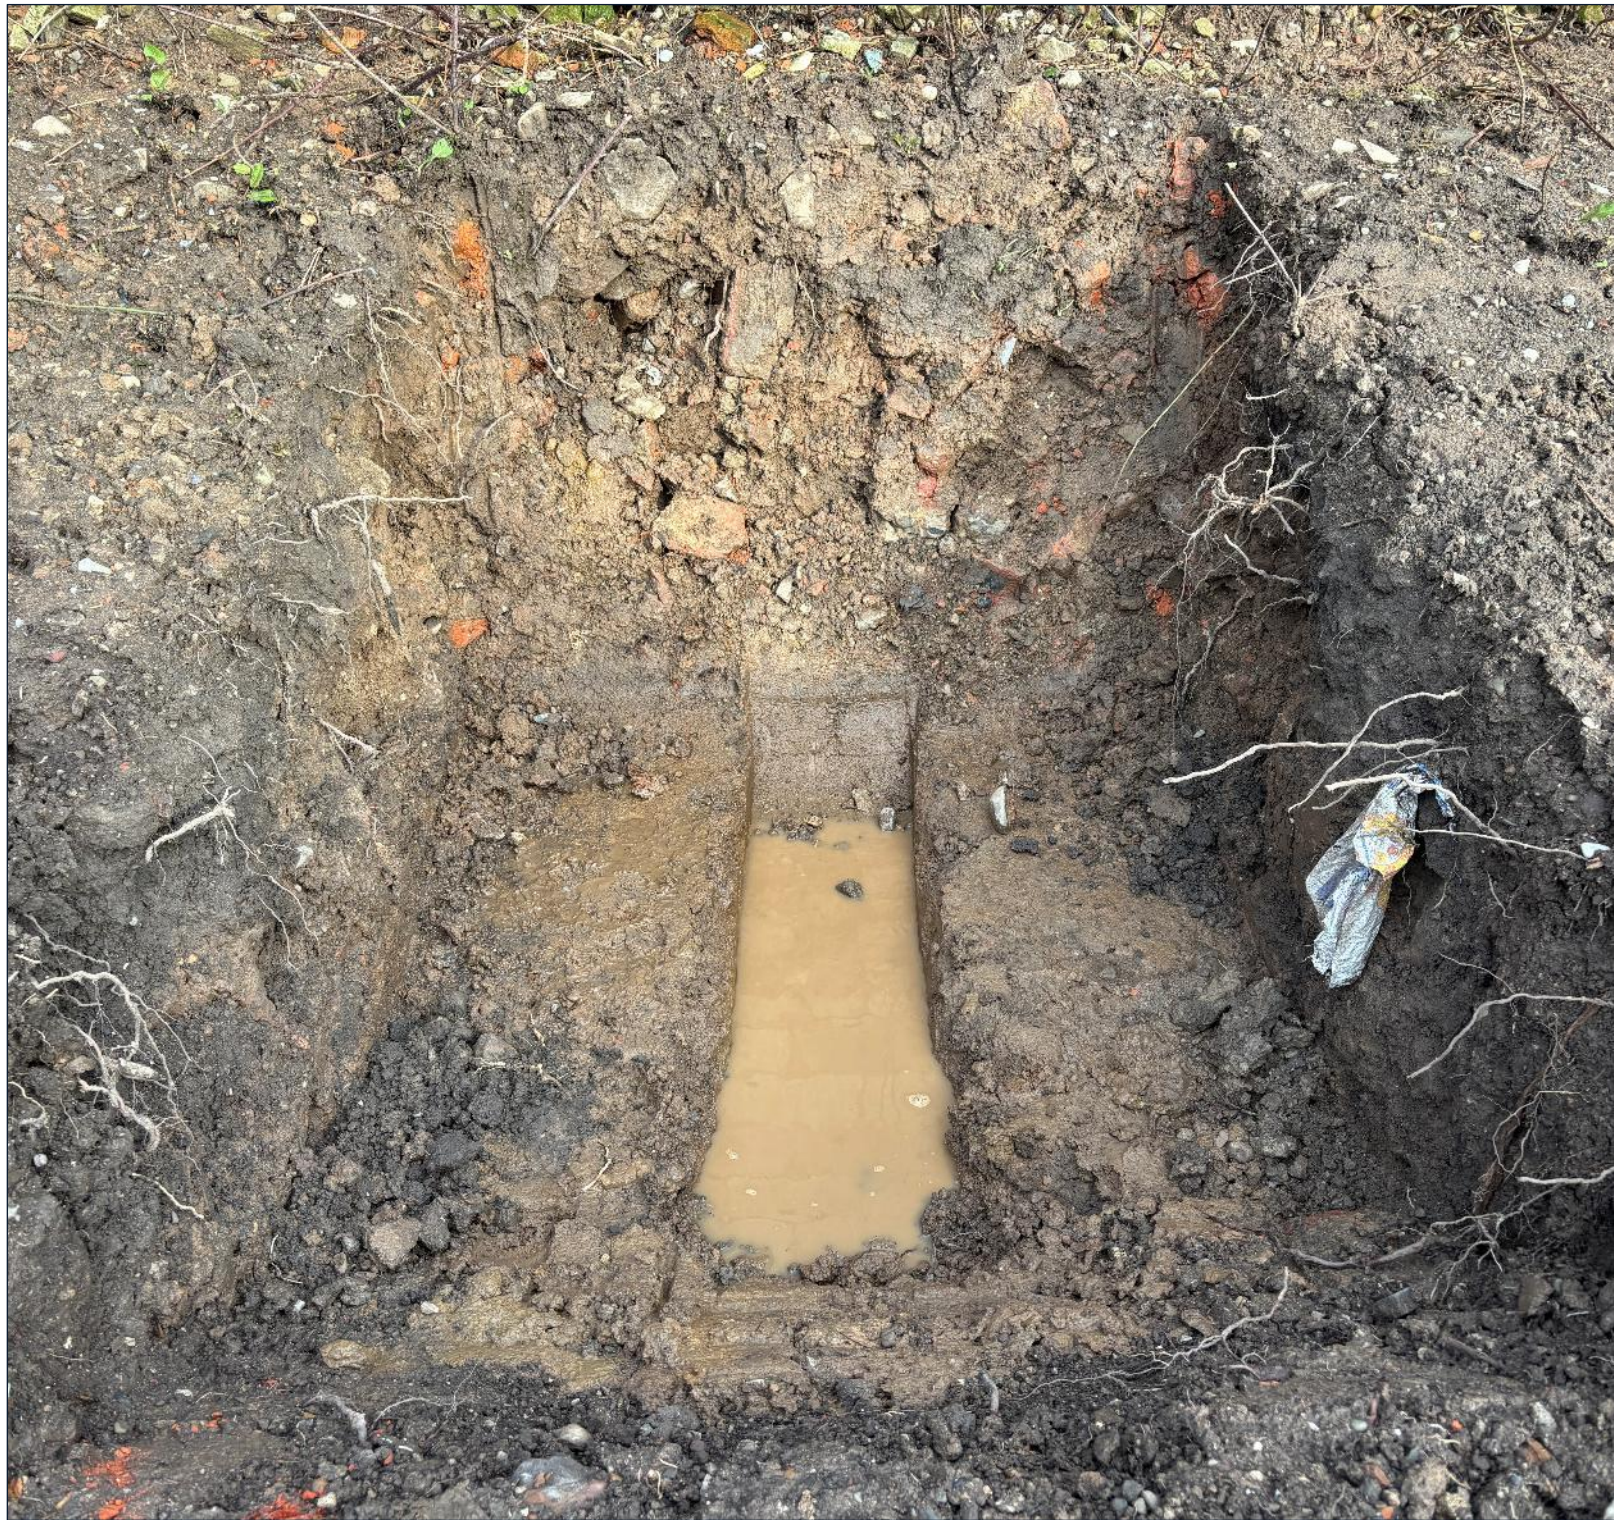
Ground conditions identified in trial pit TP03 comprised made ground to a depth of 0.90m and medium brown clay with occasional gravel to the bottom of the trial pit at 1.10m.

Appendix - Site Photos
Description
Photo showing trial pit TP03
Sources
Oakshire Environmental

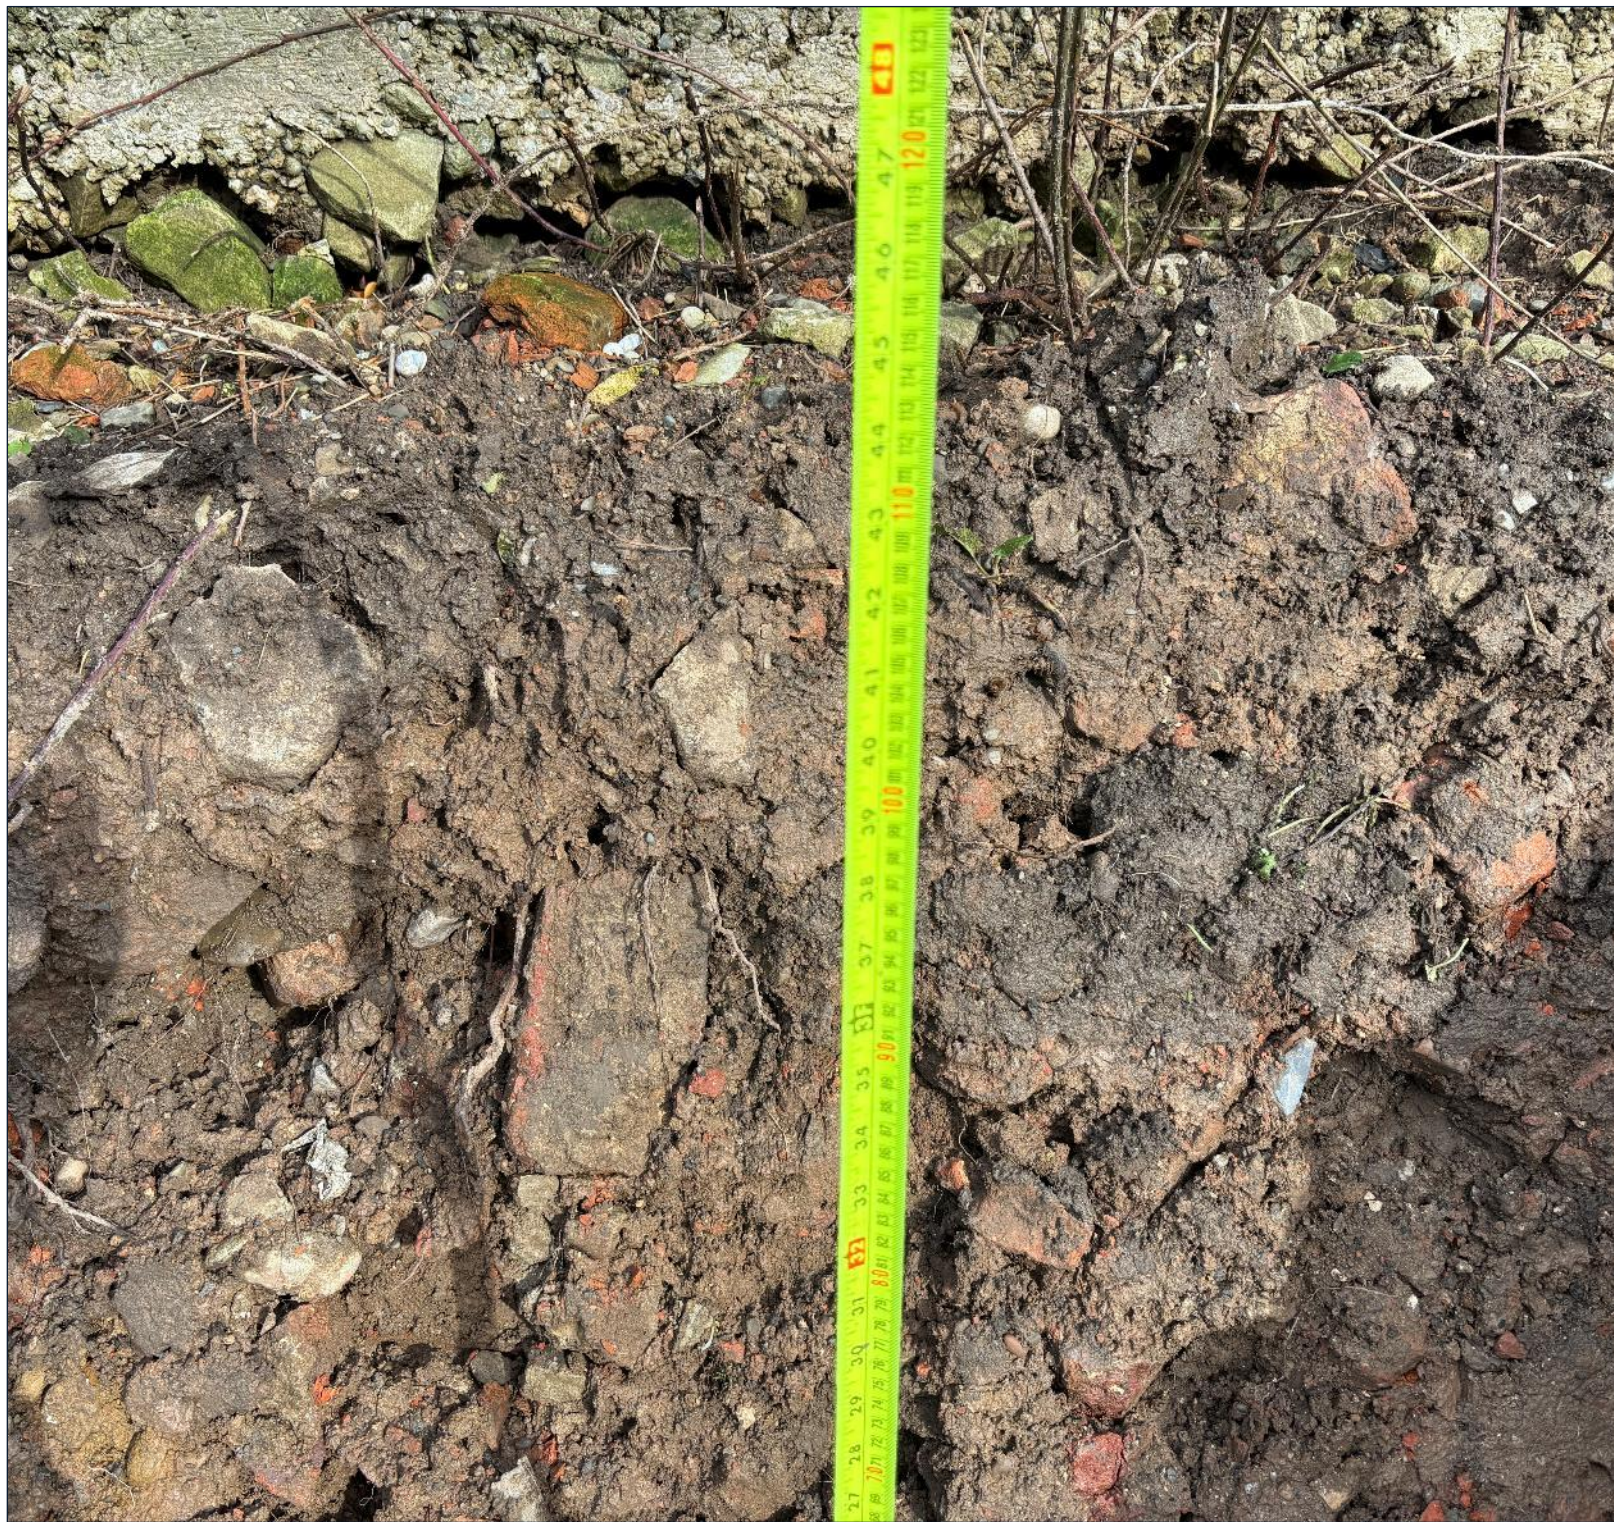
Appendix - Site Photos	
Description	Photo showing the depth of trial pit TP03
Sources	Oakshire Environmental

Site	Parsonage Farm, Church Street, Ribchester, PR3 3YE		Reference	TP03	Appendix - Ground Conditions		
Samples		Description of Strata		Thickness (m)	Depth (m)	Symbol	
Depth (m)	ID						
0.20	S05						
1.00	S06	Dark brown sandy CLAY with gravel and brick, concrete and wood fragments (MADE GROUND)		0.90	0.90		
		Medium brown CLAY with occasional gravel		0.20	1.10		
Remarks and comments							
No groundwater identified
