**BAT SURVEY, AT -  
White Bull  
Preston Road  
Alston**

REFERENCE NO 7074

The main public house and its single storey side extension will be converted to form dwellings. The rear extensions will be demolished.

The building is a public house, closed for approx. 3 years.

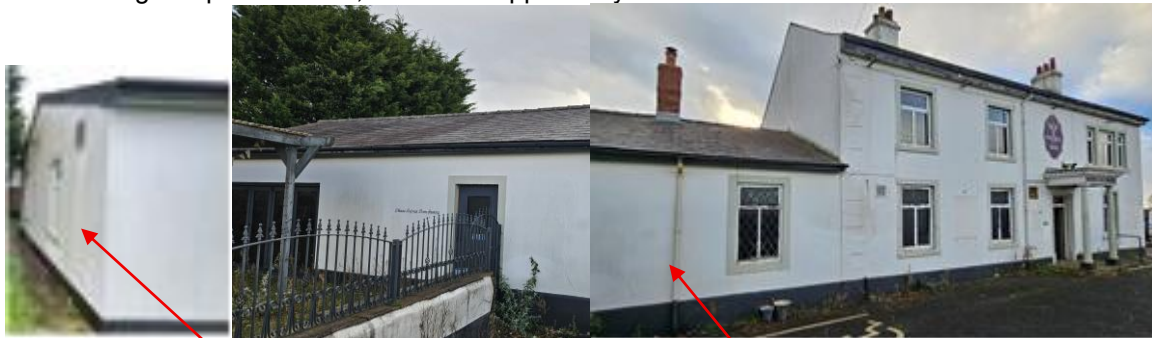
Front northwest Elevation.

Northeast end of side extension, Side extension built approx. 10 years ago to provide a function room

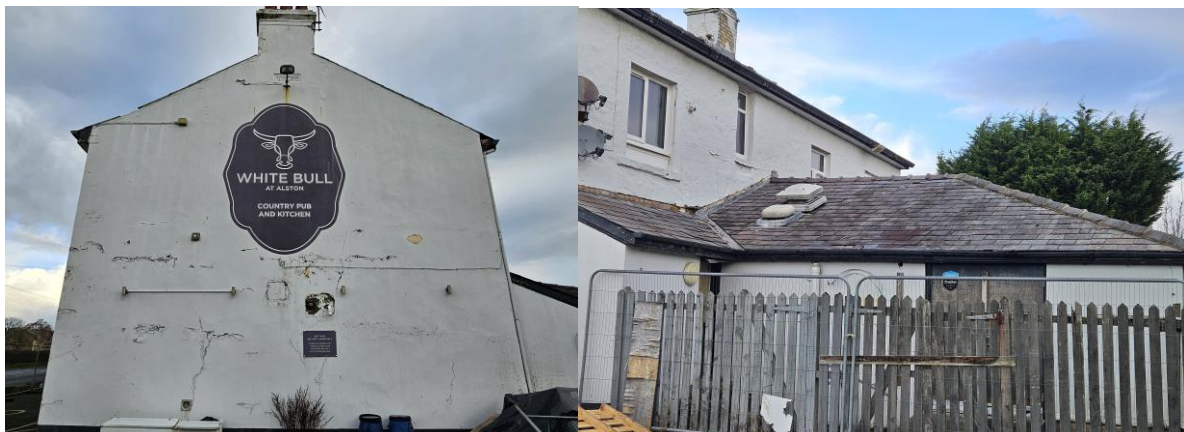
The southwest gable of the main building

and the rear single storey extensions

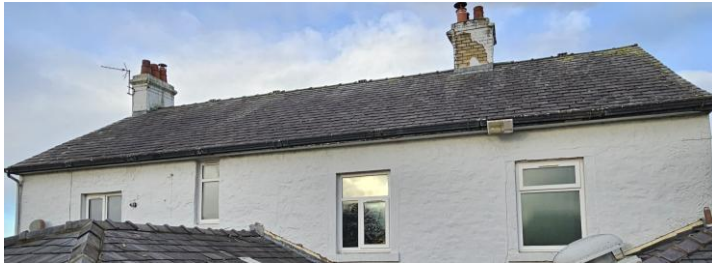
The first-floor rear elevation of the main building being retained (southeast elevation)

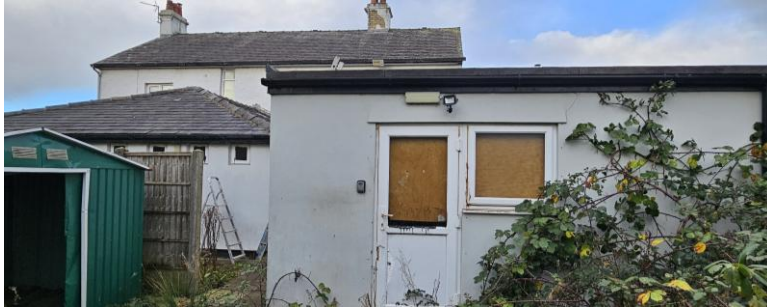
Ground floor rear extensions which were built approx. 10 years ago to form kitchen, wc and cellar/storage area (southeast elevation). To be demolished.

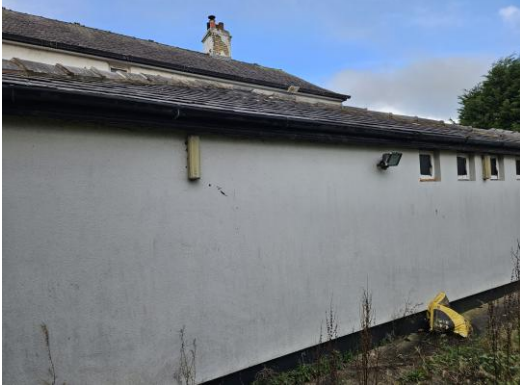
The walls of the extensions will be cavity block with a smooth render finish.

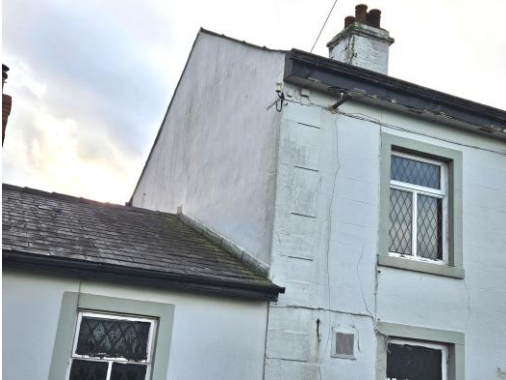
The main building wall construction is likely stone or brick with a smooth render finish.

The render throughout was in good condition. The walls did not provide any access points, cracks or crevices with the potential to provide bat roost habitat.

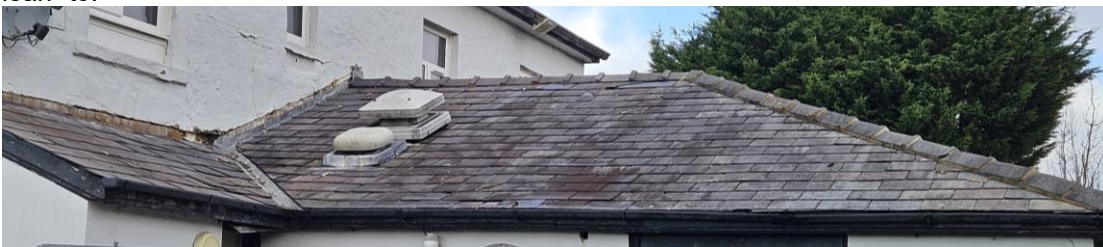
The rear extension roofs are a combination of lean to and hipped structures, with a section of felt flat with a roof lantern. The roofs are lead flashed at the abutment with the main building rear wall. The roof finish is blue slate with hip and ridge tiles; A lead valley is present at the intersection with the lean- to.

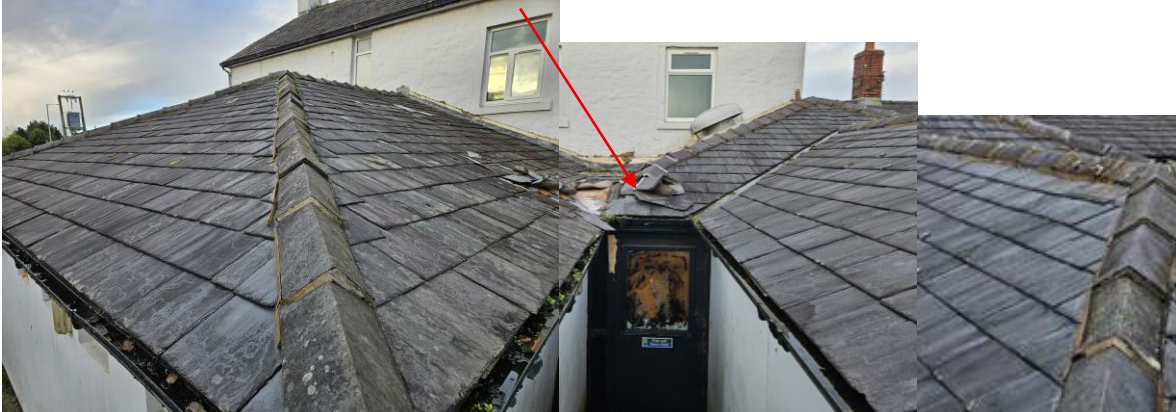
A stepped lead flat (had been) between the two outshots

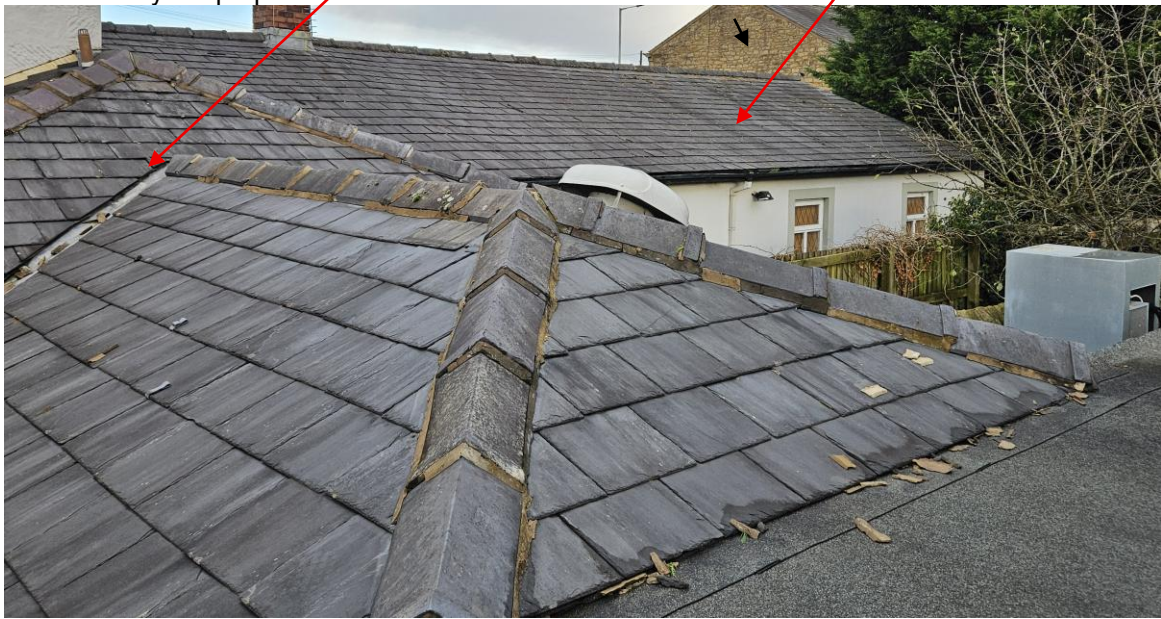
Lead valleys are present at the intersection of the two hipped roofs. Rear pitch of side extension to be unaffected by the proposal.

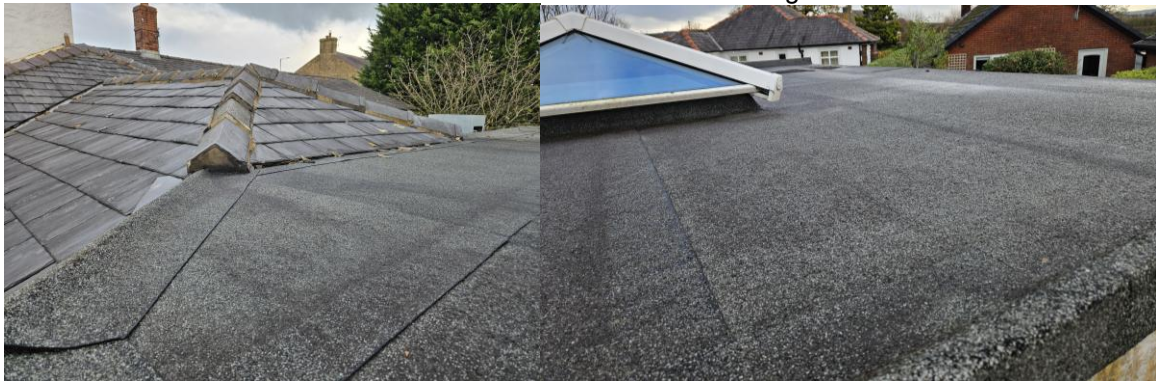
Felt flat and lantern light

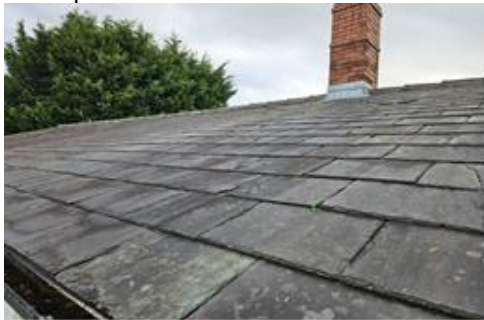
Front pitch of the side extension roof unaffected by the proposal.

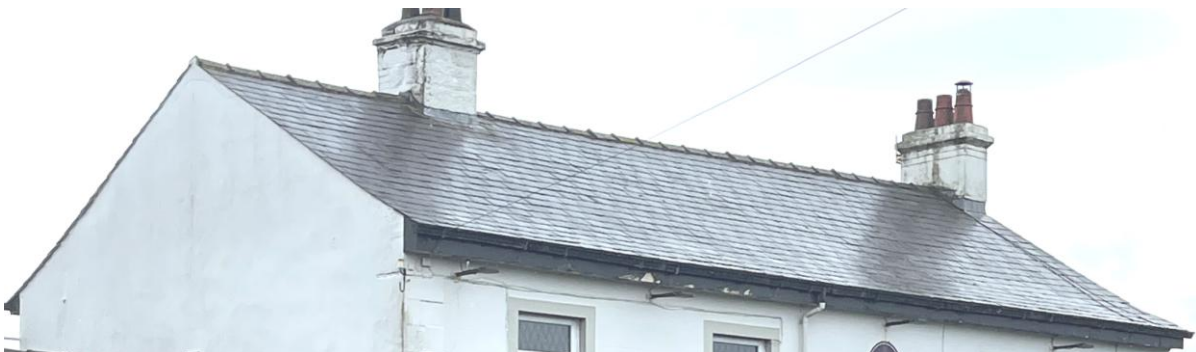
Front main roof pitch, unaffected by the proposal.

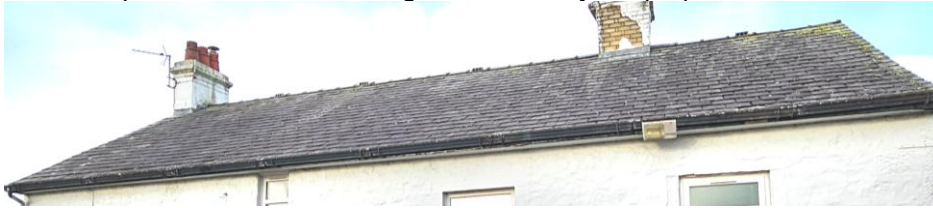
Rear roof pitch of the main building, unaffected by the proposal

Both roof pitches of the main building are in good condition. They were examined from ground level with binoculars; The slates were tightly lapped the ridge tiles were well bedded with no significant gaps in the pointing. The verges had tight abutments with the walls. This said the main roof is being retained and will be unaffected by the proposals.

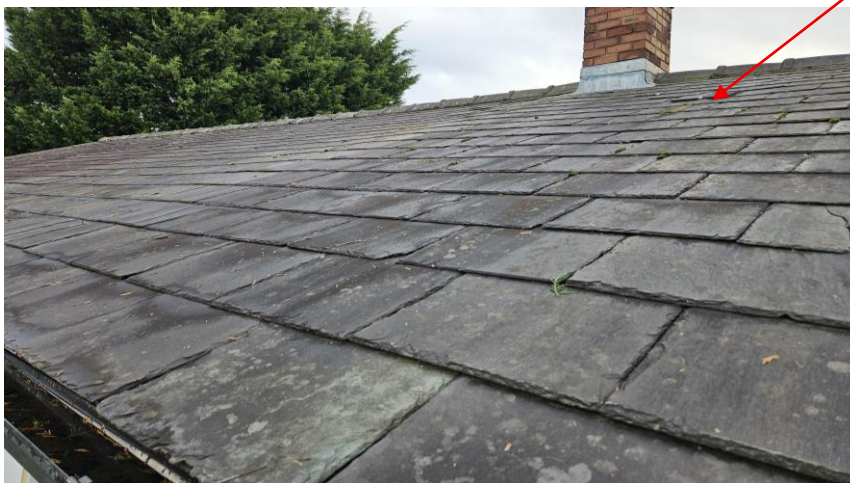
The side extension roof is in good condition except for a slipped slate; this however does not form a crevice allowing bat ingress.

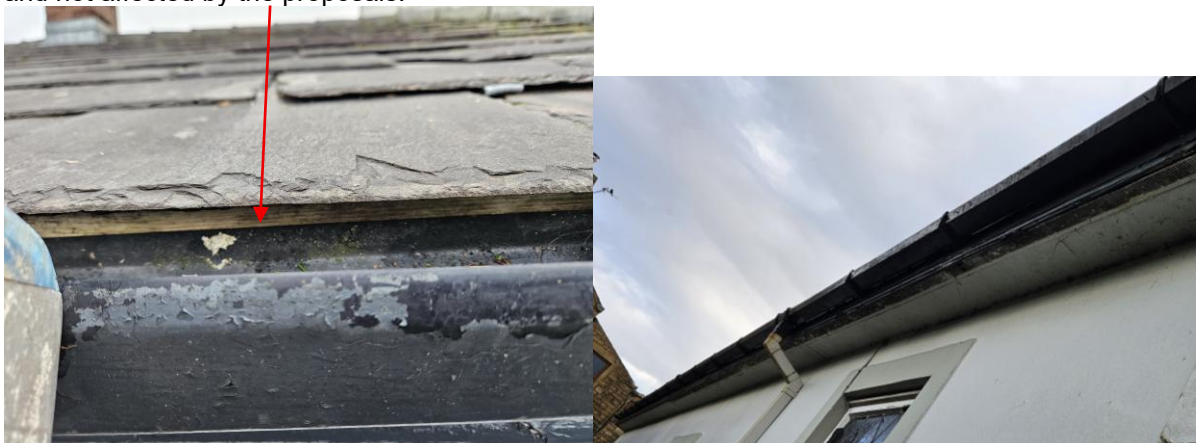
The eaves are very tight, with no possible access points present. However, this roof is being retained and not affected by the proposals.

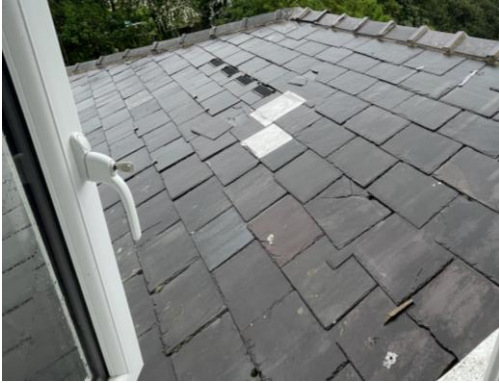
The rear extension roofs being only 10 years old were generally in good condition with some isolated slipped slates, to the northeast pitch of the outstot adjacent to the car park. This said no cracks or crevices suitable for bat ingress were present.

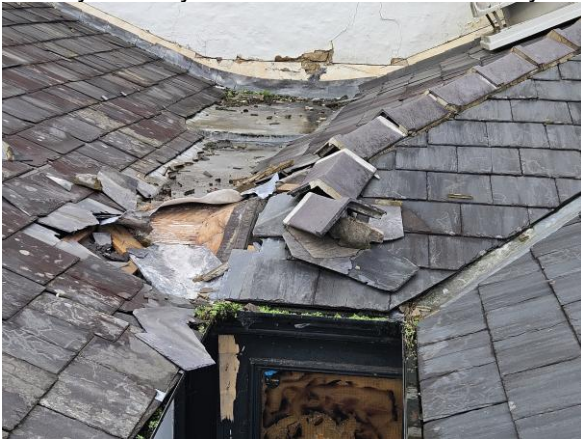
Recent attempts to steal Lead (stepped lead flat roof) between the two outshots have been carried out leading to significant damage to the structure. The area was examined although it was highly unlikely that any bats would have entered any crevices. The result was negative.

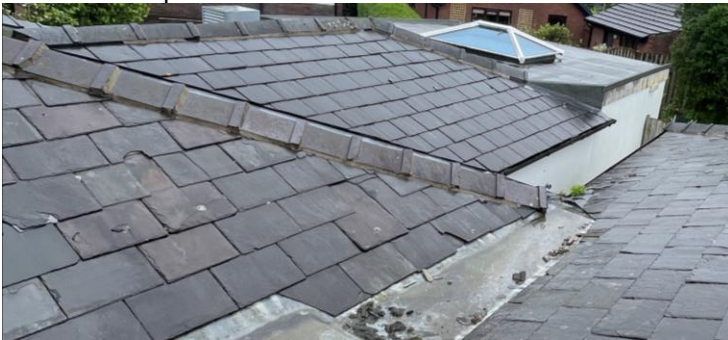
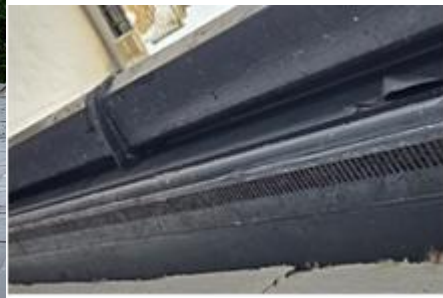
Southwest pitch of the second outshot prior to lead theft. The eaves of the outshots had timber fascias and soffits with plastic grille ventilators, all in good condition and tight fitting. No access points for bats were present.

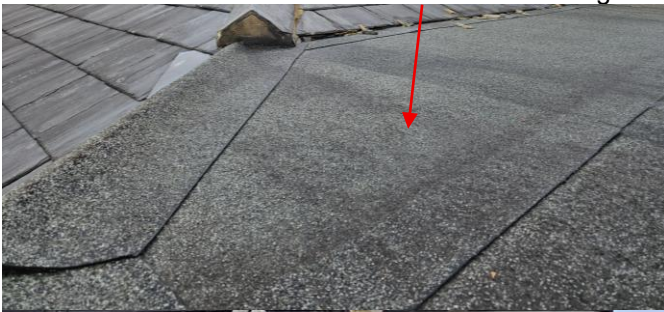
The felt flat is in excellent condition. The flush fitting fascias are tight fitting and are in good condition.

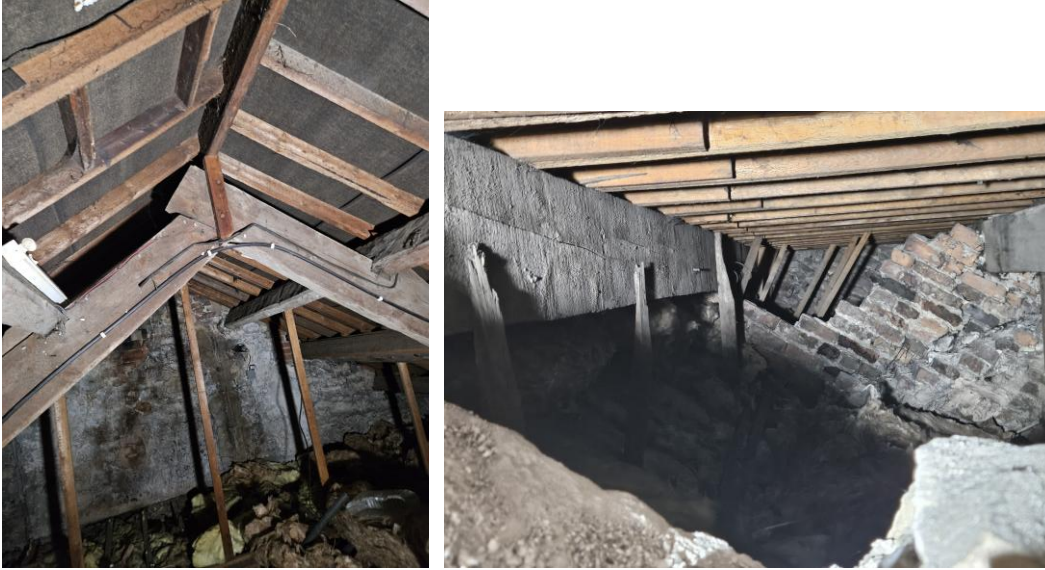
The main roof space was insulated at ceiling level. The rafters appeared in good condition and relatively new. The felt was in reasonable condition. No evidence of bats currently or historically present in the space. The roof will not be affected by the conversion.

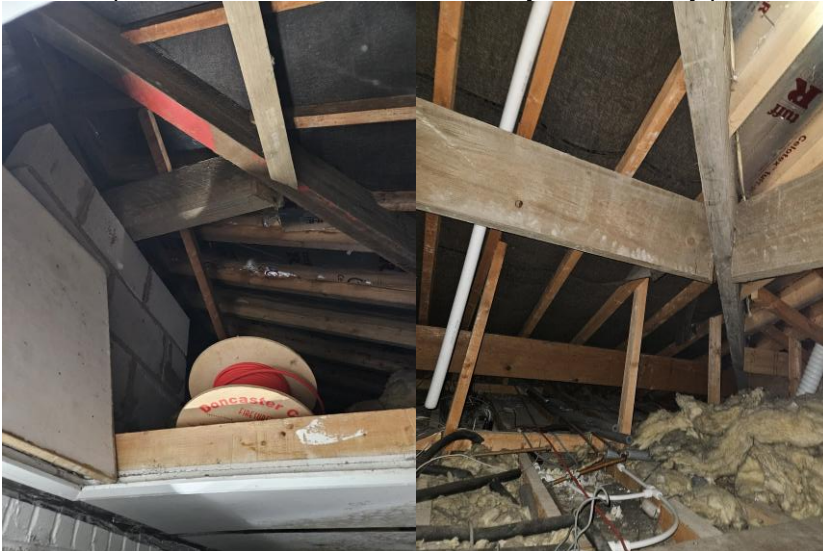
The roof structure in the outshots is timber purlins, rafters and hip joists. The underlay and sections with insulation between the rafters are all in excellent condition. There was no bat roost potential in the roof space. No evidence of bats currently or historically present in the space.

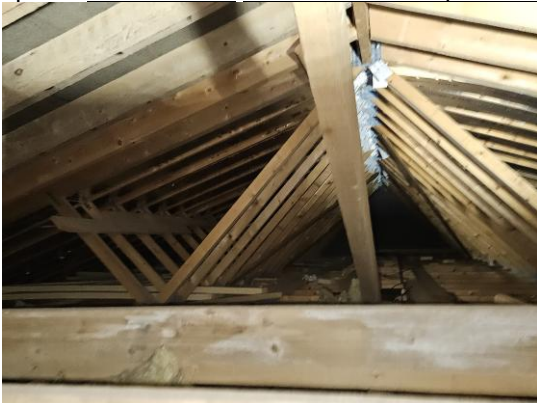
The side extension roof is a truss rafter construction with underlay insulation quilt is present between ceiling joists. All in excellent condition, no evidence of bats currently or historically present in the space. This roof will not be affected by the conversion
