**A Report of the Archaeological Recording  
and Watching Brief at  
Cockshotts Farm and Cottage, School Lane, Simonstone, Burnley**

**Part 1 The Building Survey**

**D J A Taylor, Dip Arch, PhD, RIBA, MIFA  
Chartered Architect, Archaeologist  
46 Applecross Drive  
Burnley  
BB10 4JP**

**September 2002**

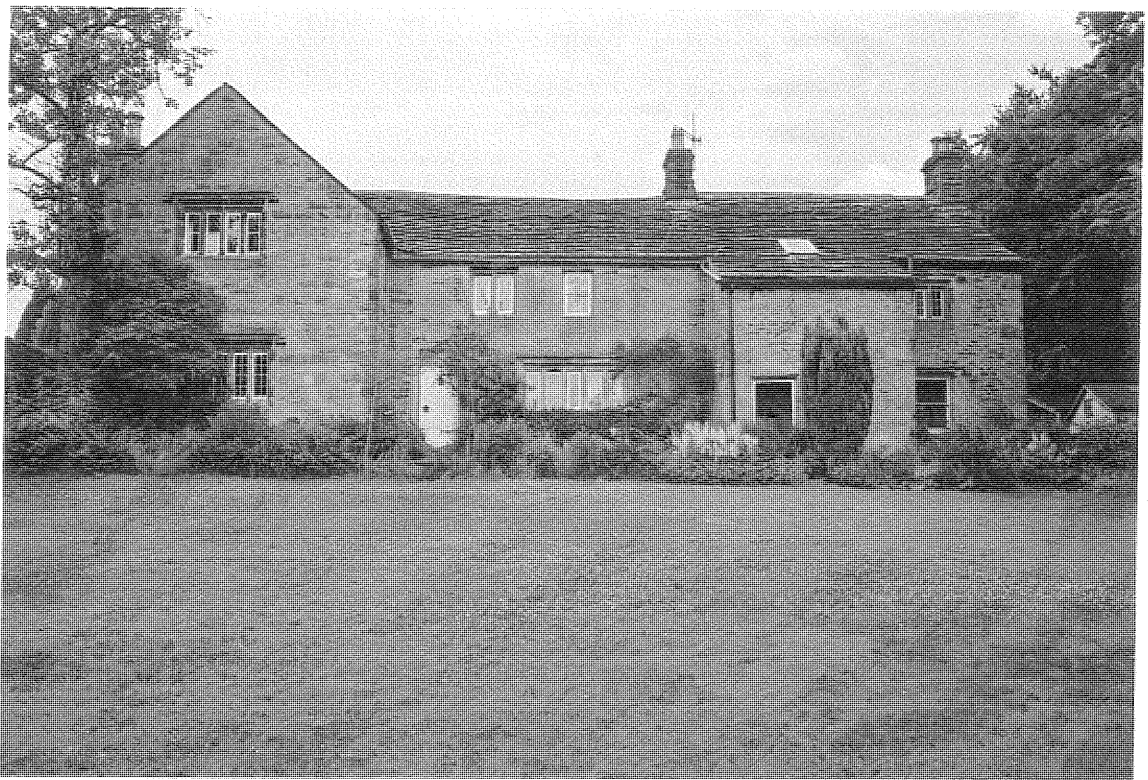
Pl. 2 South elevation

The initial upstanding phase of the buildings comprised a through-passage and housebody, which formed the central part of the south elevation between the projecting wing and the stair turret porch. It was built of coursed slobbered thin sandstone rubble. The five-light mullion window has recessed ovolo and fillet moulded mullions with a hood mould over (pl. 3). A similar two-light window is at first floor level. To the left of this is a later probably nineteenth century door, with a twelve-pane sash window of similar date at first floor level.

The cross-wing projecting to the left, which was added at a later date, is built of squared, sandstone masonry. There is a five-light mullion window at ground level (pl. 4), with a four-light window above. The mullions are cavetto-moulded with hood moulds over.

The cottage to the right was added as a third phase and is built of coursed, thin sandstone rubble with squared quoins. There is a three-light mullion window at first floor level with a hood mould, and a later inserted two-pane sash window at ground level with a hood mould over.

The projecting stair turret porch was added as a final phase with the roof line, being carried down over it. The walling is similar to that of the farm cottage. There is a double chamfered doorway to the left and a round headed window to the right (pl. 5), which would have lit the area below the stair.

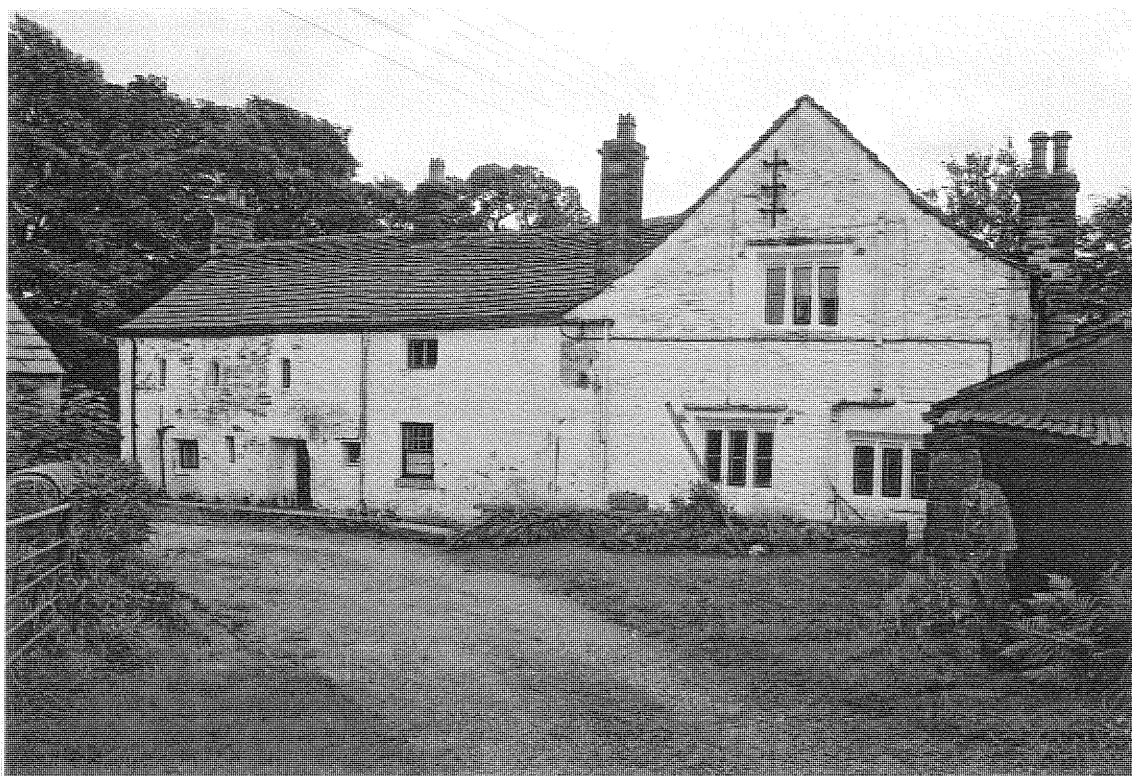
Pl. 6 North elevation

The rear of the housebody has an inserted twelve-pane window at ground floor level, together with a similar style doorway. A small square window adjoining the cottage could have lit the area within the firehood. At first floor there is a two-light mullion window with the mullion removed, and a small square light above the rear door. Slight unevenness in the stonework between the two first floor windows suggests that a former window opening might have been blocked at a later date.

To the rear of the projecting cross-wing are two three-light mullion windows at ground floor level and one at the upper level, all with hood moulds except the one at ground floor level to the west (pl. 7). This window also does not line up with the one adjacent. This, together with the lack of a hood mould<sup>2</sup> could reflect the use of the room, or alternatively suggest the site of a former doorway.

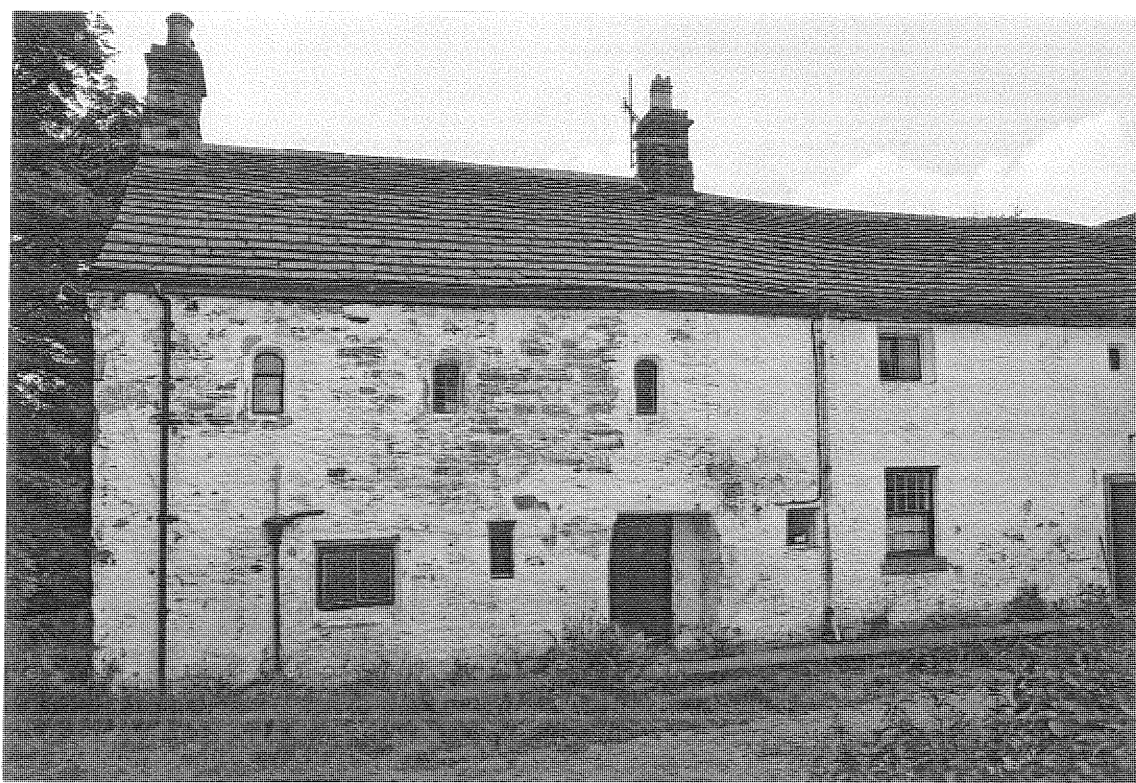
Pl. 8 Farm cottage showing the line of quoins at the junction with the farmhouse

A line of quoins is evident on the line of the wall between the farmhouse and the cottage (pl. 8). The doorway, with the quoins acting as the right hand jamb of the opening, is a wide shouldered opening leading to a recessed doorway.

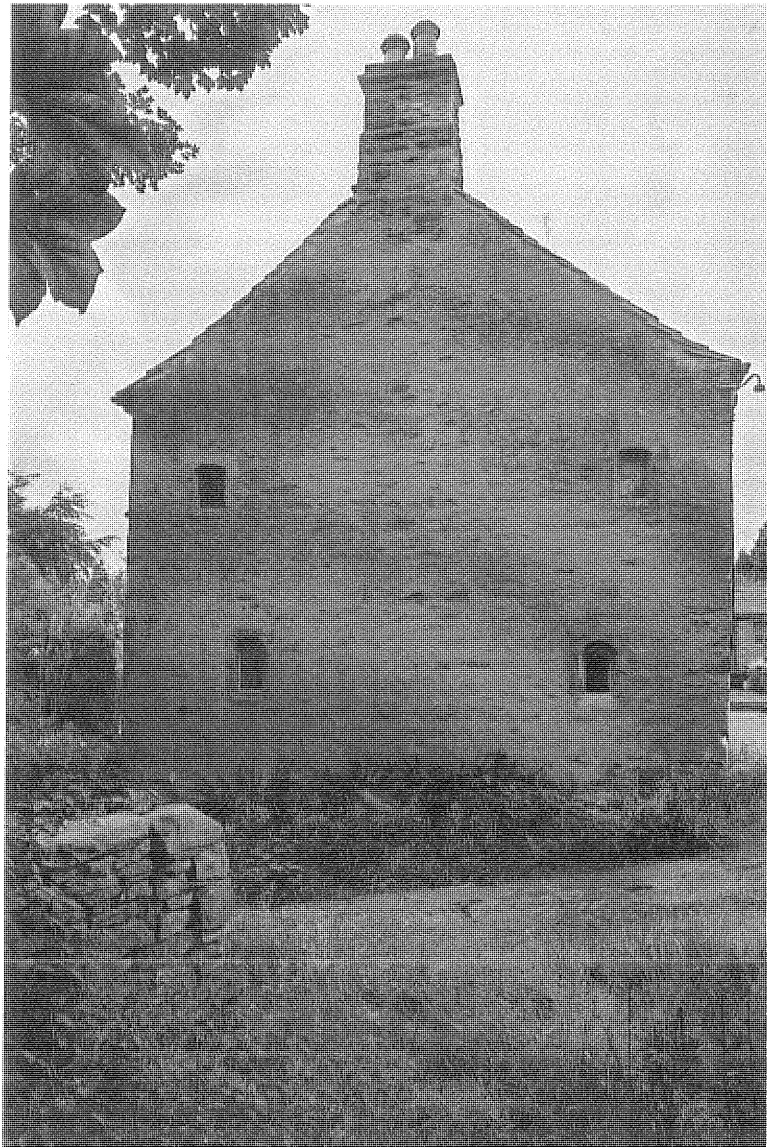
Pl. 10 East elevation

Two deeply-chamfered, round headed lights are positioned at both ground and first floor levels. One light is blocked at first floor level. The glazing is set directly into the stonework.

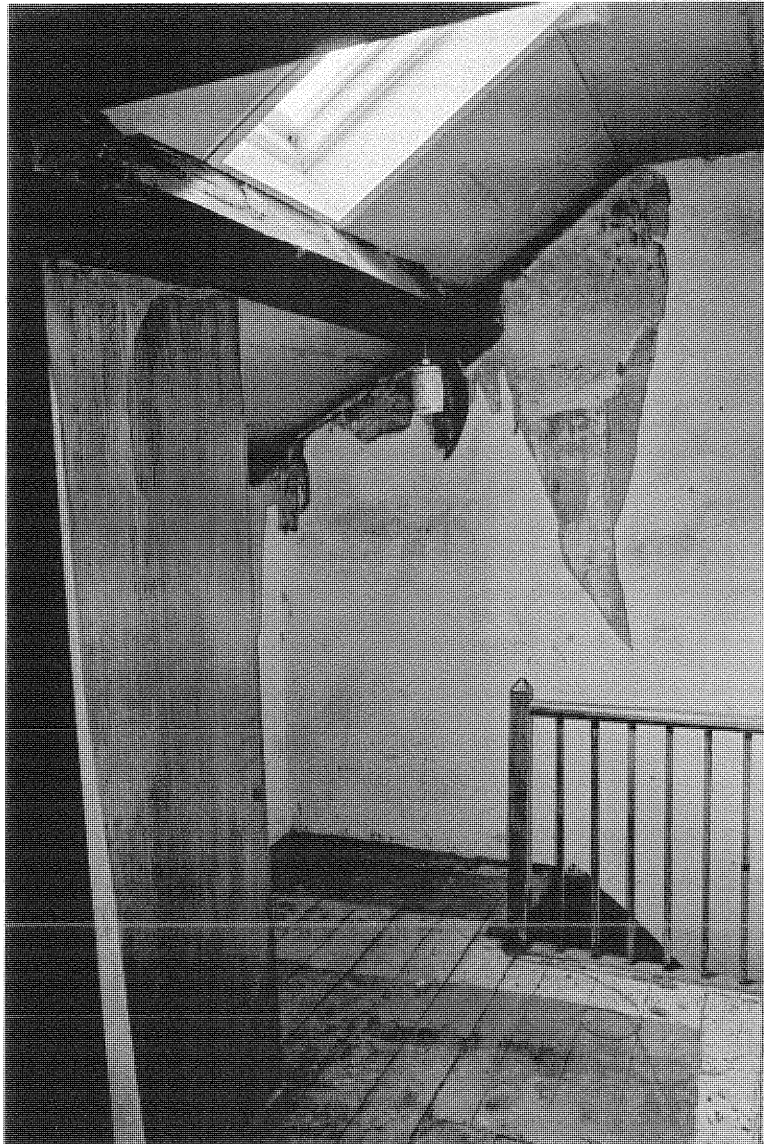
Pl. 18 First floor landing to the farm cottage

The space over the housebody and through-passage has been sub-divided to form two bedrooms, a bathroom, toilet and landing (pl. 18). The ceilings are high and have been inserted at a later date as the gable walls are plastered within the roof space.

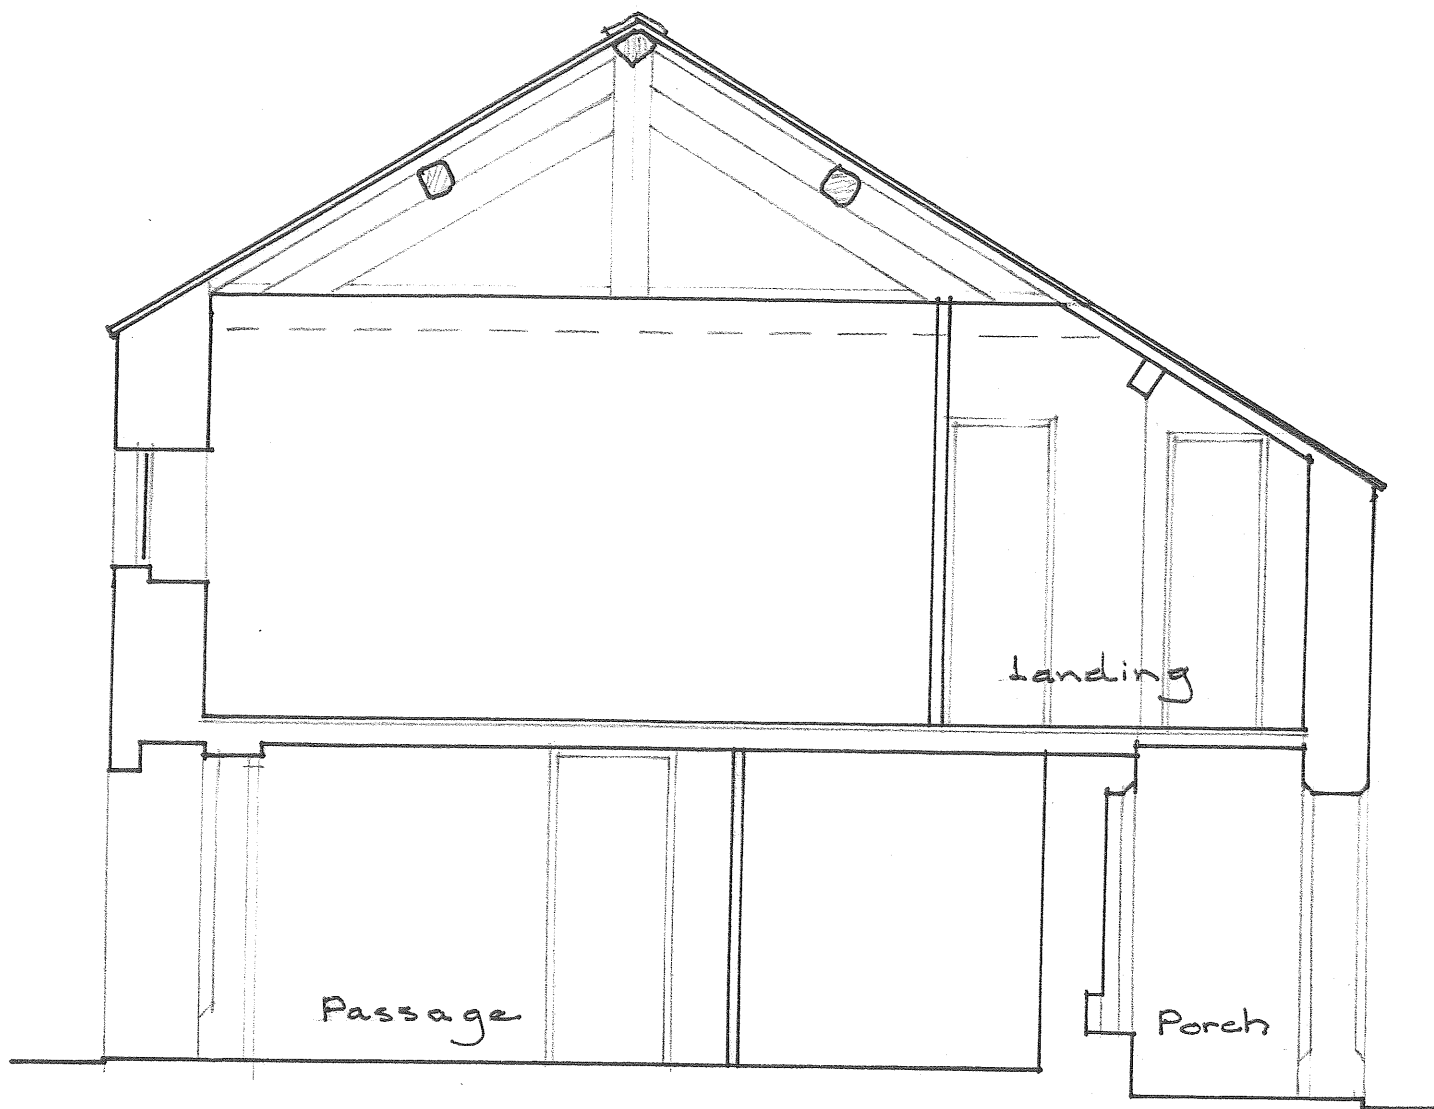
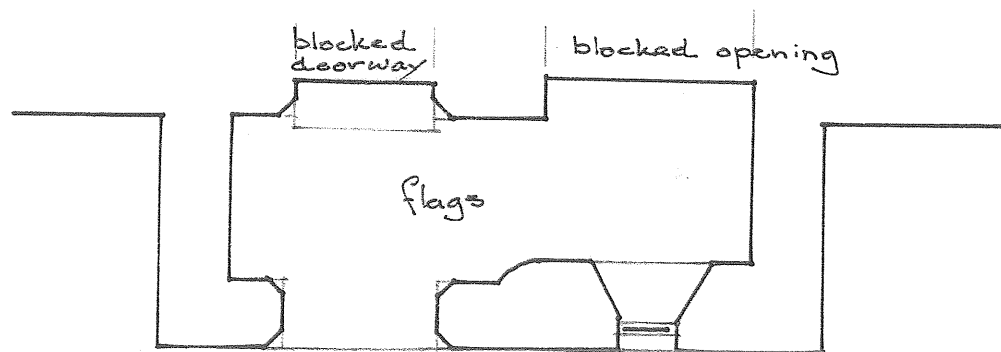
Fig 7

As the architect has prepared floor plans (figs. 2, 3, 4, 5, 6), no further recording of this element of the building was undertaken, with the exception of the south porch and stair turret which had not been recorded. A section was measured through the cottage (fig. 7) using a 2m staff and 3m steel tape.

Section of farm cottage —  
Showing through-passage & stair turret porch

Plan of stair turret porch

The southern door to the through-passage is sited under the staircase and is now blocked. The south external face of the doorway can be seen from within the present store and former stair turret (pl. 17). The door has broad chamfers and stops. The former stair within the stair turret was entered from the housebody, and the opening has been closed up within living memory. A plan of the stair turret porch together with a measured section through the farm cottage has been drawn (fig. 6).

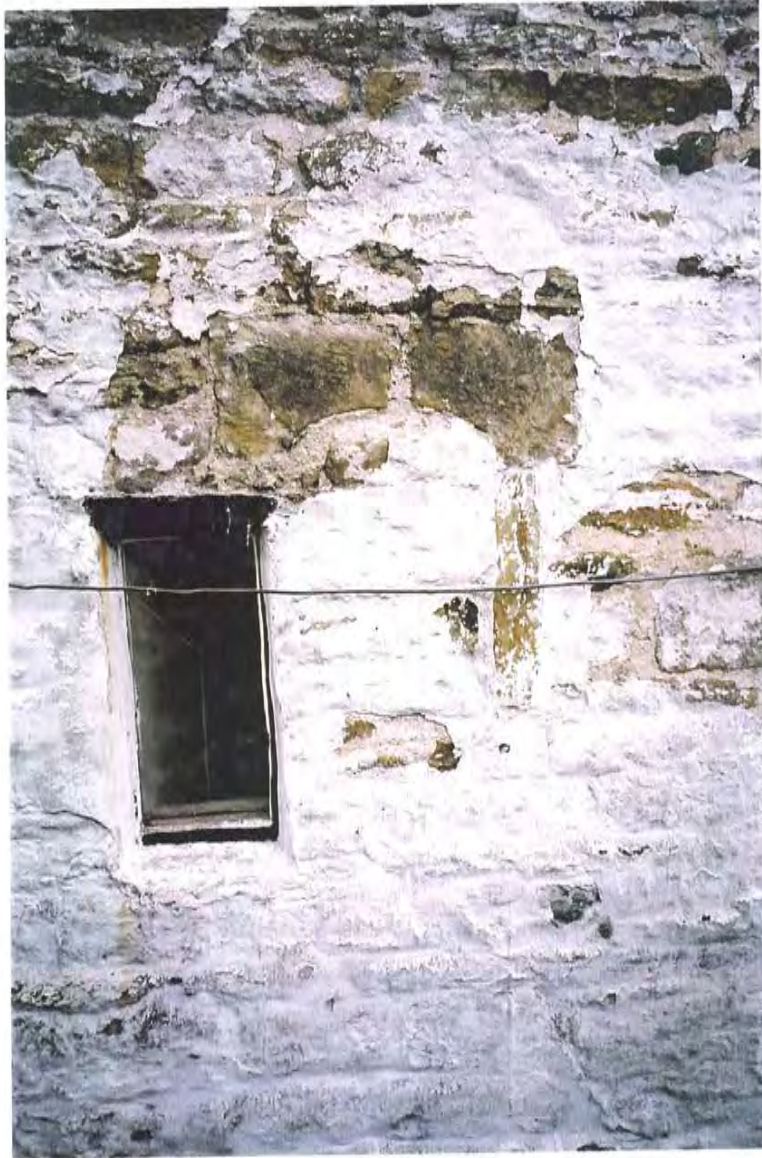
Pl. 9 Blocked-up round-headed window to ground floor of farm cottage

At ground floor level of the cottage is a two-light mullion window with the mullion removed together with a small inset window. Adjacent to this is the two-piece round headed lintel and single jamb of a blocked up window (pl. 9). At first floor level are three small deeply-chamfered round-headed windows, the central one of which is a leaded light.

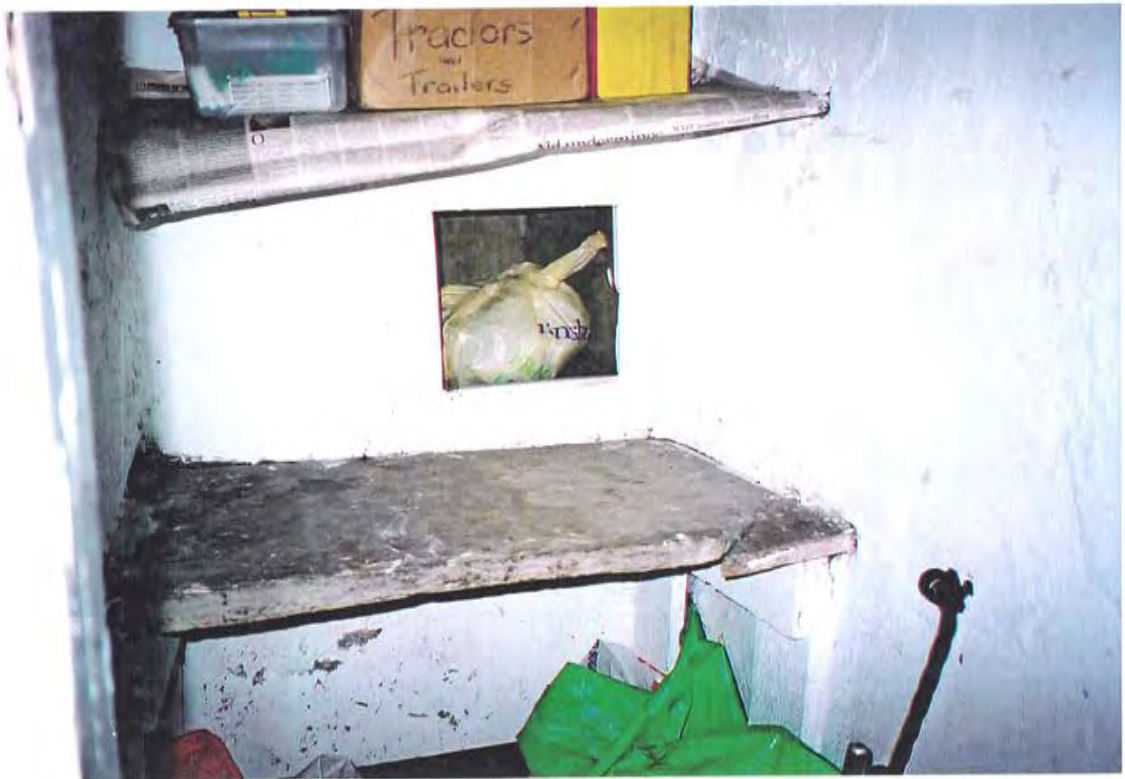
Pl. 11 Salt cupboard by fireplace in farmhouse housebody

The housebody of the farmhouse has a large chimney breast with a modern fireplace inserted and later two stores formed to each side. The chimney breast was formerly an inglenook fireplace and evidence of this can be seen in the unevenness of the plasterwork, and confirmed by oral evidence. A salt cupboard was formed in the recess to the right of the chimney breast (pl. 11).

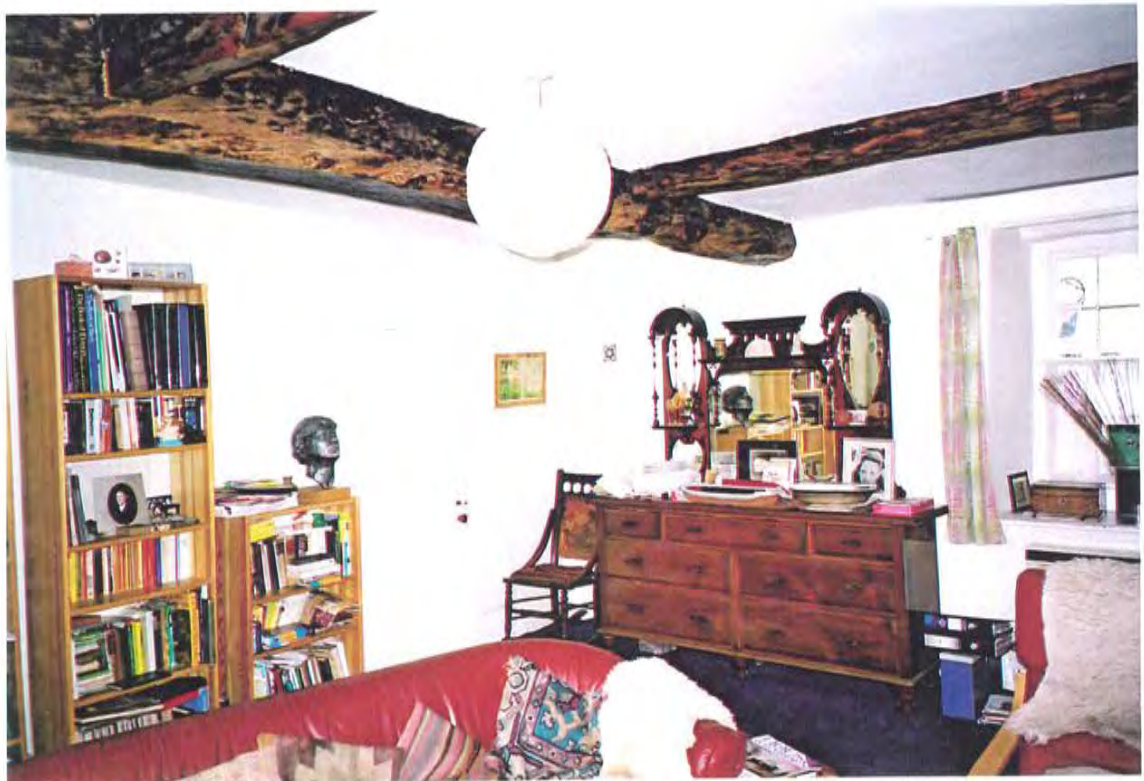
Pl. 12 Farmhouse housebody

The first floor is supported by three beams, with a large chamfered oak beam running from the front to rear wall, and two pine beams running into it from the chimney breast. The two pine beams are reused as evidence of mortices and circular holes for wattle infill can be seen.

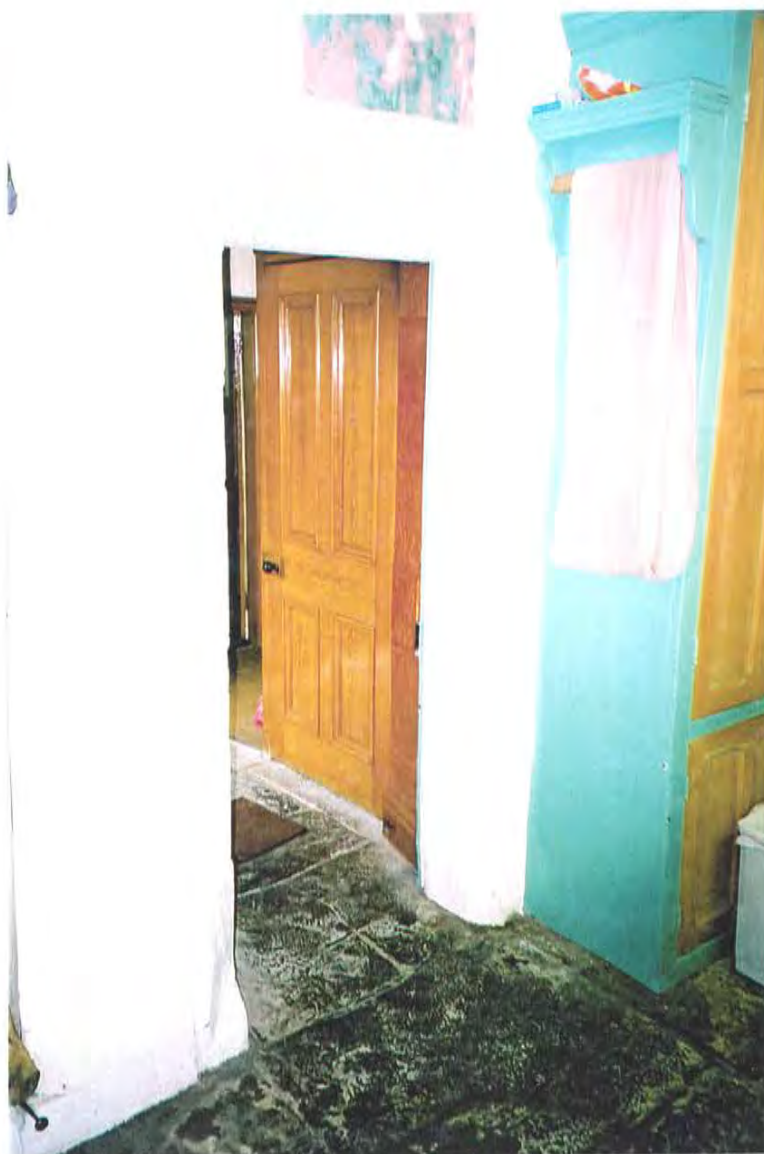
Pl. 13 Doorway leading from kitchen to through-passage

The doorway into the living room has a broad chamfer and stop (pl. 13), and is similar in appearance to an external door, and matching the doorway leading from the kitchen to the through-passage. The living room is dominated by two very large corbels (640mm x 660mm overall) built into the external wall (pl. 14). These support two beams, one chamfered and one boxed in. The corbels on the opposing wall are the quarter round type. It is probable that the large corbels are reused and may have come from Whalley Abbey, which was dissolved in 1536.

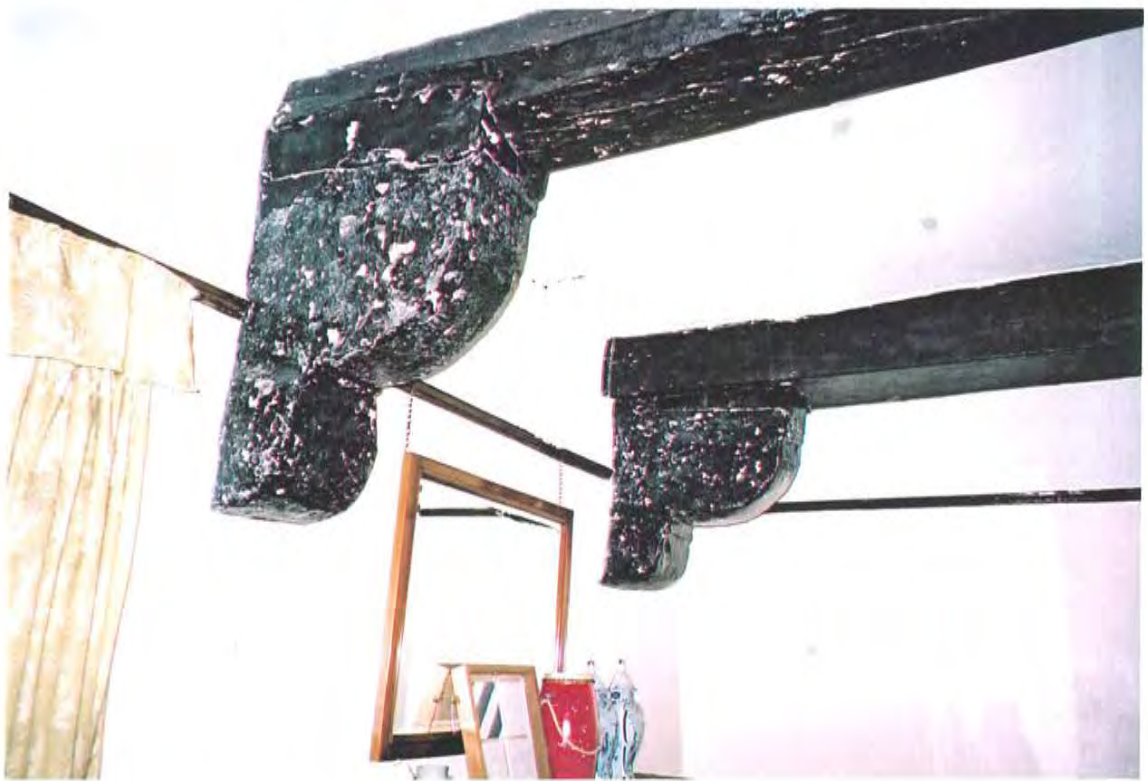
Pl. 14 Detail of corbels in external wall of living room

The kitchen leads off the through-passage and an inglenook fireplace was formed in the north-east corner. A step down leads to a large pantry. Two beams resting on corbels in the west external wall support the first floor over the kitchen and pantry. The inner beam to the kitchen is reused. Two vents (one blocked) were formed in the west wall. Evidence of a timber frame can be seen to the northern one, which is extant.

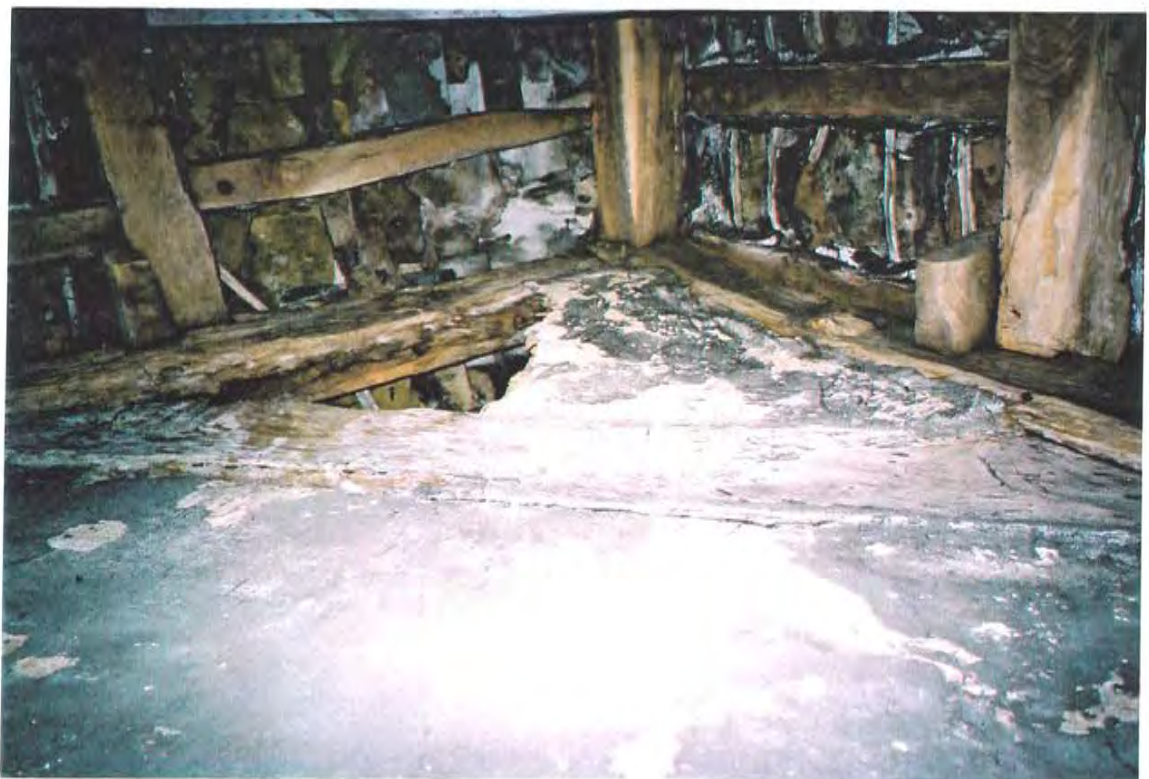
Pl. 16 Detail of roof truss over cross-wing to the farmhouse. The infill is wattle and daub

Two collared oak roof trusses support the roof to the cross-wing, on which are supported purlins and spars. The stone roof slates are pegged over the battens. The main roof members, trusses and purlins, have chamfered edges with stops. This implies that the ceilings are a later addition and that the original roof timbers would have been exposed. The areas between the tie beam and collar and the principle rafters are infilled with wattle and daub and finished with limewash (pl. 16)

A more detailed survey of this section of the roof will be undertaken when the re-slating takes place. The roof over the housebody was inaccessible.

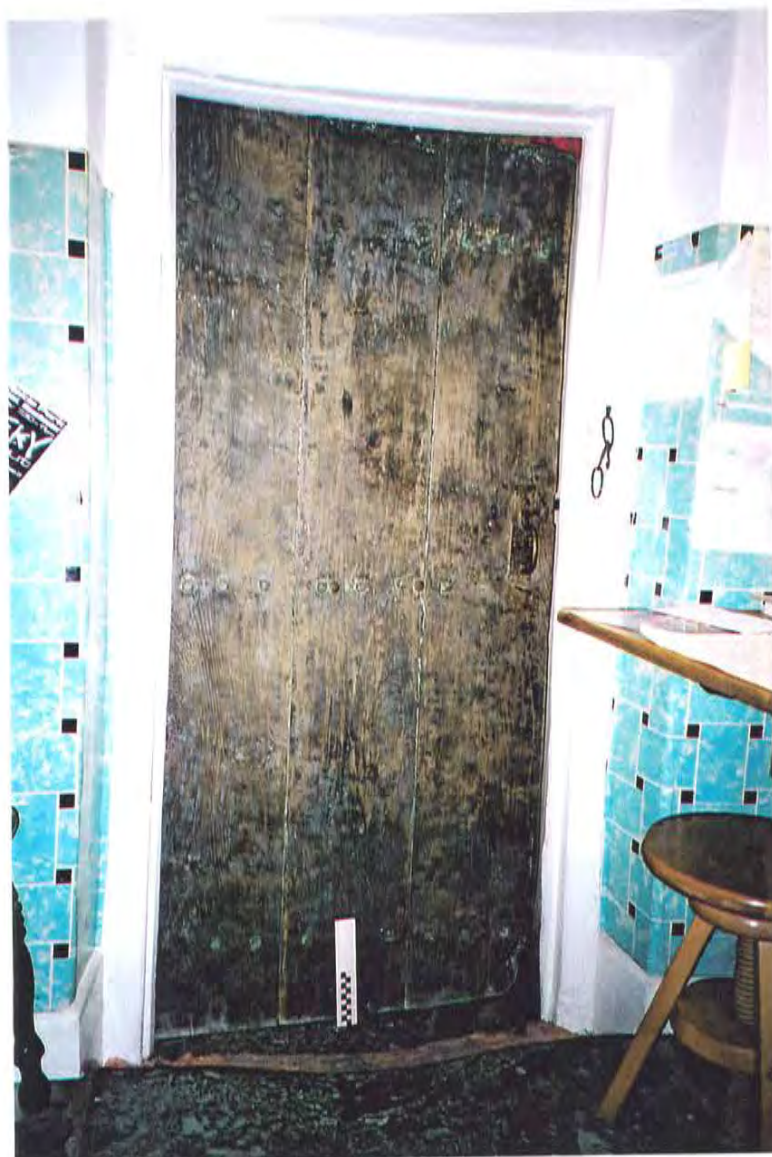
Pl. 15 Door between kitchen and pantry formed out of three oak planks

The door between the kitchen and pantry is formed of three broad planks secured to battens by pegs and hung on two strap hinges (pl. 15). Evidence of scoring for the setting out of the door can be seen on the kitchen side. This door is of some age and it is recommended that it be reused as part of the proposed alterations.
