# Cockshotts Farm

School Lane, Simonstone BB12 7HR

Window and door condition report

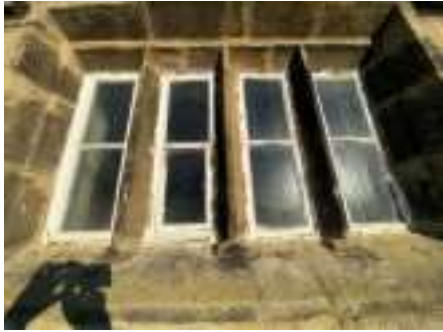
| | <p>Condition</p> <ul style="list-style-type: none"> <li>• Frames rotten right through some lower joints</li> <li>• Casement rotten and twisted</li> <li>• Putty missing</li> <li>• Single glazed and glass condensating</li> <li>• In need of full redecoration</li> </ul> <p>Recommended action</p> <ul style="list-style-type: none"> <li>• Replacement windows</li> </ul> |

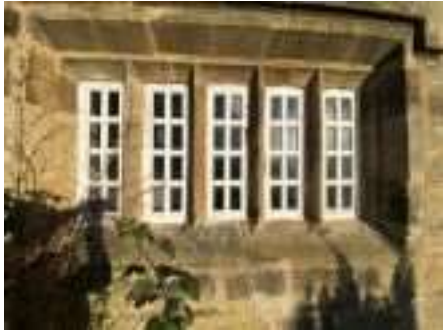
| | <p>Condition</p> <ul style="list-style-type: none"> <li>• Frames good condition</li> <li>• Single glazed and glass condensating</li> <li>• In need of full redecoration</li> <li>• Style looks to not be original and doesn't match other windows</li> </ul> <p>Recommended action</p> <ul style="list-style-type: none"> <li>• Minor repairs and full decoration</li> <li>• Or replace if style is not considered appropriate</li> </ul> |

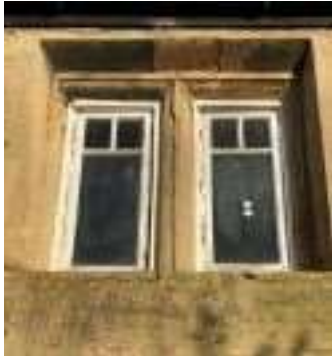
| | <p>Condition</p> <ul style="list-style-type: none"> <li>• Frames rotten right through some lower joints</li> <li>• Casement twisted and joints blown</li> <li>• Putty missing</li> <li>• Single glazed and glass condensating</li> <li>• In need of full redecoration</li> </ul> <p>Recommended action</p> <ul style="list-style-type: none"> <li>• Replacement windows</li> </ul> |

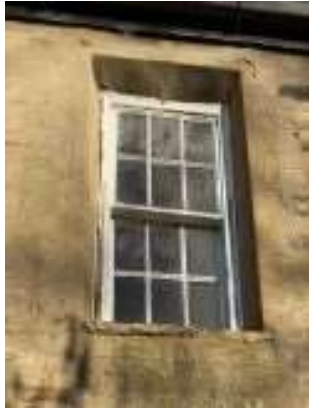
| | <p>Condition</p> <ul style="list-style-type: none"> <li>• Frames rotten right through box joints and sill</li> <li>• Sashes rotten</li> <li>• Putty missing</li> <li>• Single glazed and glass condensating</li> <li>• In need of full redecoration</li> </ul> <p>Recommended action</p> <ul style="list-style-type: none"> <li>• Replacement window</li> </ul> |

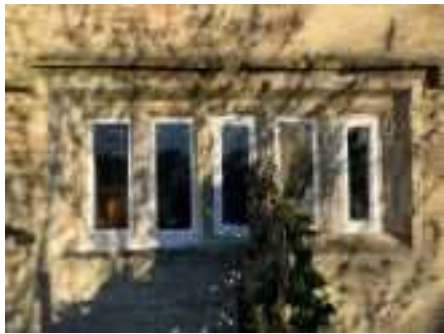
| | <p>Condition</p> <ul style="list-style-type: none"> <li>• Frames rotten right through some lower joints</li> <li>• Casement rotten and twisted</li> <li>• Casement not original style on neighbouring property</li> <li>• Putty missing</li> <li>• Single glazed and glass condensating</li> <li>• In need of full redecoration</li> </ul> <p>Recommended action</p> <ul style="list-style-type: none"> <li>• Replacement windows</li> </ul> |

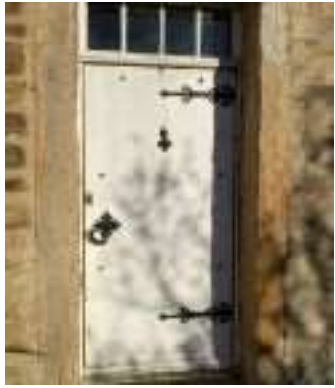
| | <p>Condition</p> <ul style="list-style-type: none"> <li>• Frames rotten at bottom, same for sill</li> <li>• Door ill fitting</li> <li>• Single glazed and glass condensating</li> <li>• In need of full redecoration</li> </ul> <p>Recommended action</p> <ul style="list-style-type: none"> <li>• General repairs to door</li> <li>• New sill and lower frame sections</li> <li>• Full redecoration</li> </ul> |

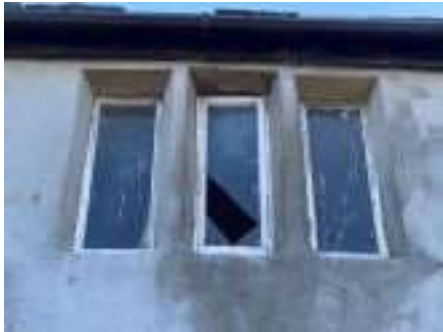
| | <p>Condition</p> <ul style="list-style-type: none"> <li>• Frames rotten right through lower joints</li> <li>• Casement made incorrectly and bottom rail likely to drop off</li> <li>• Single glazed and glass broken/condensating</li> <li>• In need of full redecoration</li> </ul> <p>Recommended action</p> <ul style="list-style-type: none"> <li>• Replacement windows</li> </ul> |

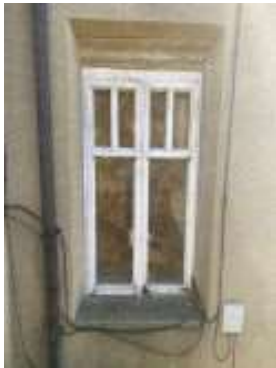
| | <p>Condition</p> <ul style="list-style-type: none"> <li>• Some rot to bottom of frame</li> <li>• Casement rotten and made for double glazing (not original style of window)</li> <li>• Single glazed and glass condensating</li> <li>• In need of full redecoration</li> </ul> <p>Recommended action</p> <ul style="list-style-type: none"> <li>• Replacement windows with appropriate casement styles and construction</li> </ul> |

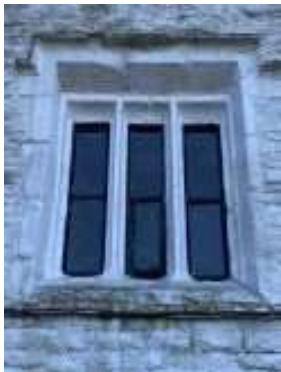
| | <p>Condition</p> <ul style="list-style-type: none"> <li>• Frame rotten to sill of left hand window</li> <li>• Casement has been badly re-fitted at some point</li> <li>• Putty missing</li> <li>• Single glazed and glass condensating</li> <li>• In need of full redecoration</li> </ul> <p>Recommended action</p> <ul style="list-style-type: none"> <li>• Replacement casement and general repairs to window frames</li> <li>• Full redecoration</li> </ul> |

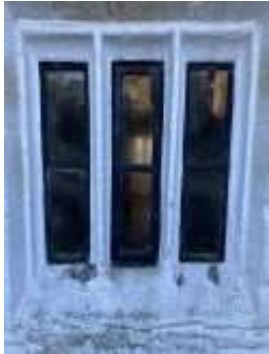
| | <p>Condition</p> <ul style="list-style-type: none"> <li>• Frames rotten right through joints</li> <li>• Casement ill fitting and joints rotten</li> <li>• Putty missing</li> <li>• Single glazed and glass condensating</li> <li>• In need of full redecoration</li> </ul> <p>Recommended action</p> <ul style="list-style-type: none"> <li>• Replacement windows</li> </ul> |

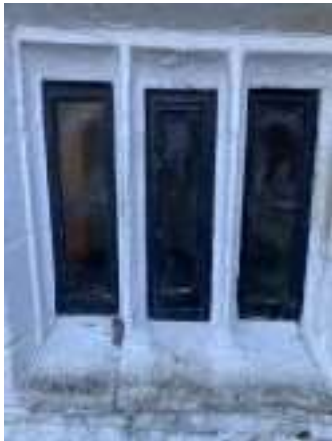
| | <p>Condition</p> <ul style="list-style-type: none"> <li>• Frames rotten at bottom</li> <li>• Casement window doesn't match original styles and is an open-in casement. Likely will leak</li> <li>• Putty missing</li> <li>• Single glazed and glass condensating</li> <li>• In need of full redecoration</li> </ul> <p>Recommended action</p> <ul style="list-style-type: none"> <li>• Replacement central casement window with appropriate new window</li> <li>• General repairs to window frames, full redecoration</li> </ul> |

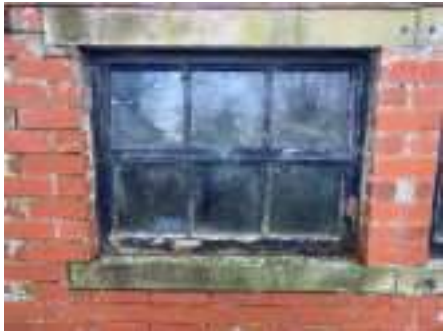
| | <p>Condition</p> <ul style="list-style-type: none"> <li>• Frames rotten right through joints</li> <li>• Casement rotten</li> <li>• Putty missing</li> <li>• Single glazed and glass condensating</li> <li>• In need of full redecoration</li> </ul> <p>Recommended action</p> <ul style="list-style-type: none"> <li>• Replacement window</li> </ul> |

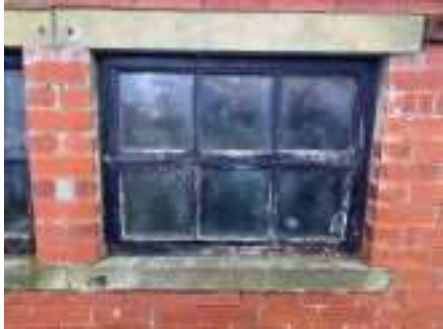
| | <p>Condition</p> <ul style="list-style-type: none"> <li>• Frames rotten right through joints</li> <li>• Casement rotten</li> <li>• Putty missing</li> <li>• Single glazed and glass condensating</li> <li>• In need of full redecoration</li> </ul> <p>Recommended action</p> <ul style="list-style-type: none"> <li>• Replacement window</li> </ul> |

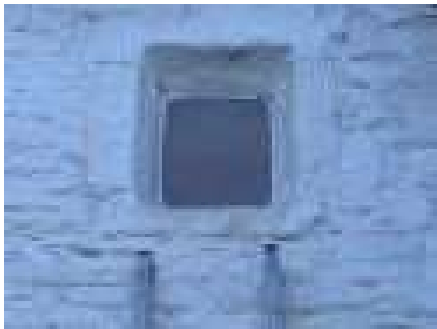
| | <p>Condition</p> <ul style="list-style-type: none"> <li>• Appears to be a single glass pane, directly glazed into surrounding stone rebates</li> <li>• Single glazed and glass condensating</li> <li>• In need of full redecoration</li> </ul> <p>Recommended action</p> <ul style="list-style-type: none"> <li>• Full redecoration</li> </ul> |

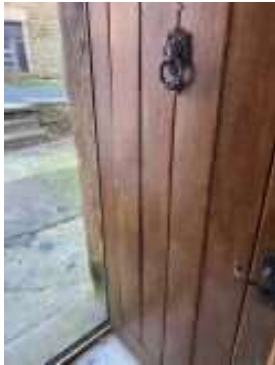
| | <p>Condition</p> <ul style="list-style-type: none"> <li>• Frame in good condition</li> <li>• Door has warped Oak boards</li> <li>• In need of full redecoration</li> </ul> <p>Recommended action</p> <ul style="list-style-type: none"> <li>• Replacement Oak boards, general re-fit of door, full re-decoration</li> </ul> |

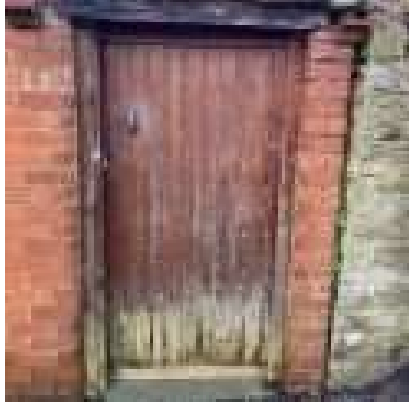
| | <p>Condition</p> <ul style="list-style-type: none"> <li>• Frames rotten at lower sections</li> <li>• Door joints rotten at low level</li> <li>• Door boarding rotten</li> <li>• In need of full redecoration</li> </ul> <p>Recommended action</p> <ul style="list-style-type: none"> <li>• Replacement door-set</li> </ul> |

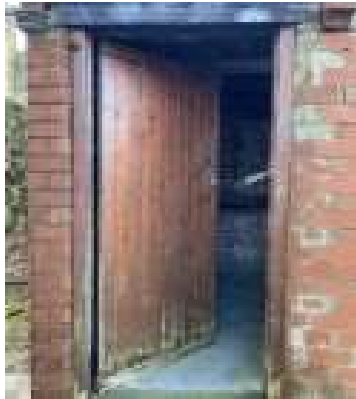
| | <p>Condition</p> <ul style="list-style-type: none"> <li>• Frames rotten at lower sections</li> <li>• Door joints rotten at low level</li> <li>• Door boarding rotten</li> <li>• In need of full redecoration</li> </ul> <p>Recommended action</p> <ul style="list-style-type: none"> <li>• Replacement door-set</li> </ul> |
