# Cockshotts Farm

School Lane, Simonstone BB12 7HR

Window and door condition report

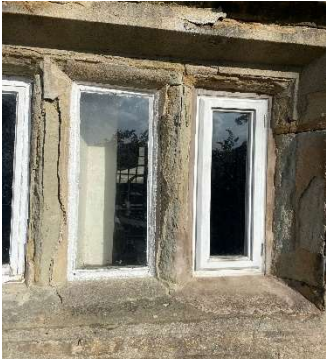
| | <p>Condition</p> <ul style="list-style-type: none"> <li>• Frames rotten right through some lower joints</li> <li>• Style looks to not be original and doesn't match other windows</li> <li>• Single glazed and glass condensating</li> <li>• In need of full redecoration</li> </ul> <p>Recommended action</p> <ul style="list-style-type: none"> <li>• Replacement windows</li> </ul> |

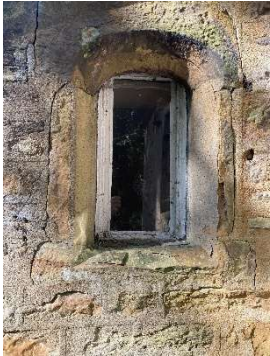
| | <p>Condition</p> <ul style="list-style-type: none"> <li>• Some minor rot to frame and casement</li> <li>• Single glazed and glass condensating</li> <li>• In need of full redecoration</li> </ul> <p>Recommended action</p> <ul style="list-style-type: none"> <li>• Repair frame and casement</li> <li>• Full redecoration</li> <li>• Re-seal frame to stonework</li> </ul> |

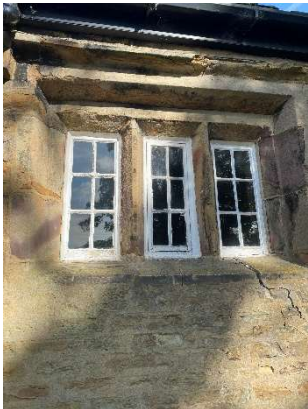
| | <p>Condition</p> <ul style="list-style-type: none"> <li>• Some minor rot to frame and casement</li> <li>• Single glazed and glass condensating</li> <li>• In need of full redecoration</li> </ul> <p>Recommended action</p> <ul style="list-style-type: none"> <li>• Repair frame and casement</li> <li>• Full redecoration</li> </ul> |

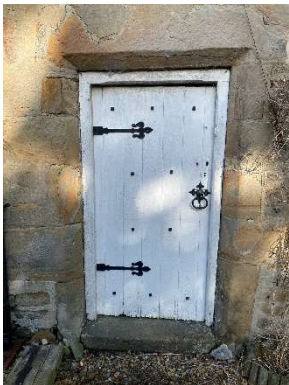
| | <p>Condition</p> <ul style="list-style-type: none"> <li>• Frames rotten at bottom</li> <li>• Door ill fitting</li> <li>• In need of full redecoration</li> </ul> <p>Recommended action</p> <ul style="list-style-type: none"> <li>• Frame repairs and re-fit door</li> <li>• Install new weather board and threshold seal to door</li> <li>• Full redecoration</li> <li>• Re-seal frame to surrounding stonework</li> </ul> |

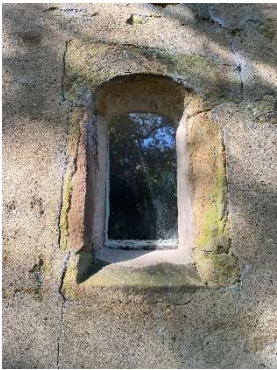
| | <p>Condition</p> <ul style="list-style-type: none"> <li>• Glass directly glazed to stone rebates</li> </ul> <p>Recommended action</p> <ul style="list-style-type: none"> <li>• Re-seal glass to stonework</li> <li>• Or replace with slim section glazed timber frame</li> </ul> |

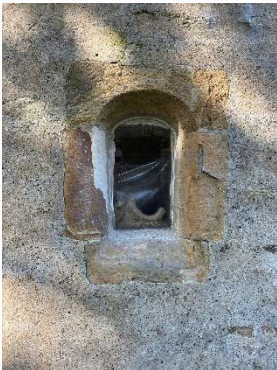
| | <p>Condition</p> <ul style="list-style-type: none"> <li>• Glass directly glazed to stone rebates</li> </ul> <p>Recommended action</p> <ul style="list-style-type: none"> <li>• Re-seal glass to stonework</li> <li>• Or replace with slim section glazed timber frame</li> </ul> |

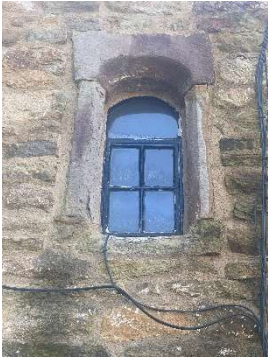
| | <p>Condition</p> <ul style="list-style-type: none"> <li>• Some minor rot to frame and casement</li> <li>• Single glazed and glass condensating</li> <li>• In need of full redecoration</li> </ul> <p>Recommended action</p> <ul style="list-style-type: none"> <li>• Repair frame and casement</li> <li>• Full redecoration</li> </ul> |

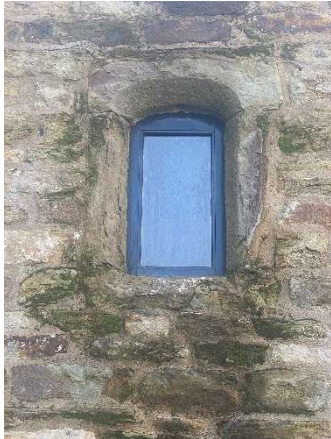
| | <p>Condition</p> <ul style="list-style-type: none"> <li>• Style looks to not be original and doesn't match other windows</li> <li>• Single glazed and glass condensating</li> <li>• In need of full redecoration</li> </ul> <p>Recommended action</p> <ul style="list-style-type: none"> <li>• Replacement window</li> </ul> |

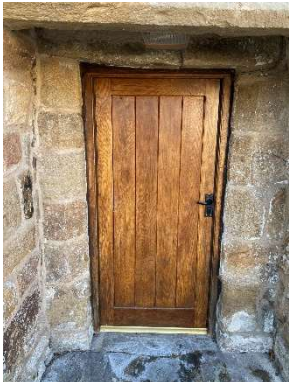
| | <p>Condition</p> <ul style="list-style-type: none"> <li>• Generally good on external inspection only</li> </ul> <p>Recommended action</p> <ul style="list-style-type: none"> <li>• Re-apply oil/stain for added weather protection</li> </ul> |
