Preliminary Bat Roost Assessment Report

**Goose Hillock Cottage,
Copster Green,
BB1 9ET**

11.05.2026

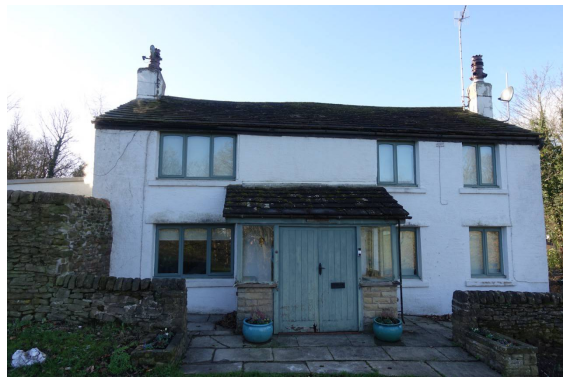
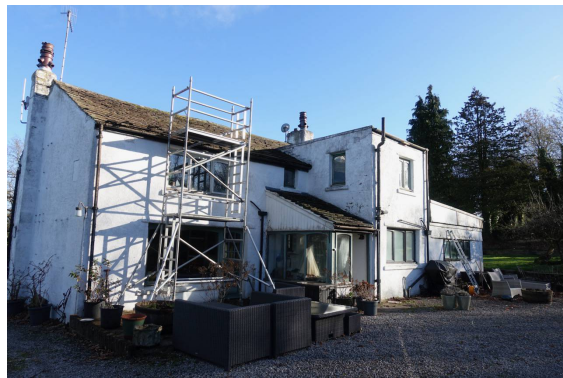
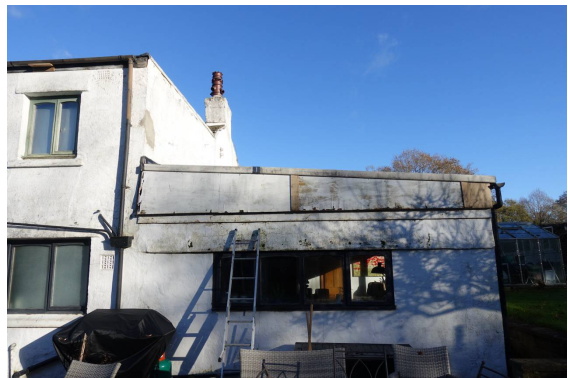
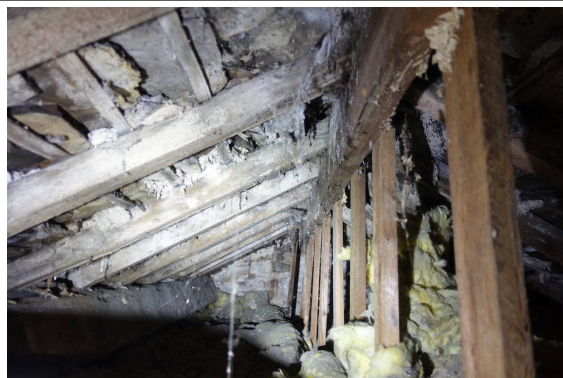
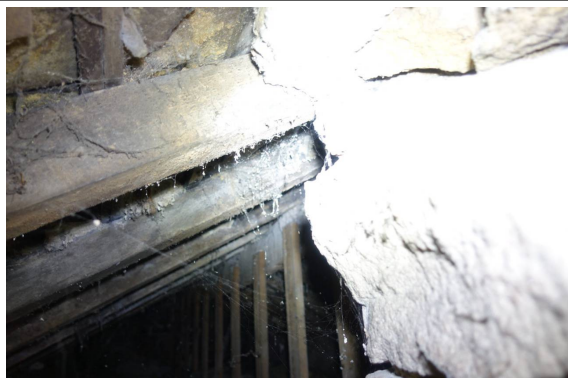
The property consists of a detached two storey stone built house with a double pitched slate roof. The two storey flat roofed extension is present to the rear facade and a single storey lean to extension is present on the south eastern gable end. Single storey porches are present on the frontage and rear facade. External walls are well pointed, and rendered, with no obvious cavities, cracks, gaps or crevices present. Gaps behind fascia boarding were noted. Roof slates are generally close fitting with some lifted, slates present around the chimney stack. Some roof slumping was evident. Ridge tiles are generally pointed and well sealed. Slates are unlined with torch pointing present, some water ingress was noted in the loft spaces which are heavily cobwebbed and dusty.

The building can be considered to offer low bat potential.

The building was observed to have no obvious suitable roost features present.

No evidence to suggest presence of roosting bats (in the form of scattered droppings, urine splashing, feeding remains or grease marking) to suggest use by bats was recorded despite suitable undisturbed horizontal surfaces being present, and at a time of year when such evidence would reasonably be expected.

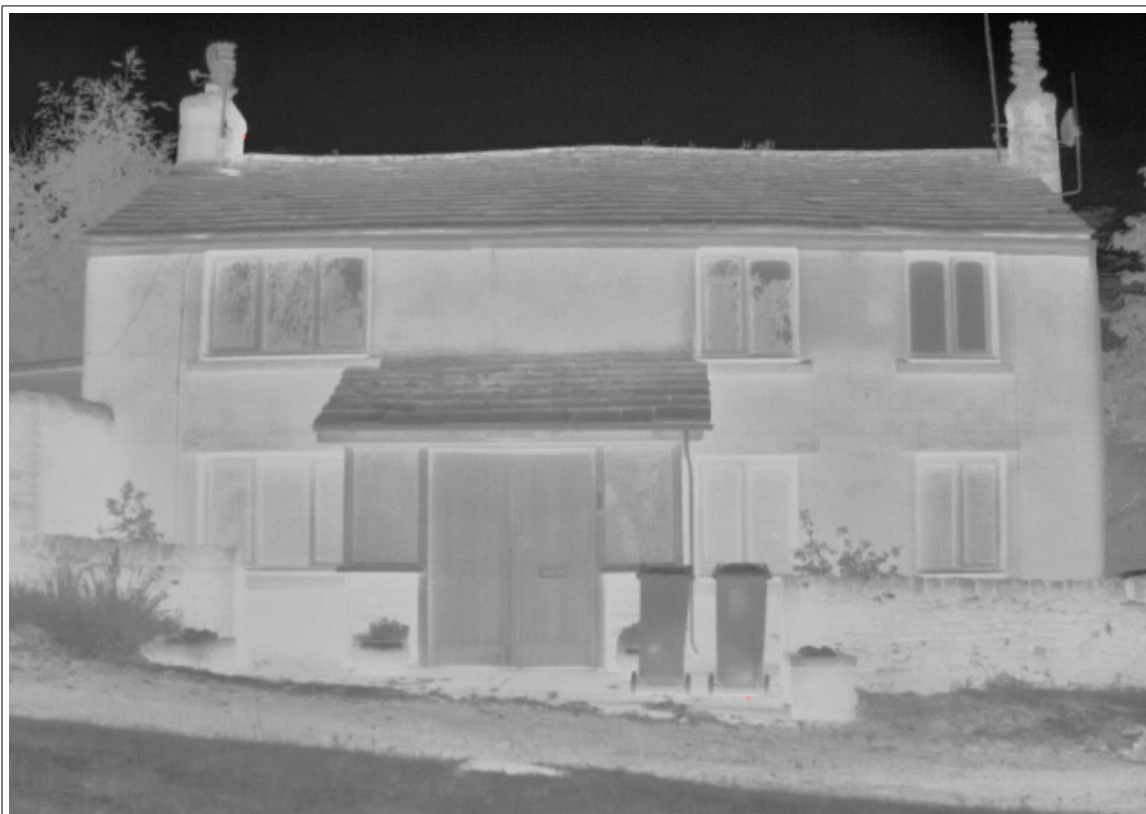
Survey summary

From 21.18 a low level of Common Pipistrelle bat activity was observed with individual bats recorded foraging along the woodland edge of the rear garden, and along the treeline associated with the lane to the front.

No bats were observed to emerge from the building.

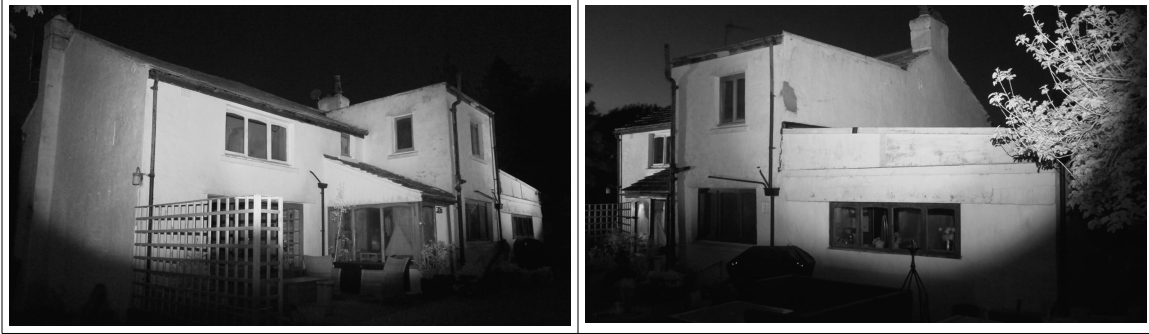
Thermal camera coverage at end of survey
