# Pendle Road, Clitheroe

## River Condition Assessment Report

Report Ref. ER-8455-02B

Richborough Estates

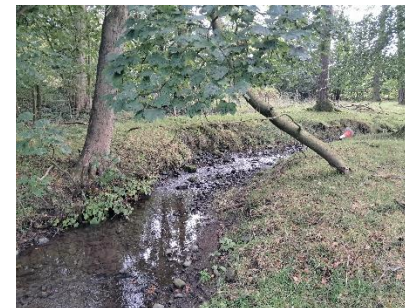
28. The upstream section, which now lies mostly off-Site, is characterised by the woodland growing on both bank tops, leading to much of the watercourse being shaded by vegetation. A mix of coniferous and deciduous tree species grow on both bank tops as an open woodland with minimal understorey, and a dense field layer of grasses and forbs. The left (south) bank top in particular supports abundant large wood in the form of fallen trees and branches.

29. Initially, at the brook's eastern end, both banks are relatively high (1m on both sides) and steeply-sloped, with visible erosion. The bank profile decreases as the brook flows westwards, and by the end of this section has reduced to 10-20cm on both banks. Gravel and cobble side bars have been deposited on the insides of curves in the brook, providing a variety of aquatic habitats.

Typical view of upstream section.

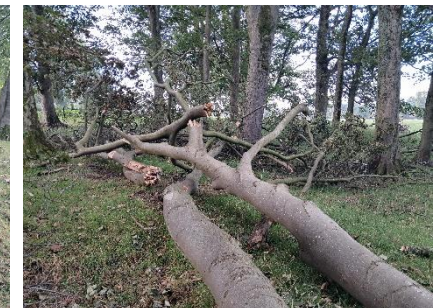
Large wood on bank top.

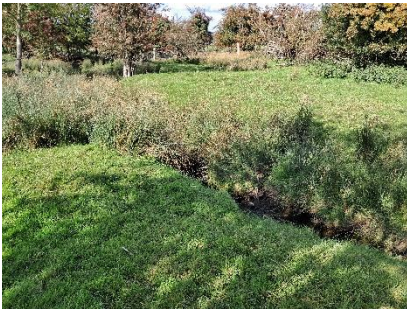
32. Both banks are heavily undercut, to the extent that in some areas, the bed of the brook is wider than the distance between the two bank tops. Both banks are relatively low, averaging 40cm on both sides.

Typical view of midstream section.

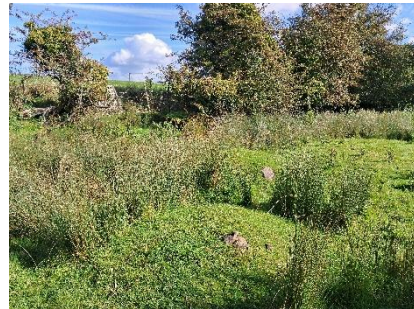
31. The midstream section is characterised by wetland vegetation growing primarily on the left bank top, with abundant hard rush and flag iris. These areas are heavily sheep-grazed, and the surrounding grass swards are very short.

Rush-dominated bank top wetland.

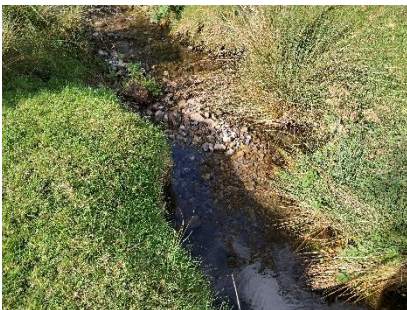
33. The brook drops through several small cascades in this section, producing relatively deep plunge pools (up to 50cm deep) compared to the generally shallower sections at the tops of the cascades (10-20cm deep). Several marginal backwaters have formed in the vicinity of the cascades, producing a wide variety of flow types suitable for aquatic species. Despite the brook's small size, a mid-channel bar of gravel and pebbles was noted forming in the western part of this section, a feature typical of larger watercourses.

Mid-channel bar.

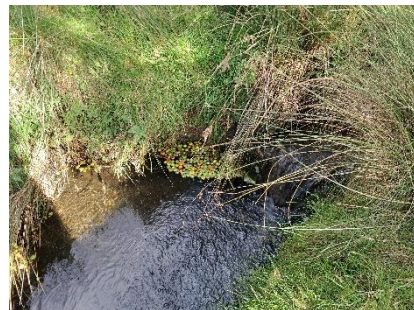
Cascade and marginal backwater.

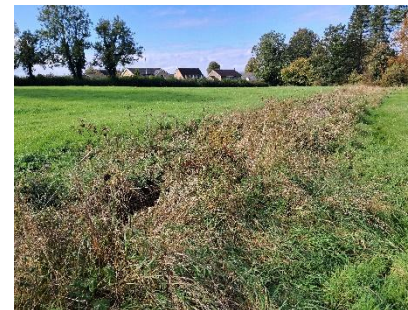
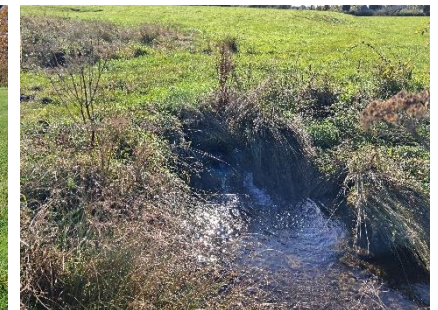
34. The downstream section is characterised by lush, agriculturally improved grassland occupying much of both bank tops, giving way to a strip of rank, herb-rich riparian grassland immediately adjacent the brook. Palatable grasses such as cock's-foot and common bent dominate. Within the riparian grassland, cock's-foot and false oat-grass dominate, alongside abundant red fescue, creeping bent, and hard rush. Forbs are abundant, with nettle and meadowsweet the most frequent, alongside cleavers, common hogweed, willowherbs, red campion, broad-leaved dock and creeping thistle. Overall, these species indicate a regularly wet, nutrient-rich environment.

35. The dense growth of riparian grassland obscures both banks for much of the brook's length, but from the visible sections they are assessed as averaging 75cm each, both with a gentle slope.

36. This section is crossed in one location by a c.4m-wide farm track to allow access between fields, and runs through a pipe culvert beneath this. Water accumulates upstream of this culvert, producing a deep section with slow flow. Downstream of the culvert, water drops down a cascade (possibly artificial, although not obviously so) into a deep, wide plunge pool, before resuming its regular narrow, shallow course.

Typical view of downstream section. Outfall of culvert.

- Investigate measures to enhance channel bed hydraulic (E3) and natural (E5) features richness.
- Remove channel bed artificial features (E10), i.e., culverts.

- Investigate measures to enhance channel bed natural features extent (E4) and material richness (E6).
- Remove channel bed reinforcement (i.e., culverts) to reduce channel bed reinforcement extent (E8) and severity (E9).

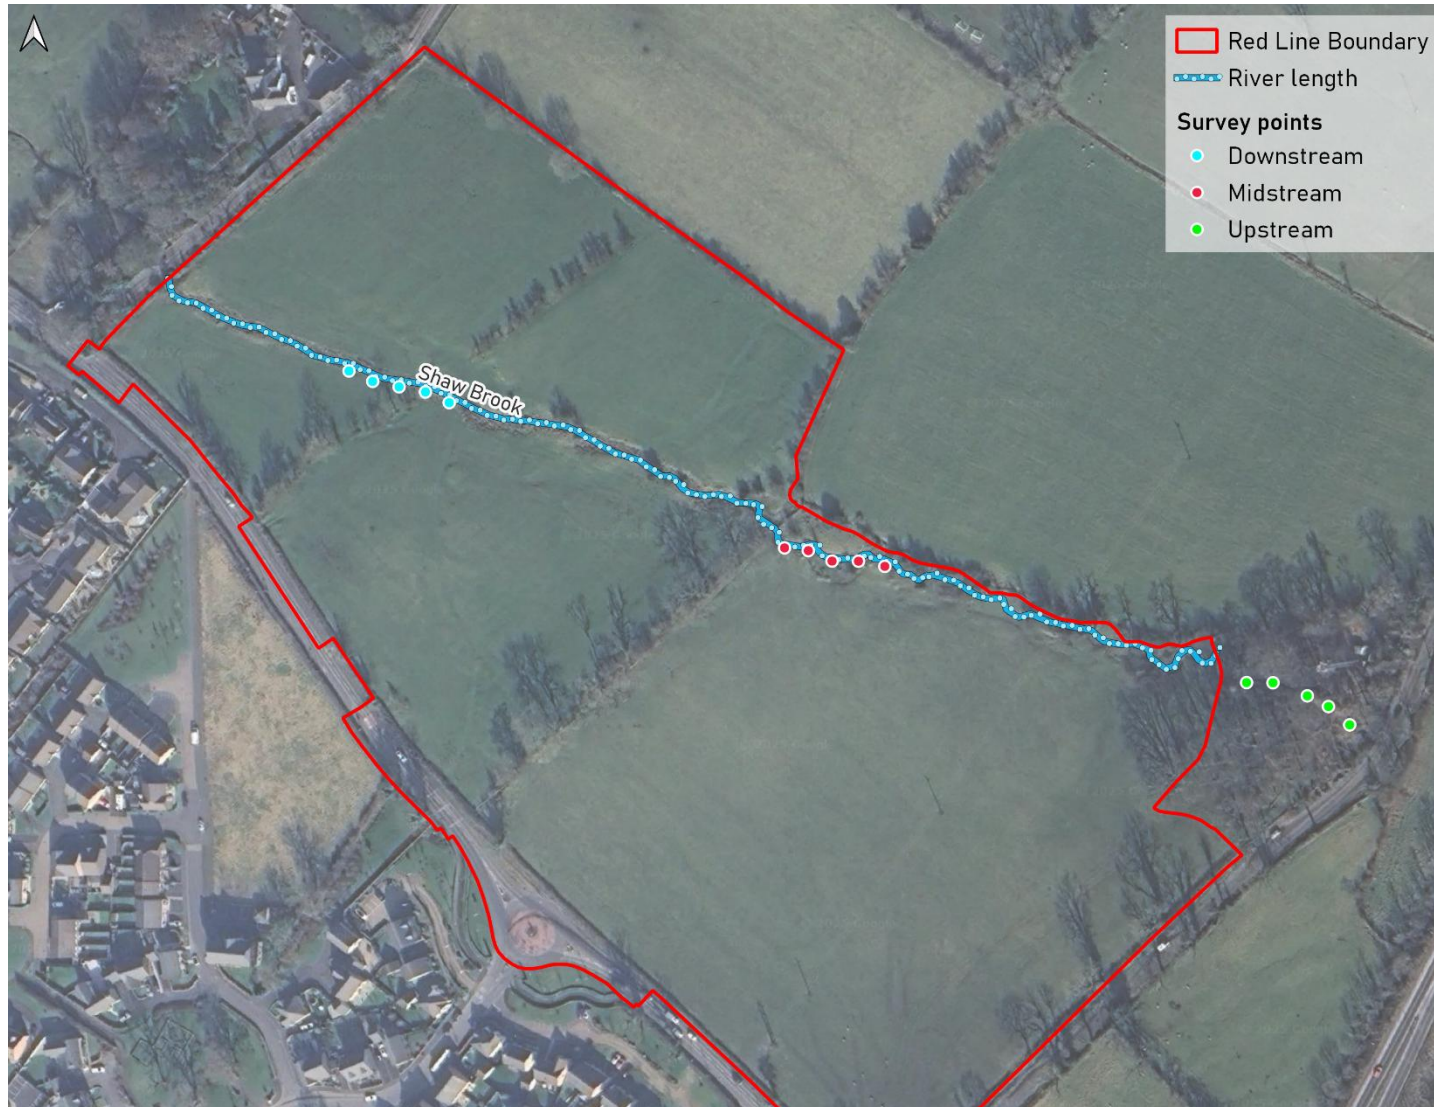
**Figure 2** MoRPh survey sites on Shaw Brook.

23. The brook was assessed as having a MoRPh river width of <5m. therefore, modules were 10m long, and MoRPh5s 50m long. The brook runs for c. 458m on-Site, and so two 50m MoRPh5s would be needed to achieve survey of 20% of the brook's length. However, as this was surveyed at a time when a greater length was included in the Site boundary, three 50m MoRPh5s were carried out.

24. During the walkover, general differences in watercourse planform, bank shape and bank top habitat were identified, splitting the brook into three sections: upstream, midstream, and downstream.

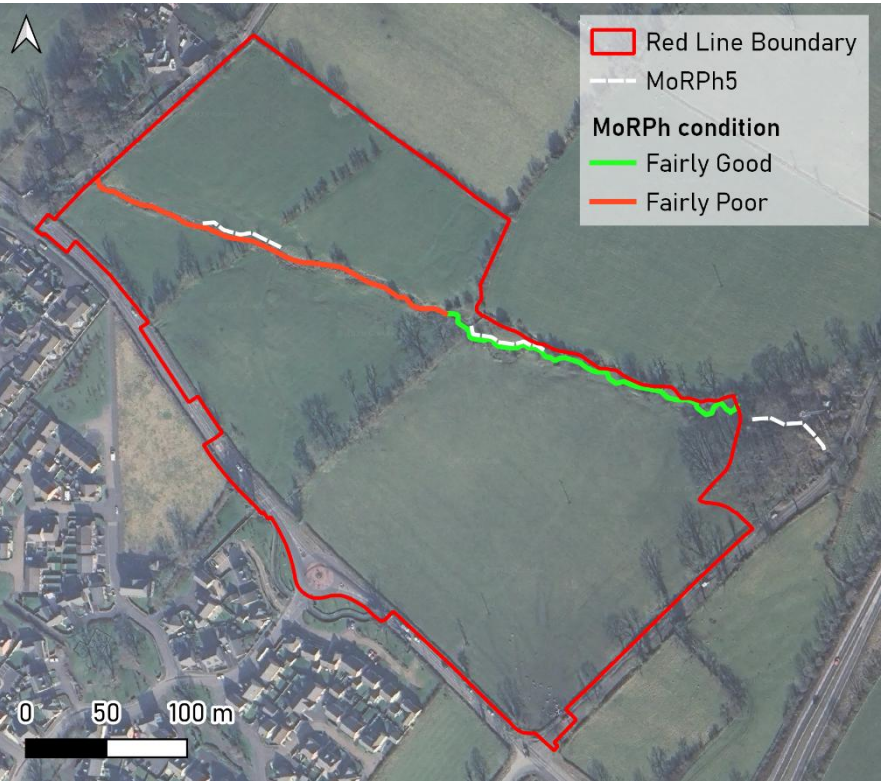
- 39. Preliminary condition scores of 1.644, 1.846, and 0.332 were generated for the upstream, midstream, and downstream sections of Shaw Beck. When assessed against the table of threshold values (see Appendix A), for a type F river, this is indicative of **Fairly Good**, **Fairly Good**, and **Fairly Poor** condition, respectively.

- 40. The brook is not considered to be overdeep, and so these condition classes have not been adjusted. This results in approximately 219m of Shaw Brook assessed as being in **Fairly Good** condition, and 239m in **Fairly Poor** condition.

Figure 3 Condition class/final score of surveyed sections of Shaw Brook.

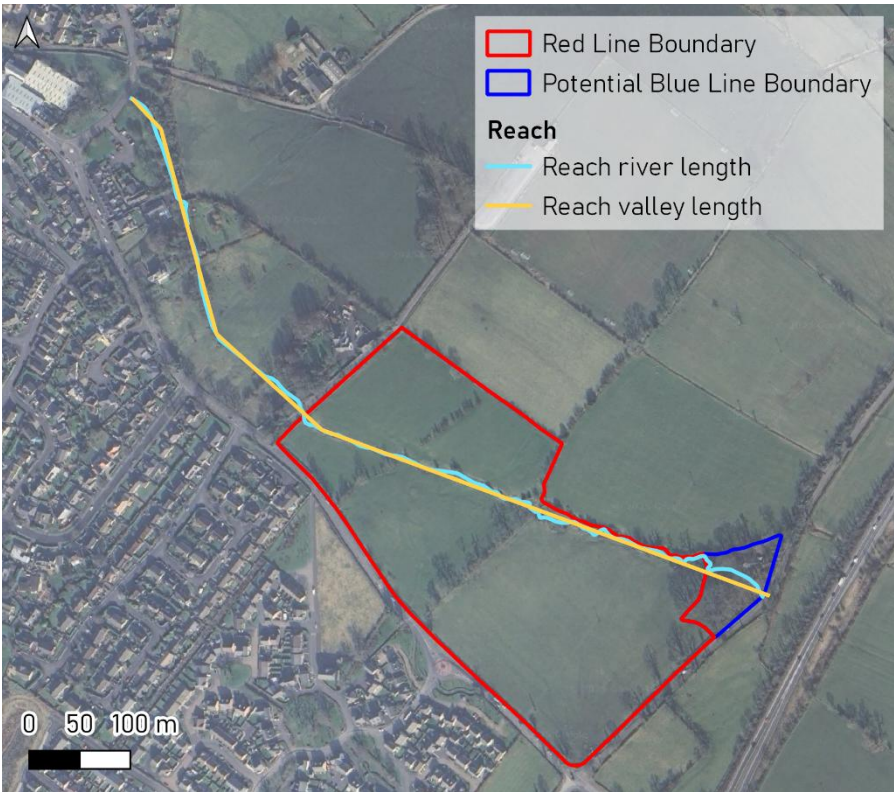
The reach used for the River Type Assessment was defined as lying between grid reference SD 75633 41043, upstream, and SD 75009 41535, downstream. Above the upstream limit, the brook becomes highly channelised into a series of drainage ditches in association with the A59 road, the construction of which (based on Lidar mapping) has significantly altered its original course. The downstream limit was set at the entrance to a 130m-long culvert beneath Highmoor Park road and a furniture warehouse, beyond which the brook becomes highly constrained by built development on both banks.

Figure B1 The reach of Shaw Brook, showing river and valley length.

This encompasses a river length of 0.91km, with a valley length (ignoring meanders but including valley side spurs) of 0.86km. River length is divided by valley length to calculate sinuosity.

The elevation of the reach starts at 117m and ends at 95m, resulting in a valley gradient of 0.02558.
