**BAT SURVEY  
AT  
MONKS BARTON  
LONGSIGHT ROAD  
LANGHO  
BB6 8AD**

**DATE AND TIME OF VISIT  
6<sup>th</sup> Jan 2026 9.30am**

**REFERENCE NO 7276**

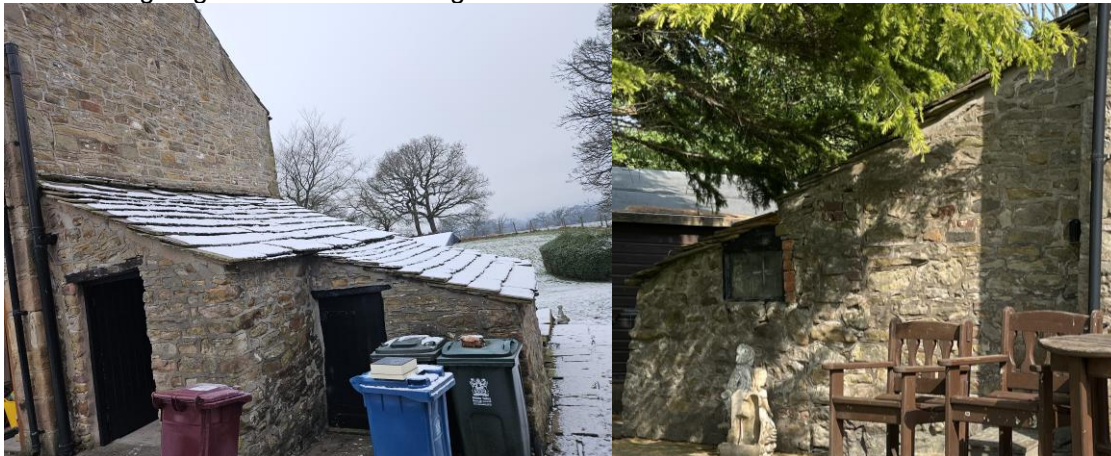
Front Southeast Elevation of stores

Rear northwest elevation

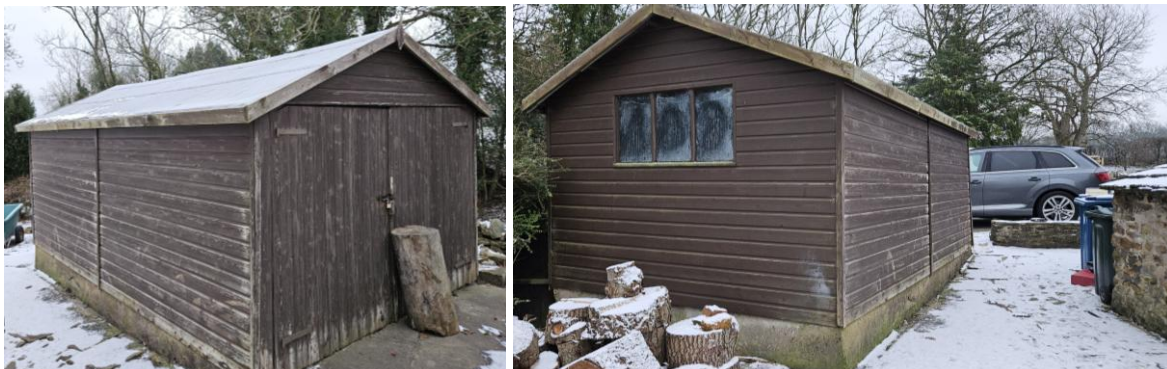
Front Southeast, side and rear northwest elevation of Timber garage.

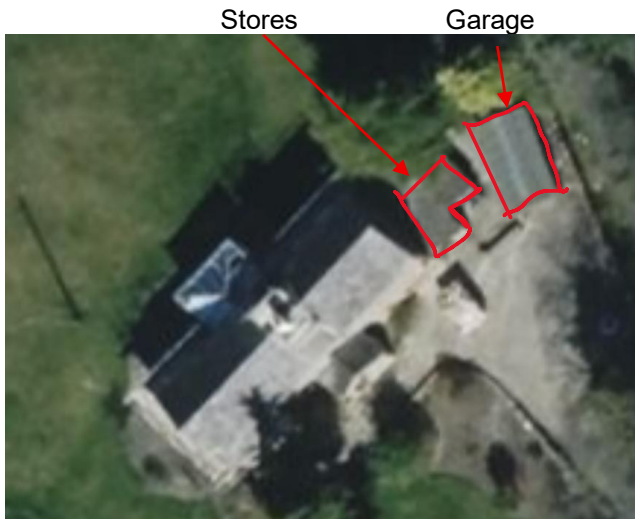
The stores are random natural stone with pointing. The adjacent house wall is pointed random natural stone. The garage is timber boarding fixed over a timber frame.

The adjacent house gable wall is in excellent well pointed condition, bat access points, cracks or crevices are not present.  
The timber boarding is in good condition and the doors fit tightly; no access points present in the garage.

The garage timber roof is in excellent condition and the abutment with the walls is very well sealed. No potential bat roost habitat present.

The garage did not have an enclosed roof void all the structure was visible and easily accessible. The structure was in excellent condition and did not provide any potential roost habitat.

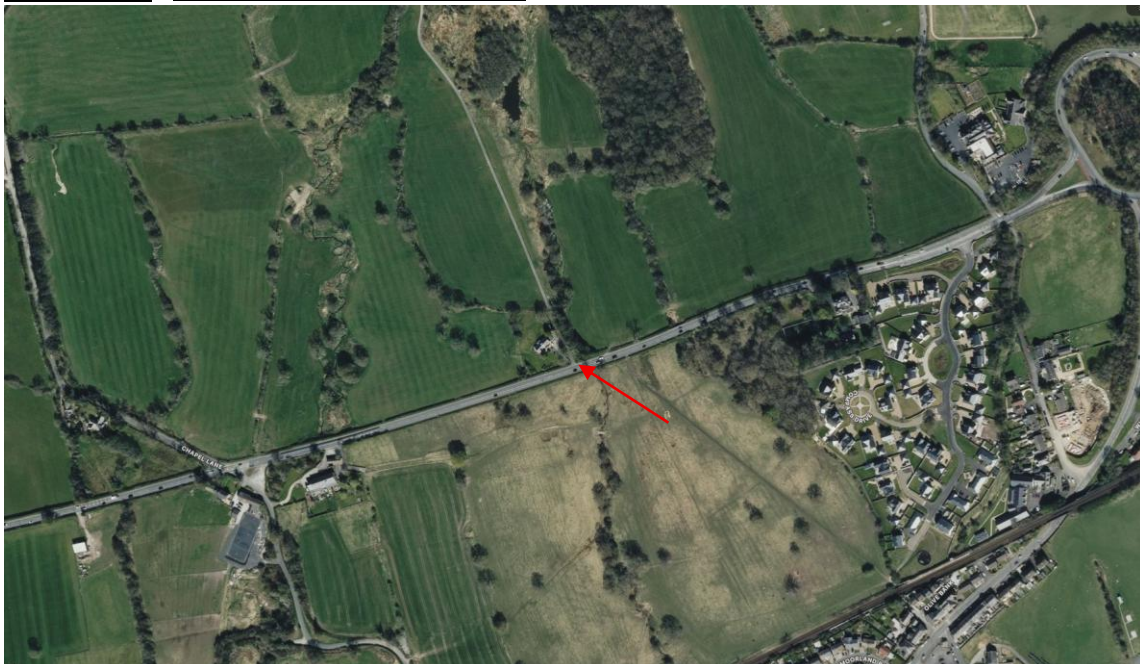
**LOCATION SD701346 53 m elevation**

The property is in a rural location approx.34m from the north edge A59 road. The edge of the Langho settlement area is 267m to the east and 421m to the south. Whalley village is 3km to the northeast.

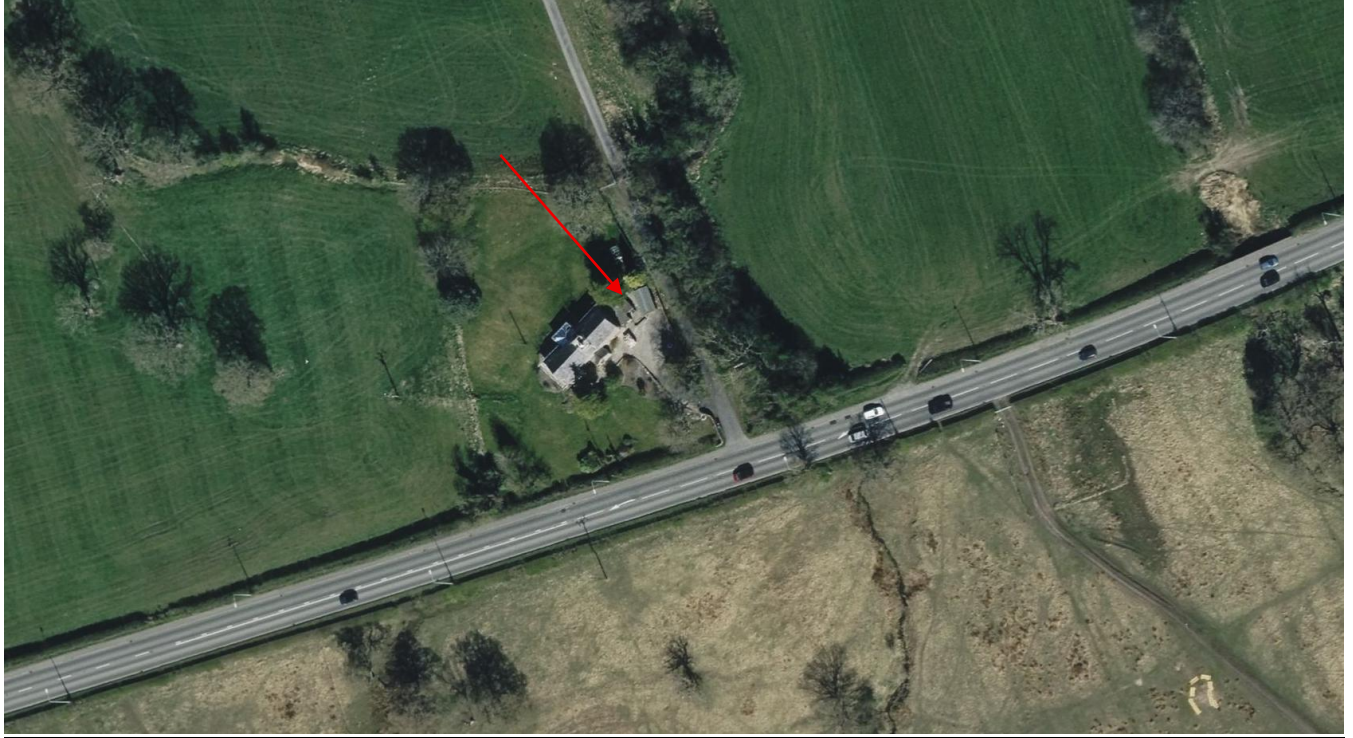
The house is in a rural location within a large garden and surrounded by pastureland mainly lined with hedgerow. There is a small Copse of trees lining an access track located to the east of the site, which connects to the greater locality together with further connecting tree lines.

The location is considered to provide an optimal level of forage potential however the close proximity of the A59 and its potential for light and noise pollution may impact the potential.

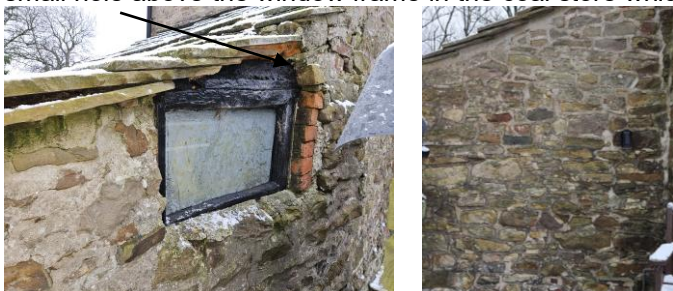
The walls are in reasonable condition, with no cracks or crevices suitable for bat ingress, except for a small hole above the window frame in the coal store which is directly into store.

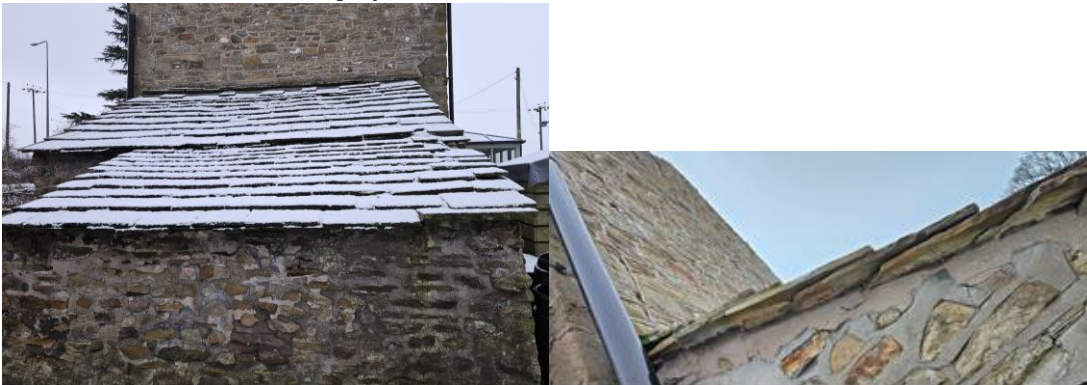
The lean – to stores have a grey slate finish with a stone flash to the house wall.

The verges and eaves are pointed.

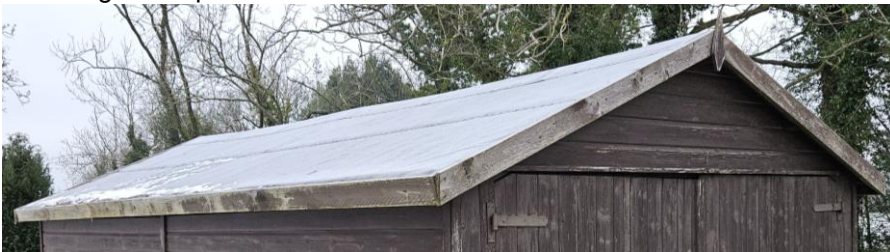
The garage roof is felt over timber boarding with a fascia and barge board present to the small overhang to the perimeter.

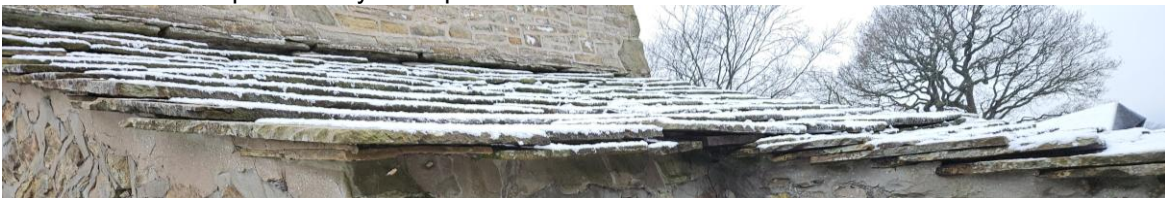
The grey slates, due to the nature of the material have some gaps at the overlaps, however they are shallow and do not provide any roost potential.

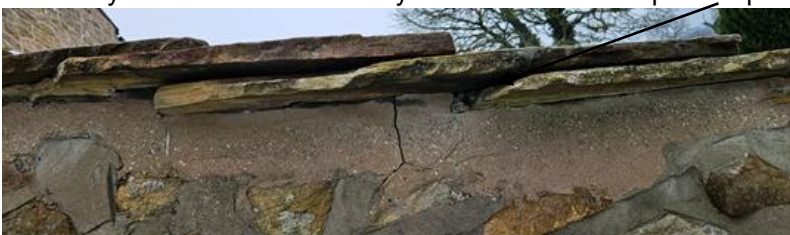
A number of small gaps were present to the verges at the abutment of the wall and slates. All could be closely examined. all were very shallow and did not provide potential habitat.

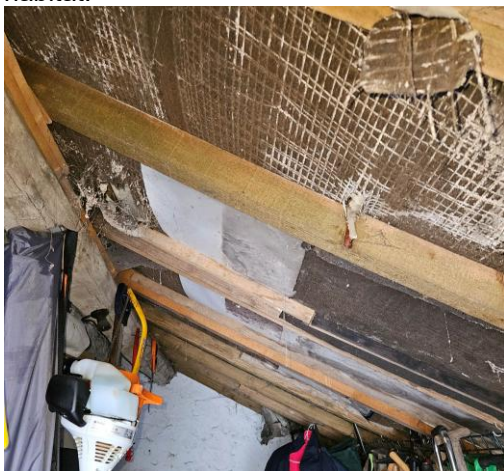
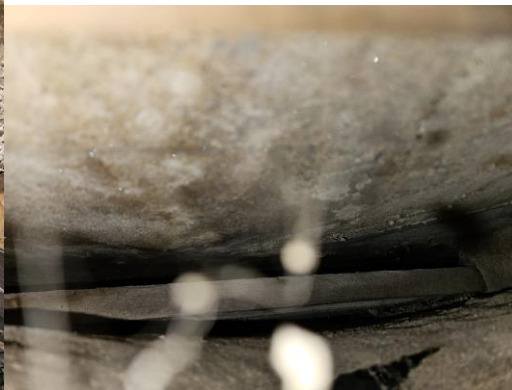
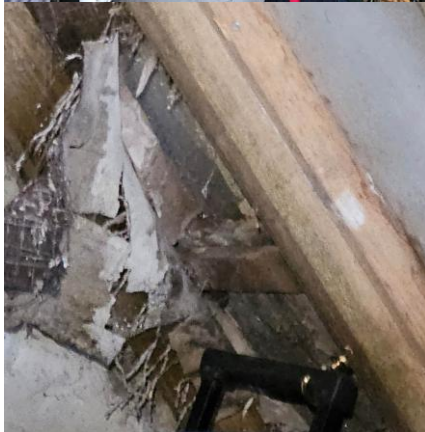
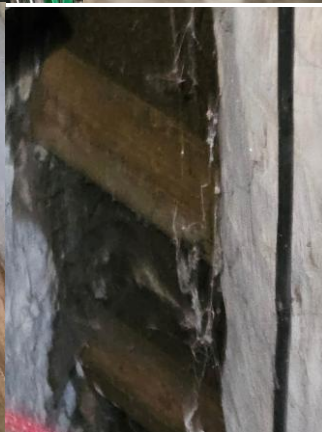
The store did not have an enclosed roof void all the structure was visible and easily accessible. The roof timber rafters appear to be relatively new, however the felt that is present is in poor condition brittle, sagging and generally degraded. The slates being largely visible it could be determined that the joints were pointed. The space was not accessible, nor did it provide any potential bat roost habitat.

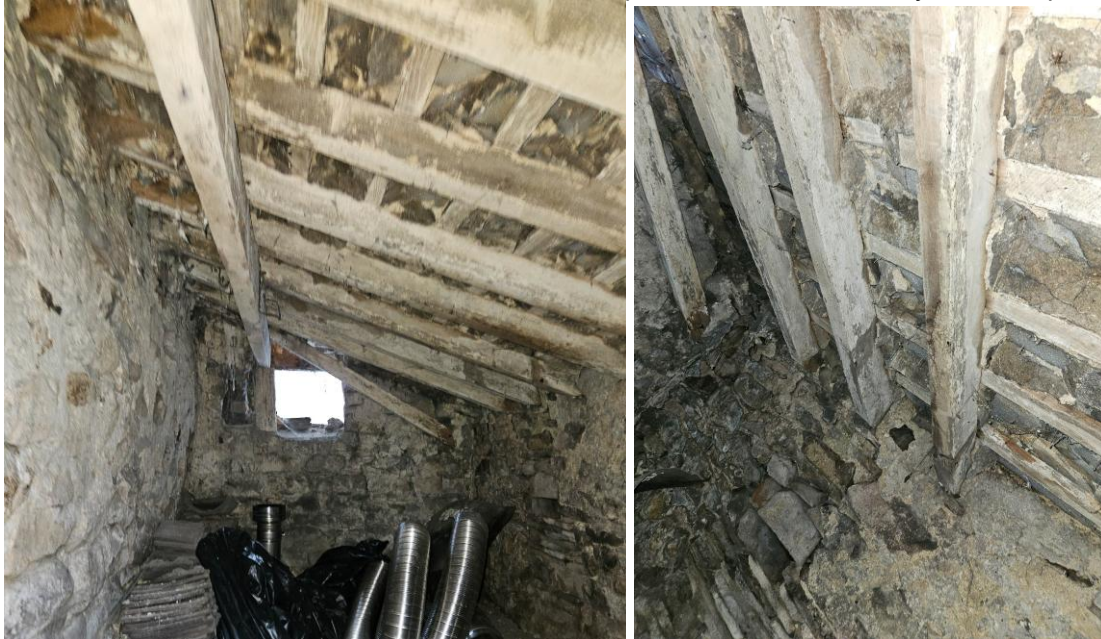
The coal store did not have an enclosed roof void all the structure was visible and easily accessible had aged timber rafters with pointed joints. Close inspection did not reveal any bat roost potential.

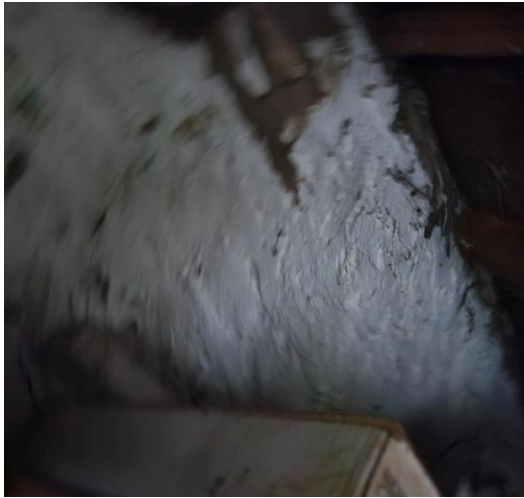
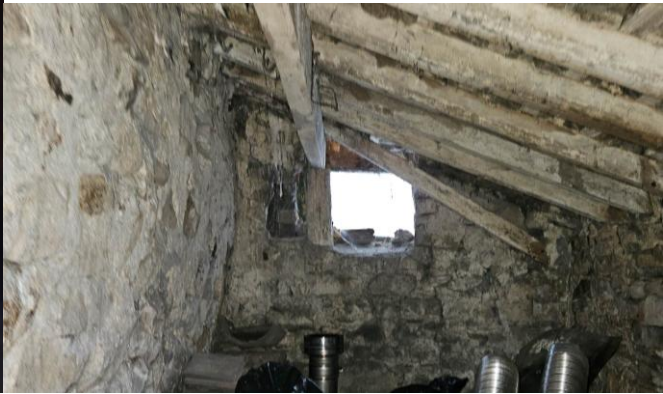
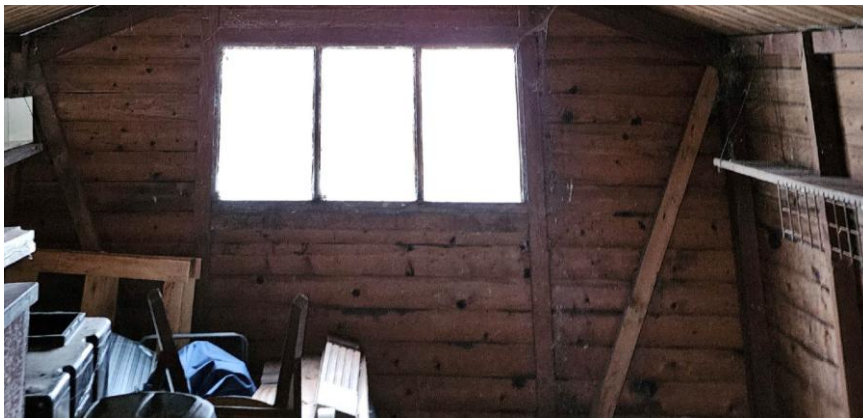
The interior of the stores and garage did not provide any high value roost habitat. Bats were not present nor were any signs of historic or current bat presence.

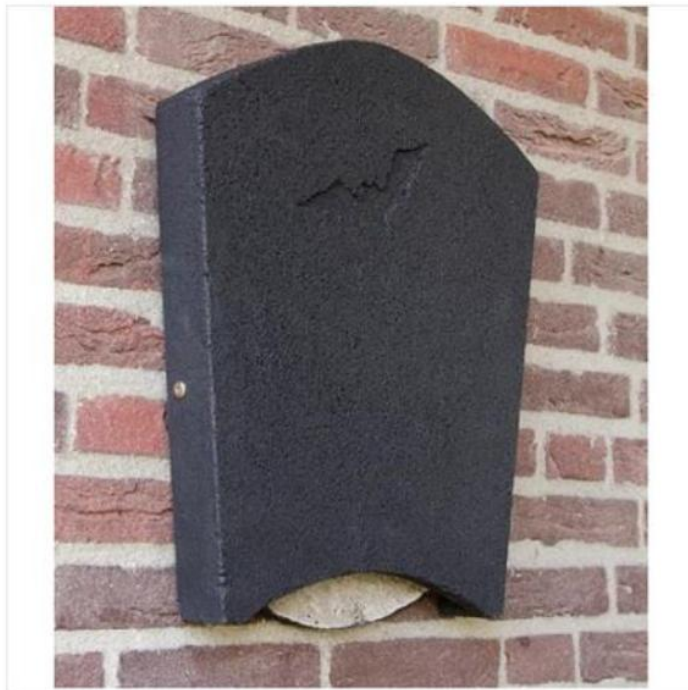
### **Beaumaris Bat Box**

It is essential that roost enhancement measures should be incorporated in the scheme. The basic requirement being that some **Sku Beaumaris (or similar)** bat boxes be fixed to the South east / south west elevations, relatively sheltered from strong winds and ideally 3-4m above ground level., in accordance with manufacturer's instructions
