BAT SURVEY, AT -
THE STABLES at
THE BARN
OLD LANGHO ROAD
BLACKBURN
BB6 8AW

REFERENCE NO 7173

Demolition of existing stable block prior to construction of a replacement stable

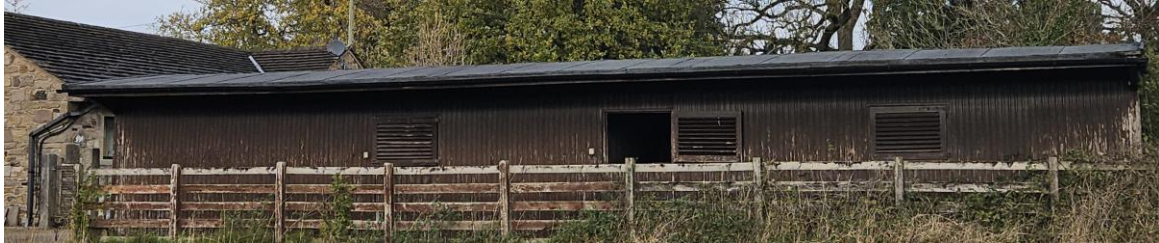
Southeast elevation

The building is an existing timber stable block of 3 loose boxes and a food store to the southwest end. It appears to have been disused for some time.

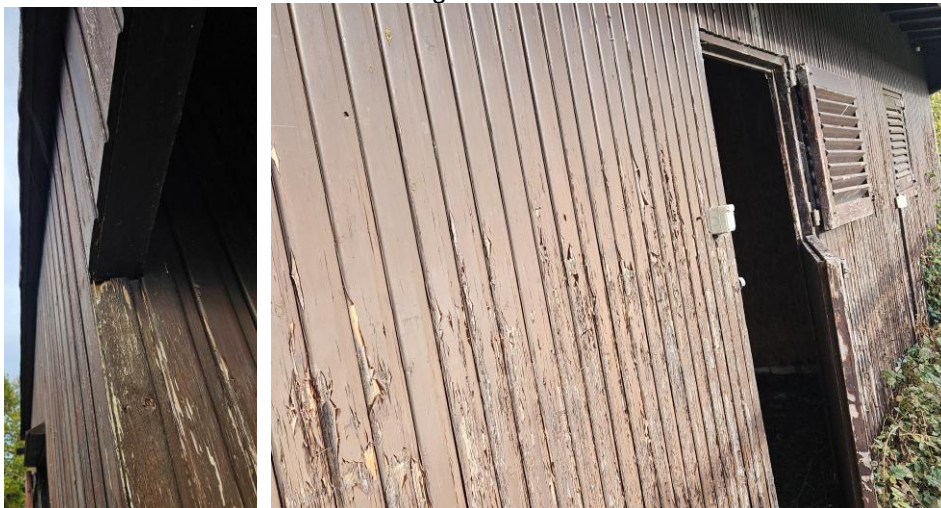
The walls are vertical timber boarding over a timber frame.

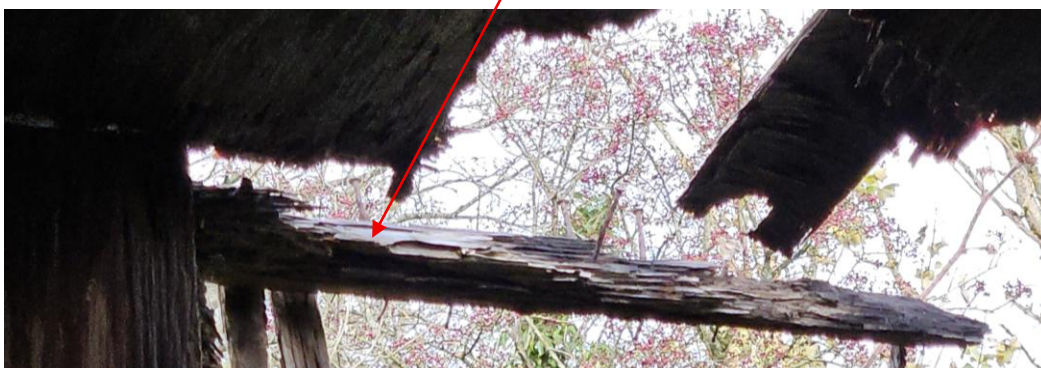
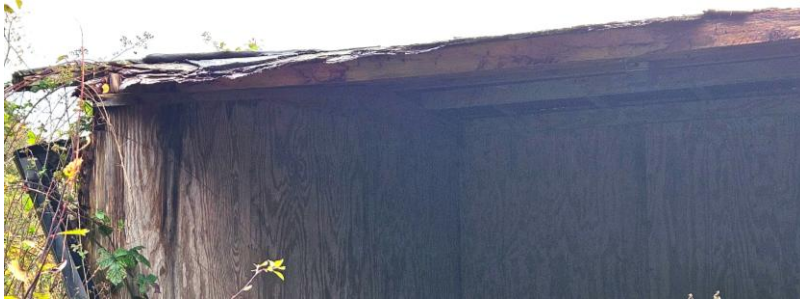
The timber finish is flaking; and the walls are in poor condition with some missing sections with some signs of rot to the adjacent timber frame. This said generally the walls do not provide any crevices for bat access. The areas of rot which were damp/ wet could be closely inspected and did not have any gaps with the potential the provide roost habitat. The interior is freely accessible through doorways and missing sections of wall.

Large section of wall missing to the rear of the loose box at the northeast end of the block.

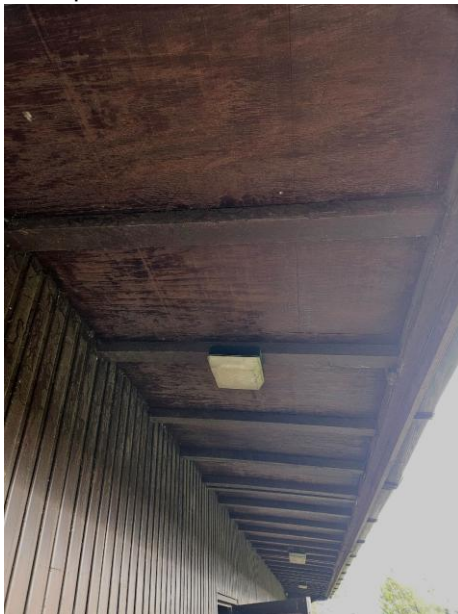
Front pitch: the felt is well sealed and lapped over the front edge of the canopy.

The underside of the canopy is board fixed over rafters with felt finish directly over. Gutter to the front edge.

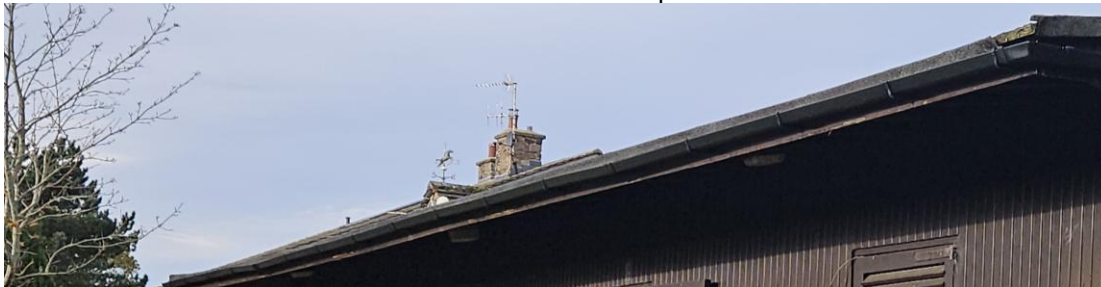
The felt is in reasonable condition on the front with no rips or lifted sections of felt.

The canopy is in good condition and the abutment with the wall is very tight fitting with no access points. This part of the roof does not provide any roost potential.

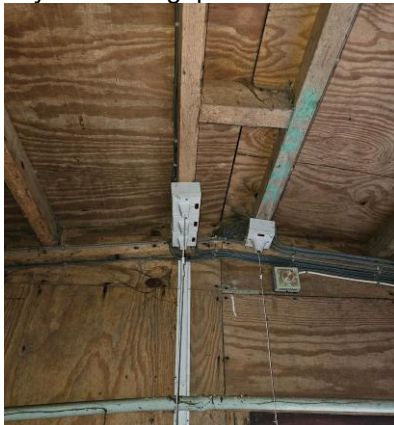
There is no enclosed roof space the timber structure is fully visible. The timber purlins and single sheet of ply forming the deck for the mineral felt finish are fully visible. The structure does not form any crevices /gaps with bat roost potential.

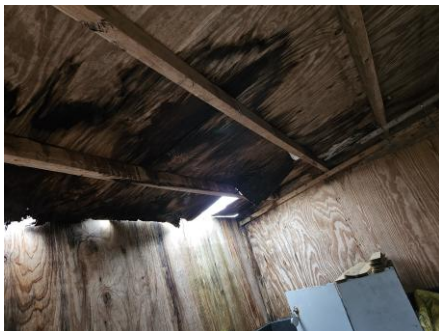
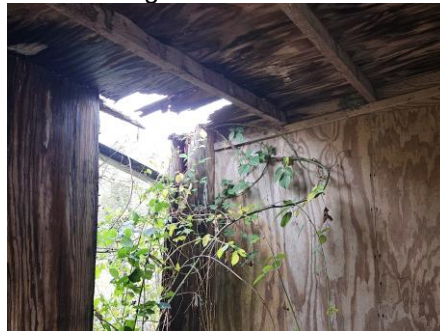
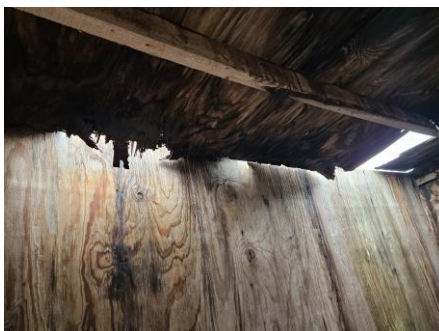
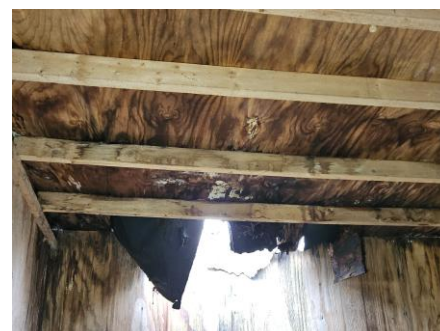
The rear roof pitch is largely in poor condition towards the eaves, due to a section of missing wall. The felt is lifted from the degraded deck below. The raised sections of felt did not provide crevices with the potential to provide roost habitat for bats being draughty and damp and not providing any protection from adverse weather conditions.

Below are the sections of deck under the lifted degraded felt.

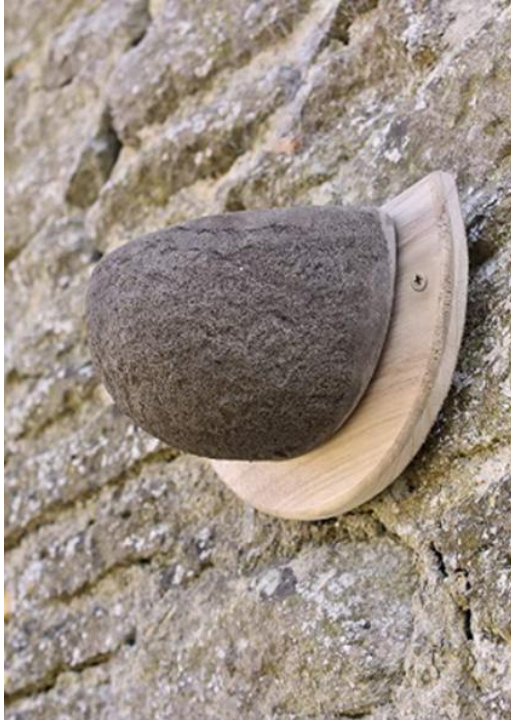
It is essential to mitigate the loss of swallow access to the stables.

This can be achieved by incorporating swallow cups or similar proprietary nesting habitat. This should be carried out after the summer and prior to the next bird breeding / nesting season.
