Bat Emergence & Roost Categorisation surveys

Site: Barn at Spring Head Farm, Bolton by Bolton.

25th November 2025

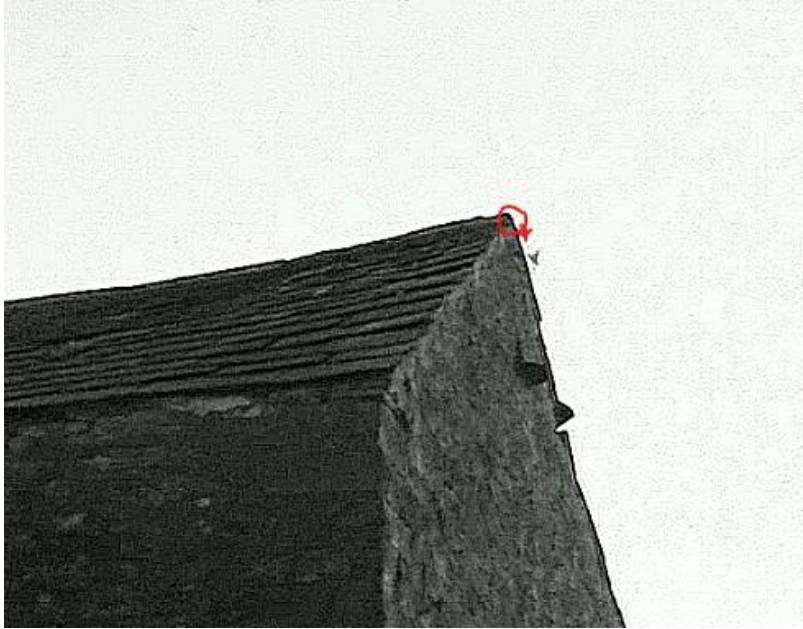
Species	Roost Type	Max count.	Location & Map ref
Common Pipistrelle	Summer Day	1	Apex of northern gable end. Map ref #1

- European protected species mitigation licence required to impact 2 Common Pipistrelle summer day roosts. The licence application will include a method statement to be followed during the works. See 4.4 *Mitigation* below.

- Potentially damaging activities should be restricted to periods of reduced sensitivity for bats, e.g. mid-September – November and March - April.
- Soft stripping of building materials in known bat roost locations.
- Roosting sites to be provided in the design of the building renovations to replicate the positions of recorded roosting sites: small gaps (15-20 x 200mm) in masonry and beneath stone-slates for crevice-dwelling bat species and the use of built-in bat roosts e.g
[Build-In Woodstone Bat Access \(wildcare.co.uk\)](http://www.wildcare.co.uk)
<https://www.wildcare.co.uk/soffit-bat-box.html>
- Minimisation of external artificial lighting during construction.
- Low impact lighting strategies will be adopted from the guidance outlined in the Bat Conservation Trust “Bats and Lighting” publications: http://www.bats.org.uk/pages/bats_and_lighting.html.

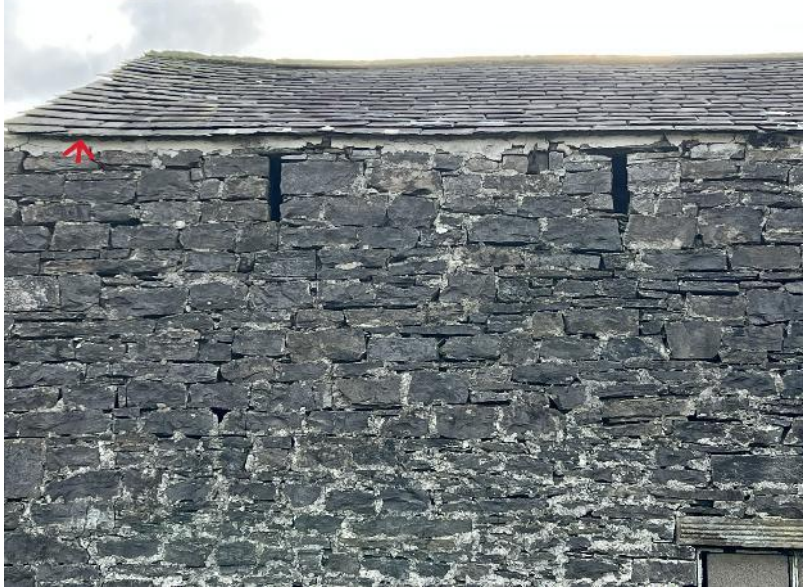
Common Pipistrelle	Summer Day	1	Eaves at north end of western elevation. Map ref #2

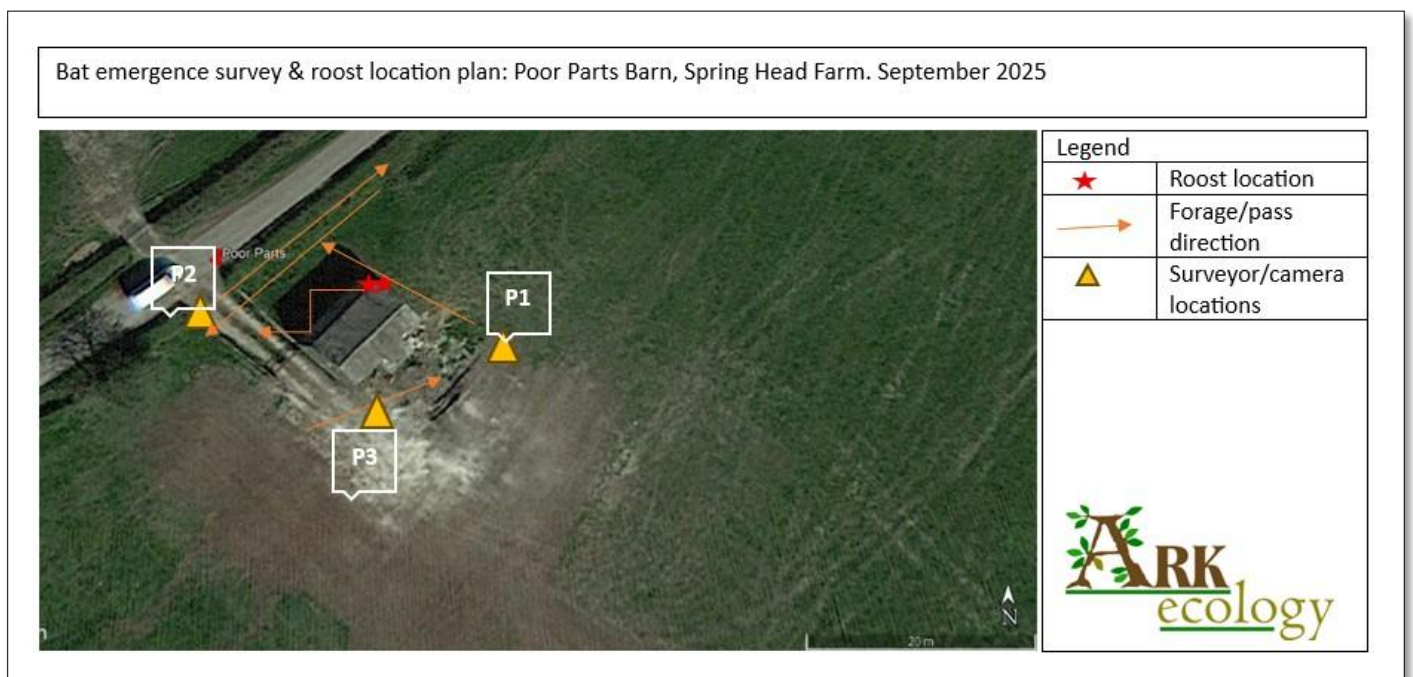
Appendix 1: Survey Plan

A survey plan is presented in Appendix 1 showing the location of each surveyor and any confirmed bat roosts.

The full detailed results of the surveys are available on request with a summary of each survey in the tables below and roost, surveyor and NVA locations shown in the map at Appendix 1.
