Preliminary Bat Roost Assessment & breeding birds survey

Site: Barn at Spring Head Farm, Bolton by Bolton.

25th February 2025

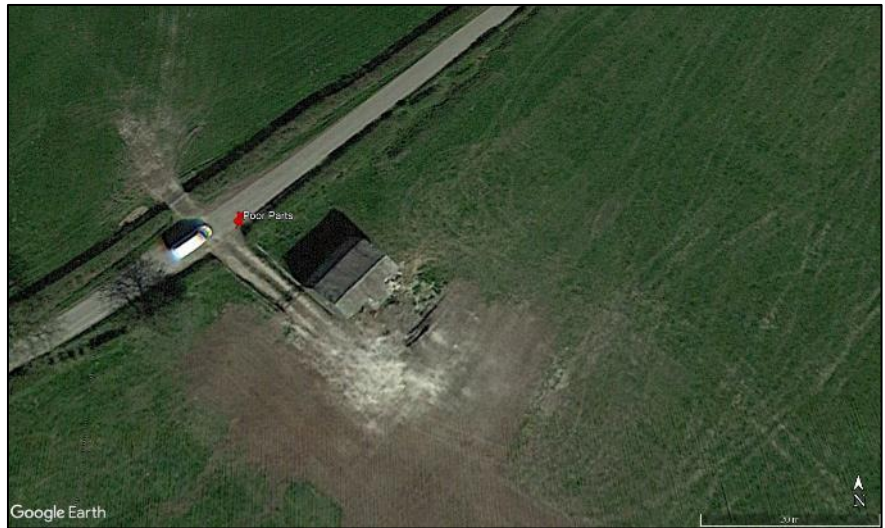
Photo 1: Overview of the site

The survey building was a detached traditional out barn.

A traditional stone-built barn, typical of the area with solid stone walls, and slate roof tiles.

The ridge of the dual pitched roof runs northeast – southwest.

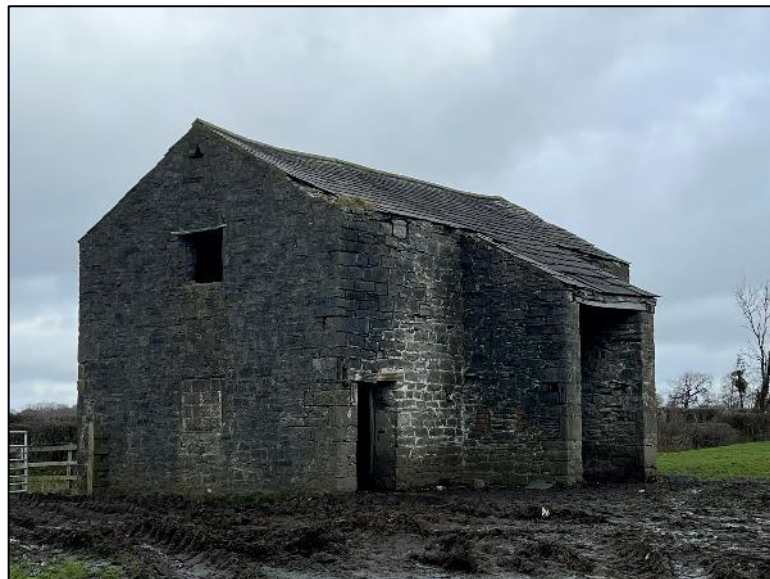
Photo 2: South and east elevations of the barn.

There were some areas of missing pointing in the stonework on all elevations, and at the eaves and verges. Although the gaps in the mortar are mostly too wide for crevice dwelling bats they allow access into the materials of the walls, which could be suitable for bats to roost.

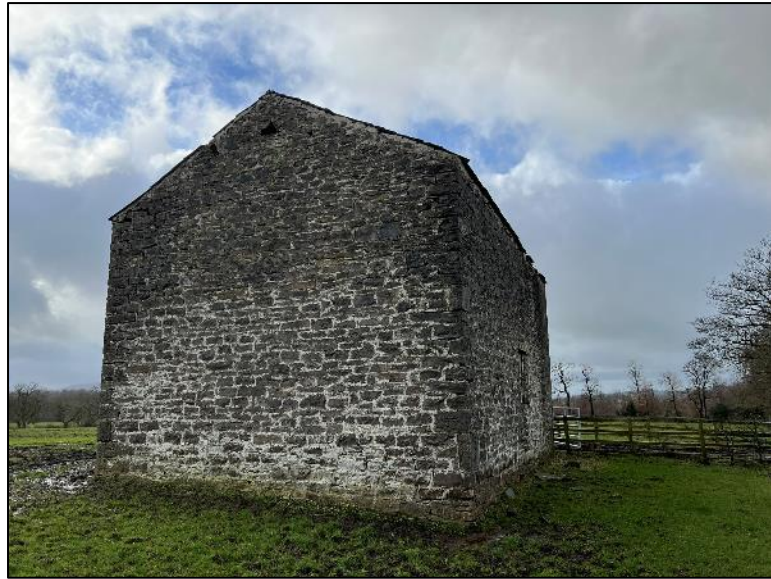
Photo 3: North gable end and west elevation of the barn.

The roof slates had multiple gaps, with some slates missing altogether. The ridge had some gaps in the pointing also.

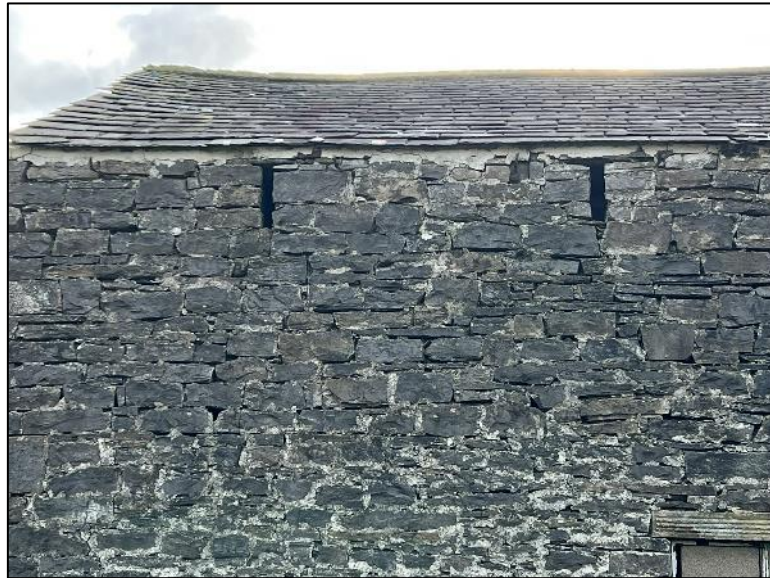
Photo 4: West elevation showing gaps to the pointing, and under the eaves and roof tiles.

Overall, there were many gaps or crevices that could be used by bats for roosting in the building.

Bats
Two further emergence surveys will be required. These should be carried out between May and September, a minimum of 3 weeks apart, and aimed at capturing the activity of bats through the peak season. If a bat roost is confirmed, then a further survey may be required to inform a Natural England Protected Species Mitigation Licence Application. In addition, if bats are found during any stage of the development, work should stop immediately, and a suitably qualified ecologist should be contacted to seek further advice.
Birds
Barn owl surveys required to determine how the building is being used, and to inform suitable mitigation.

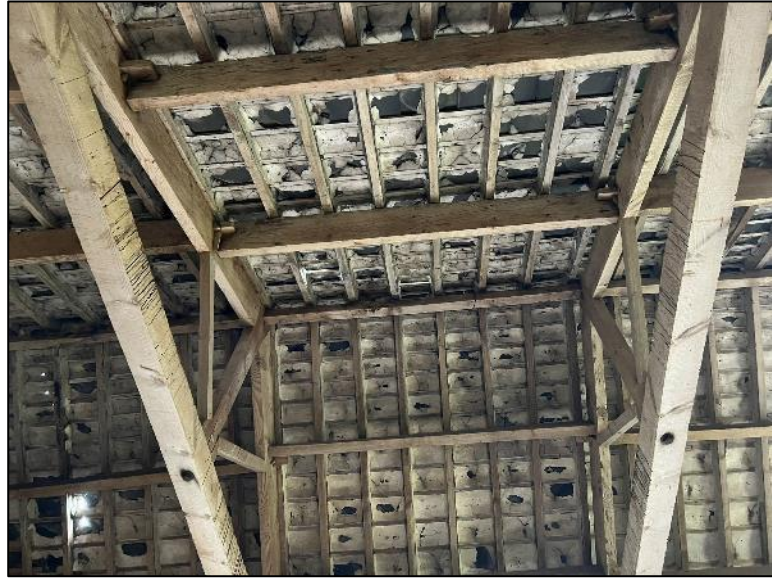
Photo 5: Internal view of roofing materials

The roofing materials were exposed internally, with the tiles being lined with sarking. There were areas of missing and cracked sarking. Areas of the stone walls had missing mortar, exposing gaps into the stonework.

The roof timbers form ideal crevices & feeding perches for bats, but the open and airy nature of the building would greatly reduce the likelihood of the presence of void dwelling bats such as brown long eared bats.

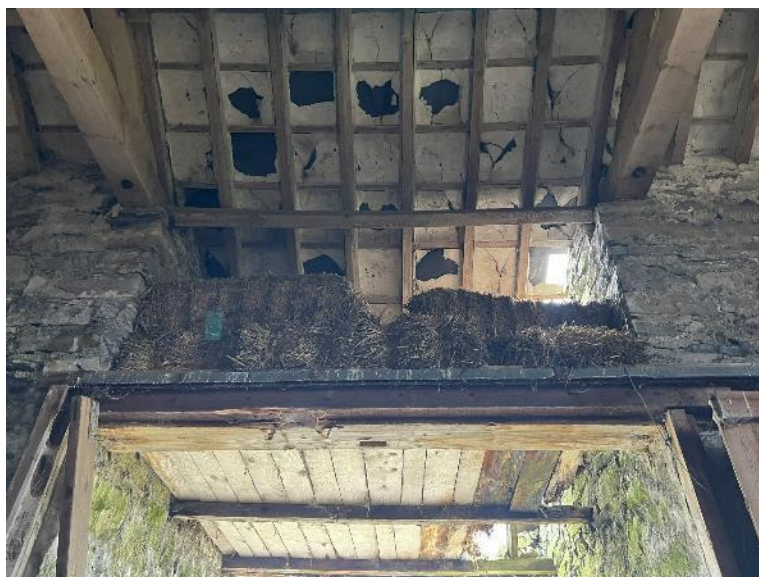
Photo 6: The small hay loft above the entrance porch, where the barn owl was roosting.

During the internal inspection a barn owl flew out from the small hayloft above the porch. There was evidence of long-term use – large numbers of owl pellets on the barn floor, and splatter on the truss beams.

Survey assessment conclusions	Barn owl nest/day roost confirmed
Foreseen impacts	High risk of disturbing nesting barn owls.
Recommendations	Further surveys for barn owl activity to determine the use of the building.
Enhancements <i>The Local Planning Authority has a duty to ask for enhancements under the NPPF and circular 06/2005: Biodiversity and Geological Conservation. Para.99</i>	To be advised following further survey effort.
