# **Bat Survey Report and Method Statement European Protected Species (Bats)**

## **Reasonable Avoidance and Mitigation Measures**

**Barn and Outbuildings at Winckley Hall Farm,  
Whalley Road,  
Clitheroe,  
BB7 9PN**

**21.11.2025**

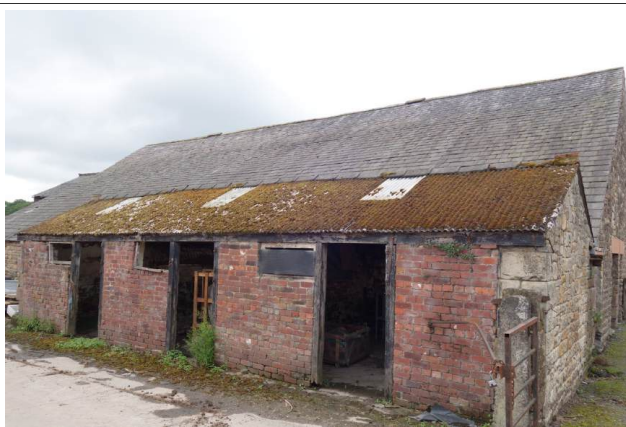
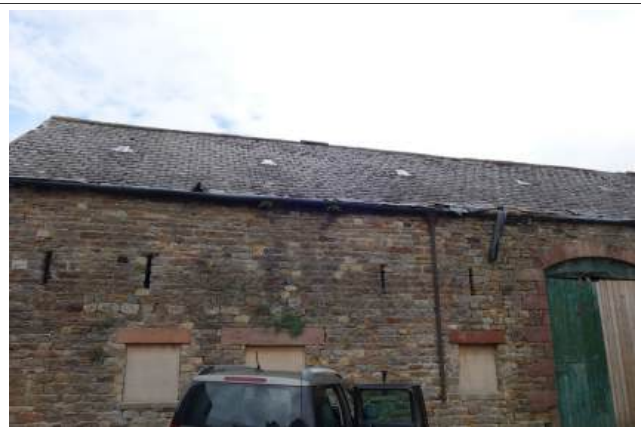
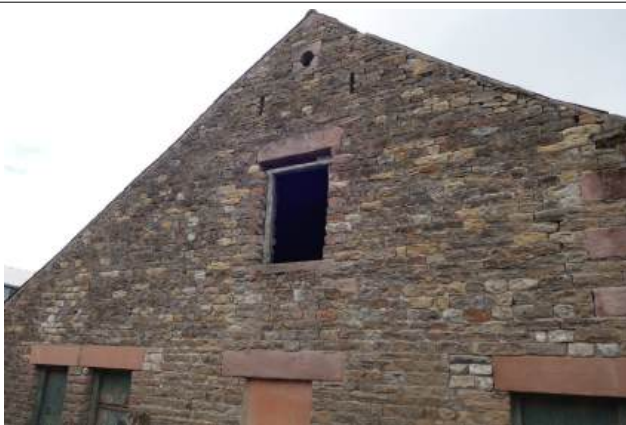
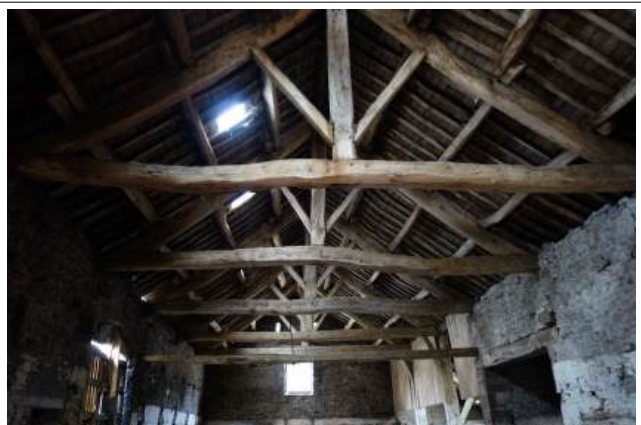
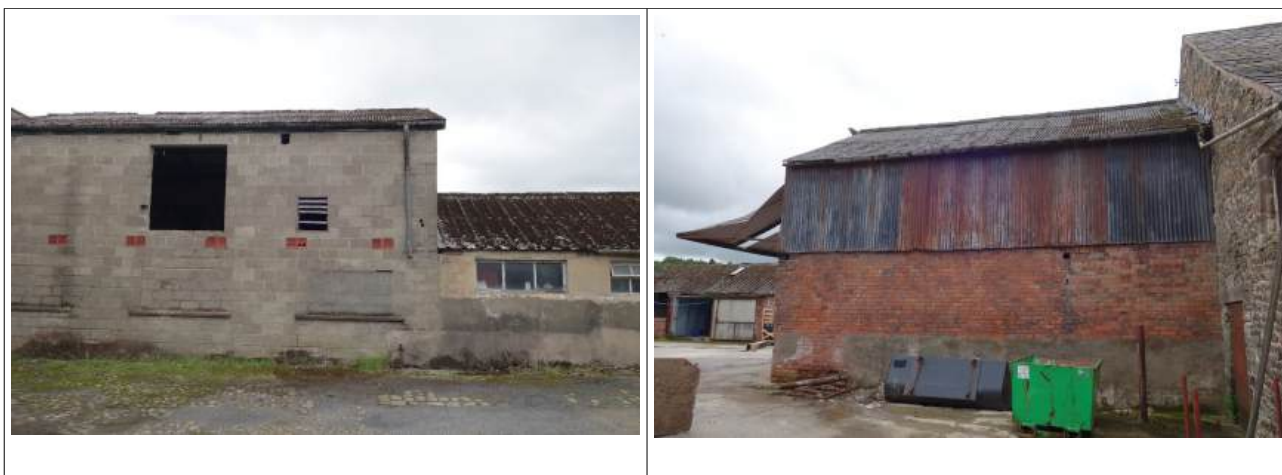
### **Main Barn**

The property consists of a detached two storey stone built barn with a double pitched slate roof. A single storey brick built midden is present on the northern facade double pitched corrugated fibreboard roof. A single skin concrete block building is present on the southern facade and a single skin brick and corrugated fibreboard extension is present on the eastern gable end.

Exterior walls are generally well pointed with no obvious crack, gaps or crevices present. Gable ends are pointed and sealed. Open windows and doorways, gaps above the main barn door, and breath holes on the frontage and gable ends allow access to the interior.

Roof slates are generally close fitting with no obvious slipped, lifted or missing slates. Ridge tiles are pointed and sealed. Roof slates are lined with timber sarking and supported by hand cut beams with gaps at joints and dessication crevices noted.

**The building was assessed as offering high roost potential when location and surrounding habitat was taken into consideration.**

Evidence in the form of a considerable number of scattered bat droppings, typical of Brown Long Eared bats, were observed within the main barn.

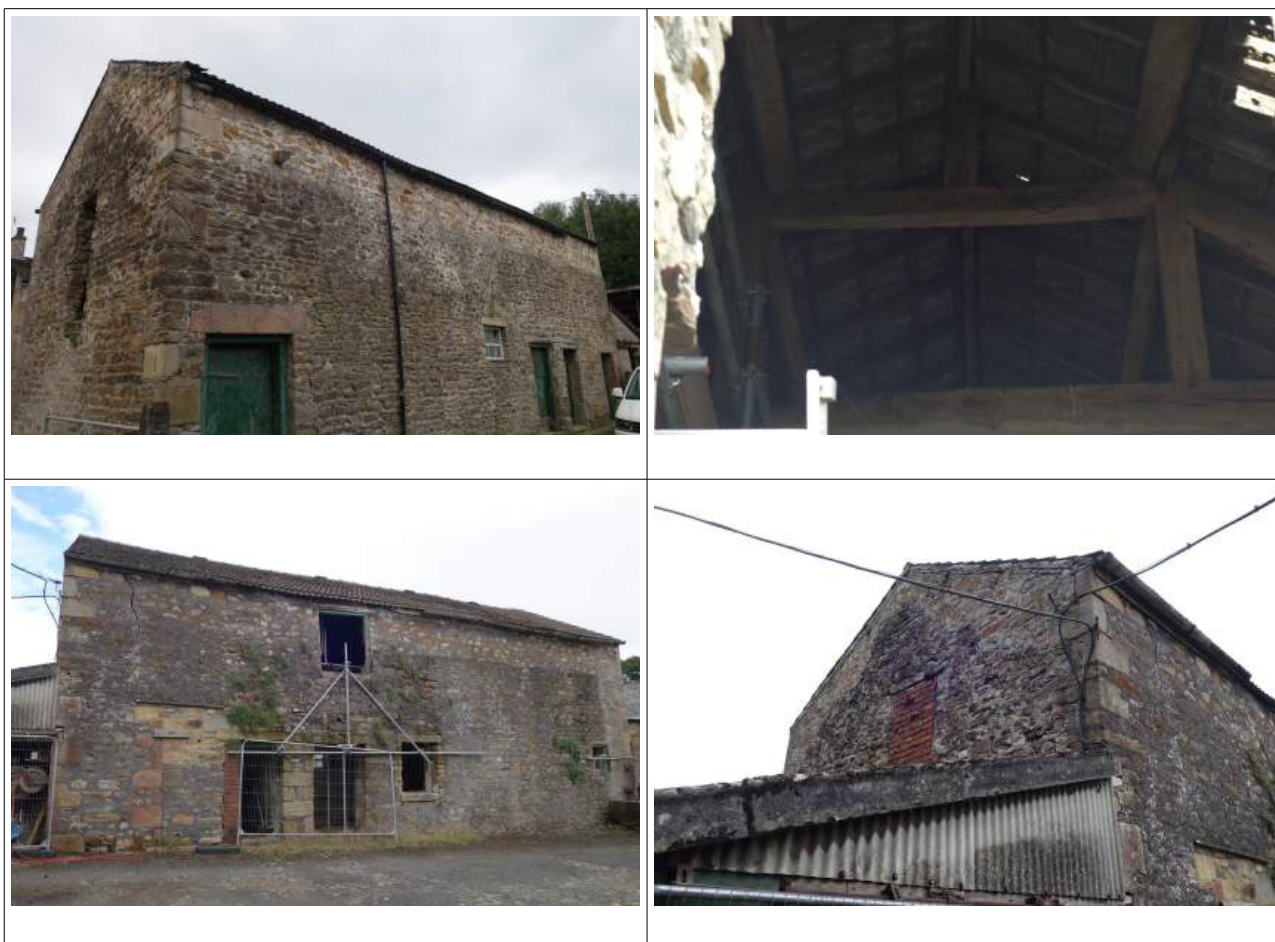
## Outbuilding 1

A stone built two storey outbuilding with double pitched tile roof is present to the west of the main barn. While generally pointed on exterior facades some crevices were noted at wall top/eaves level. The building has open windows and doorways present. Modern bandsawn roof timbers are present to the interior and tiles are unlined.

The building was assessed as offering moderate potential for roosting bats.

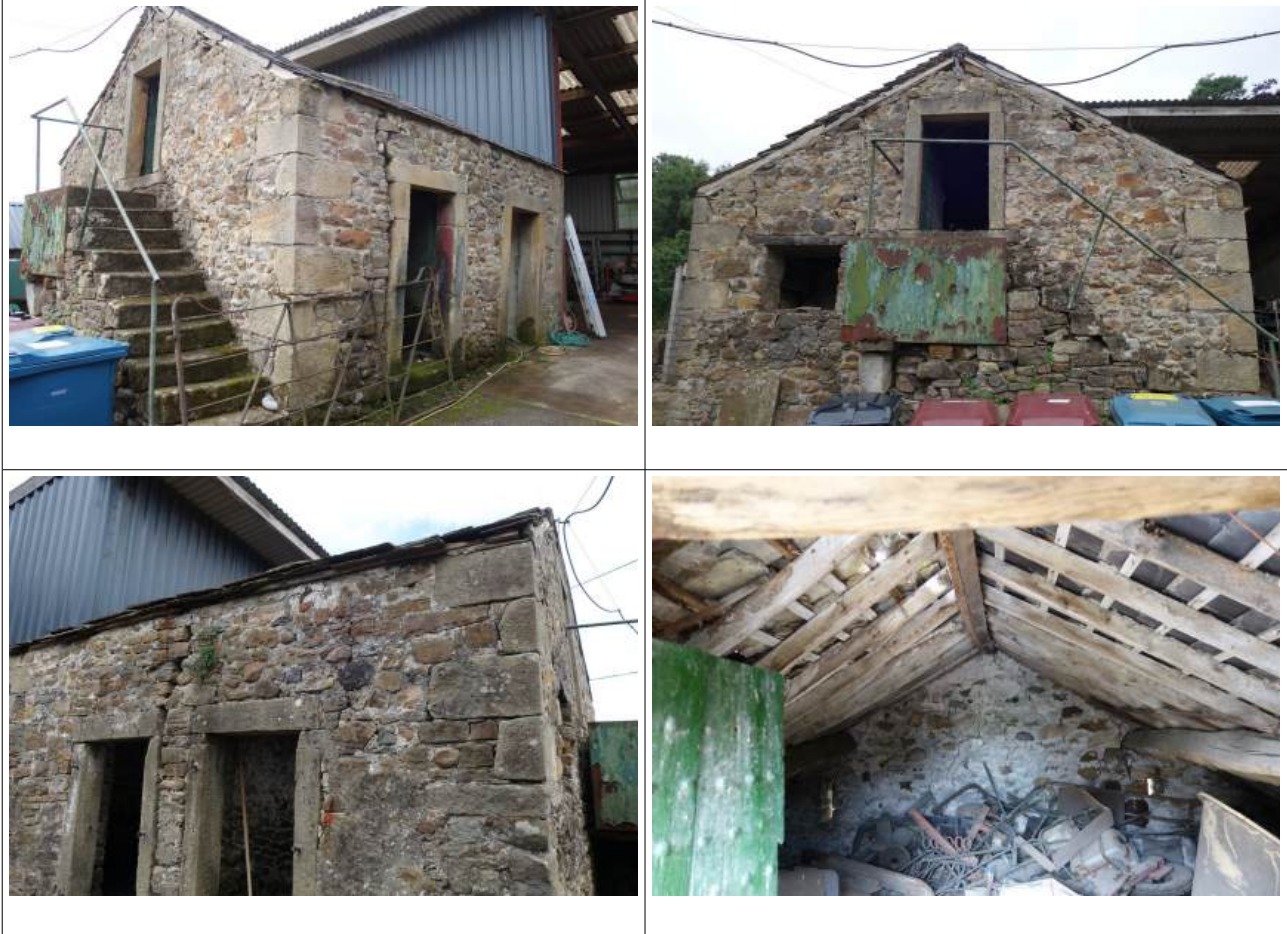
## Outbuilding 2

A small stone built outbuilding with double pitched slate roof is present to the south west of Outbuilding 1. Gaps were noted at wall top and eaves where pointing was missing. Roof slates are unlined to the interior.

Then building was assessed as offering low potential for roosting bats.

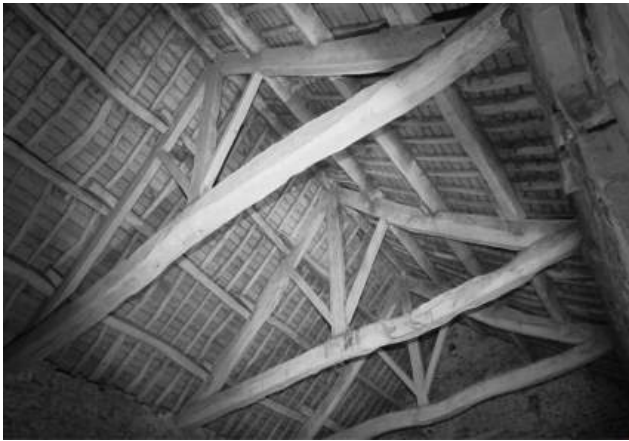
*Infrared camera coverage at end of survey*

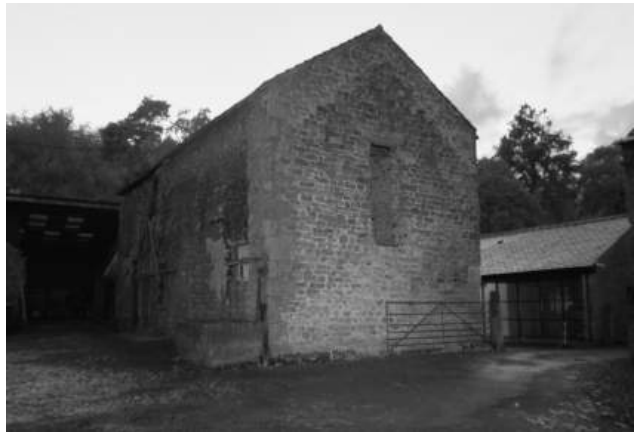
*Infrared camera coverage at end of survey*

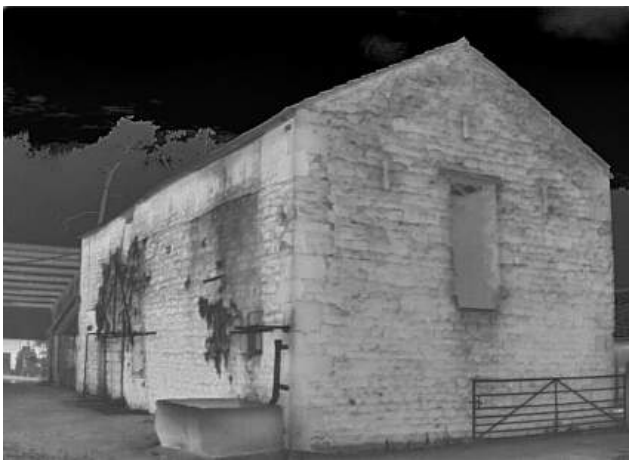
*Thermal camera coverage at end of survey*

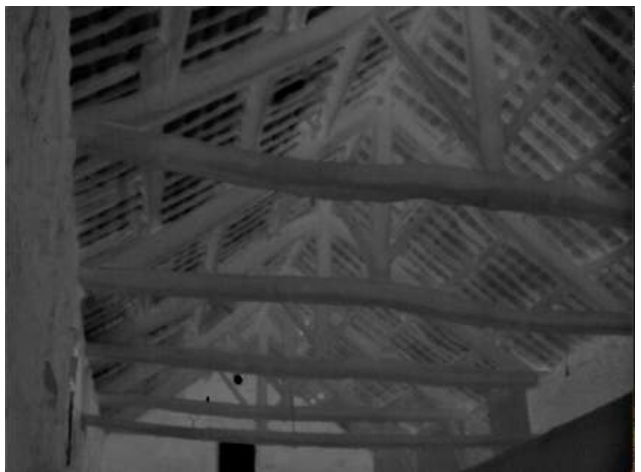
*Thermal camera coverage at end of survey*
