Existing Drainage Report

Site: Proposed Development at Radholme Laund Farm

Site Visit: 24 November 2025

Prepared by: DART Engineers

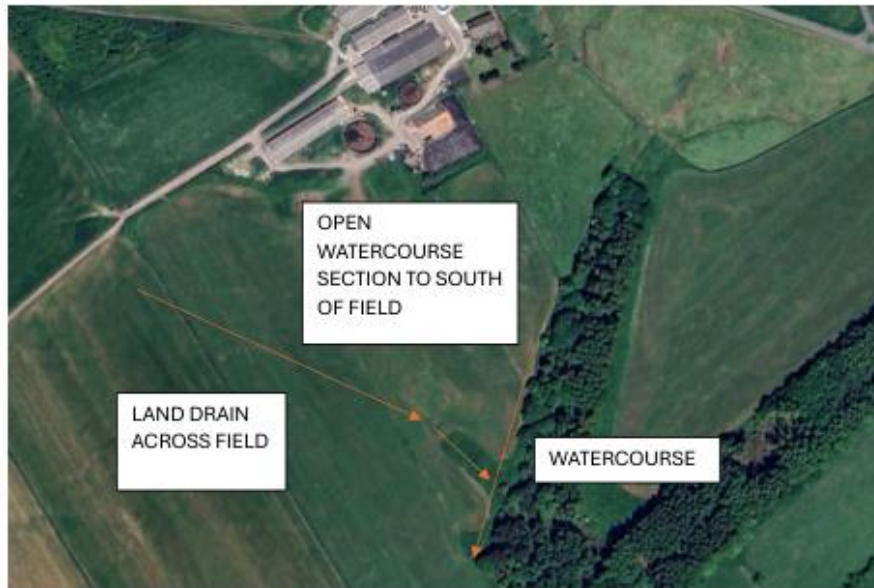
Site Plan

A plan was provided by the client showing the indicative route of an existing land drain running across the field and connecting into an open watercourse situated at the southern boundary.

The plan illustrates a land drain extending southwards across the agricultural field, directing water toward the southern boundary where it transitions into an open watercourse.

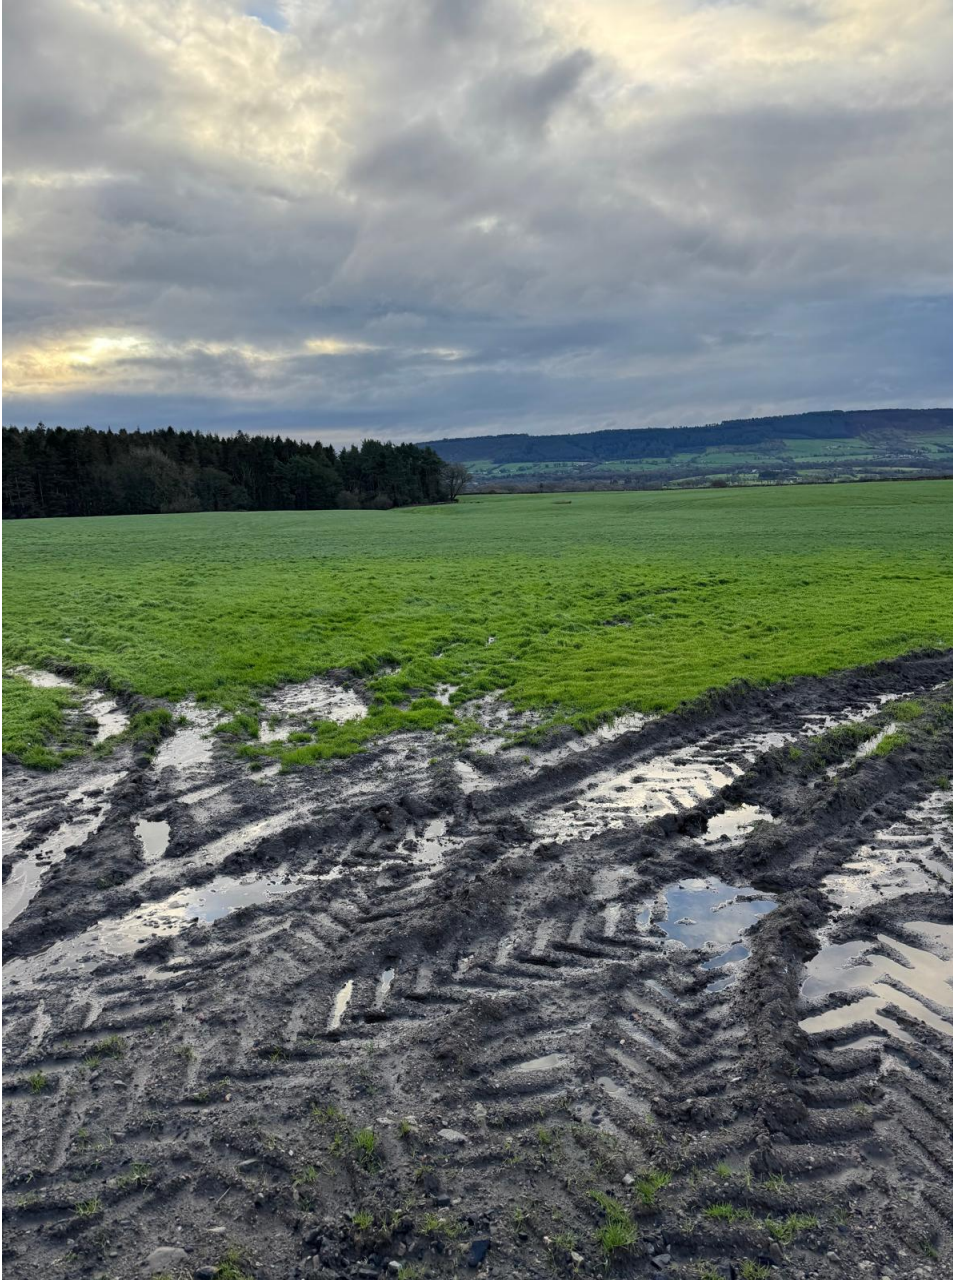
Photo 1 – South across field from development site towards watercourse.

Photo 1 – View south across field from development site

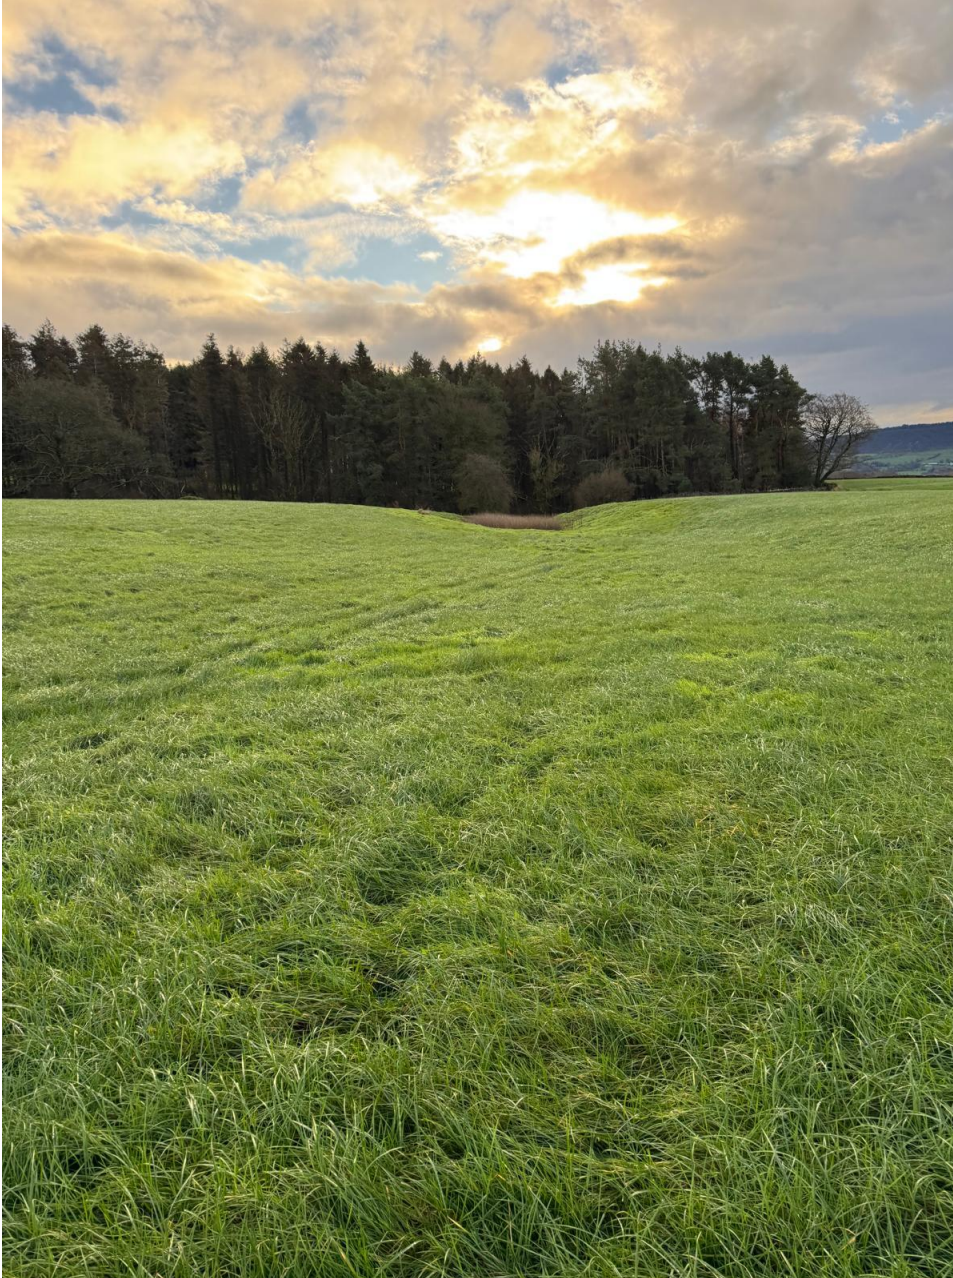
Photo 2 – Looking south towards open watercourse / land drain outfall.

Photo 2 – Looking south towards open watercourse section

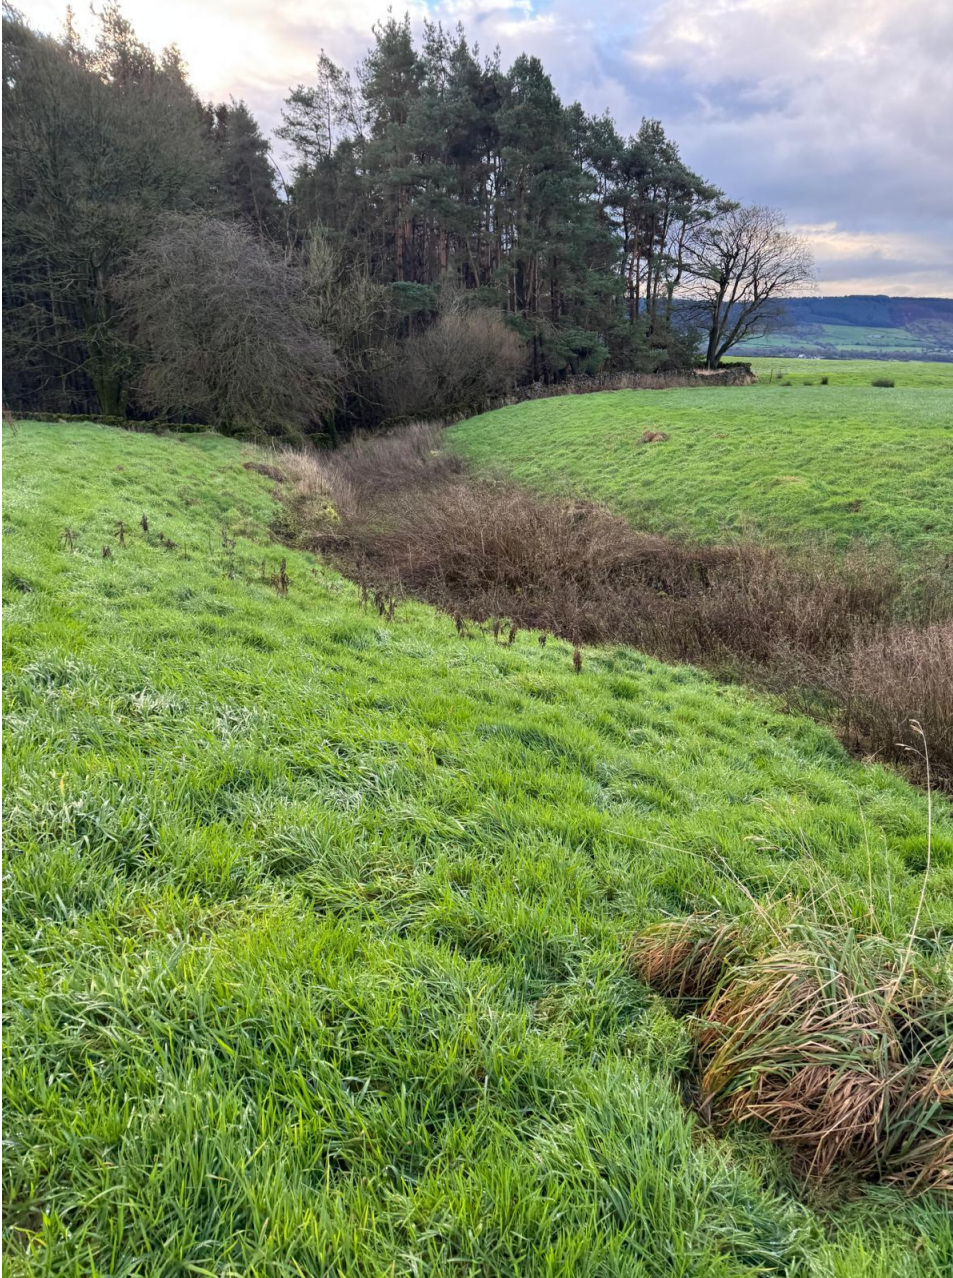
Photo 3 – Looking south towards open watercourse section.

Photo 3 – Looking south towards open watercourse / land drain

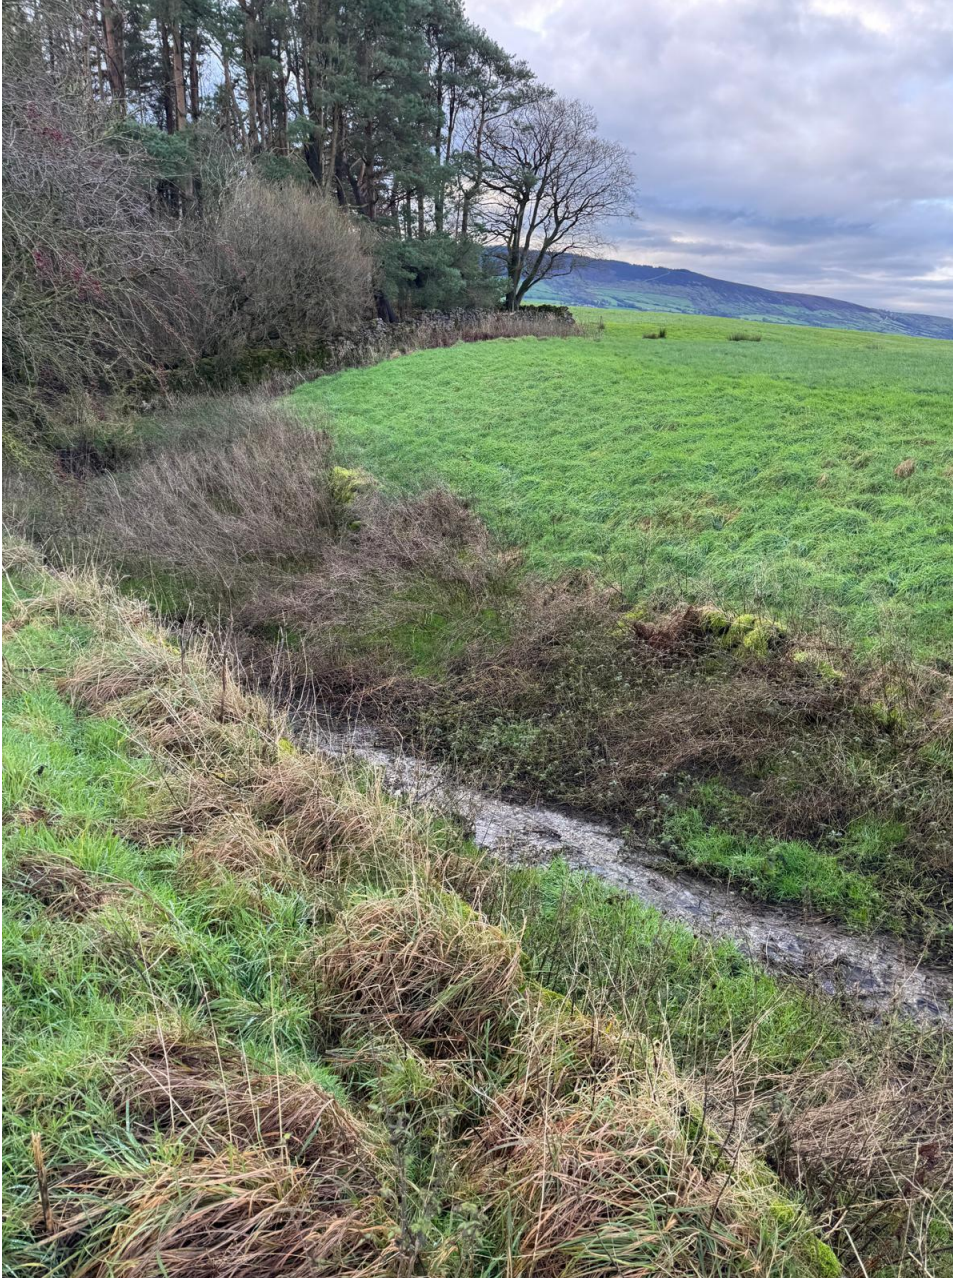
Photo 4 – Watercourse section south of the field.

Photo 4 – Watercourse section south of the field

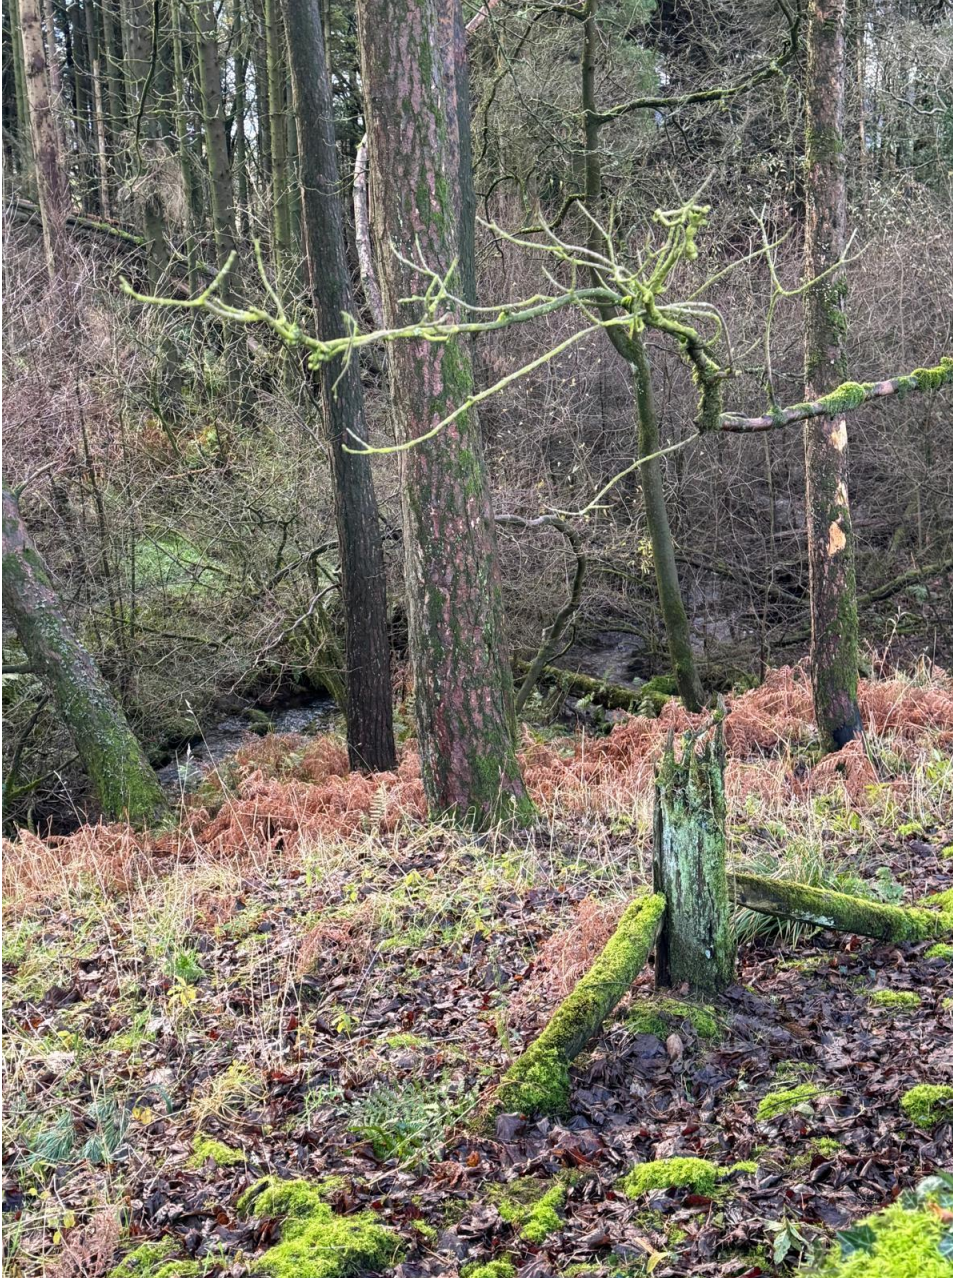
South of the open watercourse section, a more defined east–west flowing watercourse runs along the wooded boundary before continuing toward the broader drainage network.

Photo 5 – Watercourse running east–west to the south of site.

Photo 5 – Watercourse running east–west to the south
