**Method Statement and Reasonable Avoidance Measures
Removal of single skin portal style outbuilding.**

**Barn at Bomber Farm,
Skipton Road,
Gisburn,
BB7 4HP**

**Report prepared by:
Dave Anderson
Batworker.com
Dave@Batworker.com
07894 338290**

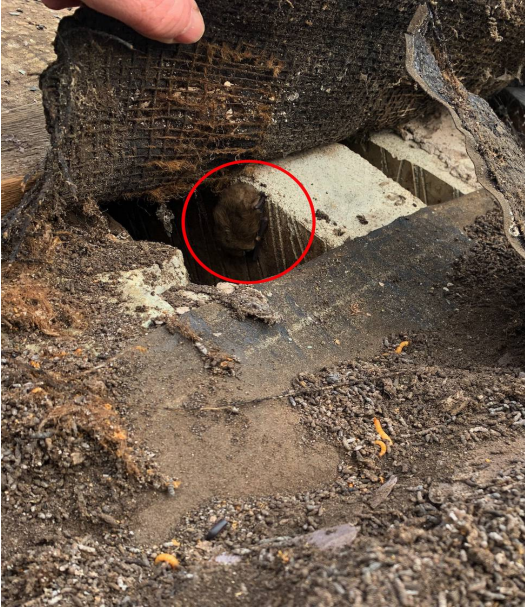
Pipistrelle bat below roofing felt.

Bats are likely to be found during day in masonry, between masonry and timbers, under roofing felt/lath, behind fascias (or anything else attached to wall) under ridge tiles.

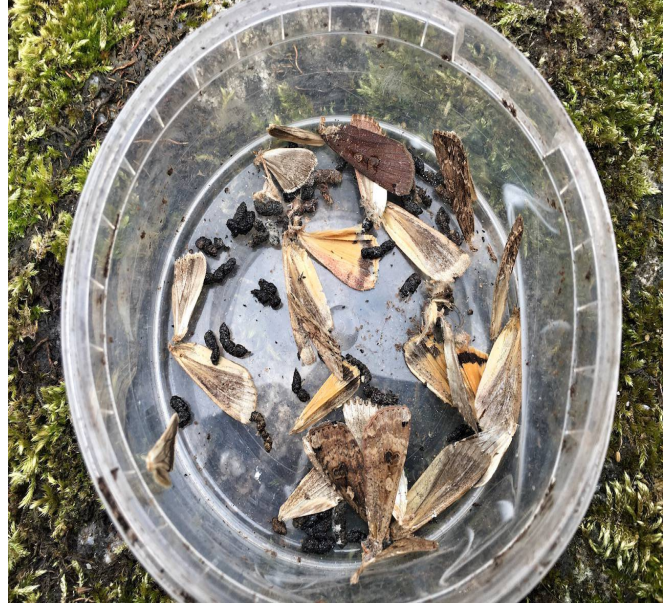
Feeding remains and bat droppings.

Look out for bat droppings – dark brown or black, about 4 to 8 mm in length. They look like mouse droppings but crumble easily, as they are made up of insect fragments.

Other signs include a sharp characteristic odour and large numbers of moth wings discarded by feeding bats
