Preliminary Roost Assessment

3 Poplar Way, Barrow, Clitheroe BB79ZN

This report is prepared to inform a planning application with Ribble Valley Borough Council. This proposal can be described as a single-storey side extension, inclusive of current detached single skin brick-built garage.

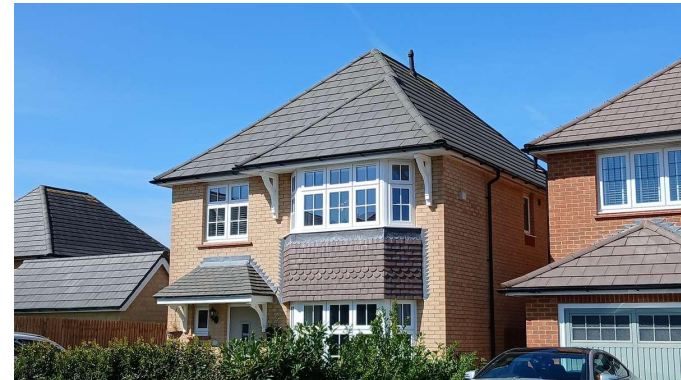
In line with Good Practice Guidelines (Collins, J (Ed) 2023), B1 is assessed to have **negligible habitat value** for roosting bats due to no suitable roosting features being identified during the inspection. The building is in good condition, with eaves, fascia, soffits, windows, walls, roof tiles, hanging tiles and lead flashing all well sealed, and no gaps, cracks, or crevices suitable for bats

B1 - southeast elevation

were observed. The loft void is similarly well sealed and does not present any suitable access points or roosting opportunities for bats.

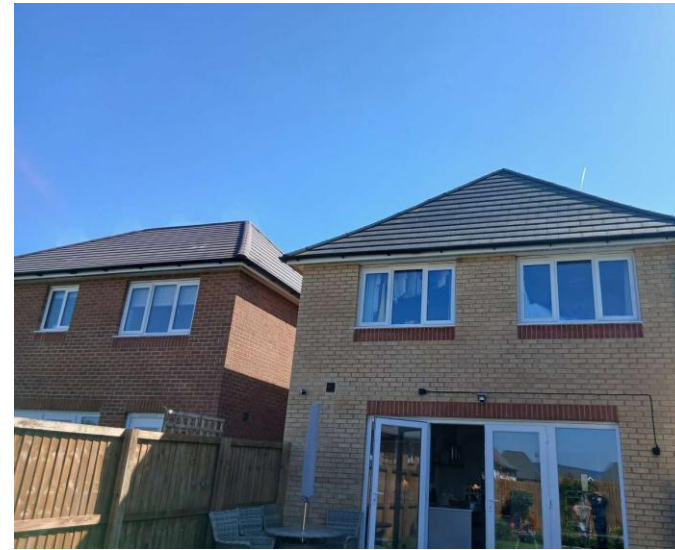
B1 - northwest elevation

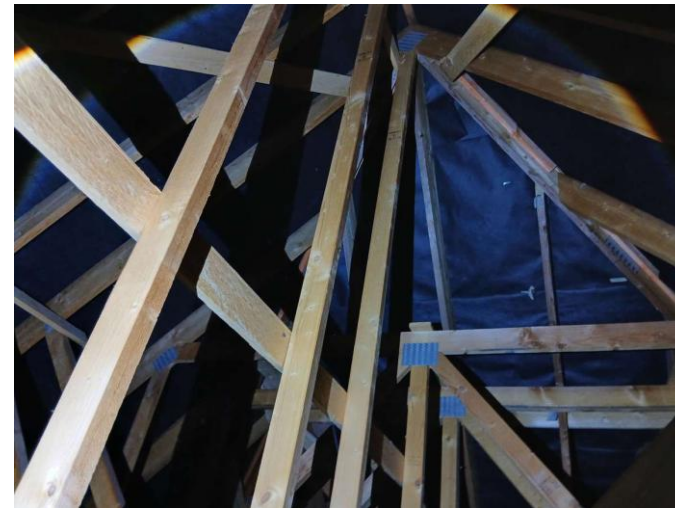
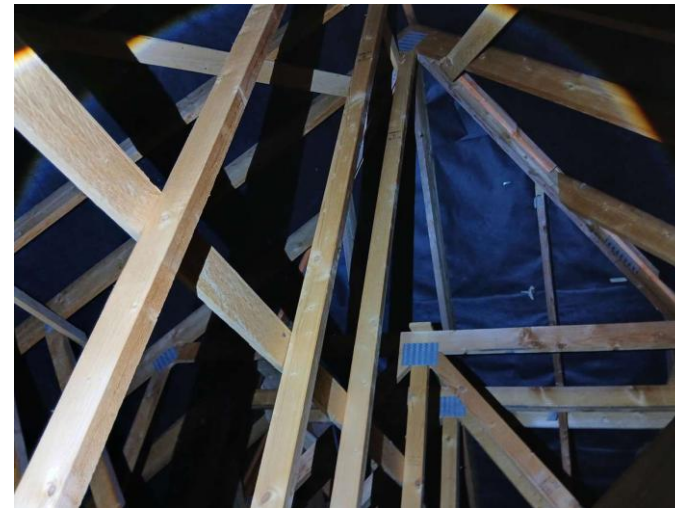
| Voids | Bitumen felt | A loft void was recorded within B1. This void is accessible and measures approximately 8.2m in length, 5.3m in width, and 2.9m in height, with an approximate area of 43.5m ² . The void is lined with bitumen felt, insulated with fibreglass and features timber rafters and purlins. The recorded temperature was 12.3°C and the humidity was 53.2%. No suitable roosting features or bat evidence were noted within this void. | |

B1 - loft void - no suitable features observed

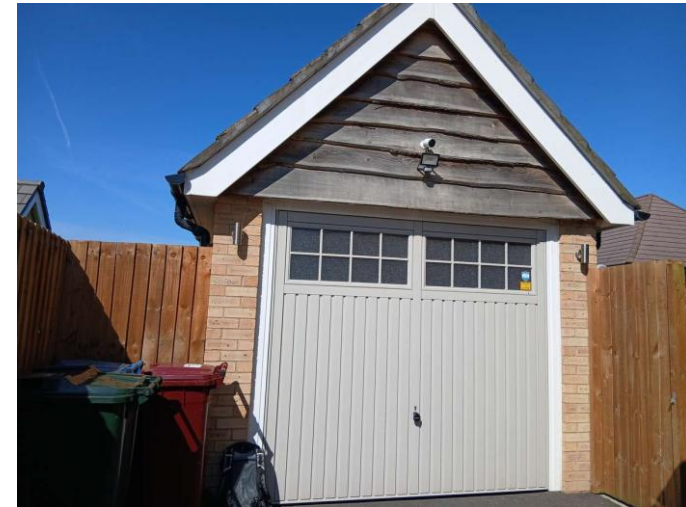
In line with Good Practice Guidelines (Collins, J (Ed) 2023), B2 is assessed to have **low habitat value** for roosting bats due to gaps in between the timber weatherboarding on the southeast gable end leading behind to a timber board which is suitable for use by crevice dwelling bats on an opportunistic basis.

B2 - southeast elevation

No works to B2 that may block or remove potential roosting features should be carried out until the required pre-commencement endoscope check has been completed. Undertaking such work beforehand could unlawfully affect bats if present and may compromise the validity of the surveys and hinder the planning application process.

As only one feature has been identified, and the feature can be assessed and inspected using a torch and/or endoscope, prior to the removal of the timber weatherboarding for the single-storey side extension, an endoscope check should be conducted. This will ensure no bats or evidence of bats are identified within the identified feature. Should there be no evidence of bats within the feature, no further surveys are required. Construction works should take place the day of the inspection to ensure no bats can move into the structure in the interim between the inspection and construction works.

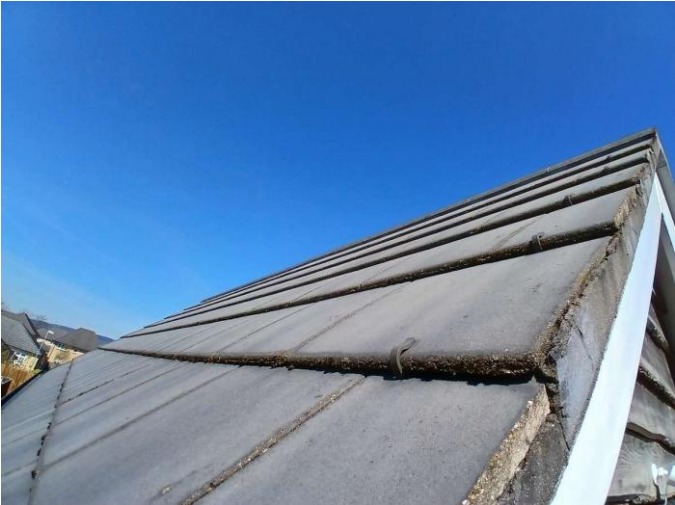
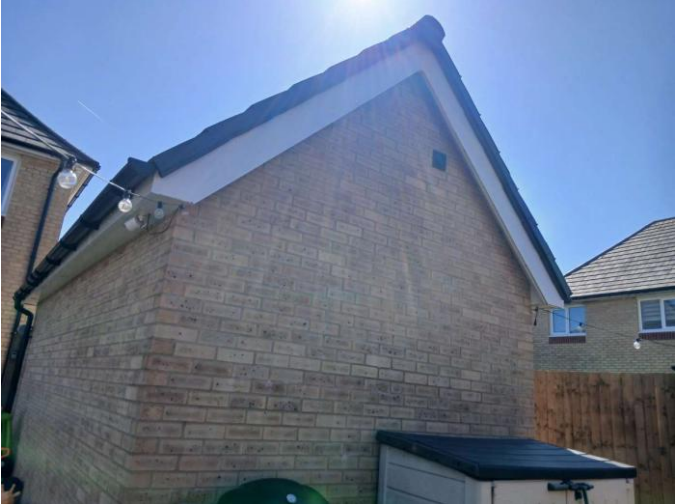
| Feature | Materials | Condition/Suitability | Photographs |
|---|---|---|---|
| | | | <p><i>B2 - well sealed roof tiles</i></p> <p><i>B2 - northwest elevation</i></p> |

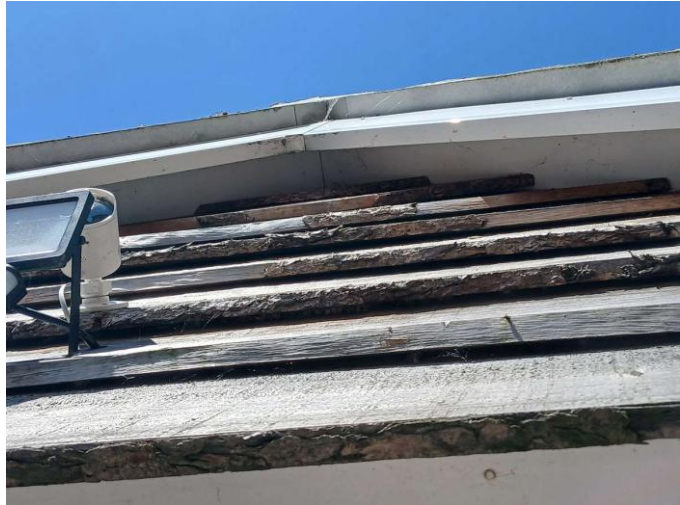
| | Roof | Timber weatherboarding | <p>The roof is gabled and constructed of clay tiles, noted as being in good condition with an intact covering and no gaps. Timber weatherboarding is present on the gable end. Gaps between the timber weatherboarding on the southeast gable end provide suitable roosting features, leading behind the weatherboarding to a timber board. The timber board behind the weatherboarding is well sealed, preventing access into the internal void of the garage however crevice-dwelling bats may utilise this feature on an opportunistic basis.</p> | <p><i>B2 - Gaps in between timber weatherboarding</i></p> |

If evidence of bats is identified during the endoscope check, no works can commence. Three bat emergence/re-entry survey would be required on B2 during the active bat season (May – September) to characterise the roost present.

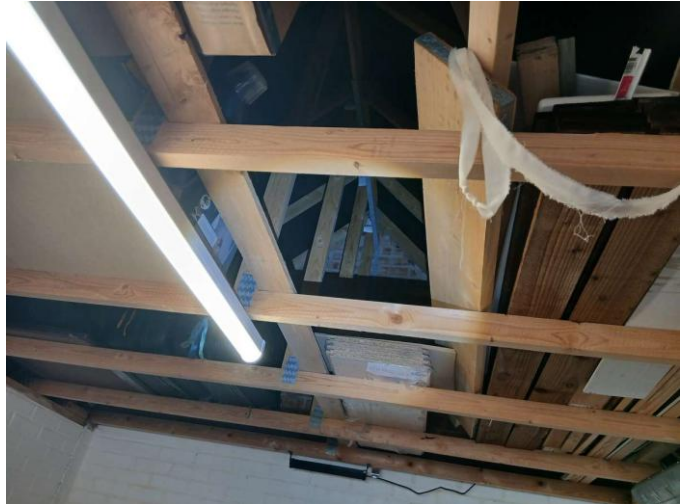
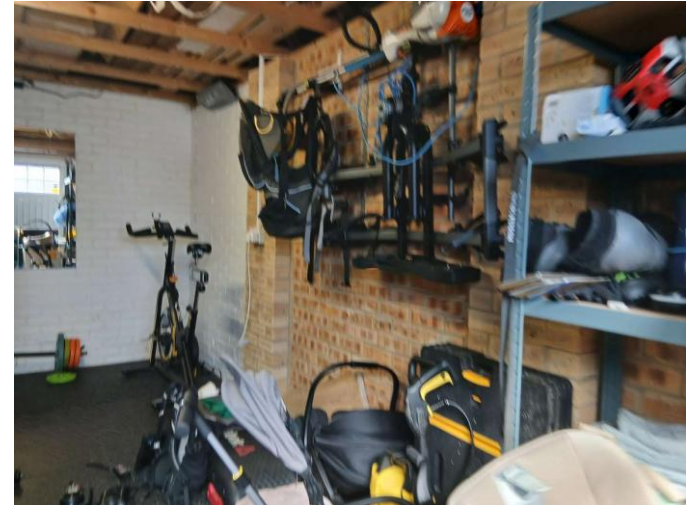
| | Voids | Bitumen felt | <p>A void was recorded within the interior of the garage. This void is lined with bitumen felt, has timber rafters and purlins, with exposed brick on the northwest gable end and a timber board on the southeast gable end. It has a recorded temperature of 15°C and humidity of 47%. The void has dimensions of 5.9m in length, 2.9m in width, and 4.1m in height, with an approximate area of 17.11m². No suitable features were identified</p> | |

within the void and no evidence of bats was observed.

B2 - Well sealed bitumen lining and exposed brick on the gable end

B2 - interior

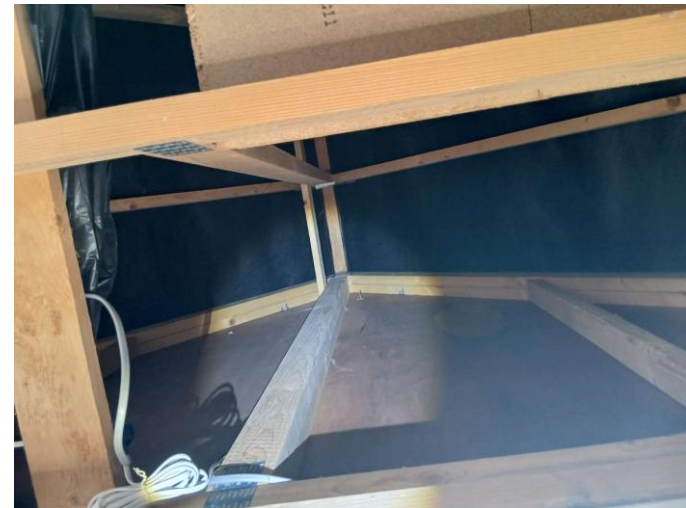
| | | | <i>B2 - Timber board situated on the opposite side of the timber weatherboarding showing no access into the internal from the suitable feature</i> |

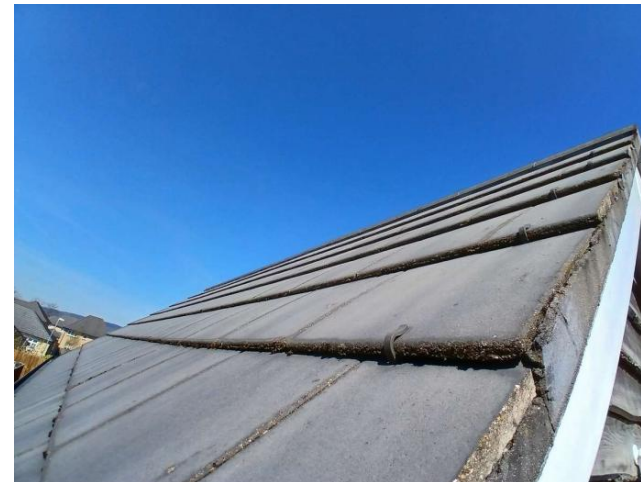
Photo 4: B2 - well sealed roof
