WRITTEN STONE FARM, WRITTEN STONE LANE, LONGRIDGE, PRESTON, LANCASHIRE

Additional Archaeological Building Recording

March 2026

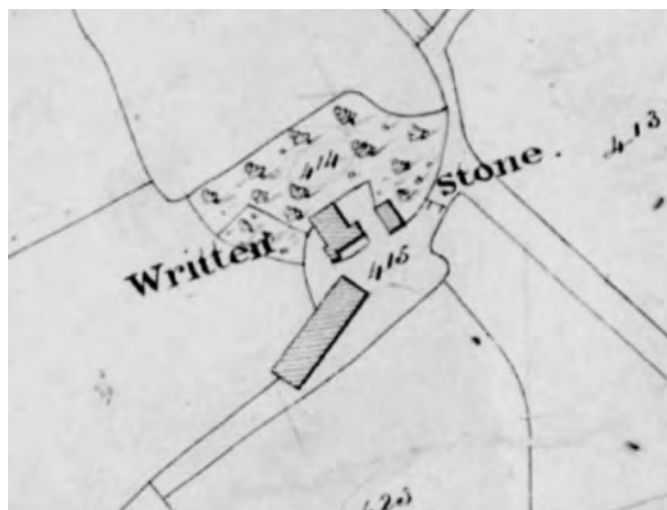
Plate 1: Extract from the tithe map of 1837

3.1.2 **Tithe map, 1837:** Written Stone Farm is marked on the tithe map for Dilworth in the parish of Ribchester and named as ‘Written Stone’ (NA IR 30/18/101 1837; Plate 1). Details of the plot numbers recorded in the accompanying tithe apportionment are summarised in Table 1. The L-shape of the farmhouse is discernible, albeit with a jutting block to the south corner, and the south end the barn is shown as a simple rectangle. The outbuilding to the north is not depicted. The main buildings are within Plot 415 and some overlap Plot 414 to the north. All the land was owned by John Browne and occupied by William Browne at the time.

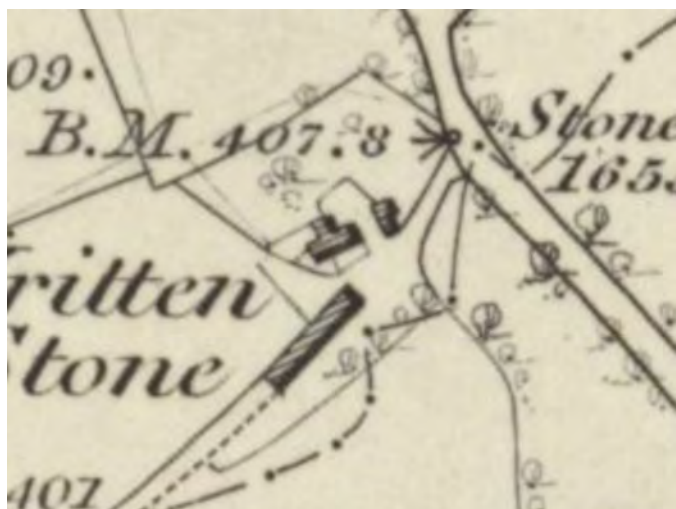
Plate 2 (left): Extract from the Ordnance Survey map of 1847

3.1.3 **Ordnance Survey, 1847:** this edition of the Ordnance Survey map was surveyed in 1844 and produced at a scale of 1:10,560. The farmhouse is shown as a T-shape and the barn as an L-shape jutting out to the east at the north end (Plate 2). The outbuilding to the north is not depicted. The Written Stone is marked as just ‘Stone’ to the east of the farmhouse.

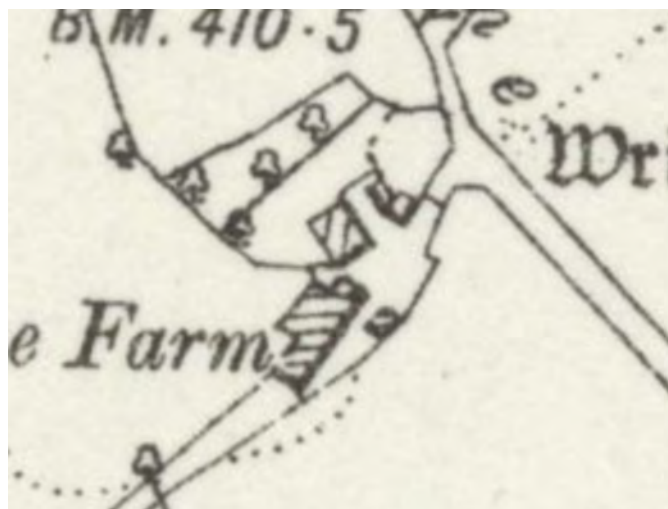
Plate 3 (right): Extract from the Ordnance Survey map of 1895

3.1.4 **Ordnance Survey, 1895:** the 1895 1:10,560 edition of the Ordnance Survey map was re-surveyed in 1891-92. The farmhouse is shown as a rectangle (Plate 3). The barn is again shown as an L-shape but flipped compared to the earlier edition (cf. Plate 2). The ‘Written Stone’ to the east of the farmhouse is not apparently shown, although it is named in Gothic script.

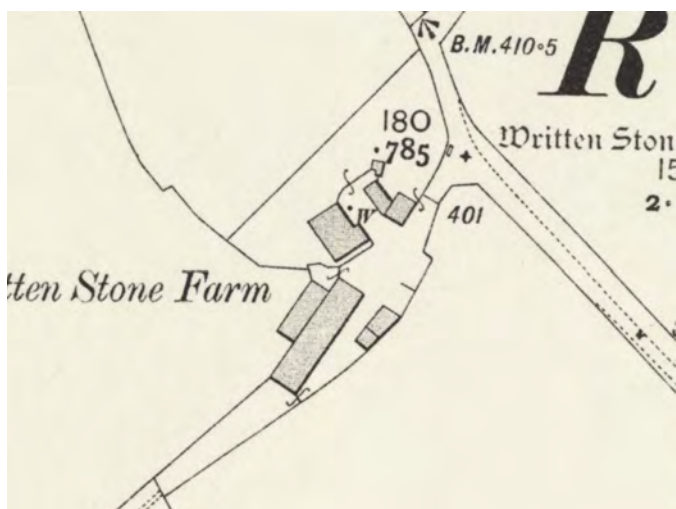
Plate 4 (left): Extract from the Ordnance Survey map of 1912

3.1.5 **Ordnance Survey, 1912:** the 1:2,500 edition of the Ordnance Survey published in 1912 map was revised from the earlier survey in 1910 (Plate 4). The footprint of both the farmhouse and the barn more closely resemble their current plans, and a small outbuilding has been constructed to the north of the barn. The 'Written Stone' is again marked in Gothic script and apparently shown as a rectangular block in its current location.

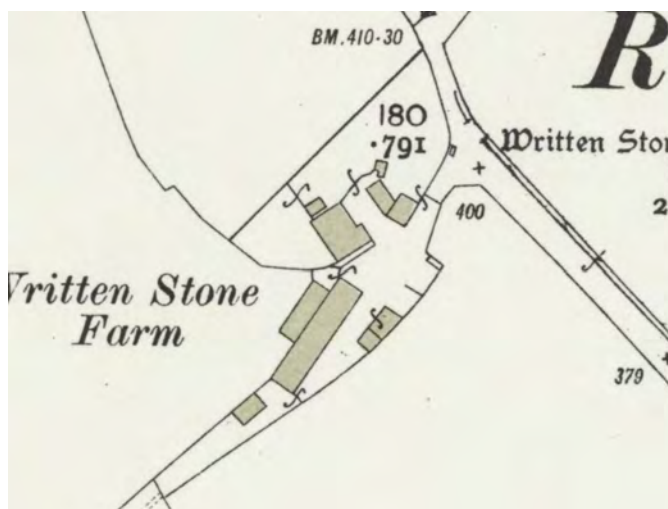
Plate 5 (right): Extract from the Ordnance Survey map of 1932

3.1.6 **Ordnance Survey, 1932:** the 1:2,500 edition of the Ordnance Survey published in 1932 map was revised in 1930. The farmhouse and the barn are unchanged though a small outbuilding is shown immediately to the north of the farmhouse (Plate 5).

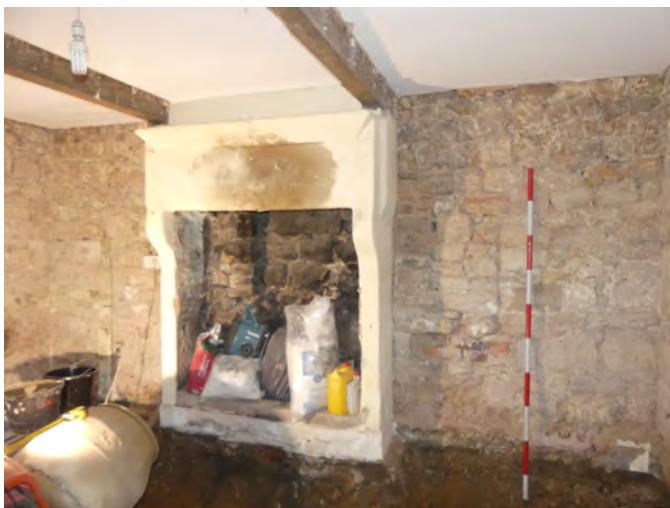
4.4.1 **Ground floor Room 1 (G1):** the north-west elevation comprised relatively well-dressed blocks (Plate 6), including a re-used piece with a rectangular slot on the south-west side (Plate 7). The north-east side, beyond the fireplace had what appeared to be a blocked opening for a small cupboard or alcove (Plate 8) and a possible butt joint was evident within the fireplace opening. The north-east elevation consisted of plain blocks, the doorway to the south-east with a quoined north-west jamb and stone lintel (Plate 9). The south-west elevation (Plate 10) had a doorway on the north-east side, which was evidently inserted (Plate 11), with the south-west side rebuilt, a stone step and a sloping lintel, while the north-east side has an apparent butt joint where two wall surfaces meet (Plate 12). To the south-west of this was an obvious butt joint finished with quoins (Plate 13), although not quite extending to the ceiling, south-west of which is a former doorway with a reused timber lintel and blocked with stone. The stonework to the south-east of this comprises very small pieces. The south-west elevation has a doorway on the south-east side with a timber lintel. To the north-west is a window with a rough timber lintel, the square jambs of which originally extended to form a window seat, with the lower part now infilled with stone (Plate 14).

Plate 6 (left): General view of the north-west elevation, Room G1, viewed from the east

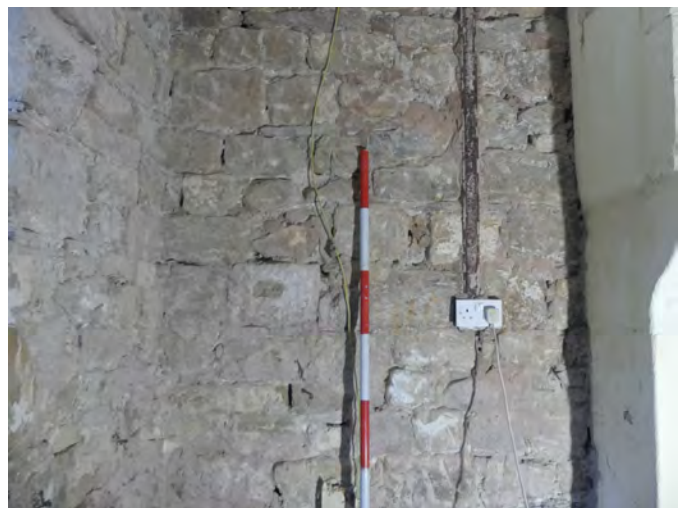
Plate 7 (right): Re-used stone with rectangular slot, south-west side of the north-west elevation, Room G1, viewed from the south-east

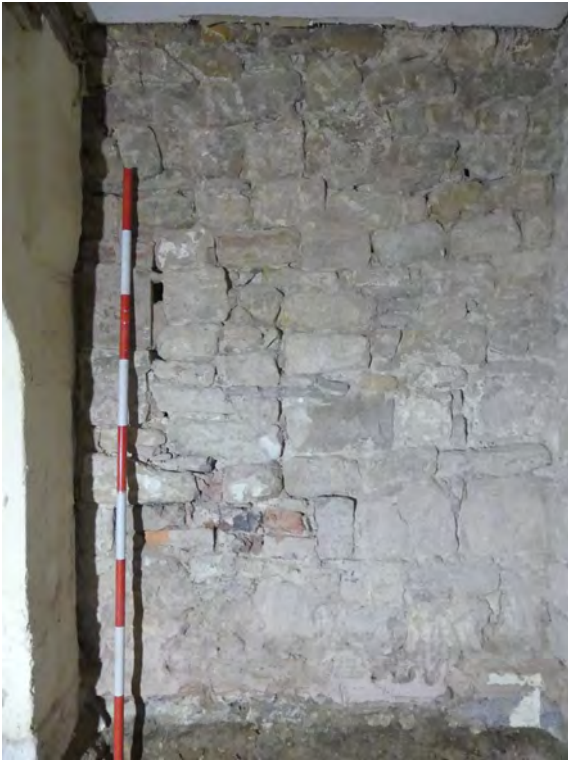
Plate 8 (left): Blocked opening on the north-east side of the north-west elevation of Room G1, viewed from the south-east

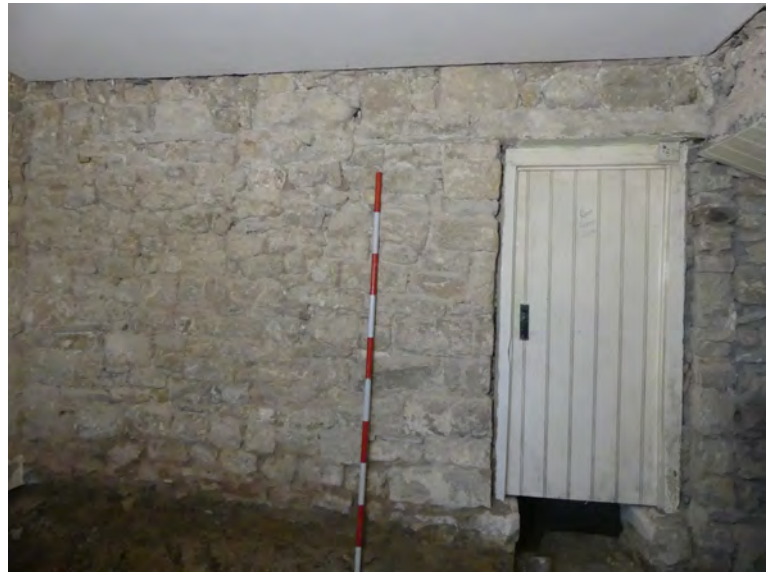
Plate 9 (right): North-east elevation, Room G1, viewed from the south-west

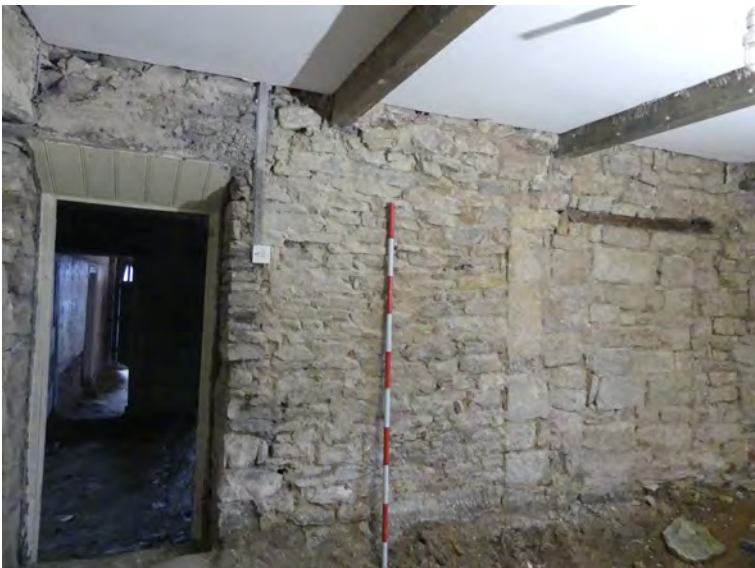
Plate 10 (left): General view of the south-east elevation, Room G1, viewed from the north

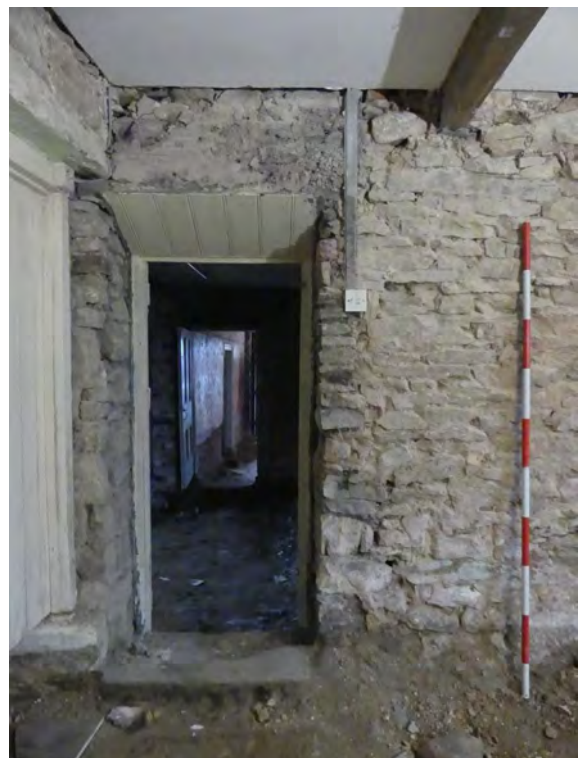
Plate 11 (right): Doorway on the north-east side of the south-east elevation of Room G1, viewed from the north-west

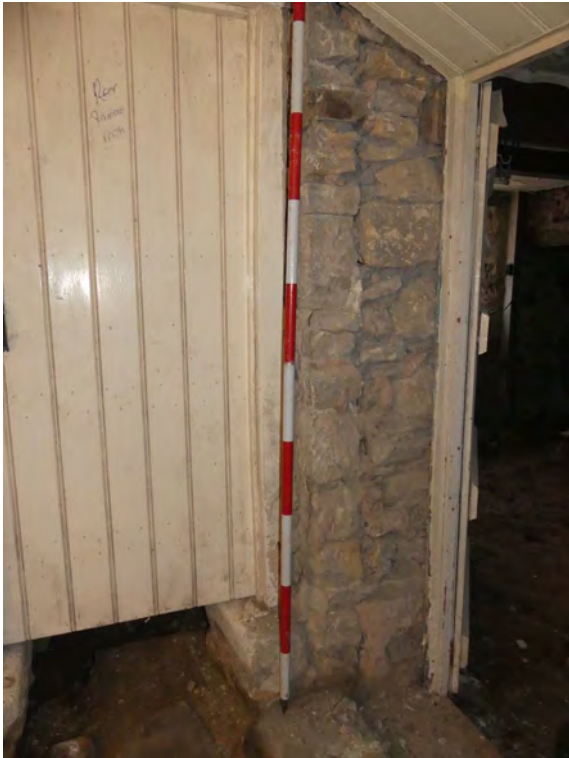
Plate 12 (left): Joining fabric visible on the north-east jamb of the doorway in the south-east elevation, Room G1, viewed from the south-west

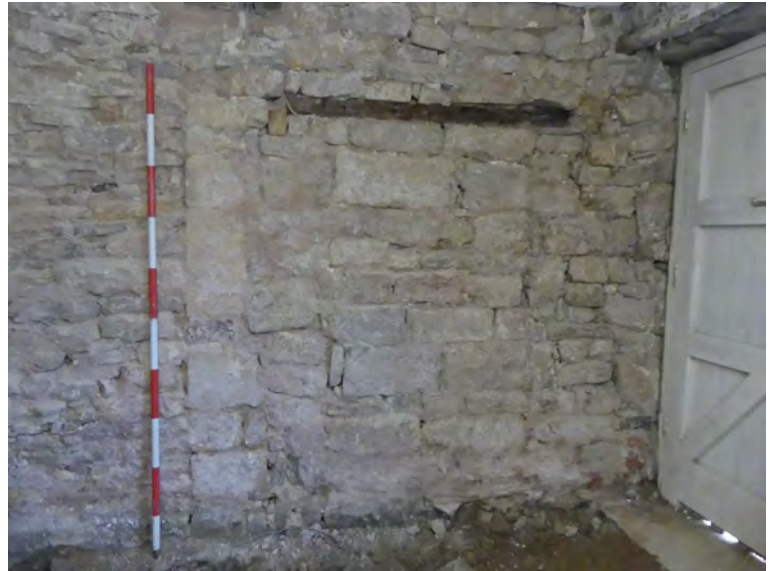
Plate 13 (right): Quoined butt joint and blocked doorway on the south-west side of the south-east elevation, Room G1, viewed from the north-west

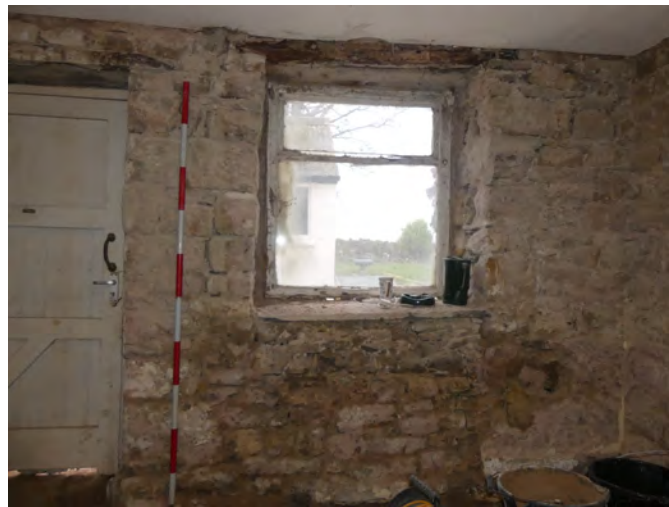
Plate 14: Window in the south-west elevation, Room G1, viewed from the north-east

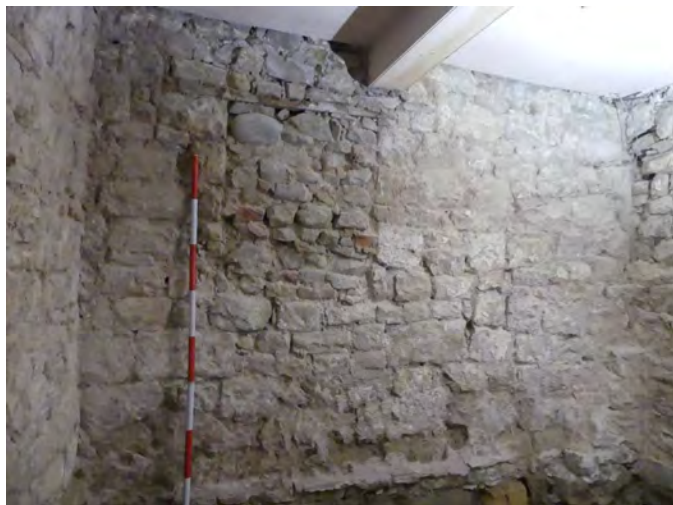
Plate 15 (left): North-west elevation, Room G2, showing blocked window, viewed from the south-east

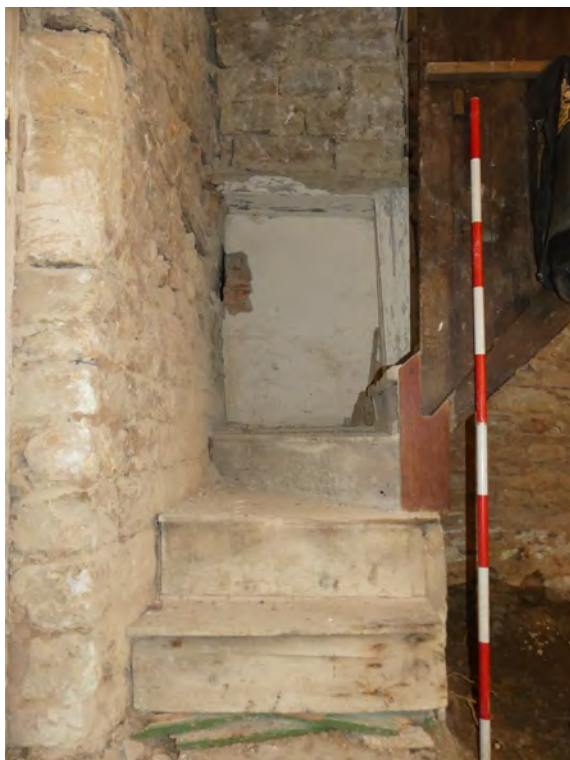
Plate 17 (left): Blocked doorway in alcove, north-east side of the south-east elevation, Room G2, viewed from the north-west

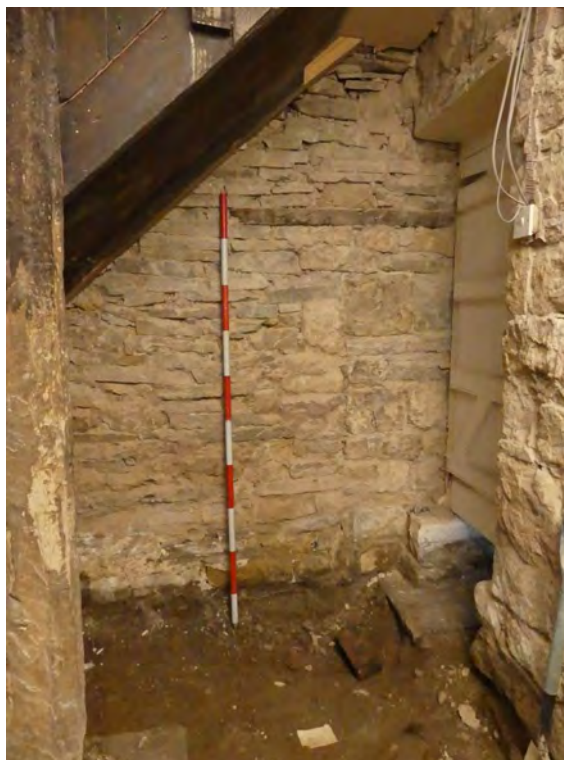
Plate 18 (right): Blocked doorway on the south-west side of the south-east elevation, Room G2, viewed from the north-west

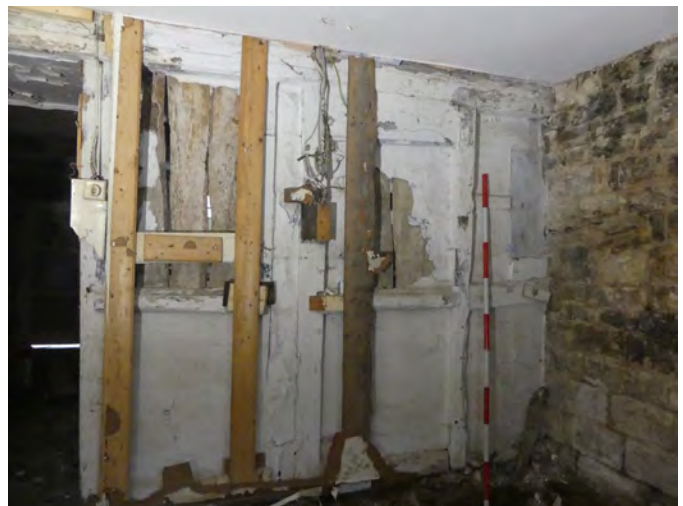
4.4.3 **Ground floor Room 3 (G3):** the north-west elevation had a large, blocked opening on the south-west side, with a chamfered jamb to the south-west and a chamfered lintel, which projected slightly from the wall line (Plate 20). The opening is blocked with dressed stone but a block of masonry on the north-east side apparently represents the truncated end of a wall return, corresponding with a line in the south-east elevation. To the north-east of this was a quoined butt joint, although this was the reverse of the butt joint in Room G1, with a rougher build to the north-east. The north-east elevation comprises a timber stud wall covered by thick planks, which has been partly removed on the north-west side and incorporated what appears to be a blocked doorway, also filled with thick boards (Plate 21). The south-east elevation has well-dressed blocks on the north-east side, apparently representing an external face, with the truncated stub of a return wall marking the change to a much rougher build at the south-west end (Plate 22). The south-west elevation has a window that has the remains of a doorway in the south-west side, now blocked, but was originally a single long mullion window, the former north-east side of which was blocked with red handmade brick, typically 23cm long by 8cm thick (Plate 23).

Plate 20 (left): Blocked doorway, north-west elevation, Room G3, viewed from the south-east

Plate 21 (right): Timber north-east elevation, Room G3, viewed from the south-west

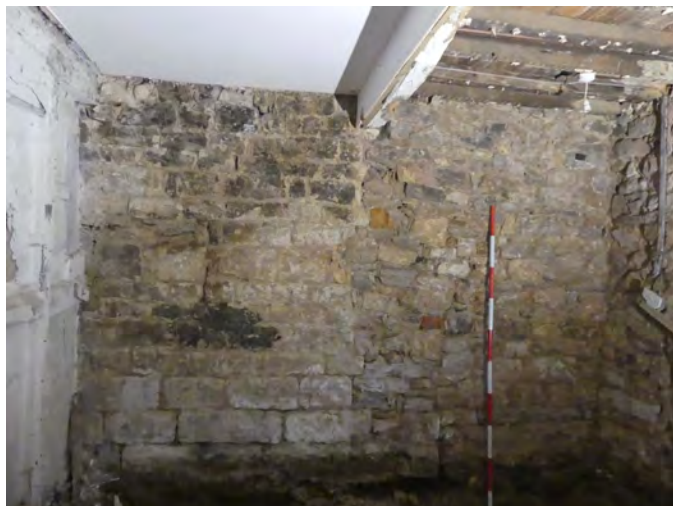
Plate 22 (left): Change in wall build of south-east elevation, Room G3, viewed from the north-west

Plate 23 (right): Blocked window and former doorway, south-west elevation, Room G3, viewed from the north-east

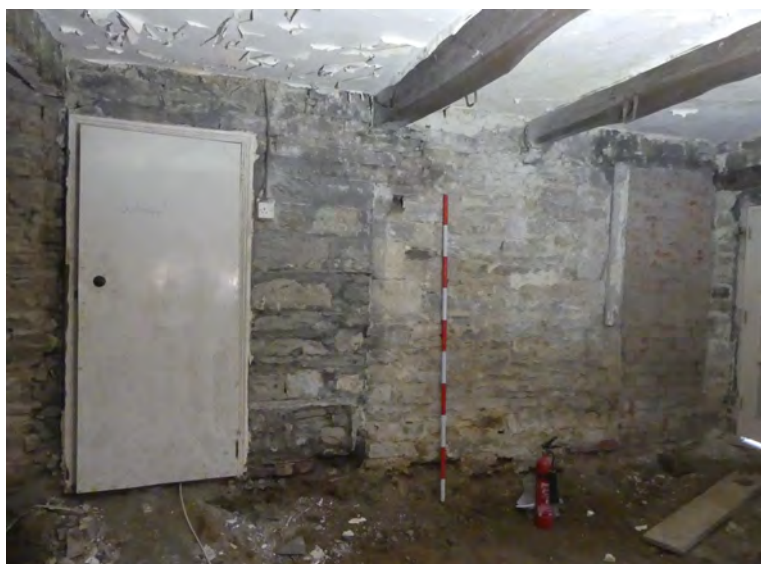
4.4.4 **Ground floor Room 4 (G4):** the north-west elevation had a blocked doorway on the south-west side, with a rough timber lintel and quoined north-east jamb, although the opening was cut through by the doorway to the south-west (Plate 24). There was a further taller doorway to the north-east, with a timber lintel, evidently a reused rail of some form, and blocked with handmade brick similar to those in the south-west elevation of Room G3 (Plate 25).

Plate 24 (left): North-west elevation, Room G4, viewed from the south-east

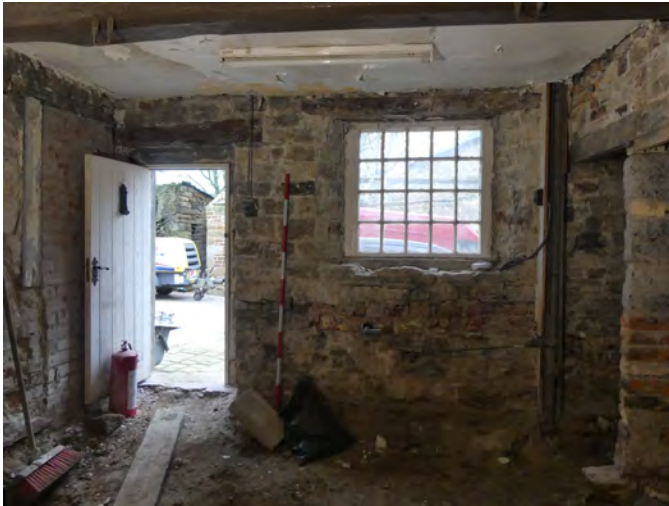
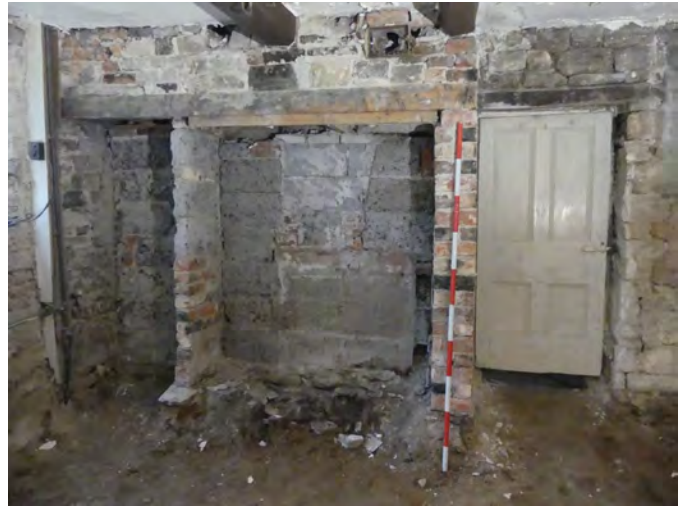
brick, a mixture of hand-made red brick and yellow firebrick, with the central part filling a large opening and blocked against modern tiles on the south-west side (Plate 27). The fireplace hearth has a modern sawn timber lintel. To the south-west is a doorway with a timber lintel and well-finished stone around, perhaps originally external, continuing to the same fabric in Room G3 (Plate 28). The south-west elevation is a timber stud finished with thick planks (Plate 29).

Plate 26 (left): North-east elevation, Room G4, viewed from the south-west
Plate 27 (right): South-east elevation, Room G4, viewed from the north-west

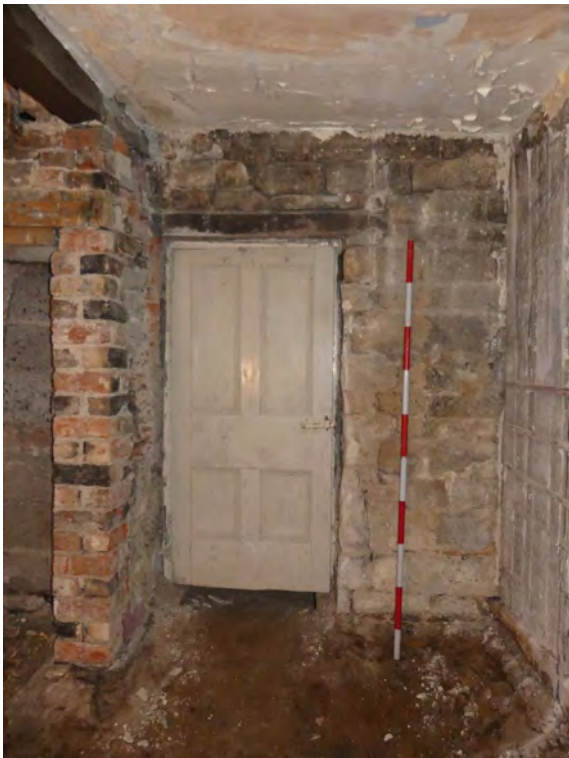
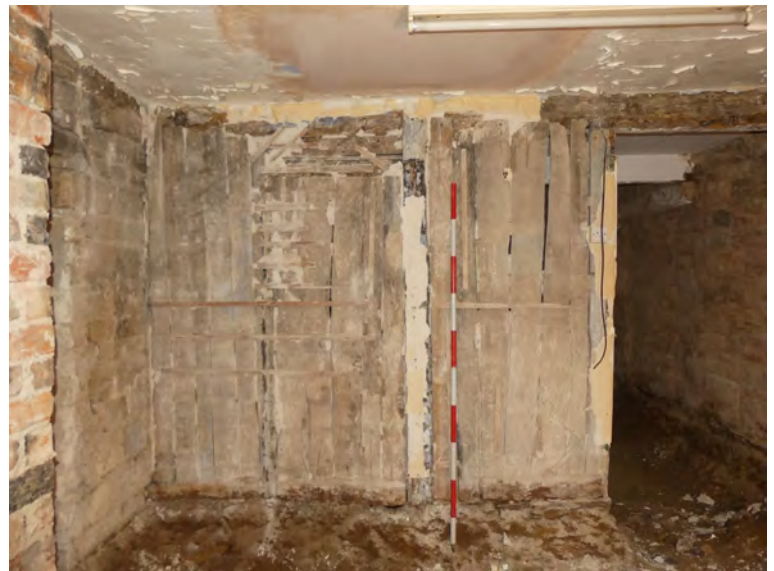
Plate 28 (left): Doorway, south-west side of the south-east elevation, Room G4, viewed from the north-west
Plate 29 (right): South-west elevation, Room G4, viewed from the north-east

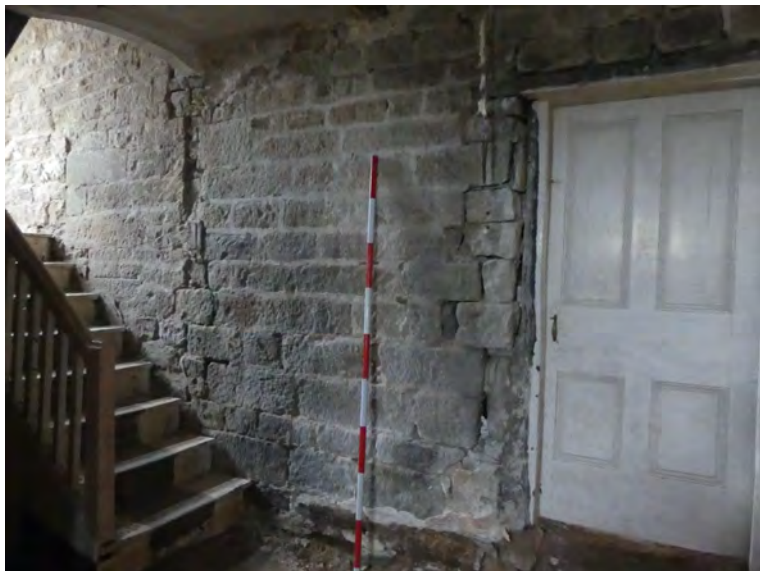
Plate 30 (left): North-west elevation, Room G5, viewed from the east

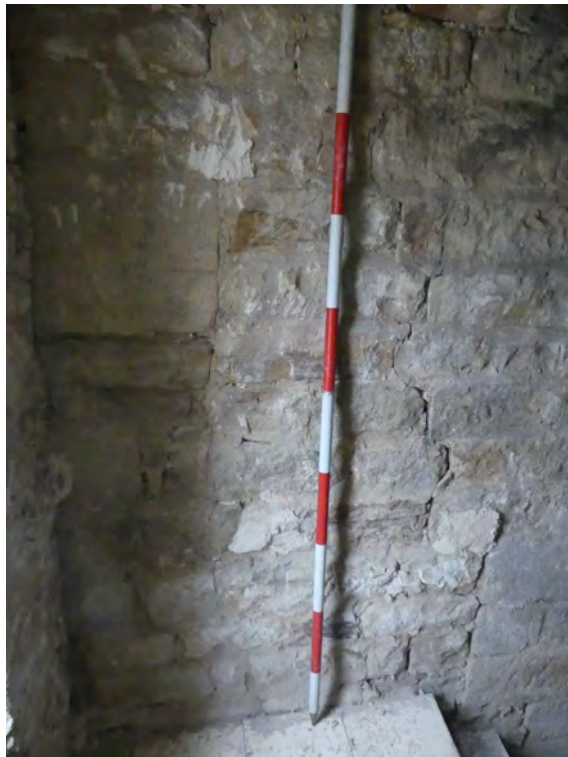
Plate 31 (right): Detail of quoins at the south-west end of the north-west elevation, Room G5, viewed from the south-east

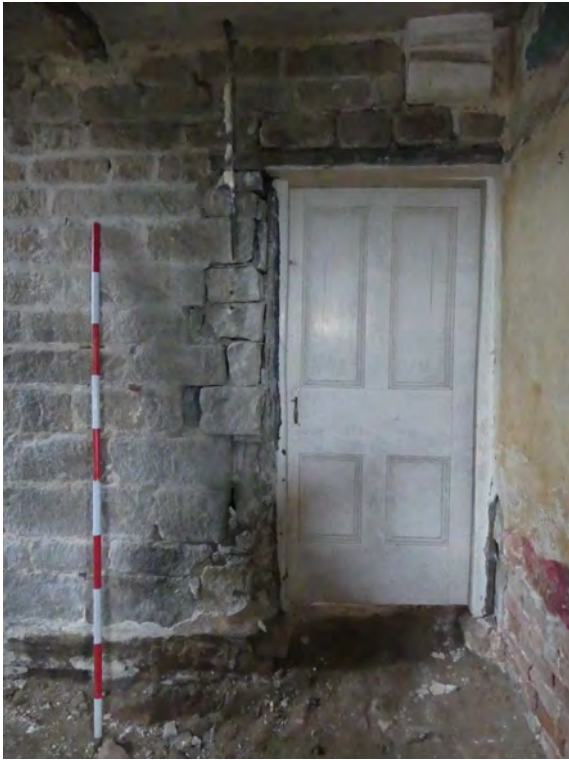
north-east side, which is clearly inserted and has a thin timber lintel (Plate 32). The north-east elevation is of brick construction, typically hand-made, pale orangey-red, and 24cm long by 6.5cm thick (Plate 33). The south-east elevation contains the front door, with well-dressed stone around it and the lintel a reused timber rail (Plate 34). The south-west elevation is of stone construction, in small angular pieces (Plate 35) with a doorway and a return to the south-west.

Plate 32 (left): Inserted doorway on the north-east side of the north-west elevation, Room G5, viewed from the south-east

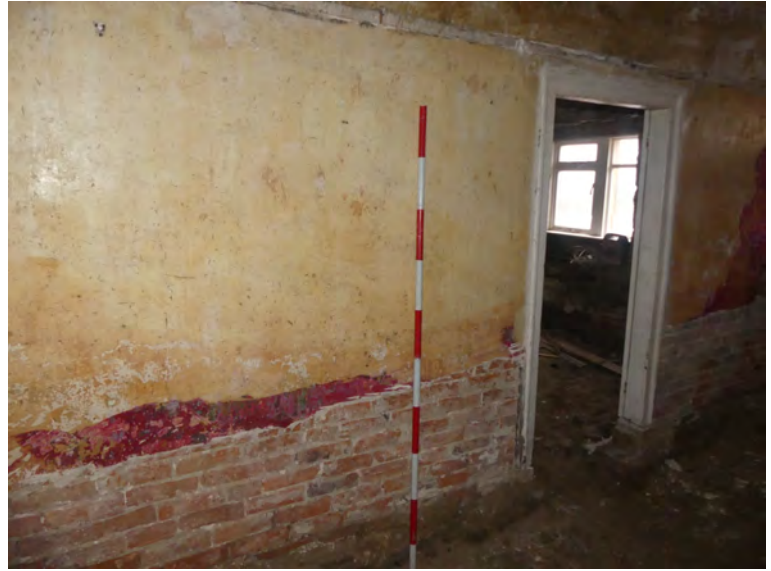
Plate 33 (right): North-east elevation, Room G5, viewed from the west

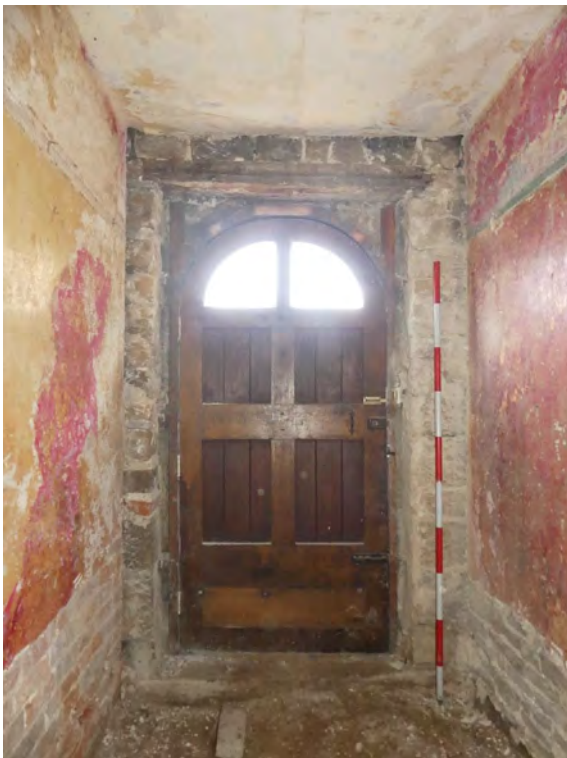
Plate 34 (left): Doorway and south-east elevation, Room G5, viewed from the north-east

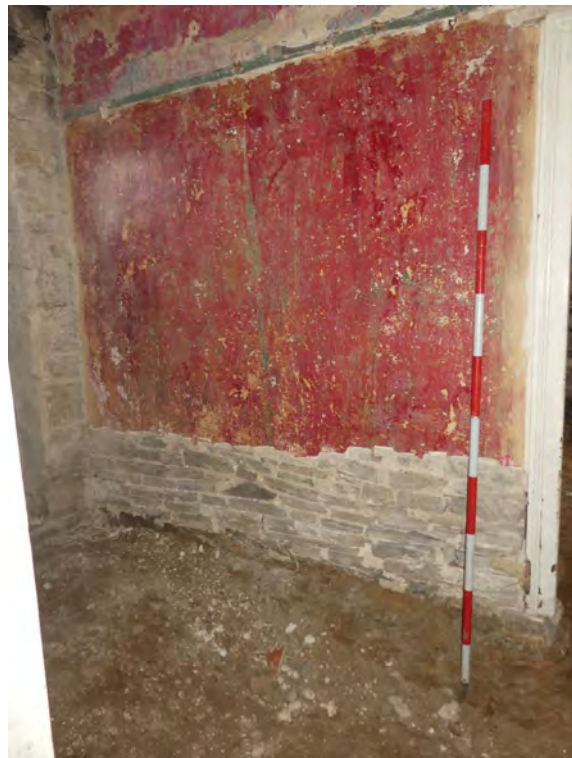
Plate 35 (right): South-west elevation, Room G5, viewed from the north

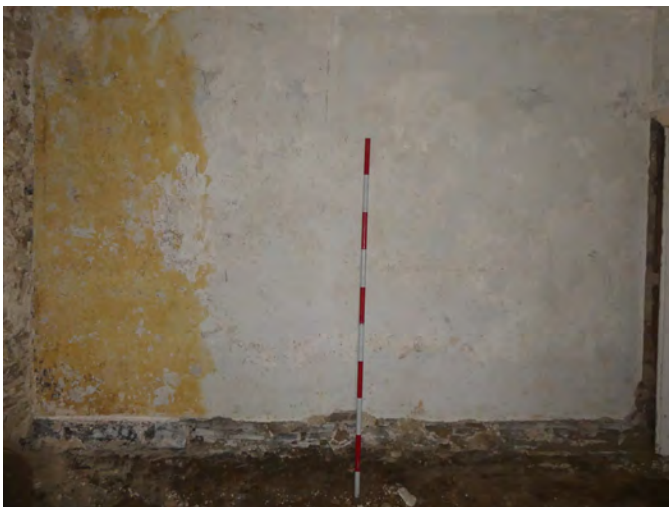
4.4.6 **Ground floor Room 6 (G6):** the two beams were exposed, both evidently reused, the north-west with a tenon slot for a timber joint (Plate 38), while there are peg holes and slots in the south-east (Plate 37). The north-west elevation is constructed from small angular pieces of stone but otherwise plain (Plate 38). The north-east elevation is essentially the same construction, with a doorway on the north-west side (Plate 39). The south-east elevation is constructed from well-dressed blocks, with a central window with splayed jambs (Plate 40). The south-west elevation is a much rougher build, with the central fireplace within an originally wider opening, partially blocked and with a smaller ceramic insert (Plate 41). There is some hand-made brick in the wall above forming the line of the flue.

Plate 38 (left): North-west elevation, Room G6, viewed from the south-east

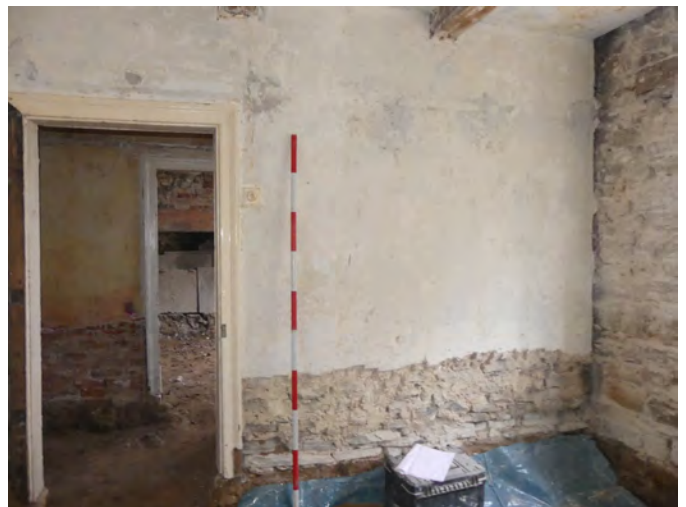
Plate 39 (right): North-east elevation, Room G6, viewed from the south-west

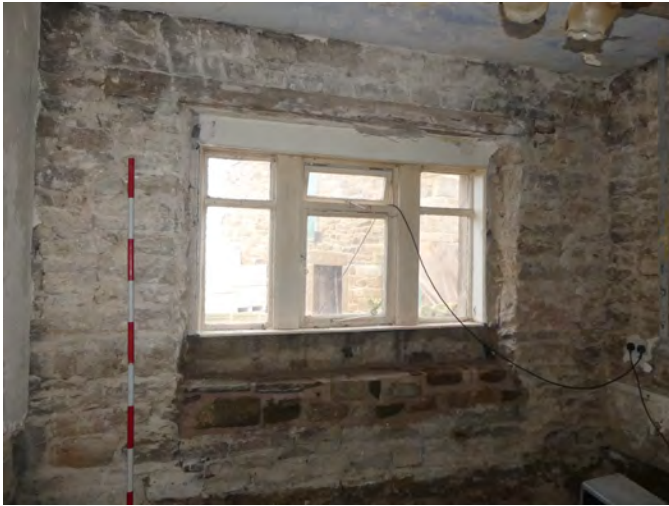
Plate 40 (left): South-east elevation, Room G6, viewed from the north-west

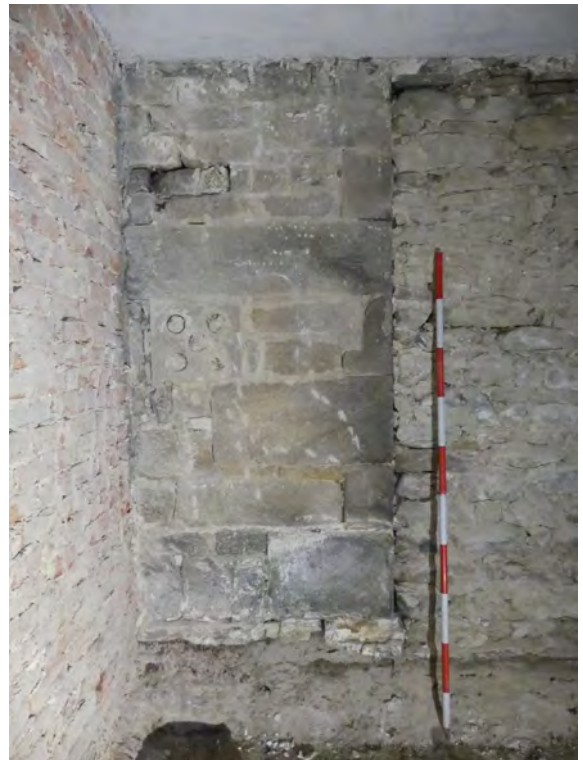
Plate 43 (right): Quoins on the south-west side of the north-west elevation of Room G7, viewed from the south-east

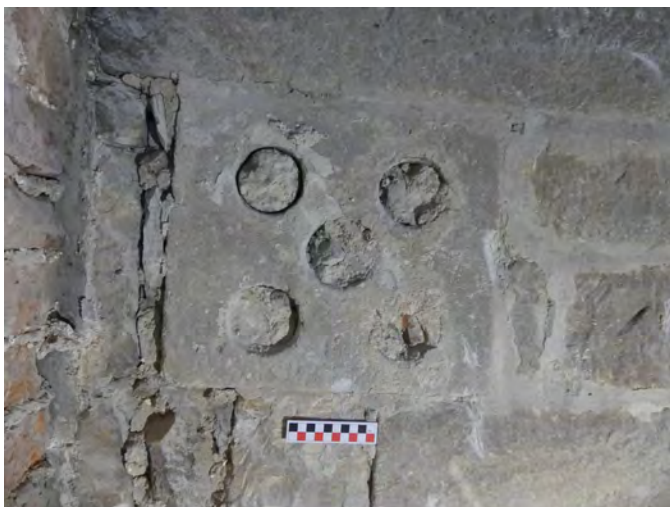
Plate 44 (left): Detail of reused stone with holes, north-west elevation, Room G7, viewed from the south-east

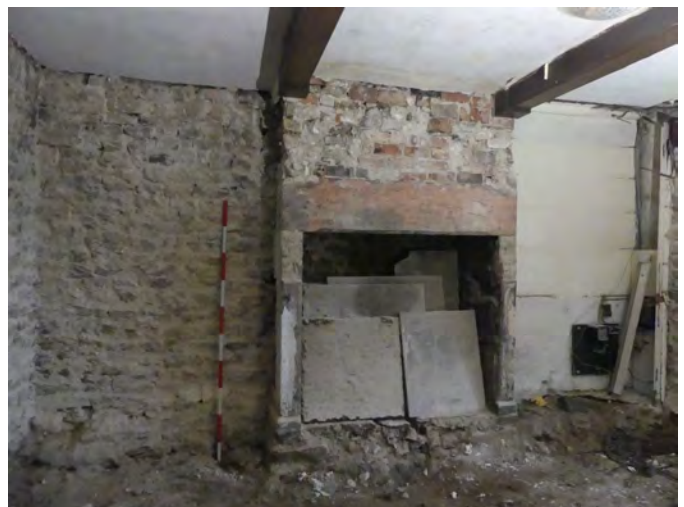
Plate 45 (right): North-east elevation, Room G7, viewed from the south-west

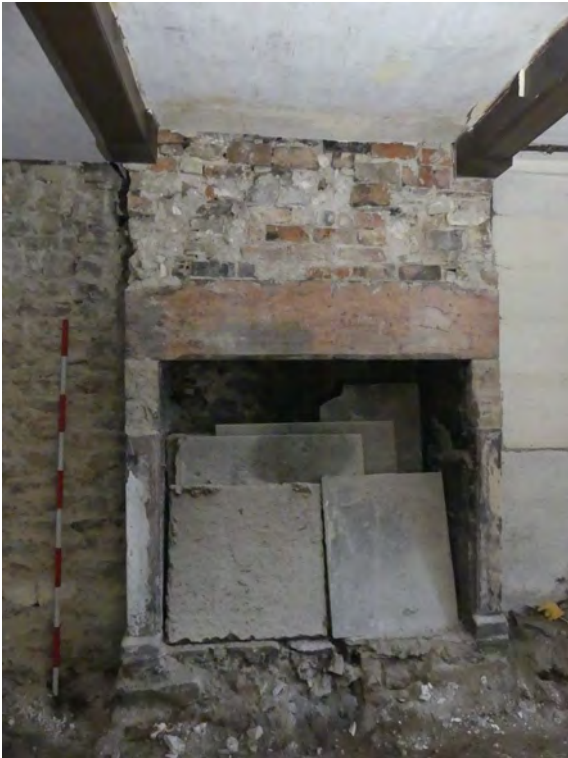
Plate 46 (left): Detail of fireplace, north-east elevation, Room G7, viewed from the south-west

5.2.5 Phase 4 (late 18th century): as noted in the earlier building recording (Greenlane Archaeology 2025b), the south-west front of farmhouse clearly originated in the late 18th century. A very worn datestone in the front of the farmhouse approximately confirms the date, reading '17[??]' with the initials 'WE' above; the rest is illegible. However, a hopper above this is dated 1784 and has the initials 'W B E', thought to correspond to William and Ellen Bourn (see Section 3.2.3). This section of the building was clearly added to form a new decorative and symmetrical Palladian-style façade to the farmhouse, essentially hiding the original property and incorporating it to the rear, and raising it in height to match. The new front essentially comprised two large ground floor reception rooms (Rooms G6 and G7) connected to a new staircase via a central hallway (Room G5) with two large bedrooms on the first floor (Rooms F8 and F9), with access to a large attic room above (Room A3). New doorways were inserted between Rooms G4 and G5 and F6 and F7. The small blocked aperture at the base of the north-east end gable suggests that there may have been a small cellar, but no further evidence for this was found, making it more likely that it is actually connected to an ash pit designed to allow the fireplace in Room G7 to be cleared and the chimney swept from the outside.

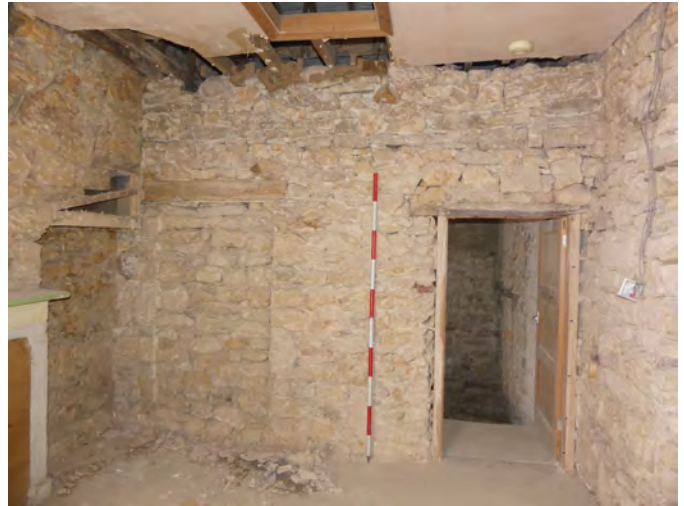
4.4.8 **First floor Room 1 (F1):** the north-west elevation is largely constructed from regular blocks, with thin angled pieces denoted the line of the flue in the chimney breast (Plate 49). It is open on the north-east side forming an alcove below the angle of the chimney breast, with stepped stone and a modern timber lintel over. The north-east elevation (Plate 50) has a blocked doorway on the north-west side with a thick timber lintel (Plate 51). To the south-east, the extant doorway is clearly inserted and has a reused timber lintel. Along the top is a noticeable change in build, presumably where the wall has been raised in height. The south-east elevation has a blocked doorway on the north-east side, extending across the line of the north-east elevation, which also has a rough timber lintel (Plate 52). The extant doorway to the south-west of this is inserted and has a sawn timber lintel. A further possible partial butt joint is evident to the south-west (Plate 53). The south-west elevation is plain except for the window, which has a rough timber lintel (Plate 54).

Plate 49 (left): North-west elevation, Room F1, viewed from the south-east
Plate 50 (right): North-east elevation, Room F1, viewed from the south-west

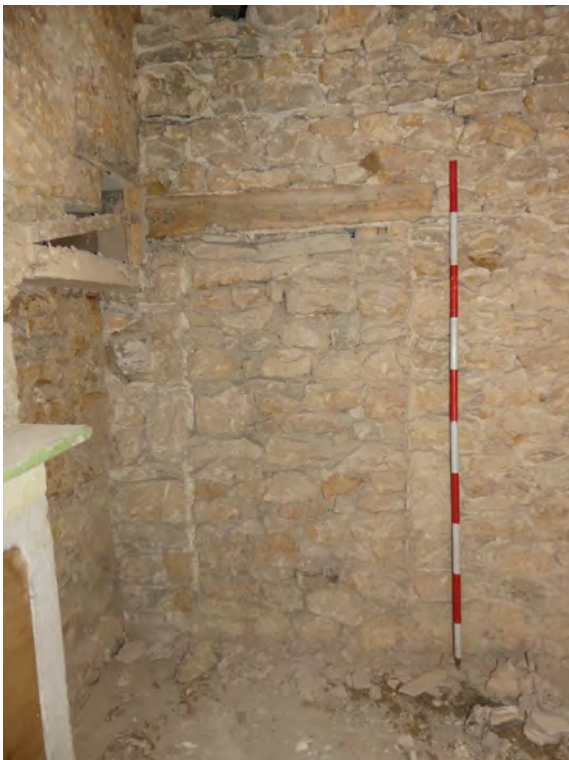
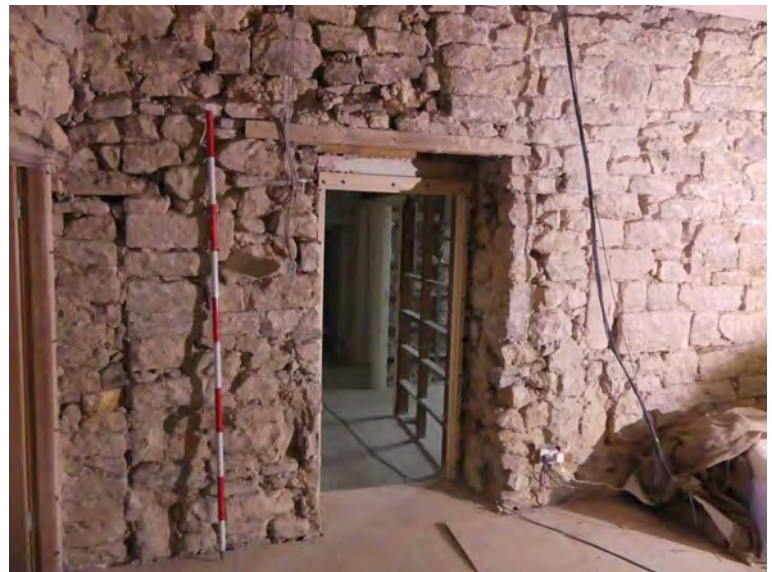
Plate 51 (left): Blocked doorway on north-west side of north-east elevation, Room F1, viewed from the south-west
Plate 52 (right): Blocked and extant doorway in the south-east elevation, Room F1, viewed from the north-west

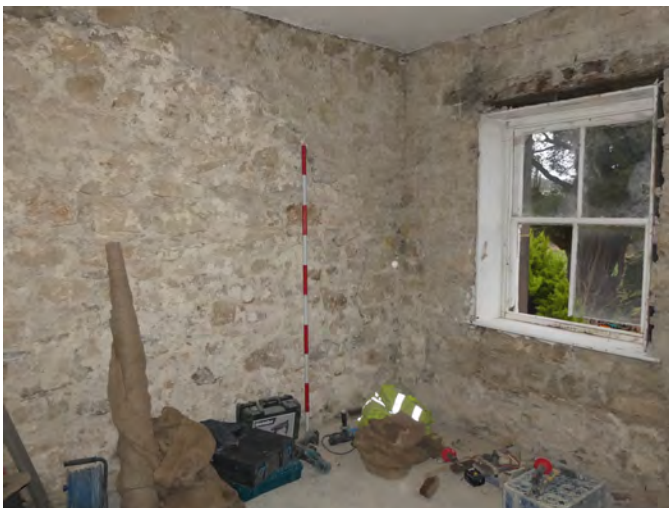
4.4.9 **First floor Room 2 (F2):** the north-west and north-east elevations are essentially plain, with the same build of roughly dressed blocks. The north-west elevation has an evident angled line on the north-east side, corresponding to where the wall has been raised, and the window to the north-east has a rough and reused timber lintel (Plate 55). The south-east elevation appears to butt the north-east (Plate 56). The top of a blocked doorway at landing level is present on the north-east side, with a timber lintel (Plate 57), and there is the jamb of a large opening to the south-east extending into Room F1, with a timber lintel (Plate 58). There is a change in height near the top of the wall, presumably denoting where it has been raised. The south-west elevation features an inserted doorway on the south-east side with a rounded timber lintel, and a blocked doorway to the north-west with a thin timber lintel (Plate 59). Again, there is an evident line along the top where it has been raised in height.

Plate 55 (left): North-west and north-east elevations, Room F2, viewed from the south

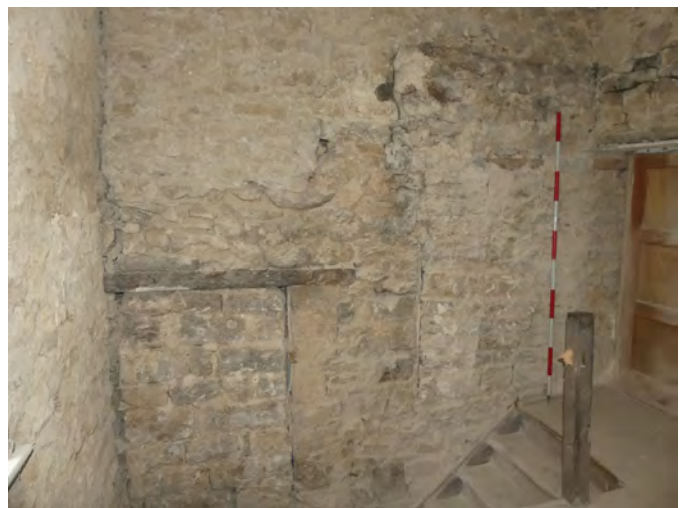
Plate 56 (right): South-east elevation, Room F2, viewed from the north-west

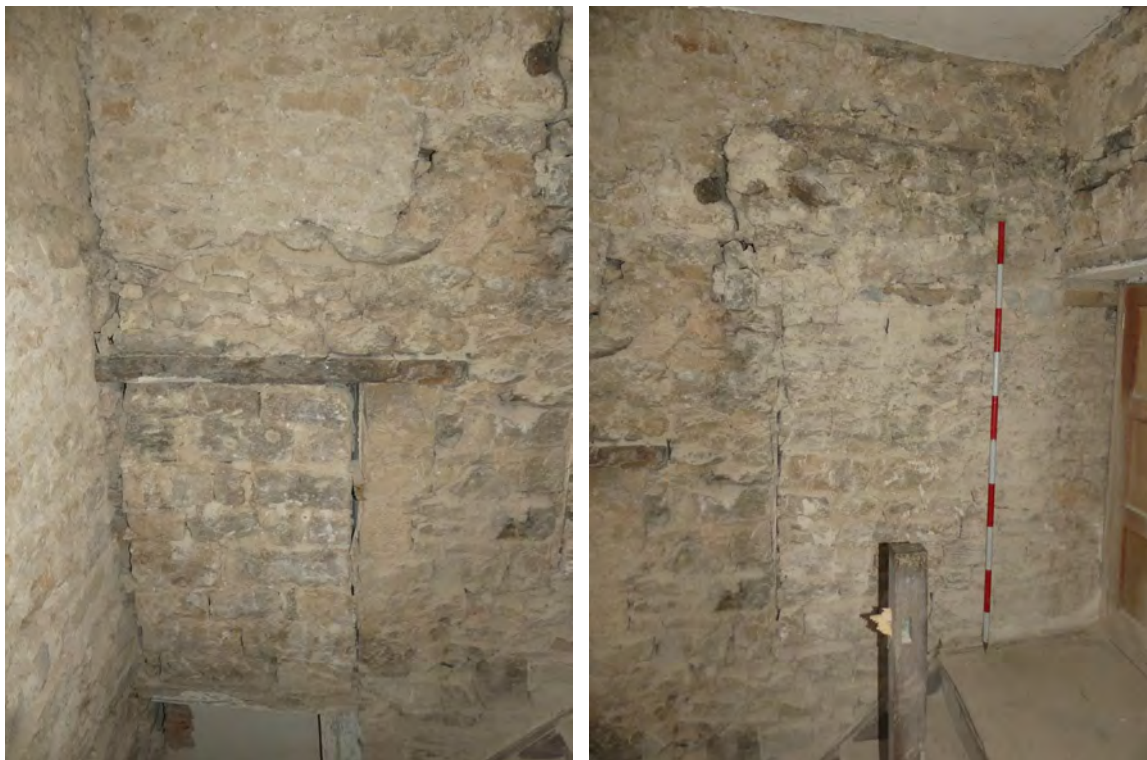
Plate 57 (left): Blocked landing-level doorway, north-east side of the south-east elevation, Room F2, viewed from the north-west

Plate 58 (right): Blocked opening, south-west side of the south-east elevation, Room F2, viewed from the north-west

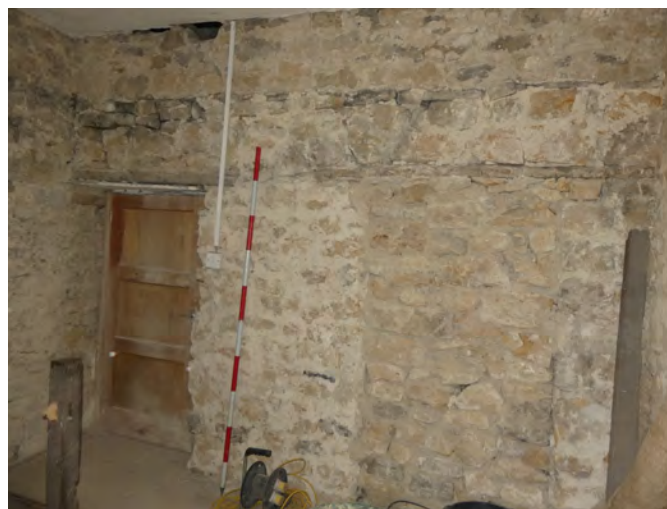
Plate 59: South-west elevation, Room F2, viewed from the north

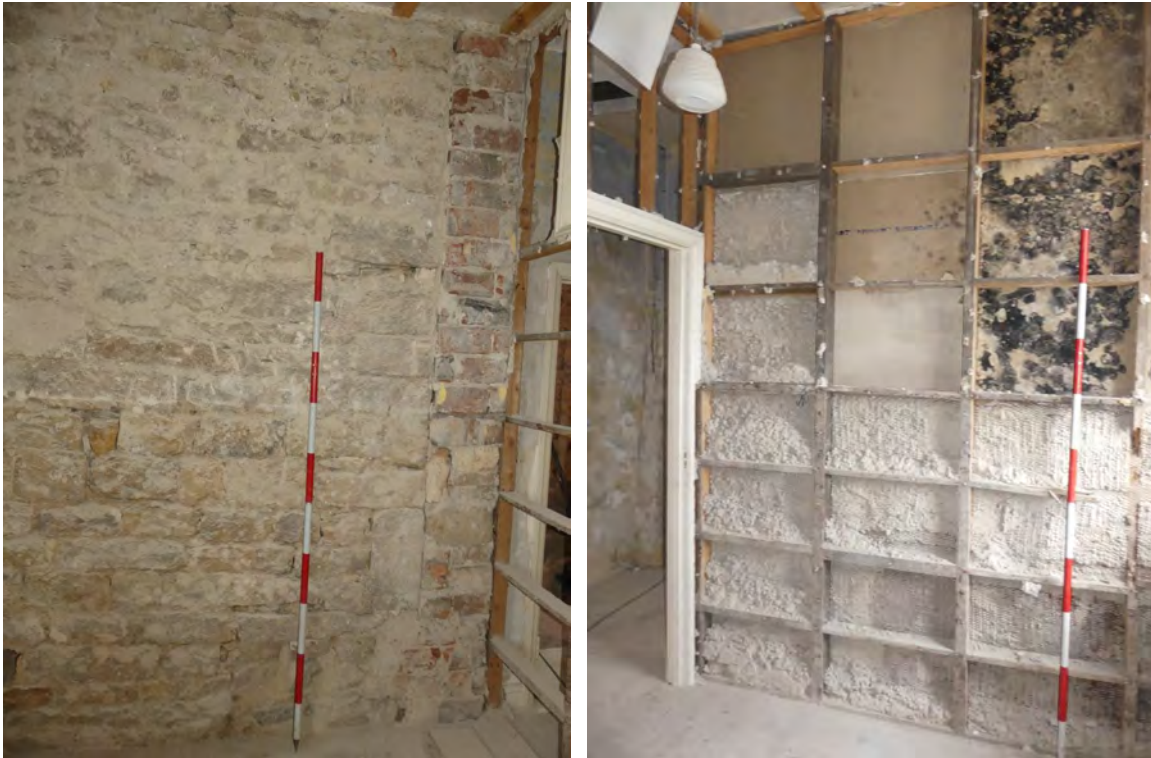
4.4.10 **First floor Room 3 (F3):** the lower part of the north-west elevation is constructed from well-dressed blocks, which come to an angled top, above which they are rough, presumably denoting where the wall has been raised in height (Plate 60). The stonework comes to a butt joint on the north-east side, quined in the lower part, beyond which it is infilled with a mixture of different brick types, including some fire brick, and some stone; one brick is frogged and marked 'ENFIELD DEERPLAY'. The north-east and south-east walls are relatively modern timber stud, with some sprayed mortar infill to the south-east (Plate 61). The south-west elevation is plain, with a rough stone build and a window to the south-east with a timber lintel.

Plate 60 (left): North-west elevation, Room F3, viewed from the south-east
