WRITTEN STONE FARM, WRITTEN STONE LANE, LONGRIDGE, PRESTON, LANCASHIRE

Additional Archaeological Building Recording

March 2026

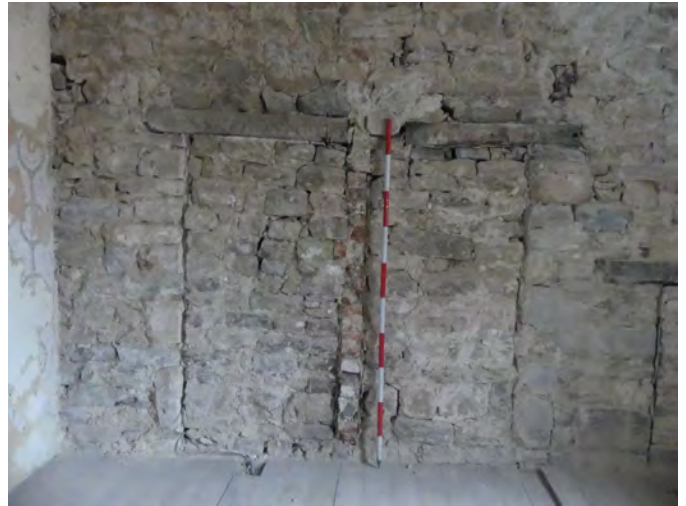
Plate 63 (right): Large blocked opening, north-west elevation, Room F6, viewed from the south-east

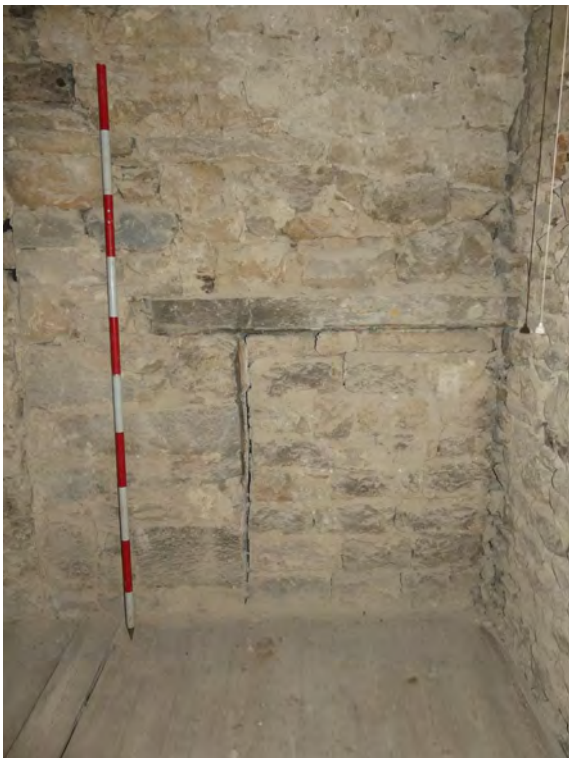
Plate 64 (left): Blocked opening, north-east of the north-west elevation, Room F6, viewed from the south-east

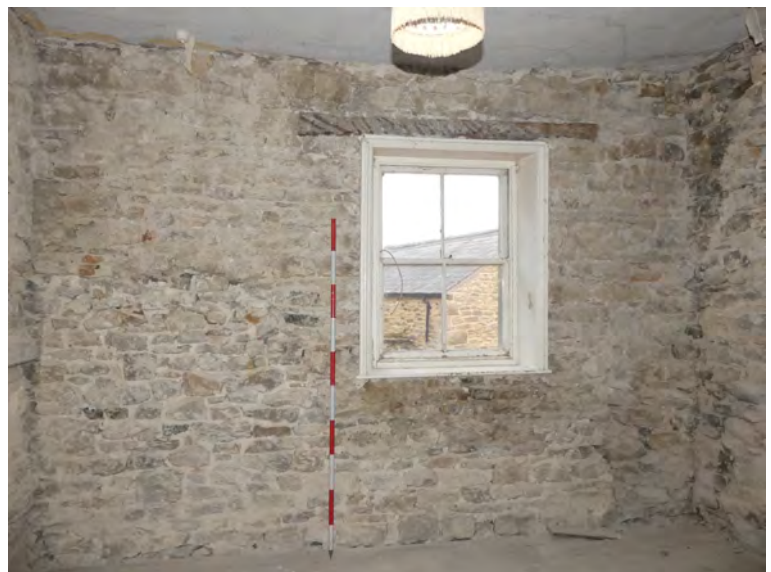
Plate 65 (right): North-east elevation, Room F6, viewed from the south-west

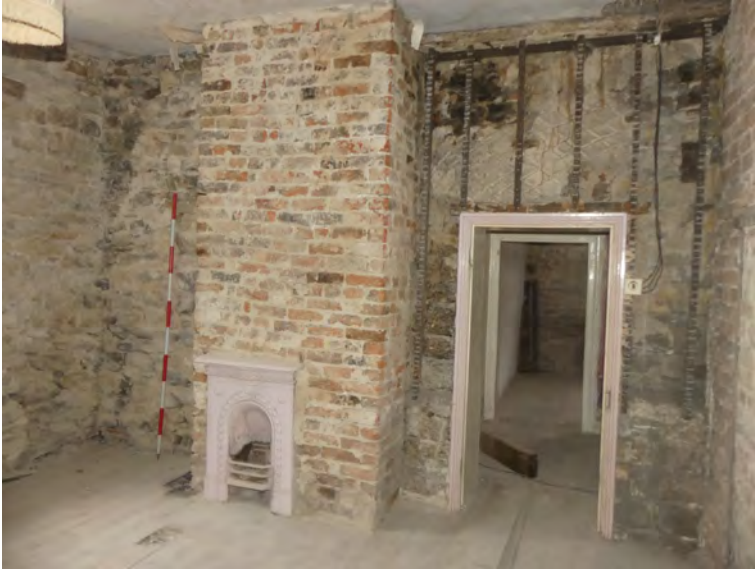
Plate 66 (left): South-east elevation, Room F6, viewed from the west

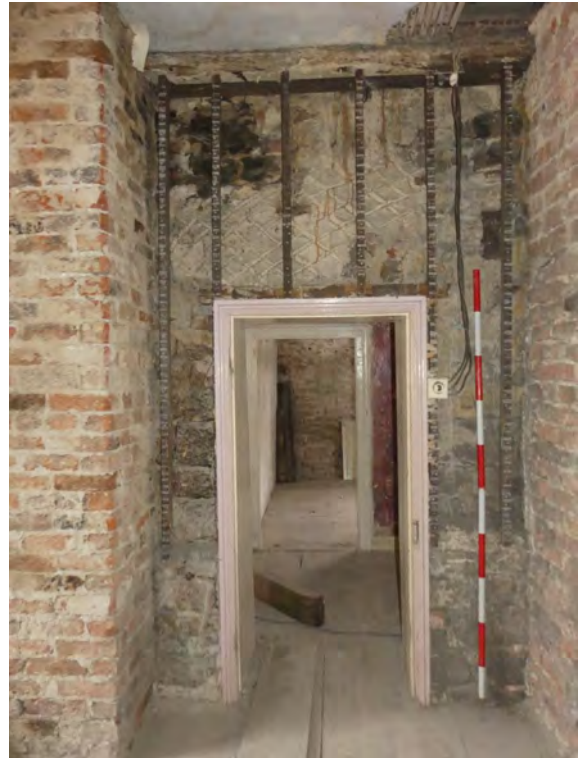
Plate 67 (right): South-west side of the south-east elevation, Room F6, viewed from the north-west

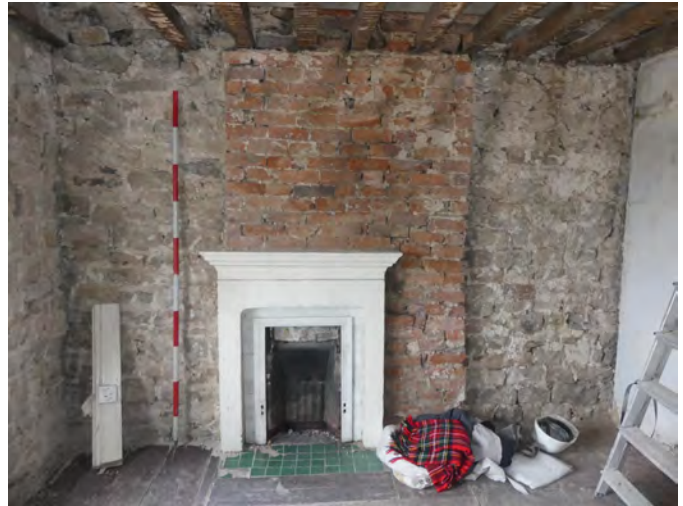
Plate 70 (right): Chimney breast, south-west elevation, Room F8, viewed from the north-east

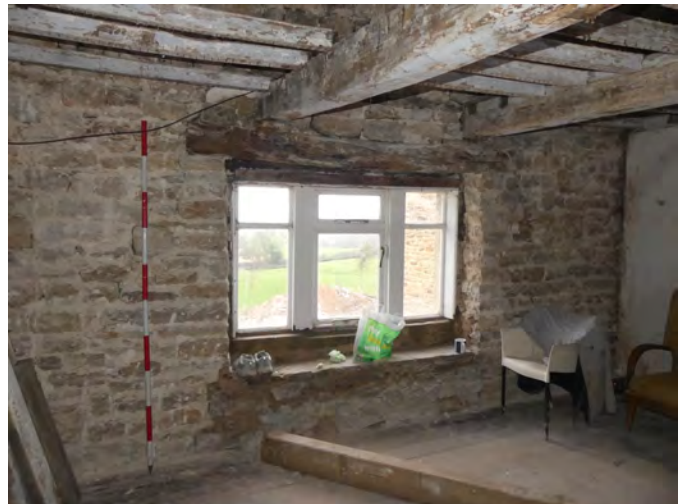
Plate 72 (right): South-east elevation, Room F9, viewed from the north

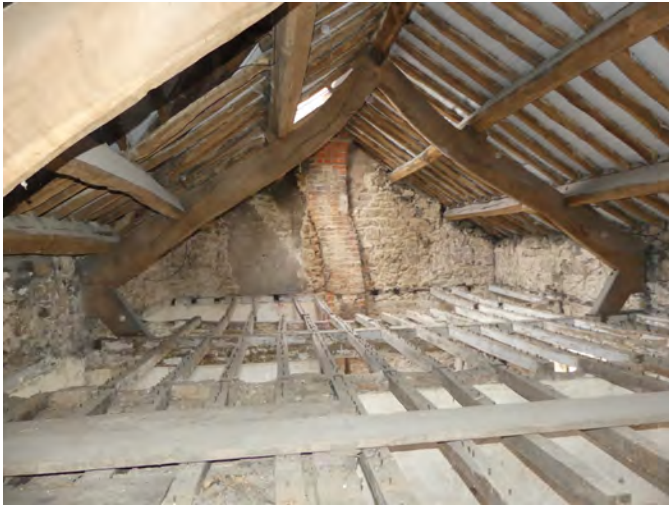
4.4.17 **Attic-level Room 3 (A3)**: this was the only area that had been substantially changed, the walls stripped of any plaster to the north-east and south-west, fully exposing the brick chimney at the north-east end (Plate 73 and Plate 74). No additional features were observed, except for the line of the former wall plate and the ends of two purlins on the south-west side of the north-west elevation with the wall line raised above (Plate 75). It was also evident that the south-west elevation butts the north-west below the level of the raised wall. There was also a butt joint evident on the north-east side of the north-west elevation, corresponding with the return of the front section of the farmhouse (Plate 76).

Plate 73 (left): General view of Room A3, showing the north-east elevation, from the south-west

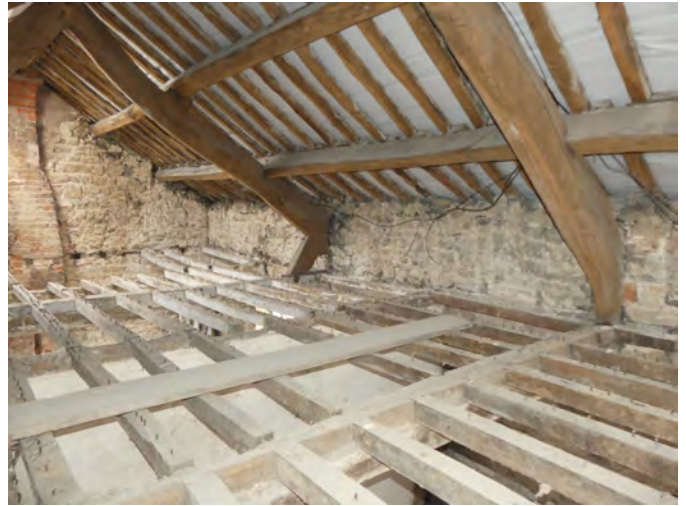
Plate 74 (right): General view of Room A3, showing the south-east elevation, from the west

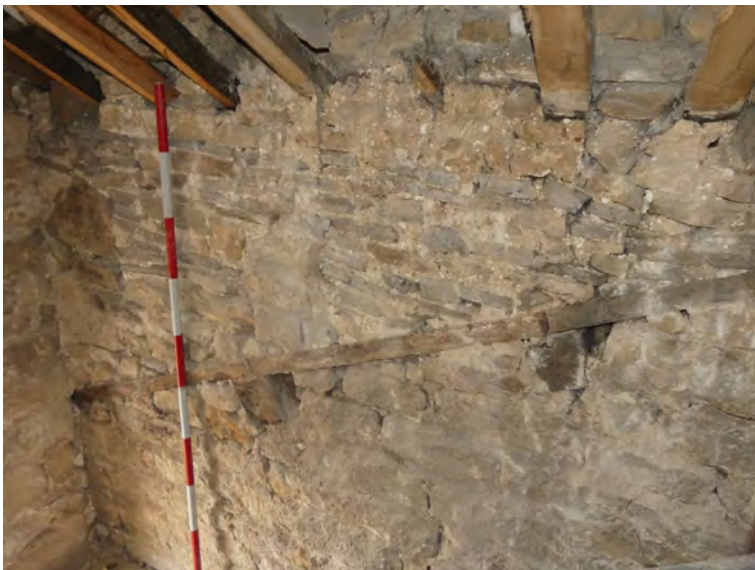
Plate 75 (left): Wall plate and raised wall line on the south-west side of the north-west elevation, Room A3, viewed from the east

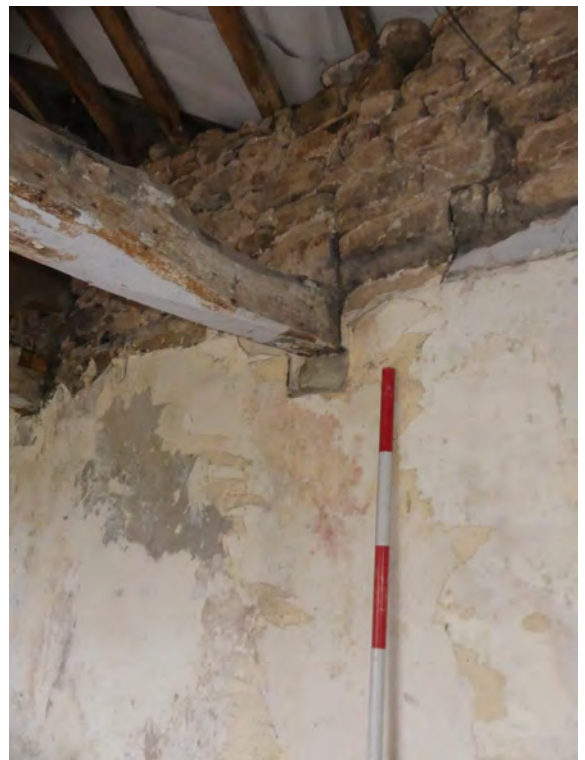
Plate 76 (right): Butt joint on the north-east side of the north-west elevation, Room A3, viewed from the east

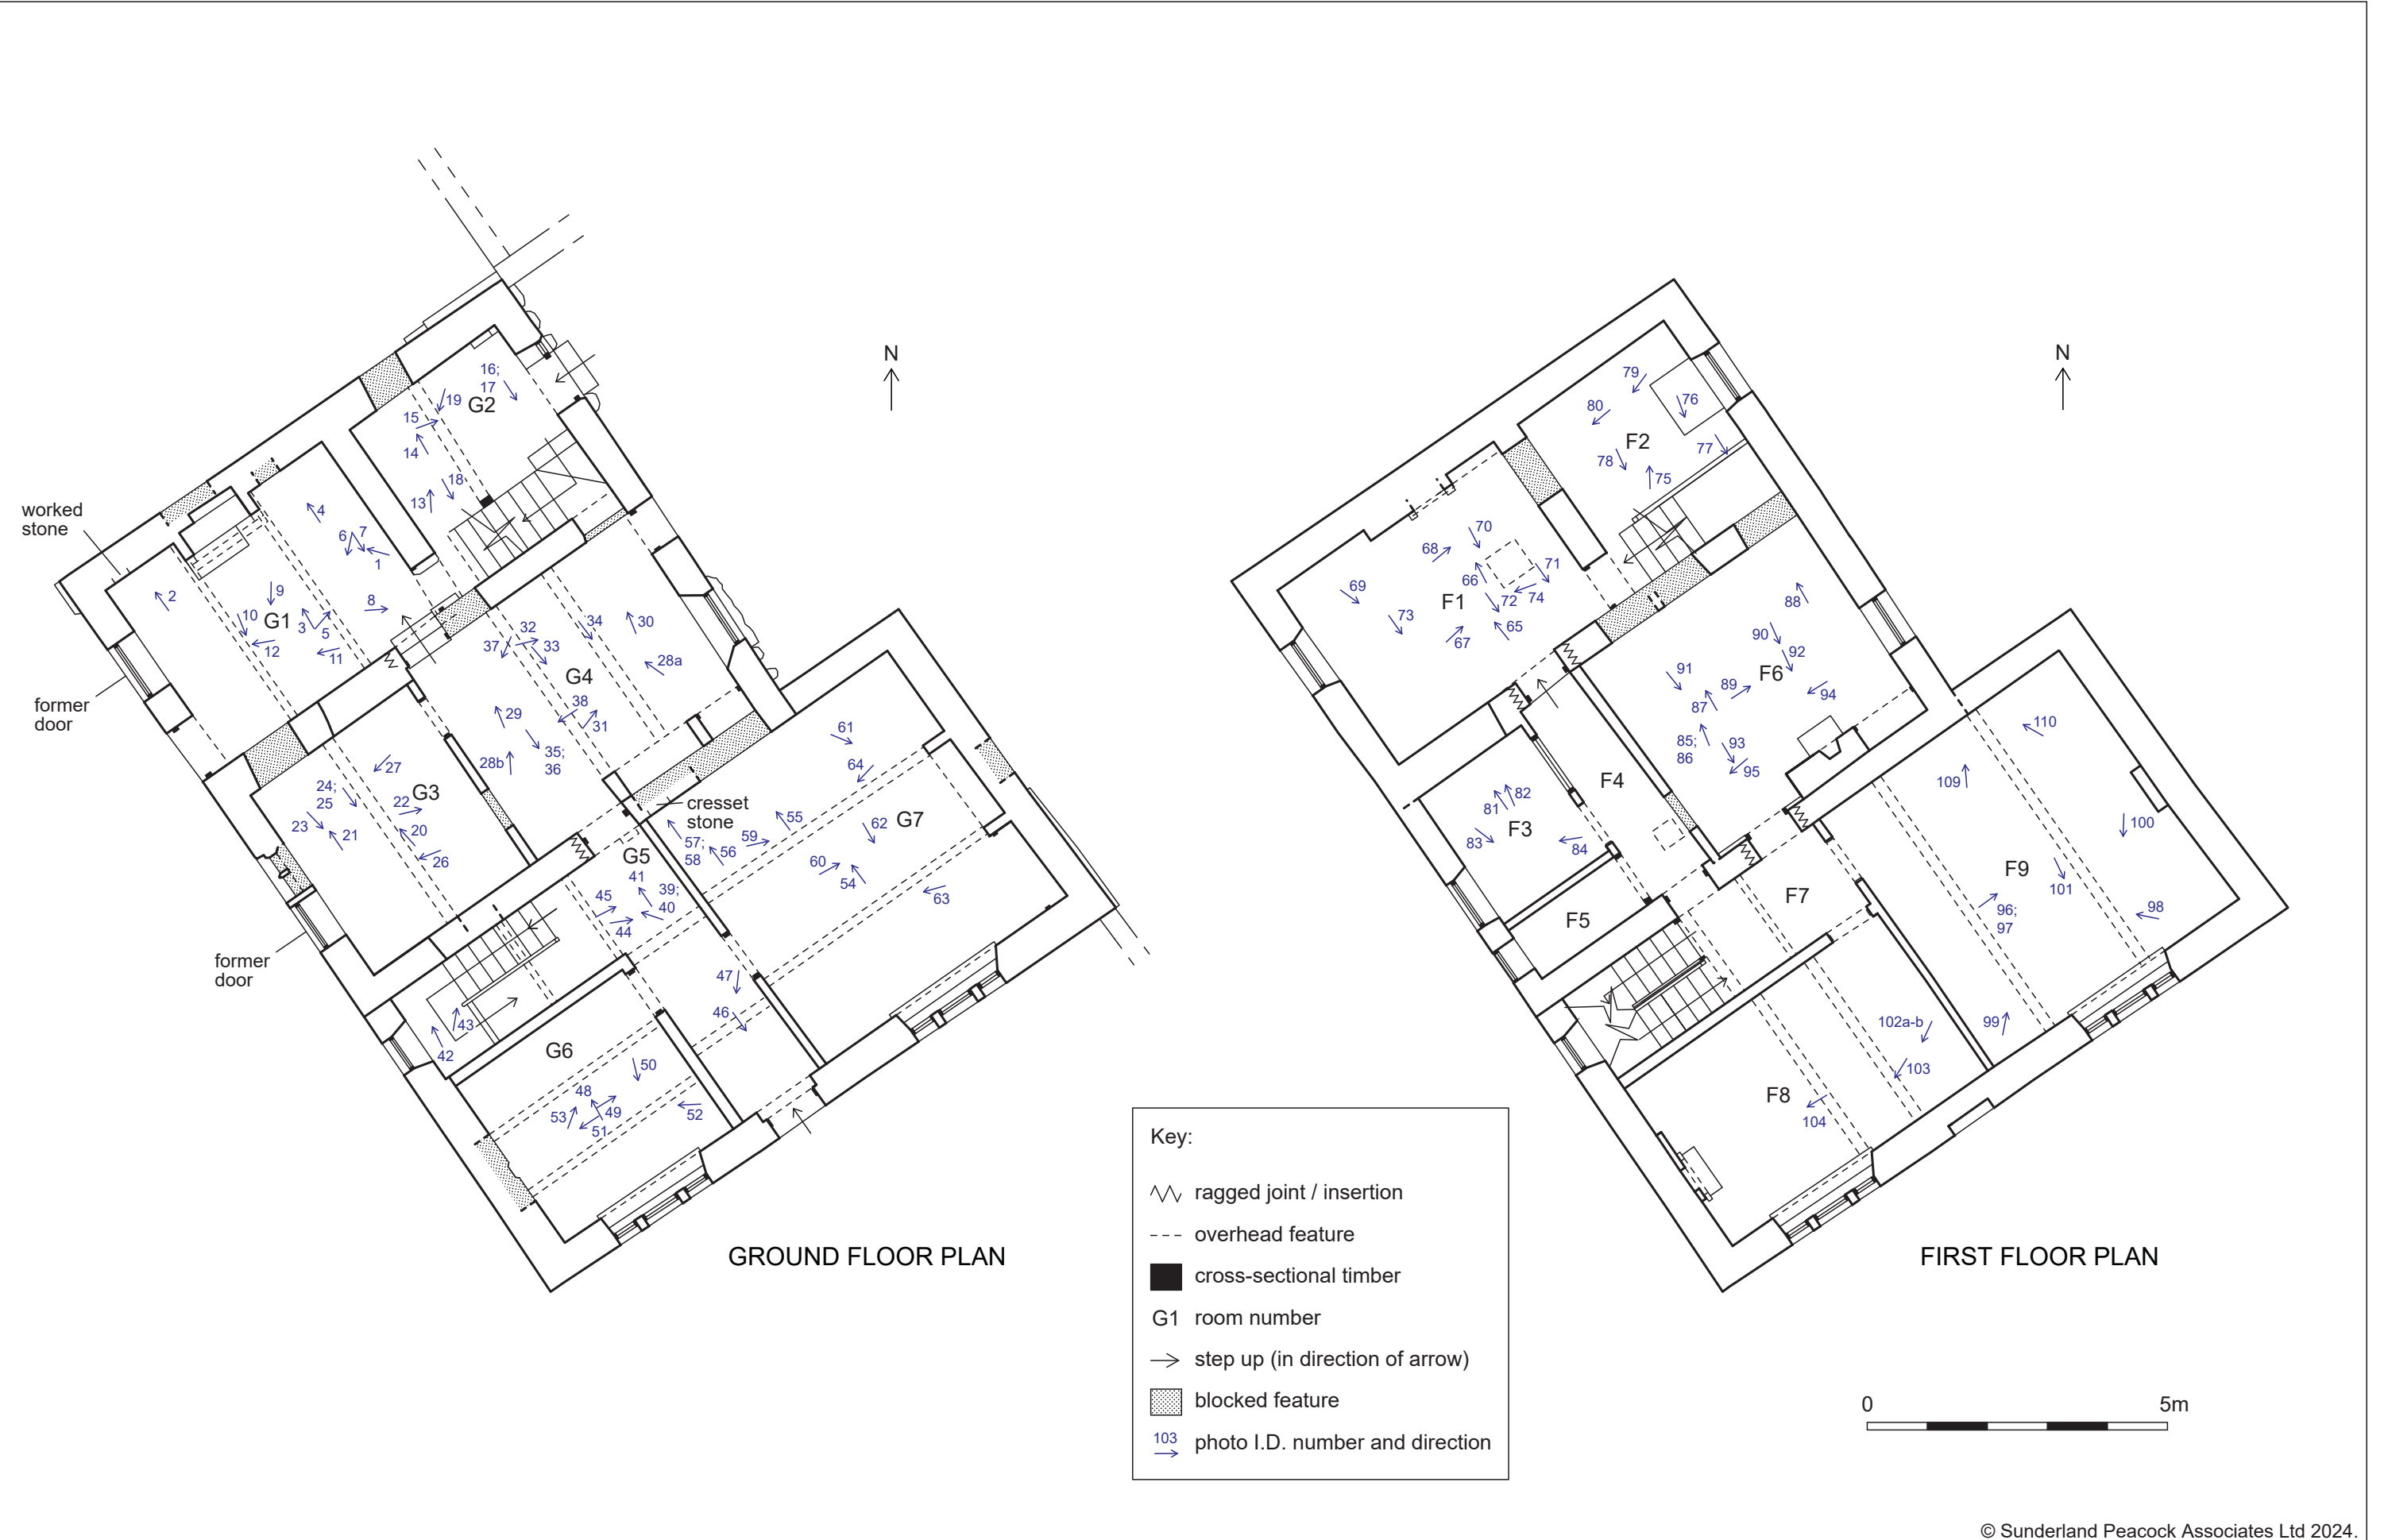
Figure 5: Ground and first floor plans of the farmhouse, showing the location and direction of photographs taken
