# LOWER REAPS FARM, WHINNEY LANE, MELLOR, LANCASHIRE

Archaeological Building Recording

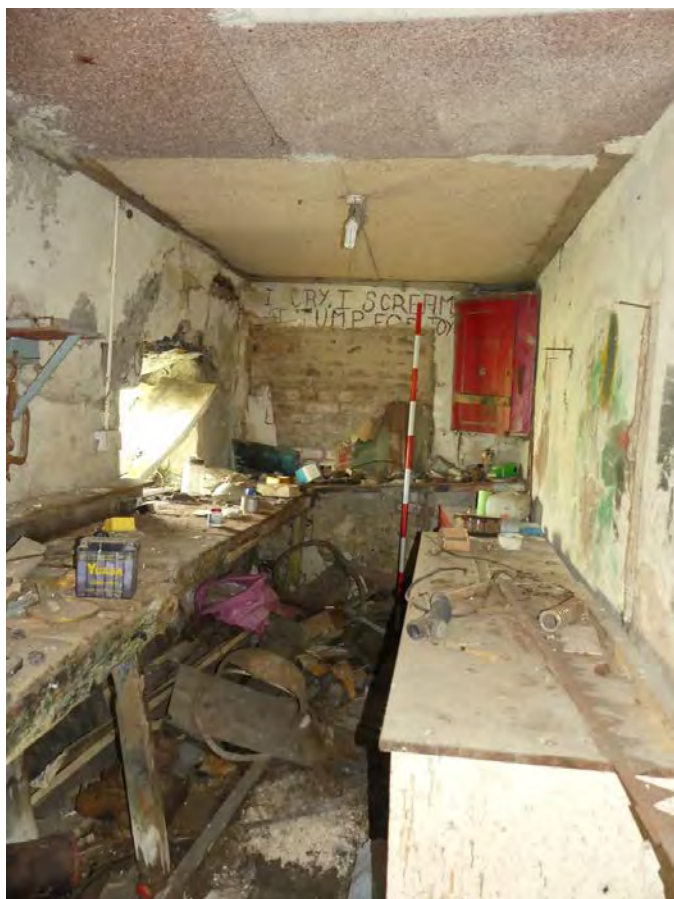
**Plate 41 (left): General view of G2 from the west**

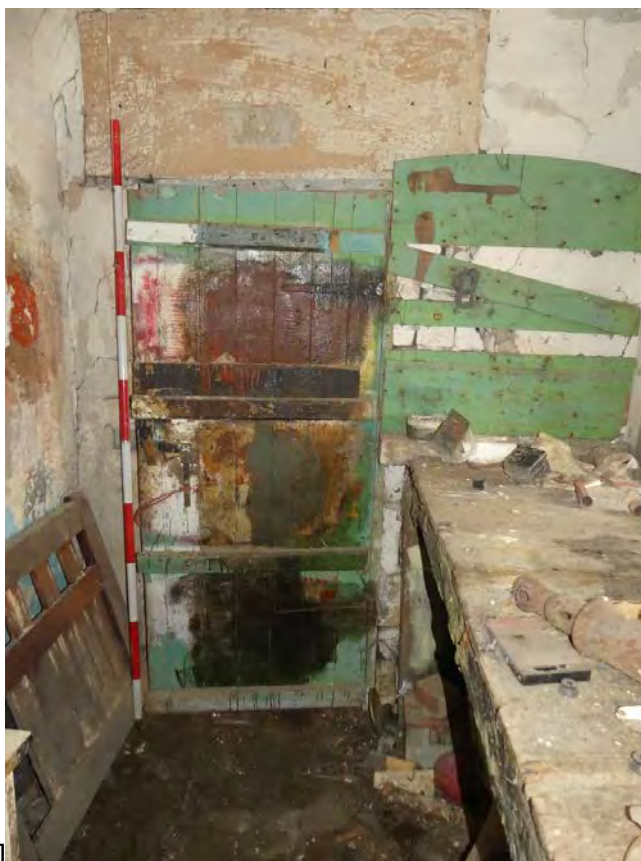
**Plate 49: West elevation of G2, viewed from the east**

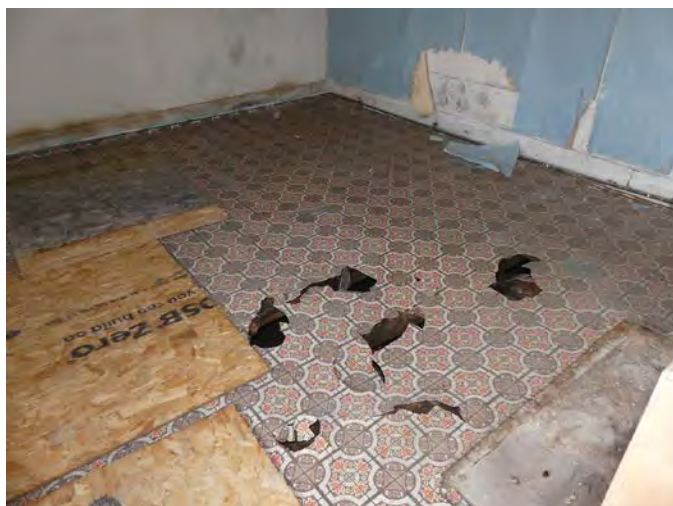
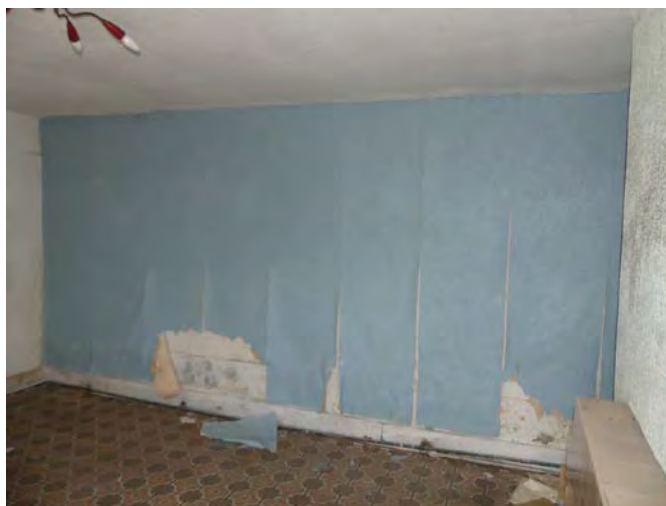
**Plate 50 (left): General view of the floor in G3 from the south-east**  
**Plate 51 (right): North elevation of G3, viewed from the south-east**

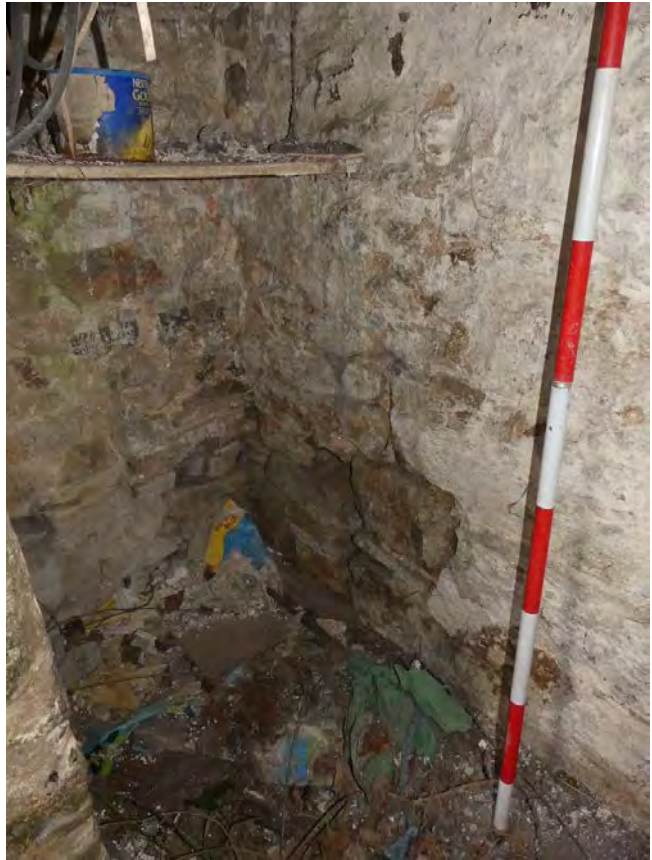
**Plate 96: General view of G9 from the north-west**

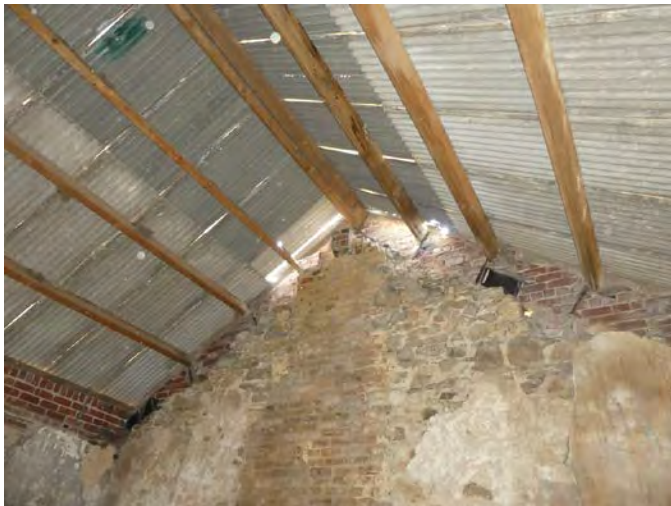
**Plate 97 (left): General view of the roof above F1 from the north-east**

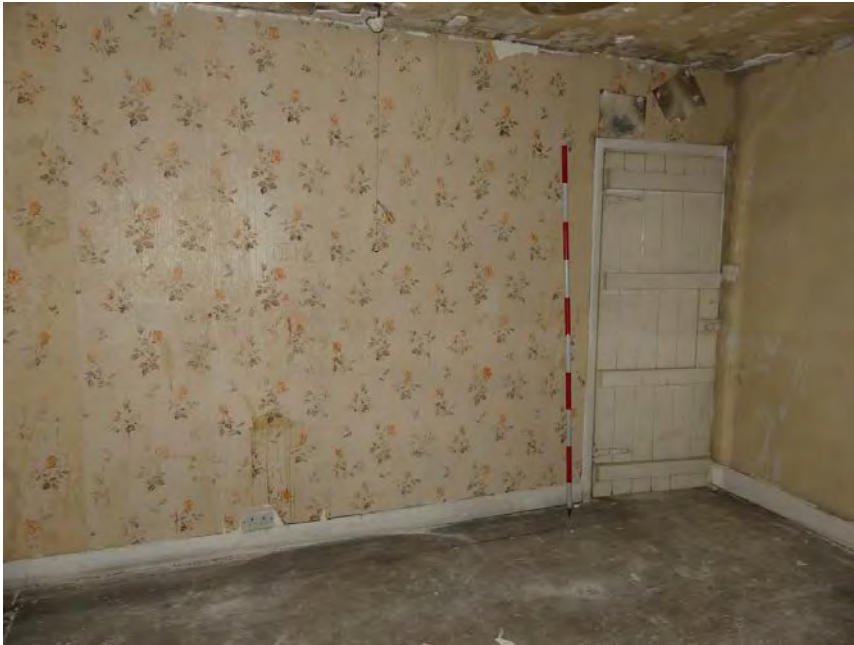
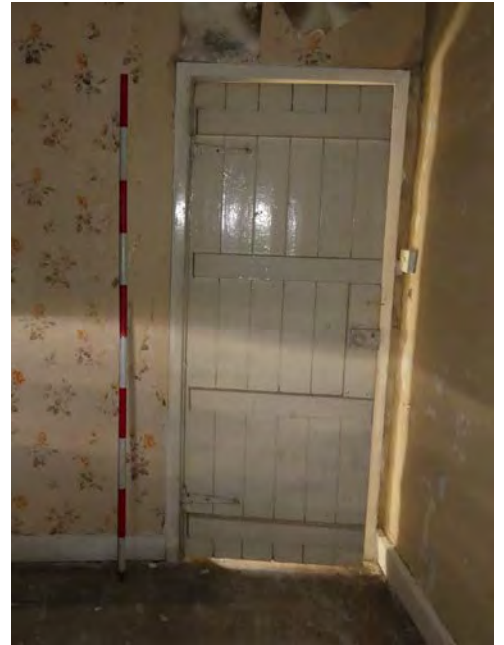
**Plate 115 (left): General view of the north elevation of F5 from the south-west**

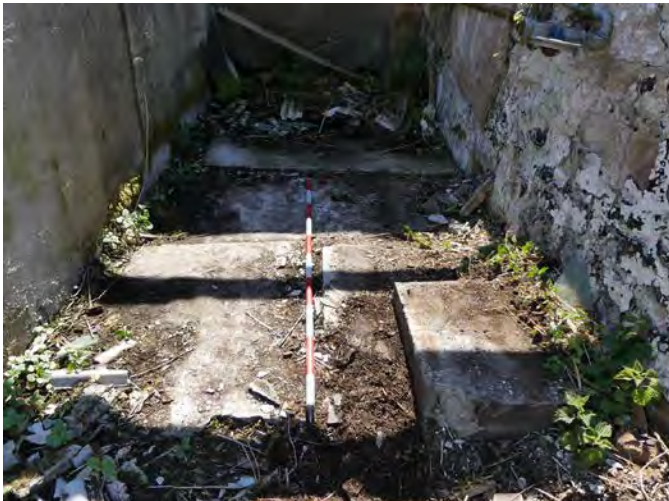
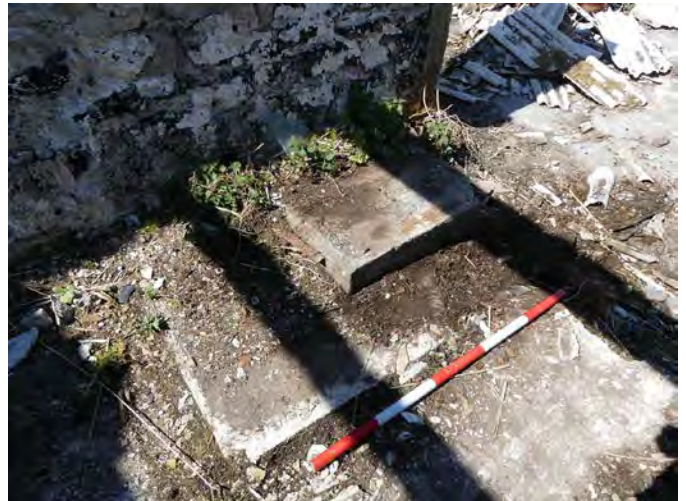
**Plate 153 (left): West side of the floor in G1, viewed from the north**

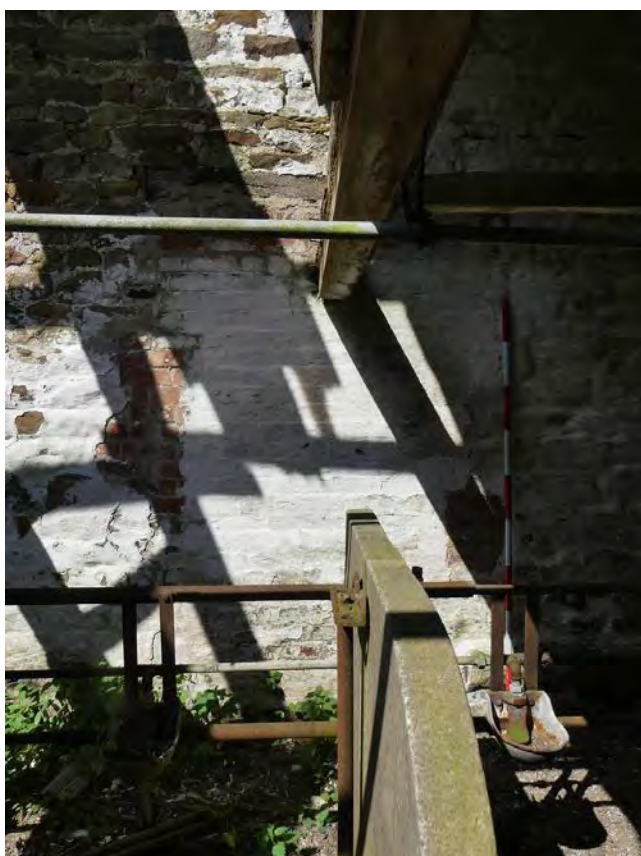
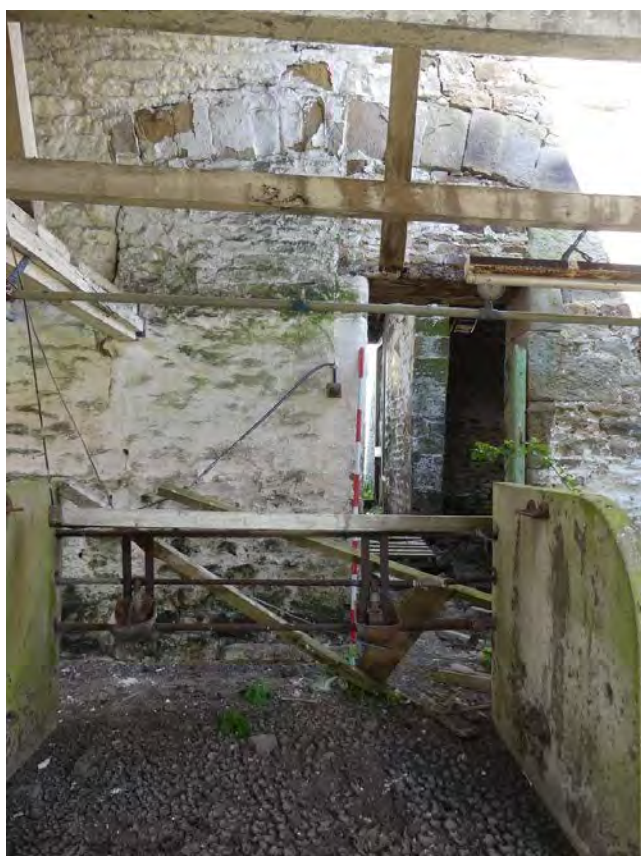
**Plate 198 (left): West door in the north elevation of G4, viewed from the south**

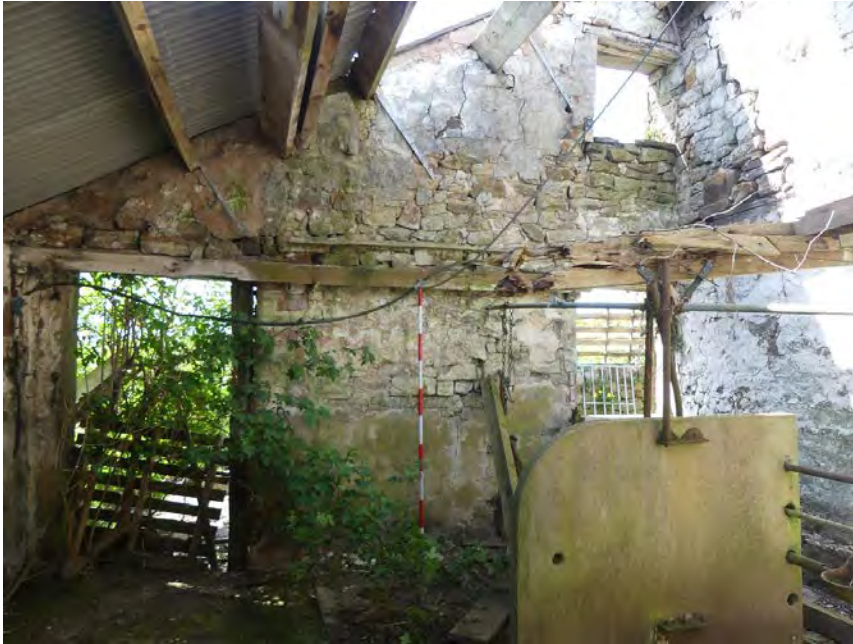
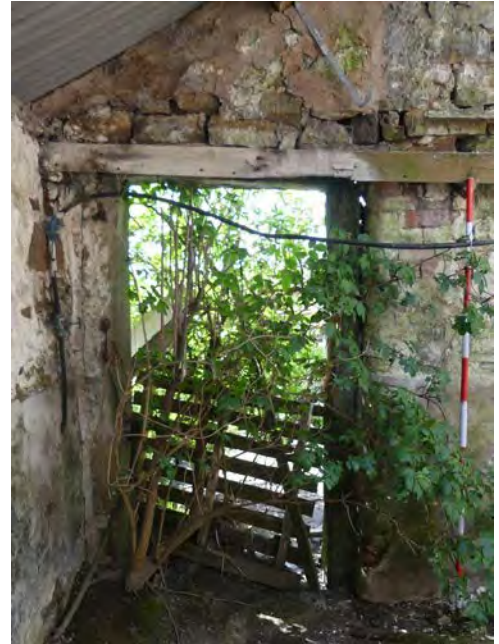
**Plate 208 (left): General view of the west elevation of G4 from the east**
