Method Statement - Archaeological Building Recording - revision A Lower Reaps Farm, Whinney Lane, BB2 7EL

Features of Interest

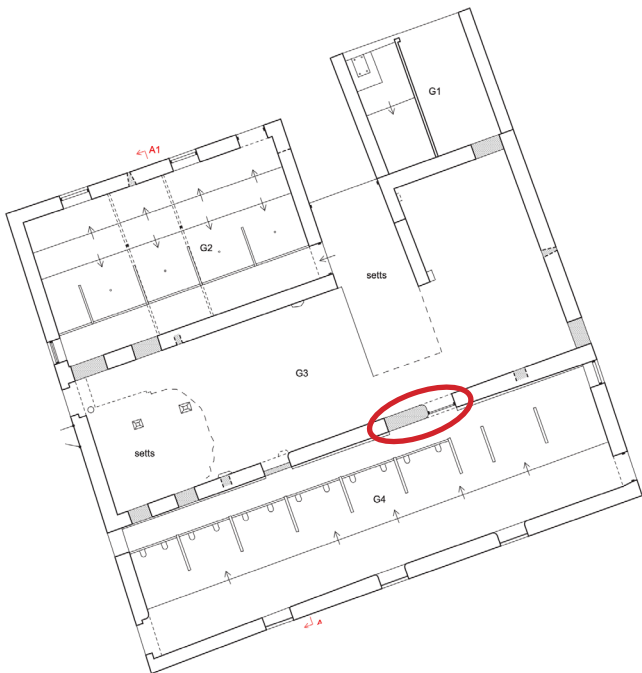
barn plan identifying feature of interest

Wagon door:

The wagon doorway is to be retained and expressed within the interior of the proposed scheme. The existing 'rough reused timber lintel' is rotten and may require treatment or replacement.

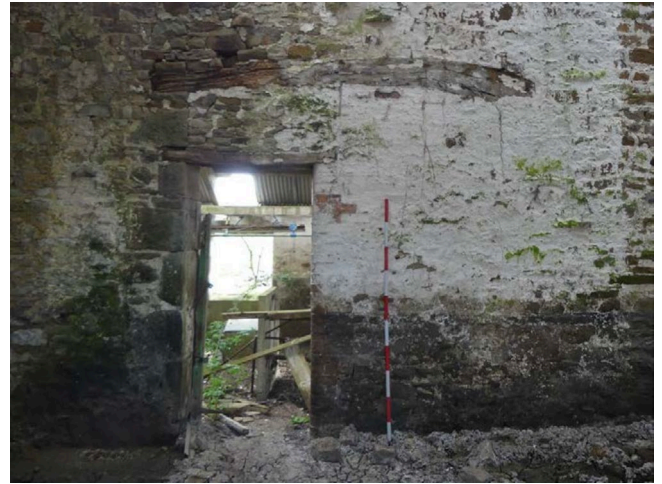
plate 188

Plate 188 of the Building Record identifies a rough reused timber lintel for a wagon doorway to the west of the south elevation of the main chamber of the barn. The existing opening has quoins in the east jamb.

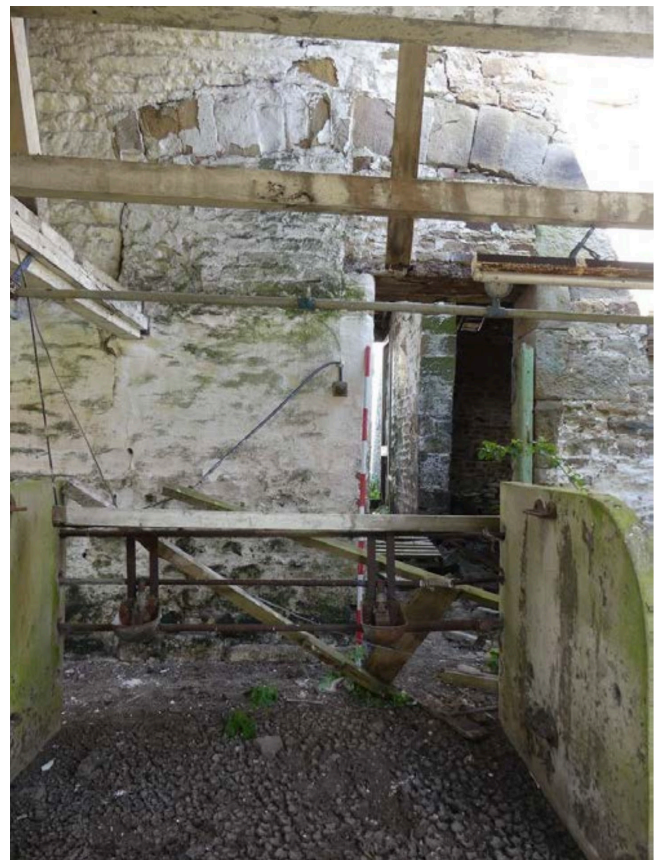
plate 199

Plate 199 identifies remains of the other side of the same wagon doorway in the north wall of the southern outshut. A flat voussoir arch of dressed stones above sets out the width of the historic doorway and quoins are evident to the east.

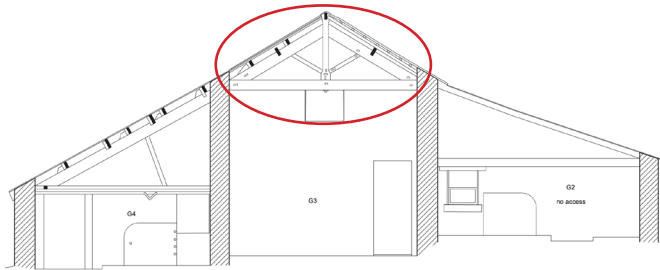
barn section identifying feature of interest

Kingpost trusses:

Where timbers aren't decayed or unusable, the trusses are to be retained and expressed within the interior of the proposed scheme.

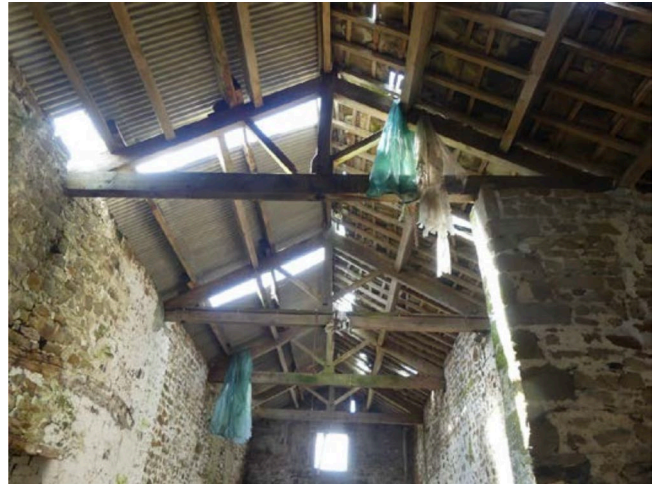
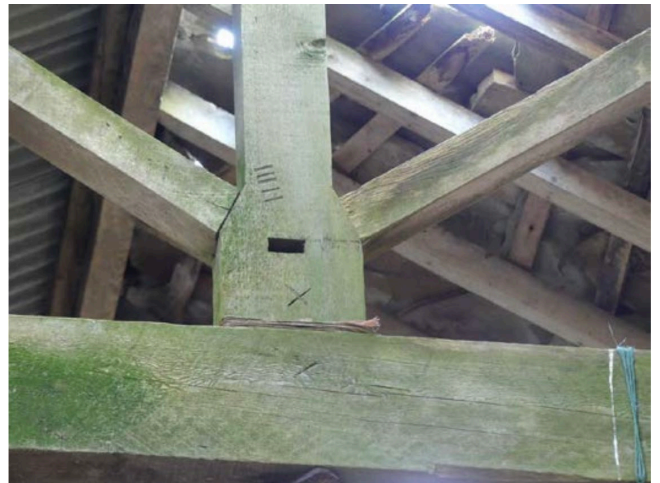
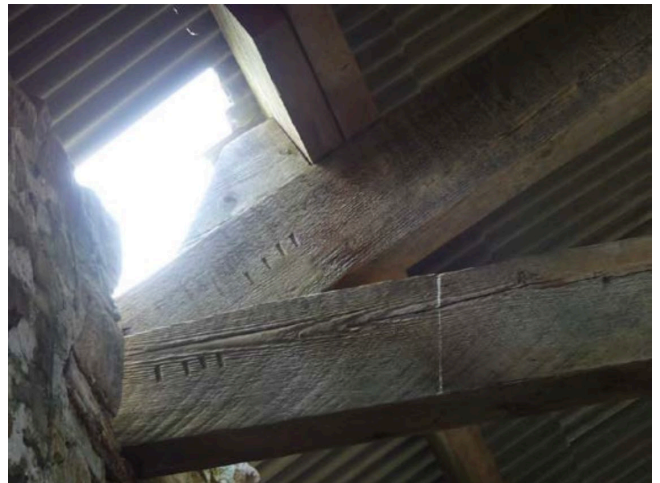
Plates 165 - 173 of the Building Record identify north/south king post trusses with angled braces bolted to the tie beams. The trusses have carpenter's marks as shown to the images and exhibit some signs of rot/deterioration (as seen to following page).

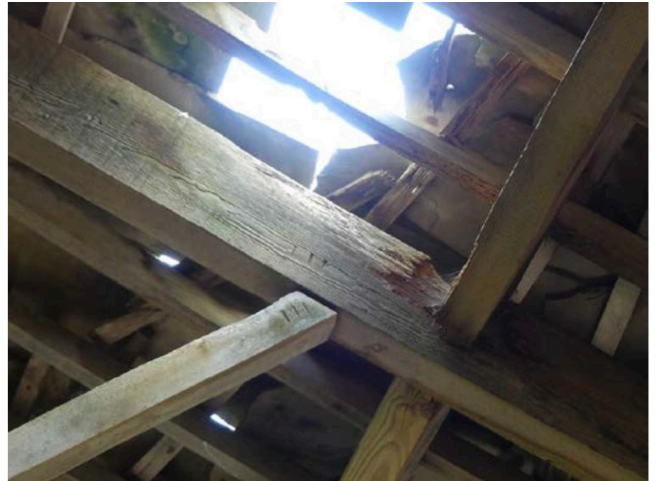
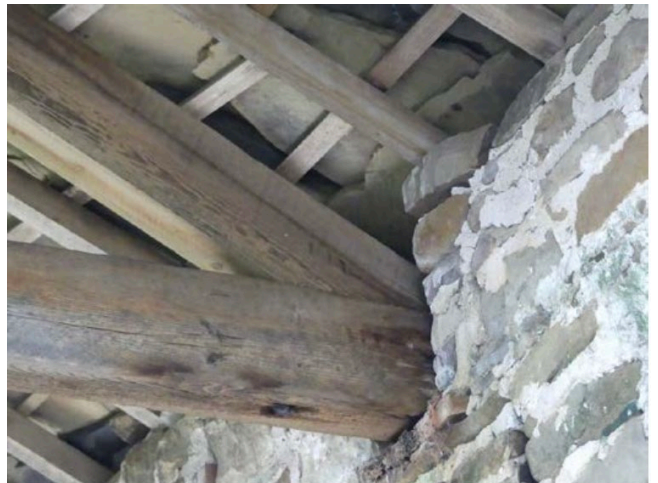
Signs of rot/deterioration in timbers as seen to plates 172 and 173 of the Building Record.
