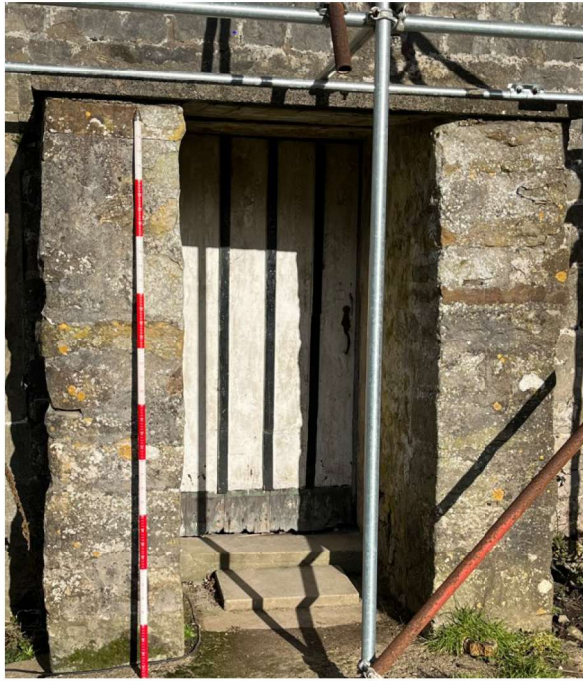
*Plate 11*

*Porch*

There is no evidence for an earlier porch set behind the present 20<sup>th</sup> century construction.

However, the door is original, and comprises four wooden boards painted white with batons covering the joints. (Discussed further on page 26)

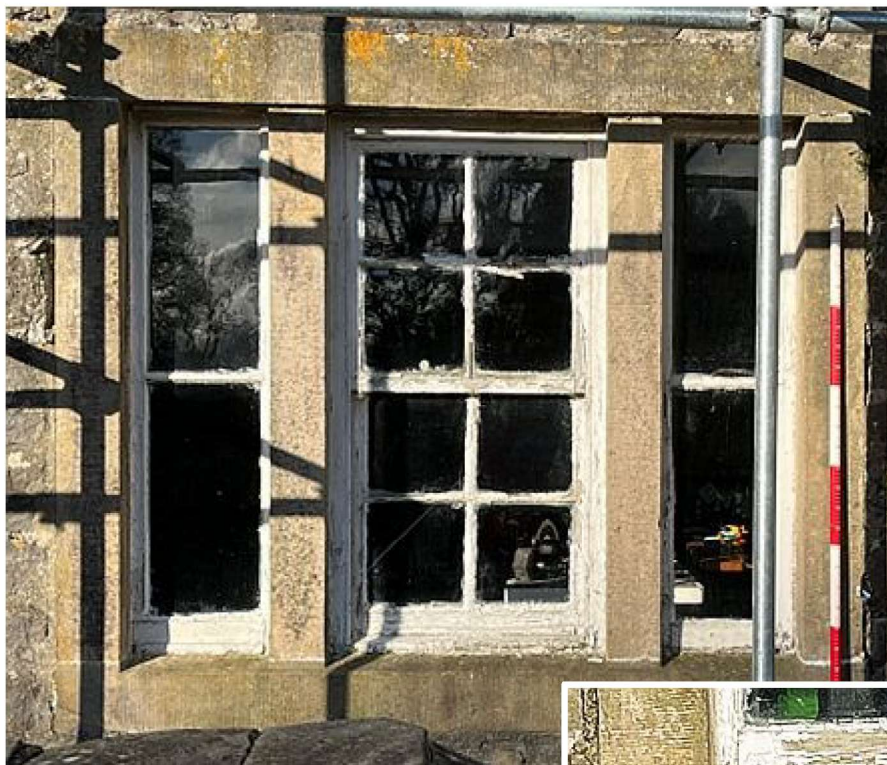
*Plate 12*

The identical tripartite windows on the front elevation comprise monolithic jambs, lintels, cills and mullions, set flush with the wall. The milled face is a typical masonry finish. By the late 18<sup>th</sup> and into the 19<sup>th</sup> century the milling was machine tooled as seen here.
