Phase II Geoenvironmental Site Assessment

Site: Higher Standen Drive, Clitheroe
Reference: 17-912-R2-1
Date: November 24

17-912-R1 – Interim Report

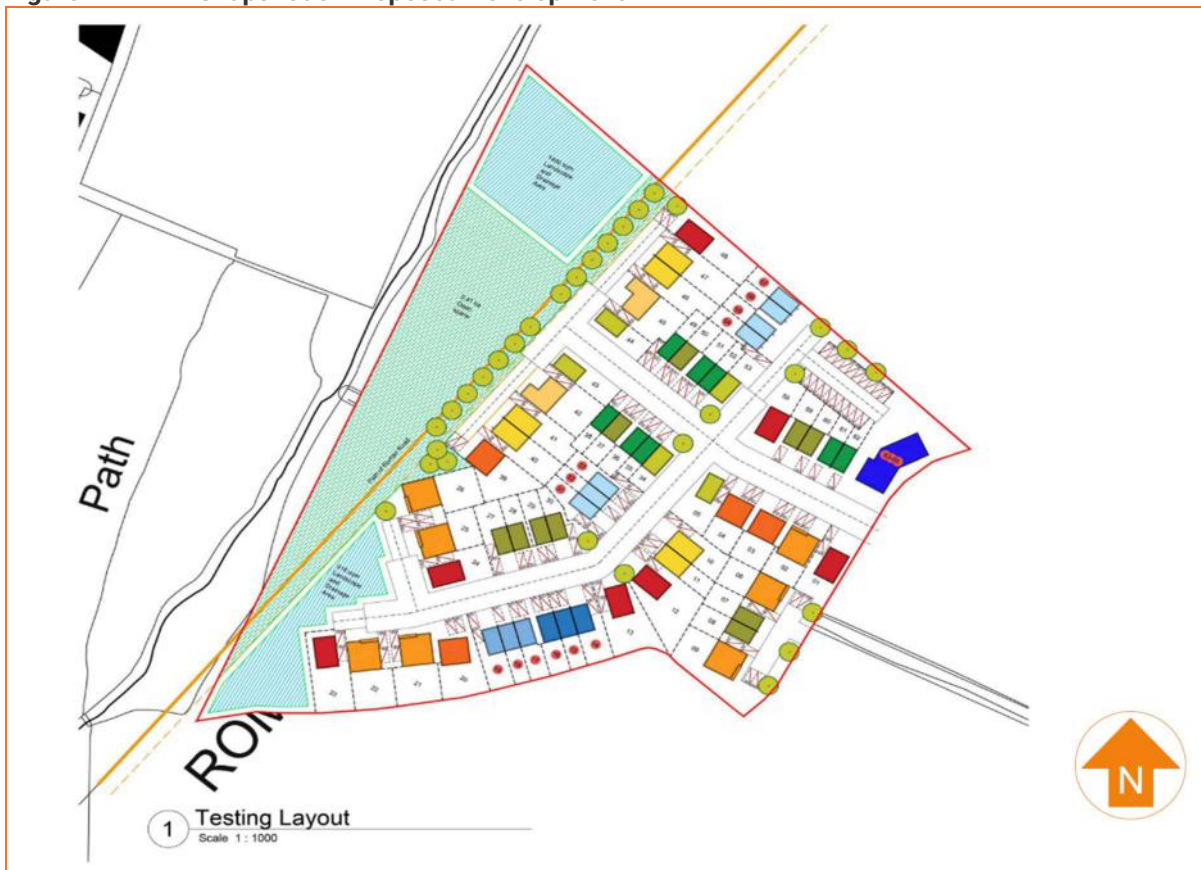
Figure 1 Snapshot of Proposed Development

A snapshot of the Proposed Development Layout is indicated in Figure 1.

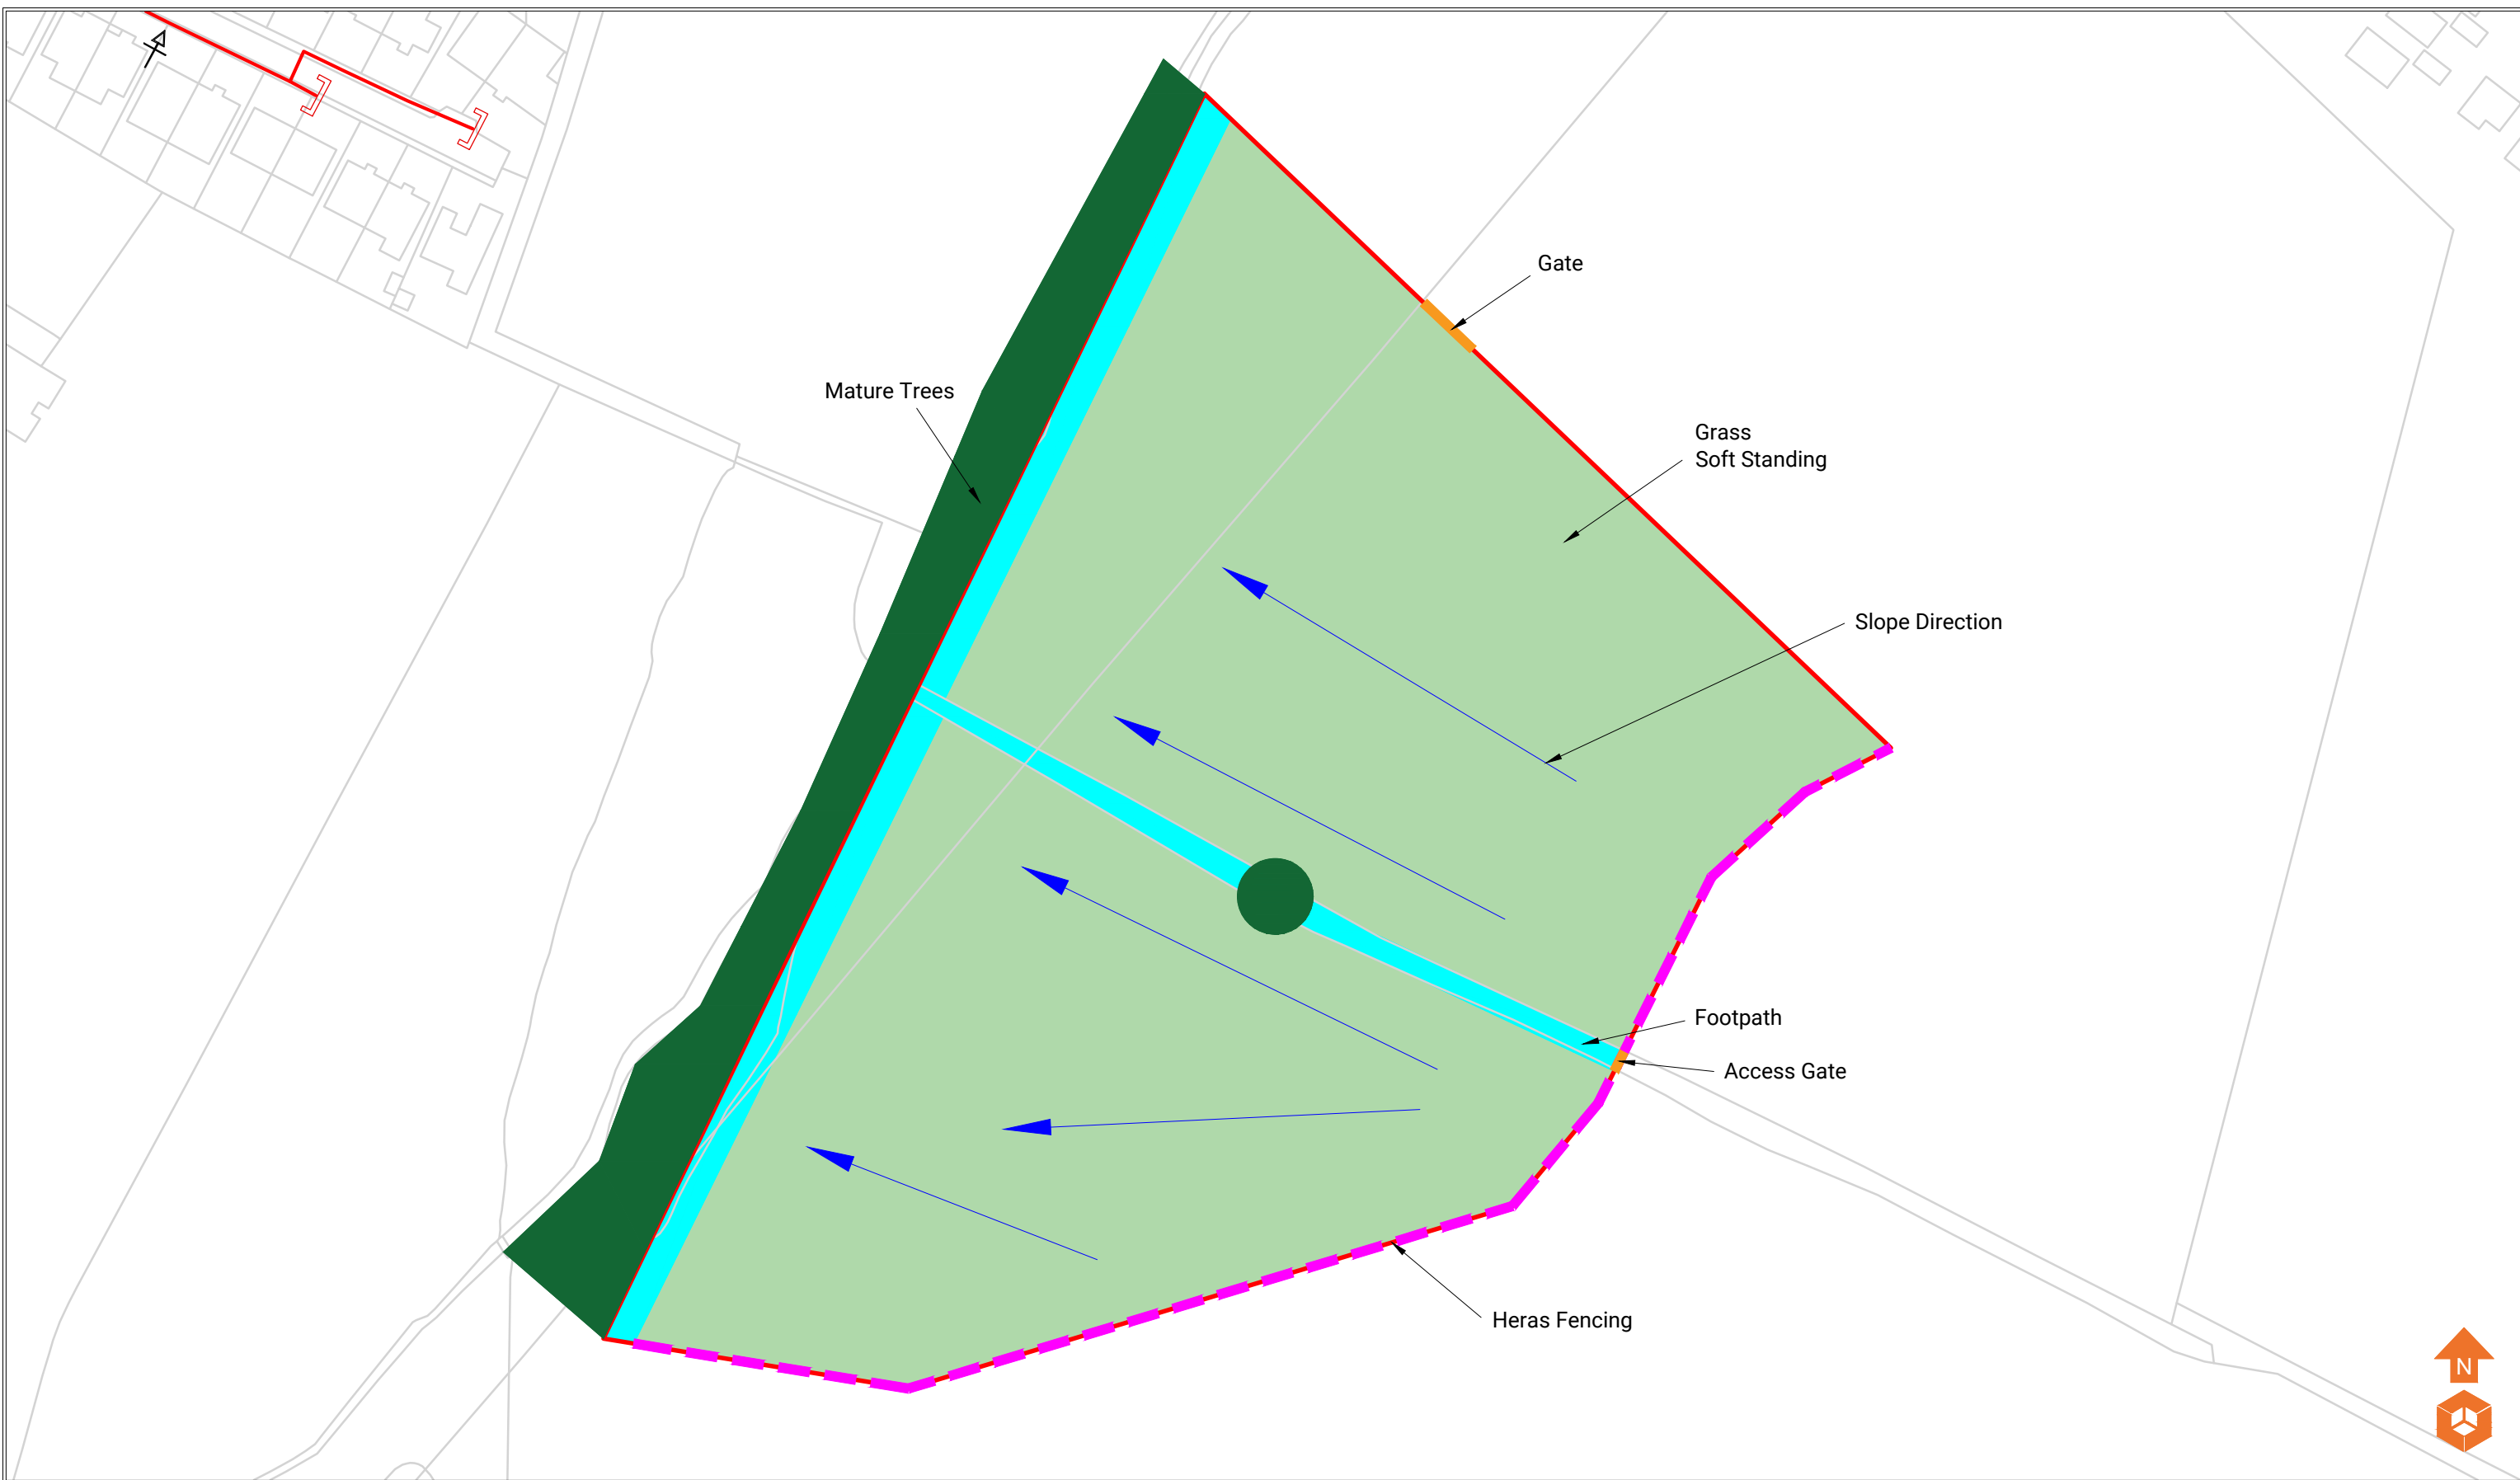
Drawing Title:
Site Features Plan

Site Features

- Soft Standing
- Mature Trees
- Footpath
- Heras Fencing
- Gate
- Slope Direction

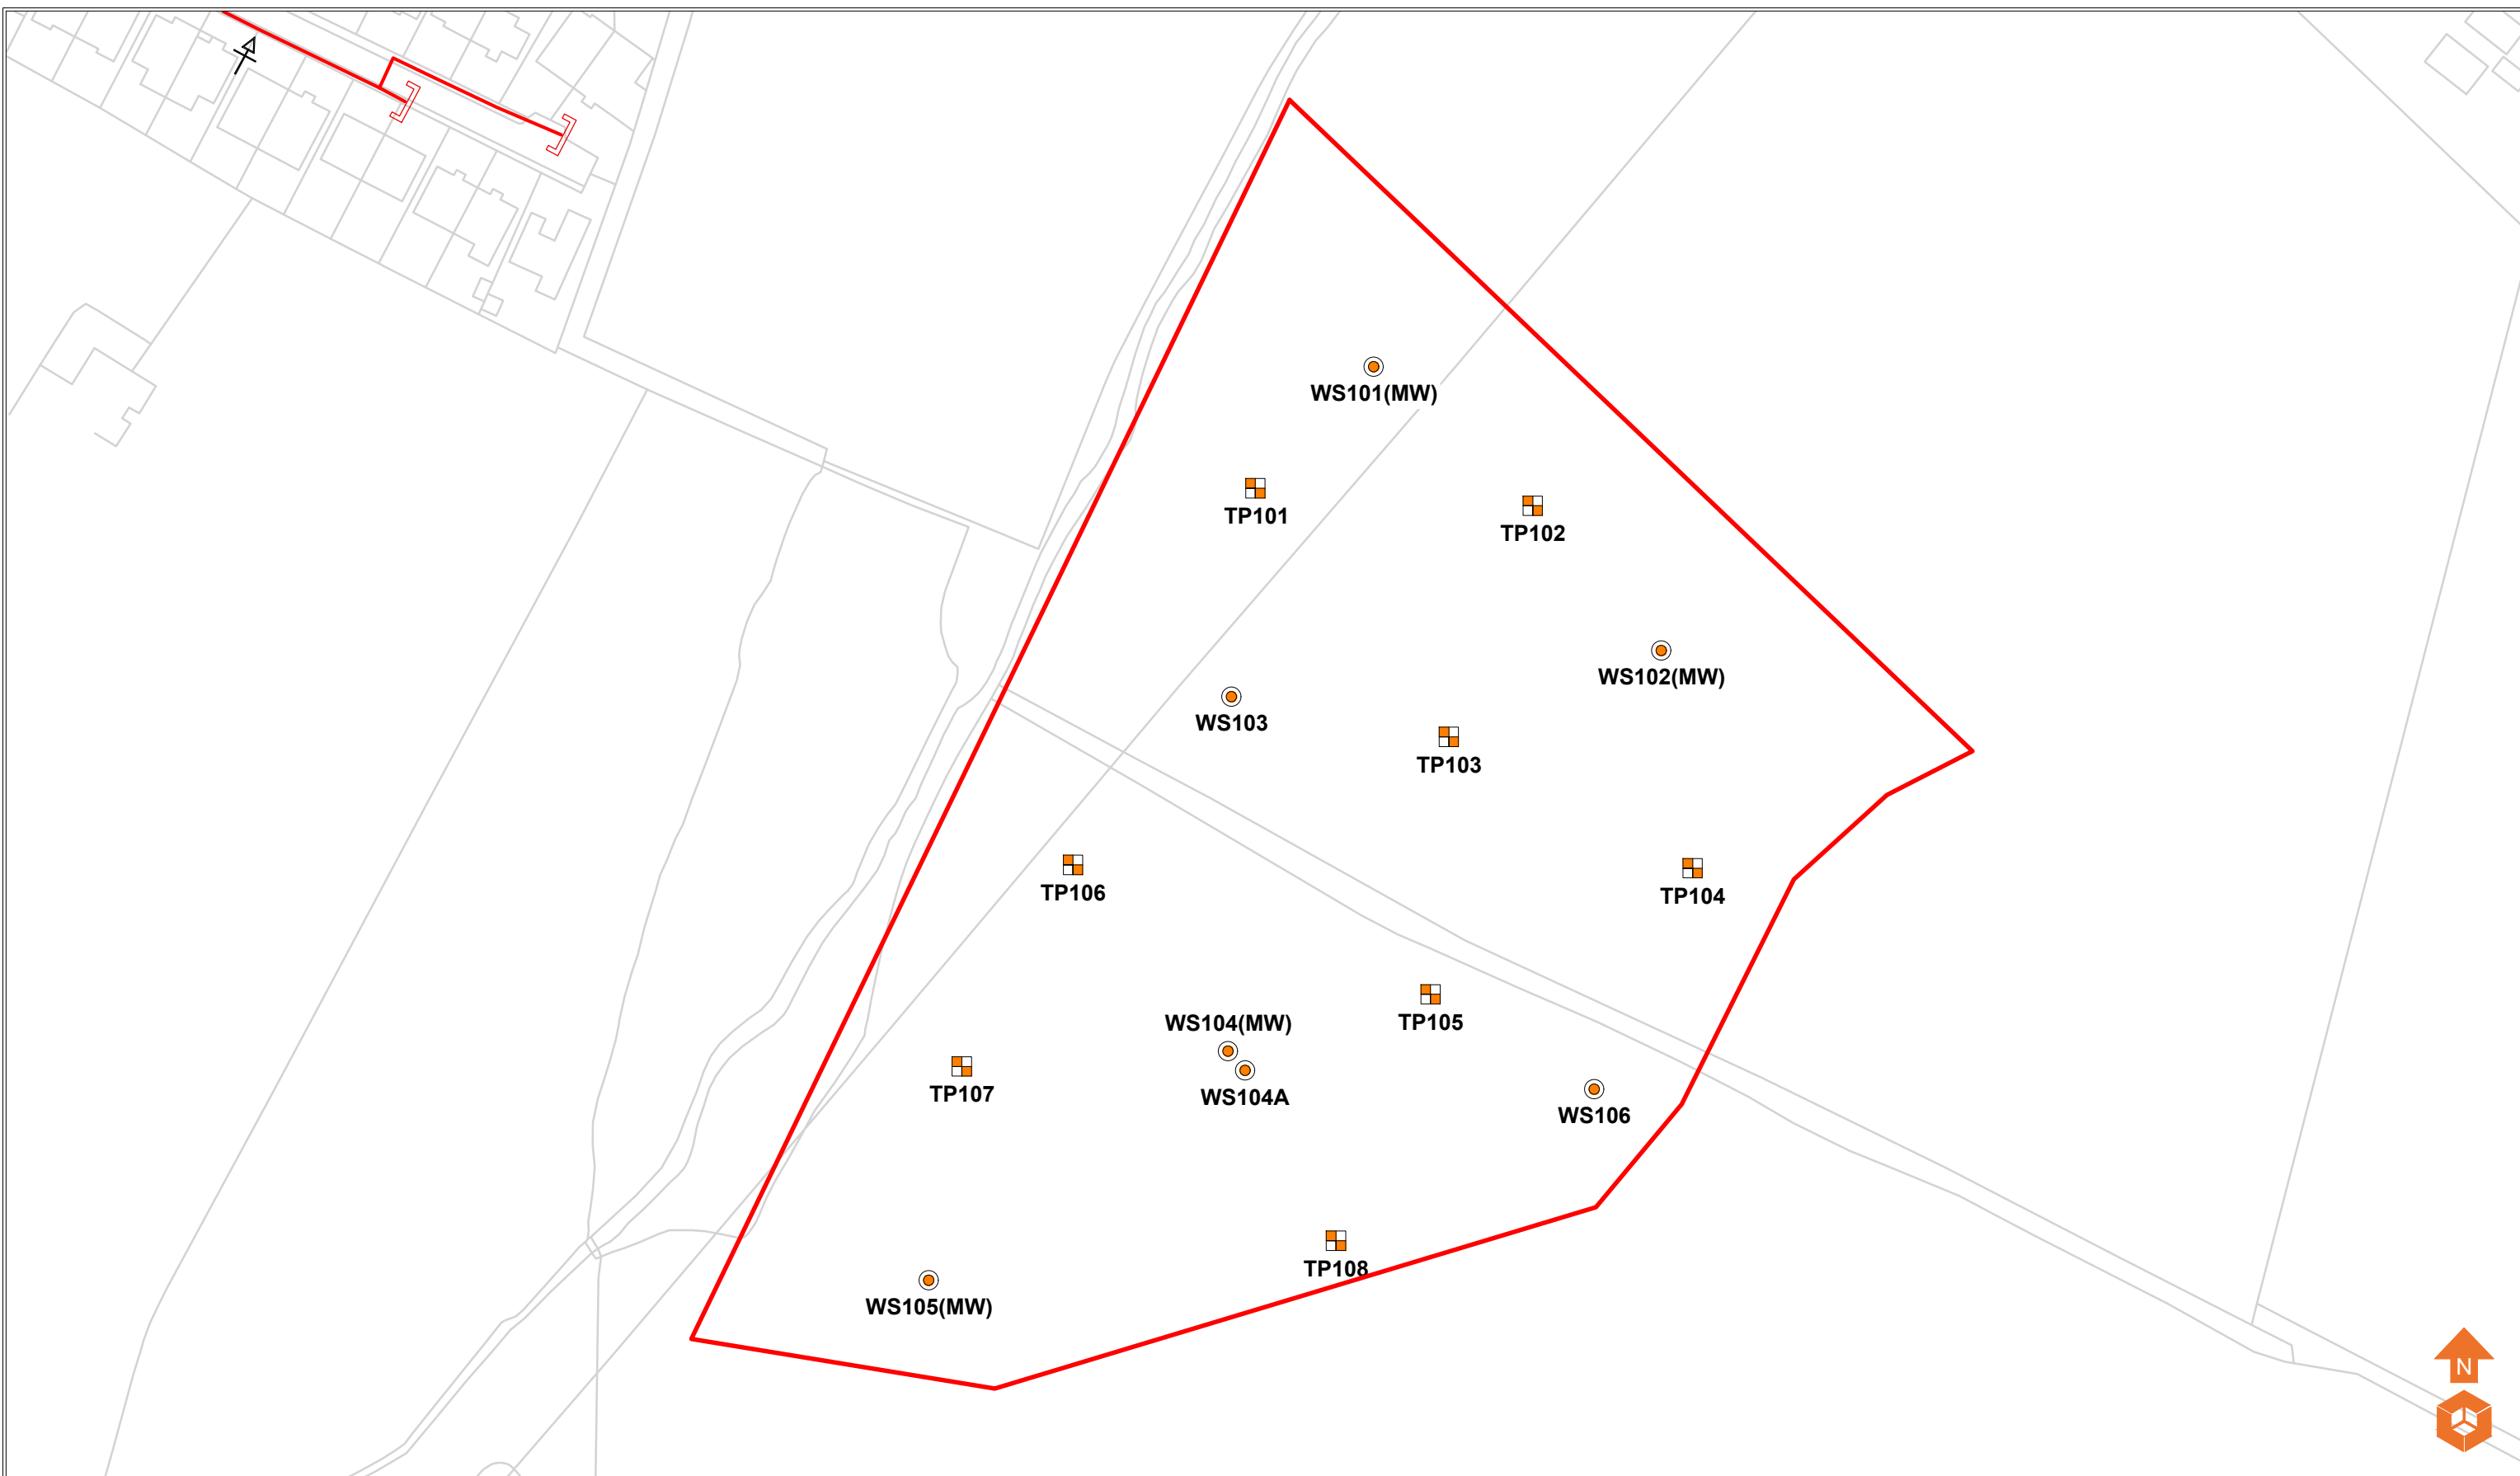
Drawing Title:
Exploratory Hole Location Plan

- Location Symbols**
- Approximate Window Sample Probehole Location (E3P Locations 2024)
 - Approximate Window Sample Probehole Location with Install (E3P Locations 2024)
 - Approximate Trial Pit Location (E3P Locations 2024)

The sampling locations are illustrated in Drawing 17-912-006 (APPENDIX IV). The ground conditions encountered are indicated on the logs, which are provided in APPENDIX VI.

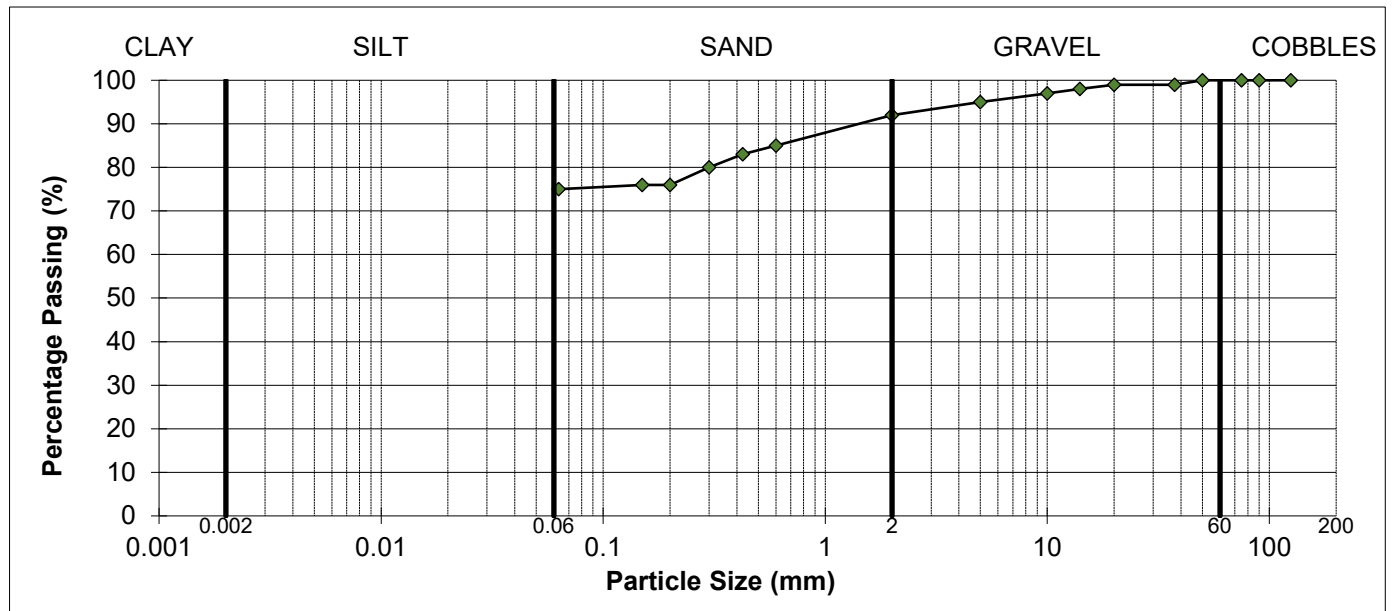
MATERIAL	Brown silty slightly sandy slightly gravelly CLAY
ADVISED SOURCE	Site Investigation Sample

Sieve Size (mm)	% Passing (%)	Specification (%)	Sieve Size (mm)	% Passing (%)	Specification (%)
125	100	100	5	95	
90	100		2	92	80-100
75	100		0.6	85	
50	100		0.425	83	
37.5	99		0.3	80	
20	99		0.2	76	
14	98		0.15	76	
10	97		0.063	75	15-100

SOIL FRACTIONS			
COBBLES	0%	SAND	17%
GRAVEL	8%	SILT / CLAY	75%
As received water content		22.2%

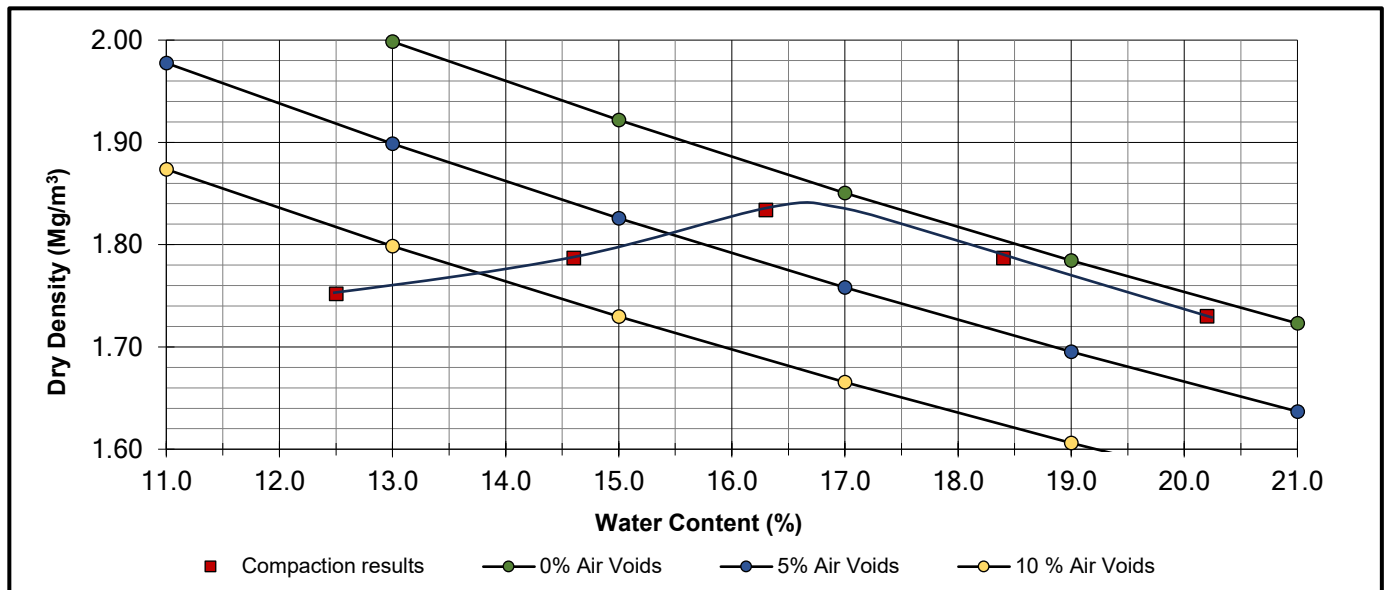
POINT NUMBER	WATER CONTENT (%)	DRY DENSITY (Mg/m ³)
1	12.5	1.752
2	14.6	1.787
3	16.3	1.834
4	18.4	1.787
5	20.2	1.730

OPTIMUM WATER CONTENT	17	(%)
MAXIMUM DRY DENSITY	1.84	(Mg/m ³)

The proctor compaction tests have indicated that the materials on site are variable with the material in TP103 being wet of the optimum. It should be noted that if this material is excavated for use in a cut/fill operation careful consideration should be taken in the stabilisation of this material.

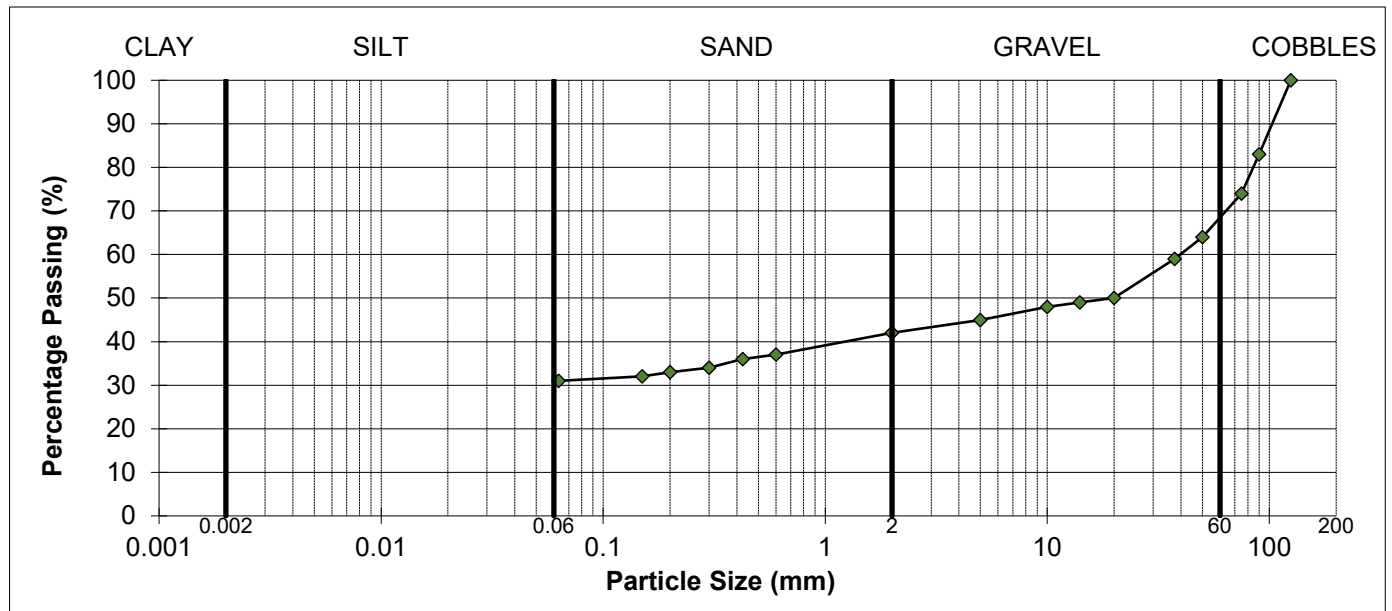
MATERIAL	Brown silty slightly sandy very gravelly CLAY
ADVISED SOURCE	Site Investigation Sample

Sieve Size (mm)	% Passing (%)	Specification (%)	Sieve Size (mm)	% Passing (%)	Specification (%)
125	100	100	5	45	
90	83		2	42	15-80
75	74		0.6	37	
50	64		0.425	36	
37.5	59		0.3	34	
20	50		0.2	33	
14	49		0.15	32	
10	48		0.063	31	15-80

SOIL FRACTIONS			
COBBLES	31%	SAND	11%
GRAVEL	27%	SILT / CLAY	31%
As received water content		8.8%

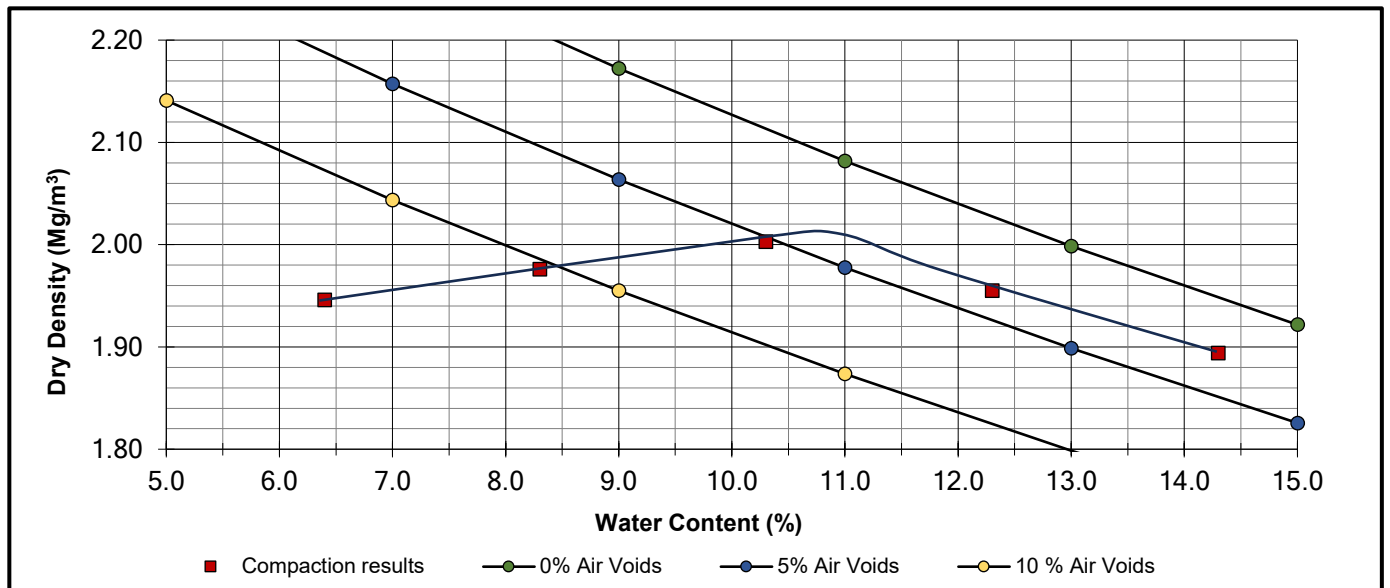
POINT NUMBER	WATER CONTENT (%)	DRY DENSITY (Mg/m ³)
1	6.4	1.946
2	8.3	1.976
3	10.3	2.003
4	12.3	1.955
5	14.3	1.894

OPTIMUM WATER CONTENT	11	(%)
MAXIMUM DRY DENSITY	2.01	(Mg/m ³)

LOCATION	LABORATORY DESCRIPTION	TOP DEPTH (M)	METHOD OF COMPACTION	INITIAL MOISTURE CONTENT (%)	OPTIMUM MOISTURE CONTENT (%)	MATERIAL RETAINED ON 37.5 MM SIEVE (%)	MAX DRY DENSITY (MG/M ³)	MATERIAL RETAINED ON 20.0 MM TEST SIEVE (%)
TP103	Silty slightly sandy slightly gravelly CLAY	0.50	4.5kg	22.2	17	1	1.84	1
TP107	Silty slightly sandy very gravelly CLAY	1.50	4.5kg	8.8	11	41	2.01	50

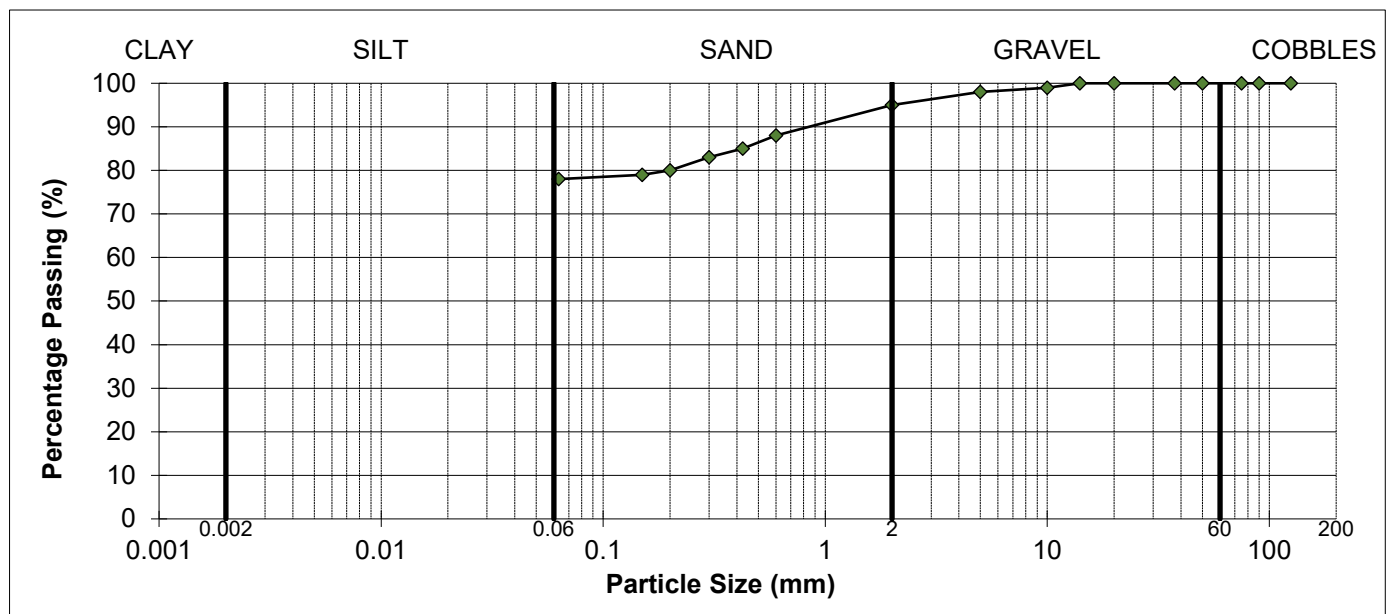
MATERIAL	Brown silty slightly sandy slightly gravelly CLAY
ADVISED SOURCE	Site Investigation Sample

Sieve Size (mm)	% Passing (%)	Specification (%)	Sieve Size (mm)	% Passing (%)	Specification (%)
125	100	100	5	98	
90	100		2	95	80-100
75	100		0.6	88	
50	100		0.425	85	
37.5	100		0.3	83	
20	100		0.2	80	
14	100		0.15	79	
10	99		0.063	78	15-100

SOIL FRACTIONS			
COBBLES	0%	SAND	17%
GRAVEL	5%	SILT / CLAY	78%
As received water content		26.3%

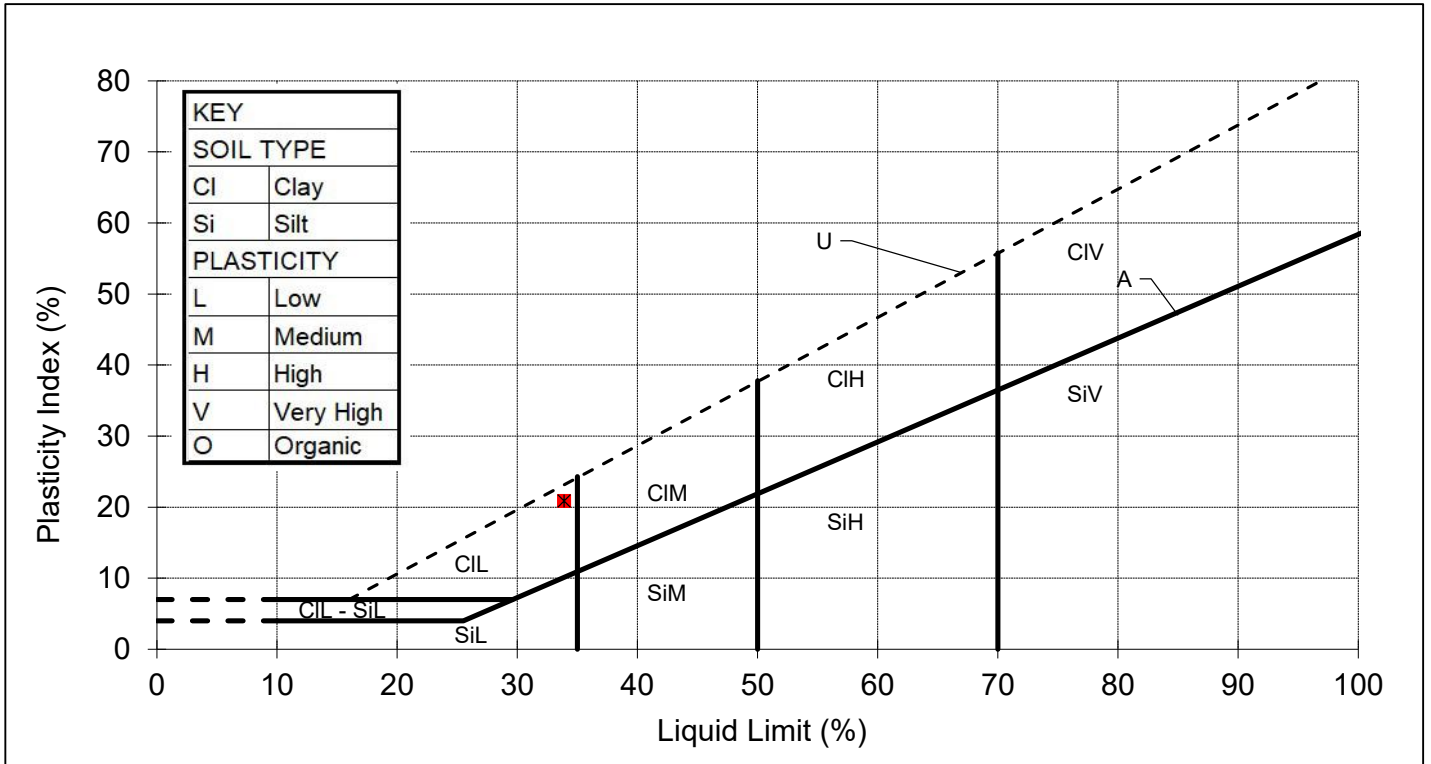
Test Readings mm (average)	Water Content %	Correction Factor	Correction factor from Clayton and Jukes 1978	
Determination 1 (avg)	18.6	33.2		1.023
Determination 2 (avg)	18.4	33.1

Natural Water Content (%)	Liquid Limit (%)	Plastic Limit (%)	Plasticity Index (%)	Passing 425 micron (%)
15.2	34	13	21	86

LOCATION	DEPTH (m)	NATURAL MOISTURE CONTENT (%)	PLASTIC LIMIT (%)	LIQUID LIMIT (%)	PLASTICITY INDEX (%)	PASSING 425 MM SIEVE (%)	MODIFIED PLASTICITY INDEX	NHBC VOLUME CHANGE POTENTIAL
WS101	1.00 – 1.45	15.2	13	34	21	86	18.06	Low
WS102	2.00 – 2.45	26	18	32	14	99	13.86	Low
WS106	1.00 – 1.45	14	13	30	17	90	15.3	Low

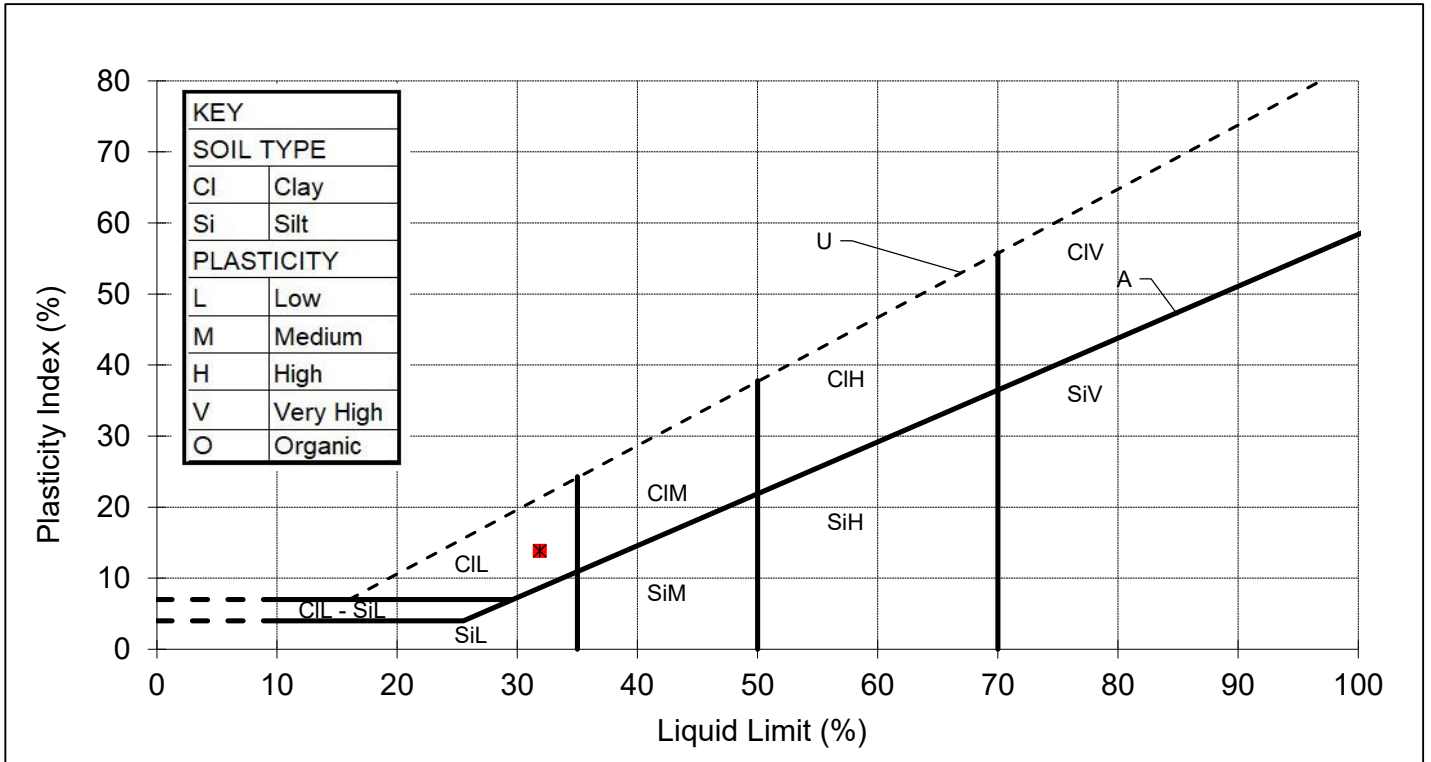
Test Readings mm (average)	Water Content %	Correction Factor	Correction factor from Clayton and Jukes 1978	
Determination 1 (avg)	21.9	32.9		0.973
Determination 2 (avg)	21.8	32.6

Natural Water Content (%)	Liquid Limit (%)	Plastic Limit (%)	Plasticity Index (%)	Passing 425 micron (%)
26.0	32	18	14	99

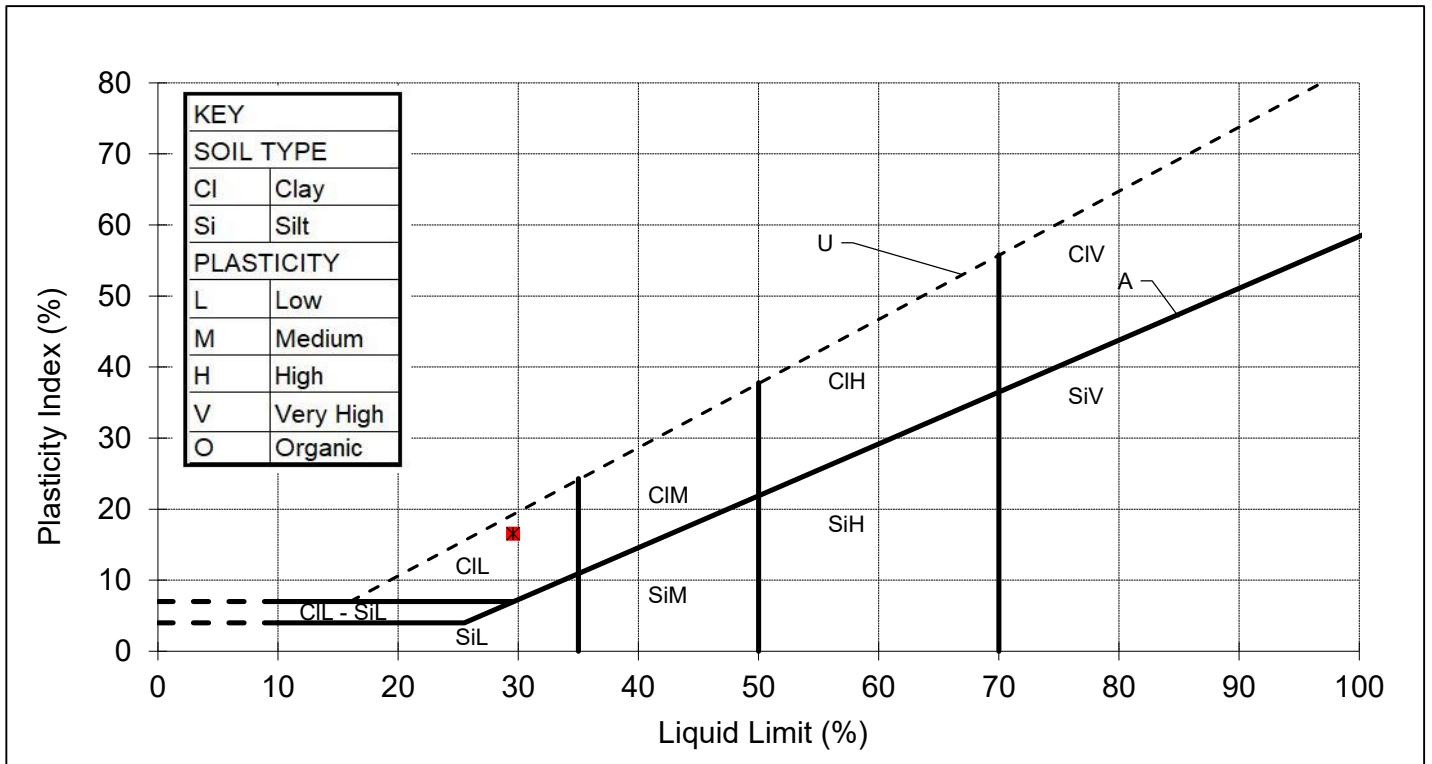
Test Readings mm (average)	Water Content %	Correction Factor	Correction factor from Clayton and Jukes 1978	
Determination 1 (avg)	20.0	29.6		1.000
Determination 2 (avg)	20.0	29.5

Natural Water Content (%)	Liquid Limit (%)	Plastic Limit (%)	Plasticity Index (%)	Passing 425 micron (%)
14.0	30	13	17	90

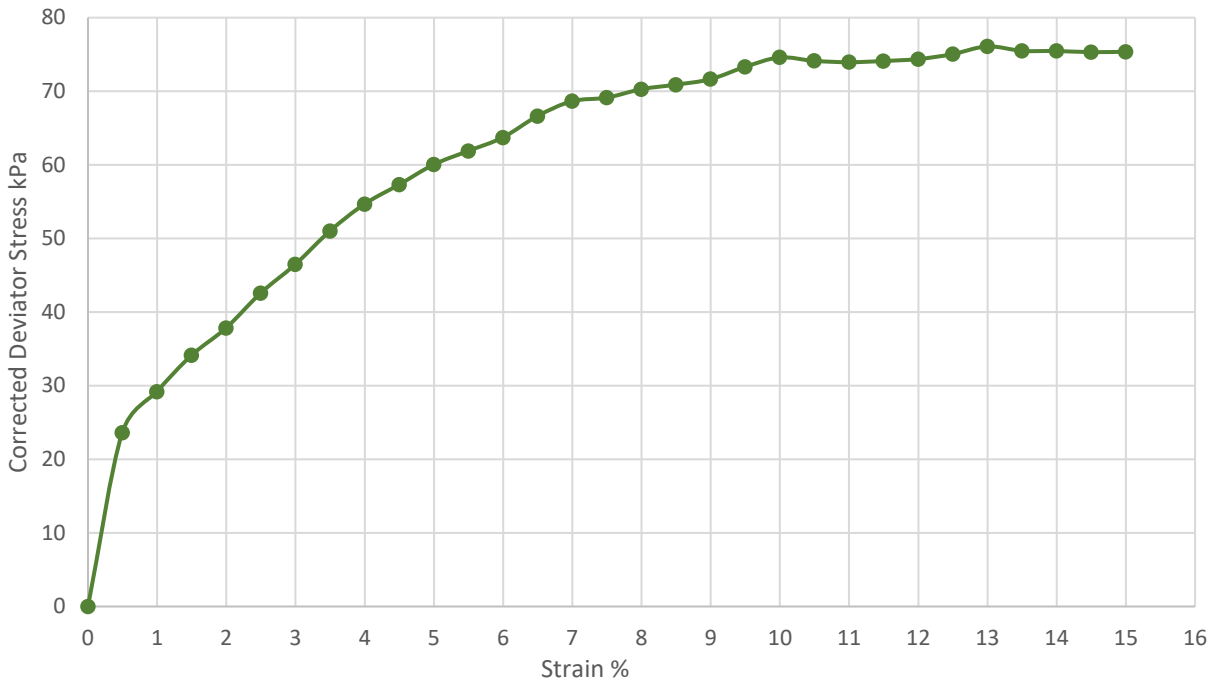
CORRECTED DEVIATOR STRESS vs AXIAL STRAIN

Specimen Location		Sample Length (mm)	450	Specimen depth from top of Sample (mm)	70
		Sample Orientation	Vertical	Specimen Condition	Undisturbed
		Specimen Length (mm)	164	Specimen Water Content (%)	13.5
		Specimen Diameter (mm)	86	Specimen Bulk Density (Mg/m3)	2.13
		Membrane Thickness (mm)	0.4	Specimen Dry Density (Mg/m3)	1.88
		Membrane Correction	3.39

TEST TYPE
SINGLE STAGE
