SITE INVESTIGATION & GROUND ASSESSMENT

LAND TO SOUTH OF ACCRINGTON ROAD **WHALLEY, CLITHEROE**

Report Ref BEK-19545-2 (Rev C)

Land to South of Accrington Road, Whalley

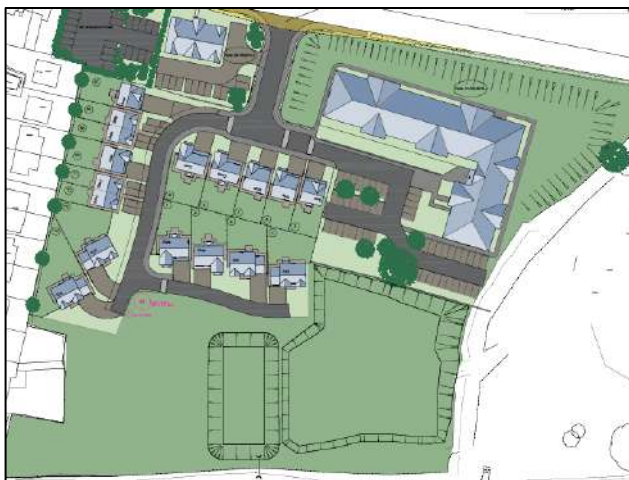
Figure 1: Development Layout

1.2.1 This report has been prepared to support a planning application for the construction of residential houses and apartments with associated gardens, access and infrastructure, see Figure 1 below:

1.2.2 The full development layout is presented on Drawing No 015/R-OAK/01 Revision G, titled 'Reduced Development Proposal', dated November 2022, a copy of which is presented in Appendix D.

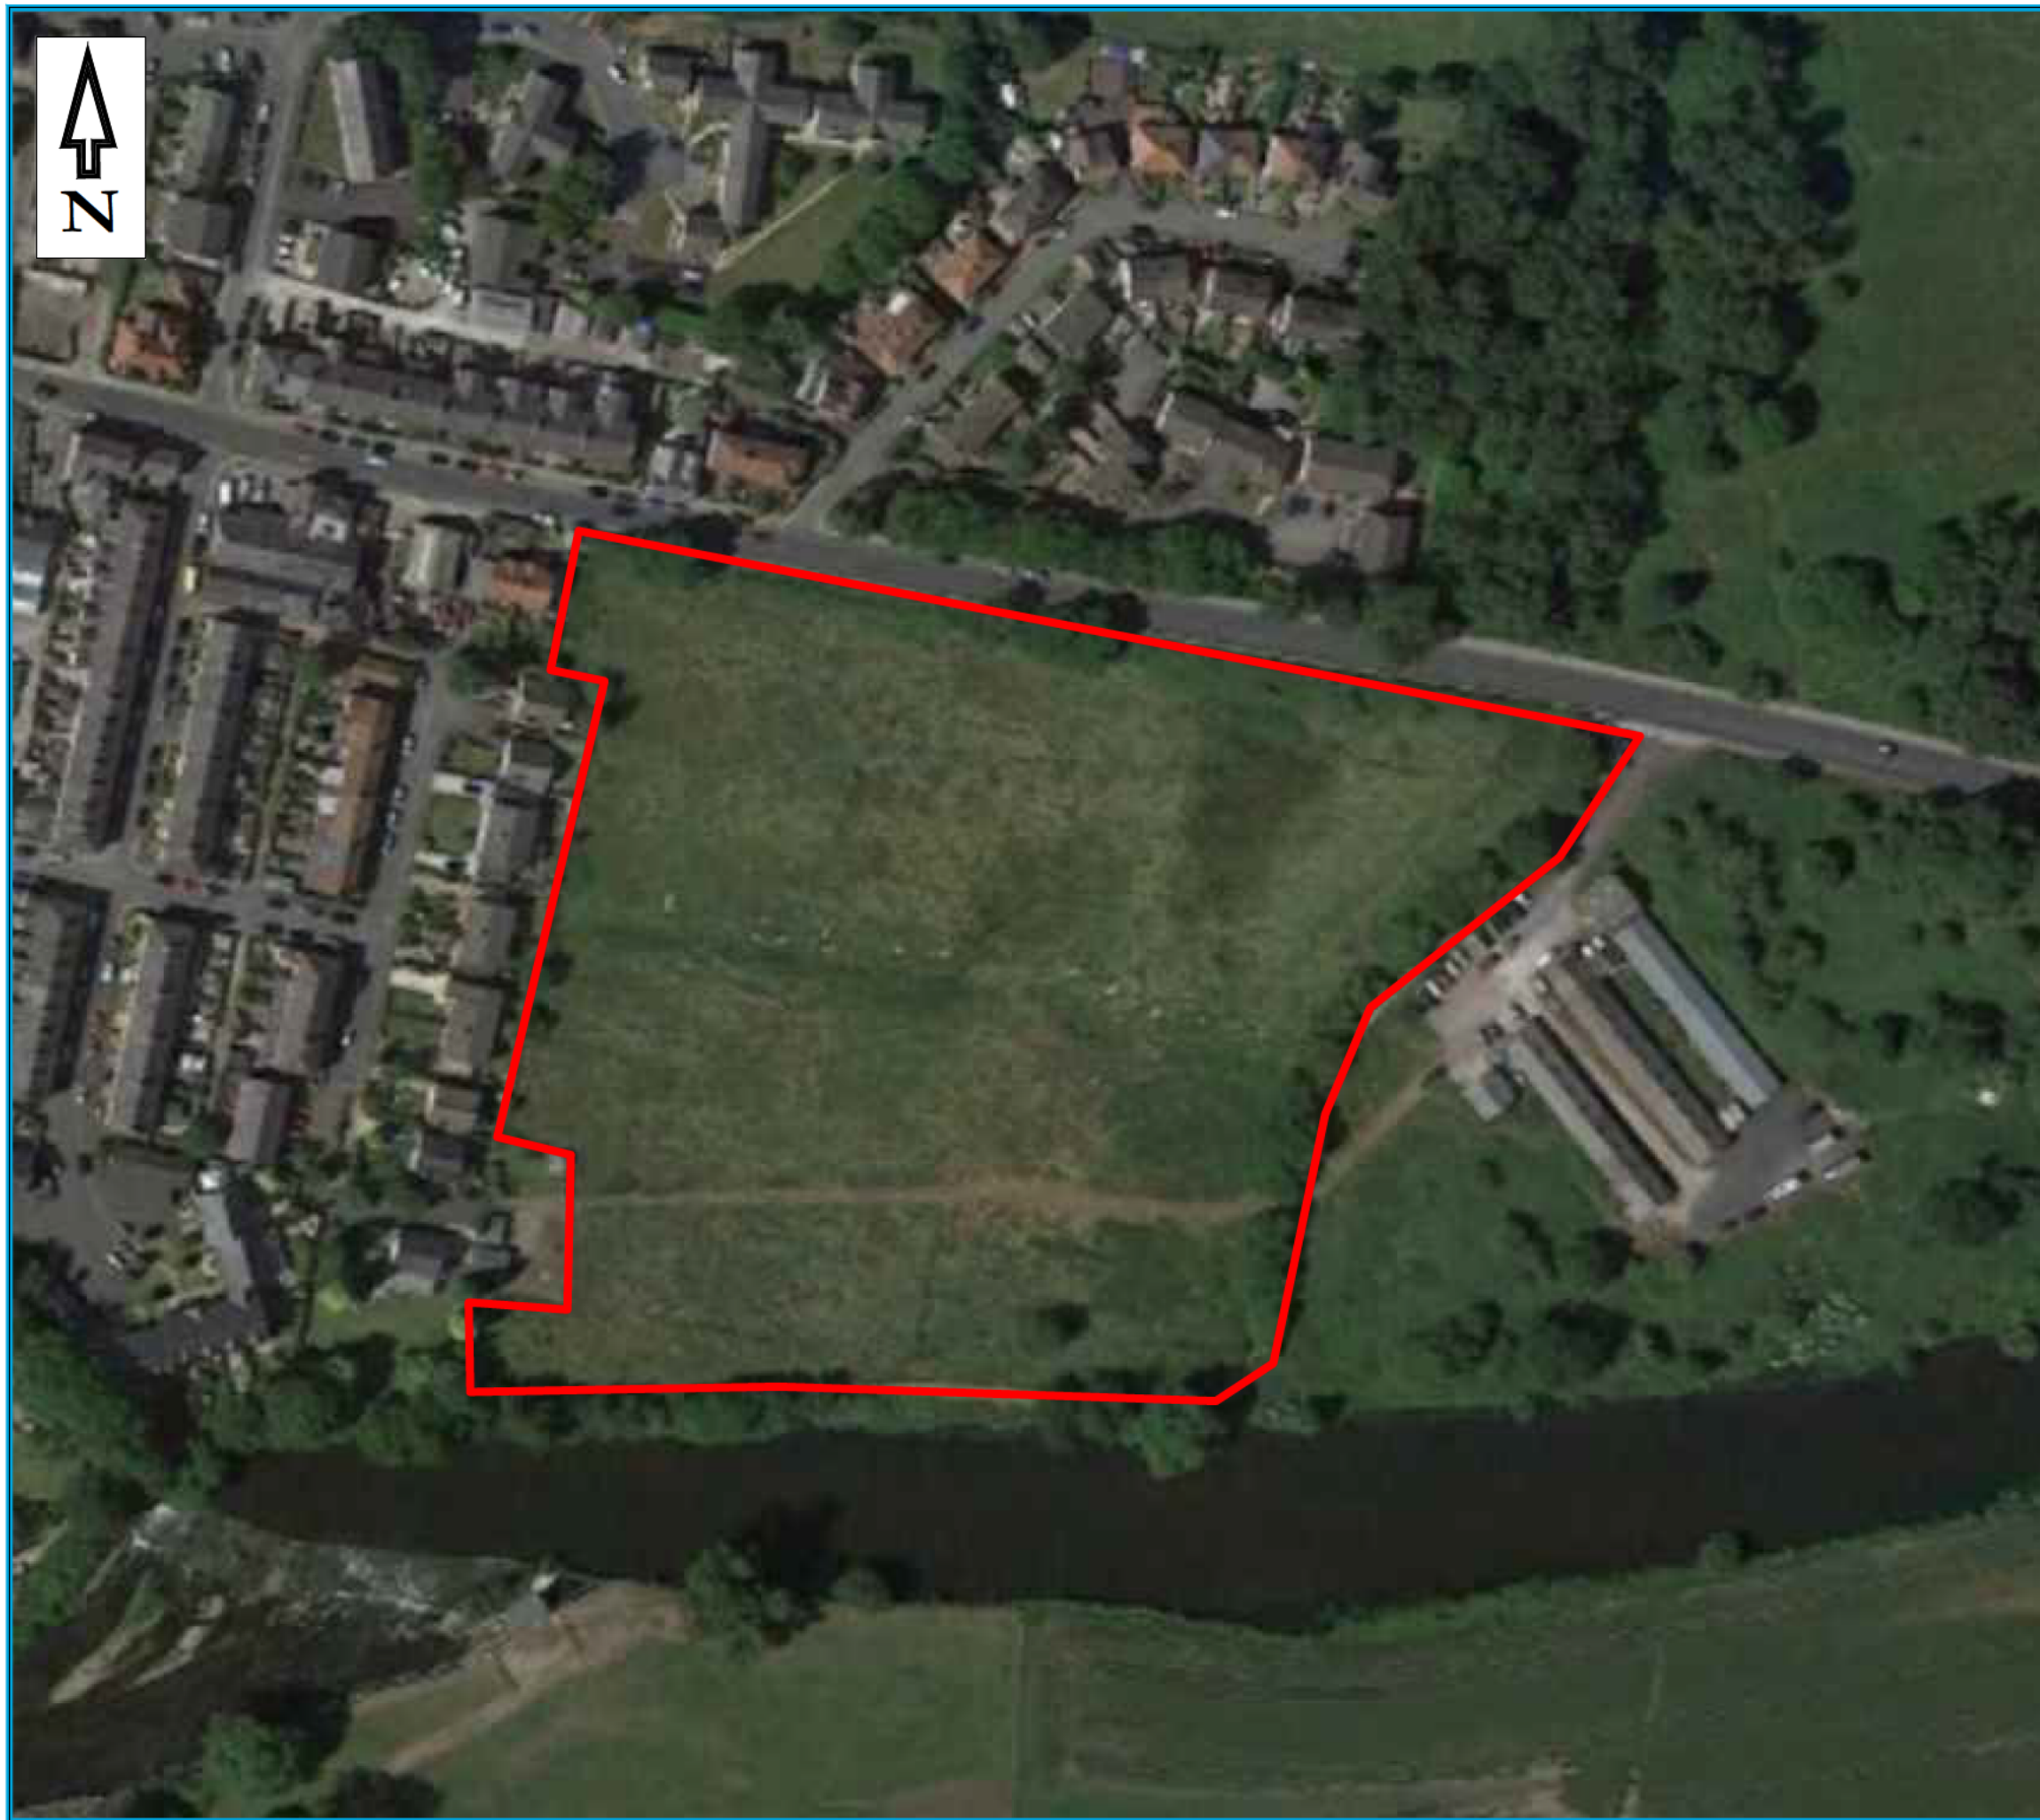
DRAWING No. 19545-2	REV. -
------------------------	-----------

1.1.4 The site location and site layout are presented on BEK Drawing No 19545-1 and BEK Drawing No 19545-2, respectively. Copies of these drawing are presented in Appendix D.

2.2.1 The site occupies some 2.84 hectares (28,400 m²) and is roughly square in shape, comprising undeveloped open scrub land covered by medium to large grass and shrubs with frequent marshy/boggy areas. There is an embankment in the north east corner.

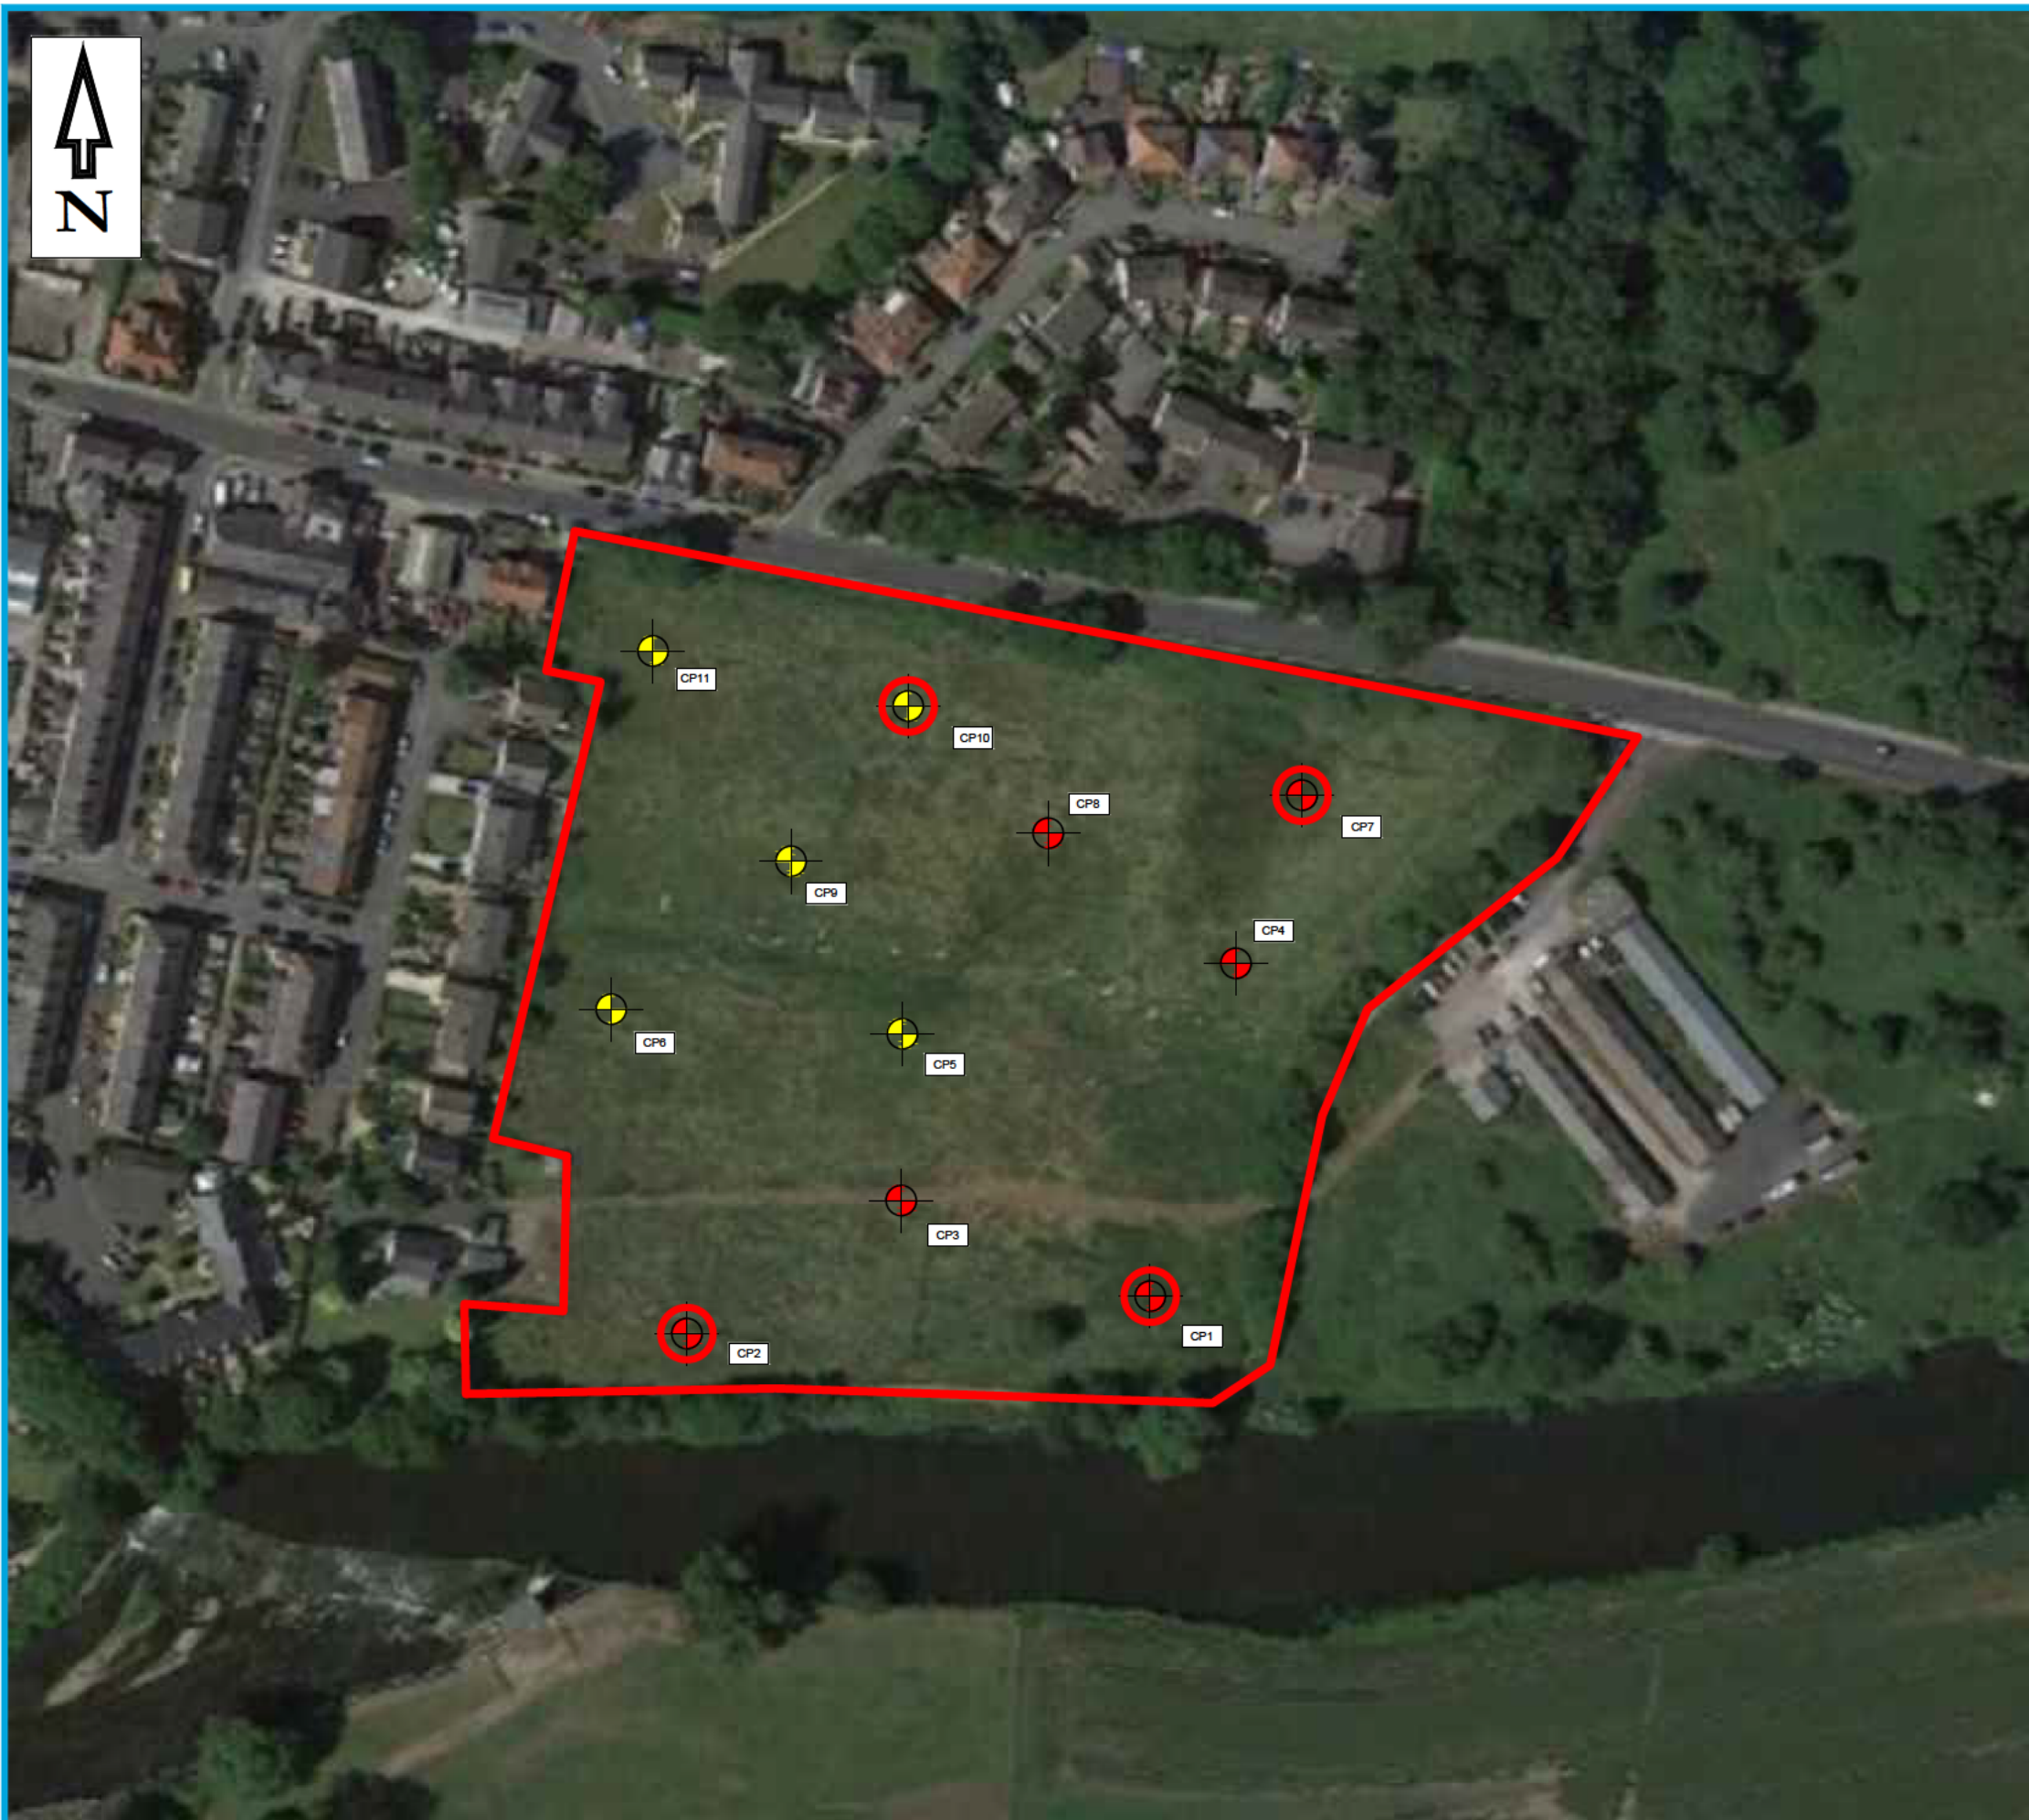
SCALE © A3. NTS	DRAWN BY. D.E.	APPROVED BY. M.B.	DATE. 10/07/19
DRAWING No. 19545-3			REV. -

- 3.2.1 Eleven cable percussion boreholes were drilled across the site with 6 boreholes being drilled to 25 m and 5 boreholes drilled to 10 m bgl.
- 3.2.2 In-situ testing (Standard Penetrations Tests (SPTs) were carried out as the drilling progressed. The ground conditions were recorded by an engineer from BEK and representative samples were recovered for chemical and geotechnical testing
- 3.2.3 Copies of the borehole records are presented in Appendix A and a borehole Location Plan is presented in Appendix D. The SPT results are presented on the borehole records.
- 3.2.4 All exploration locations were set out by the site engineer and the exploratory locations are illustrated on BEK Drawing No 19545-3 presented in Appendix D.

CABLE PERCUSSIVE BOREHOLE LOCATION PLAN

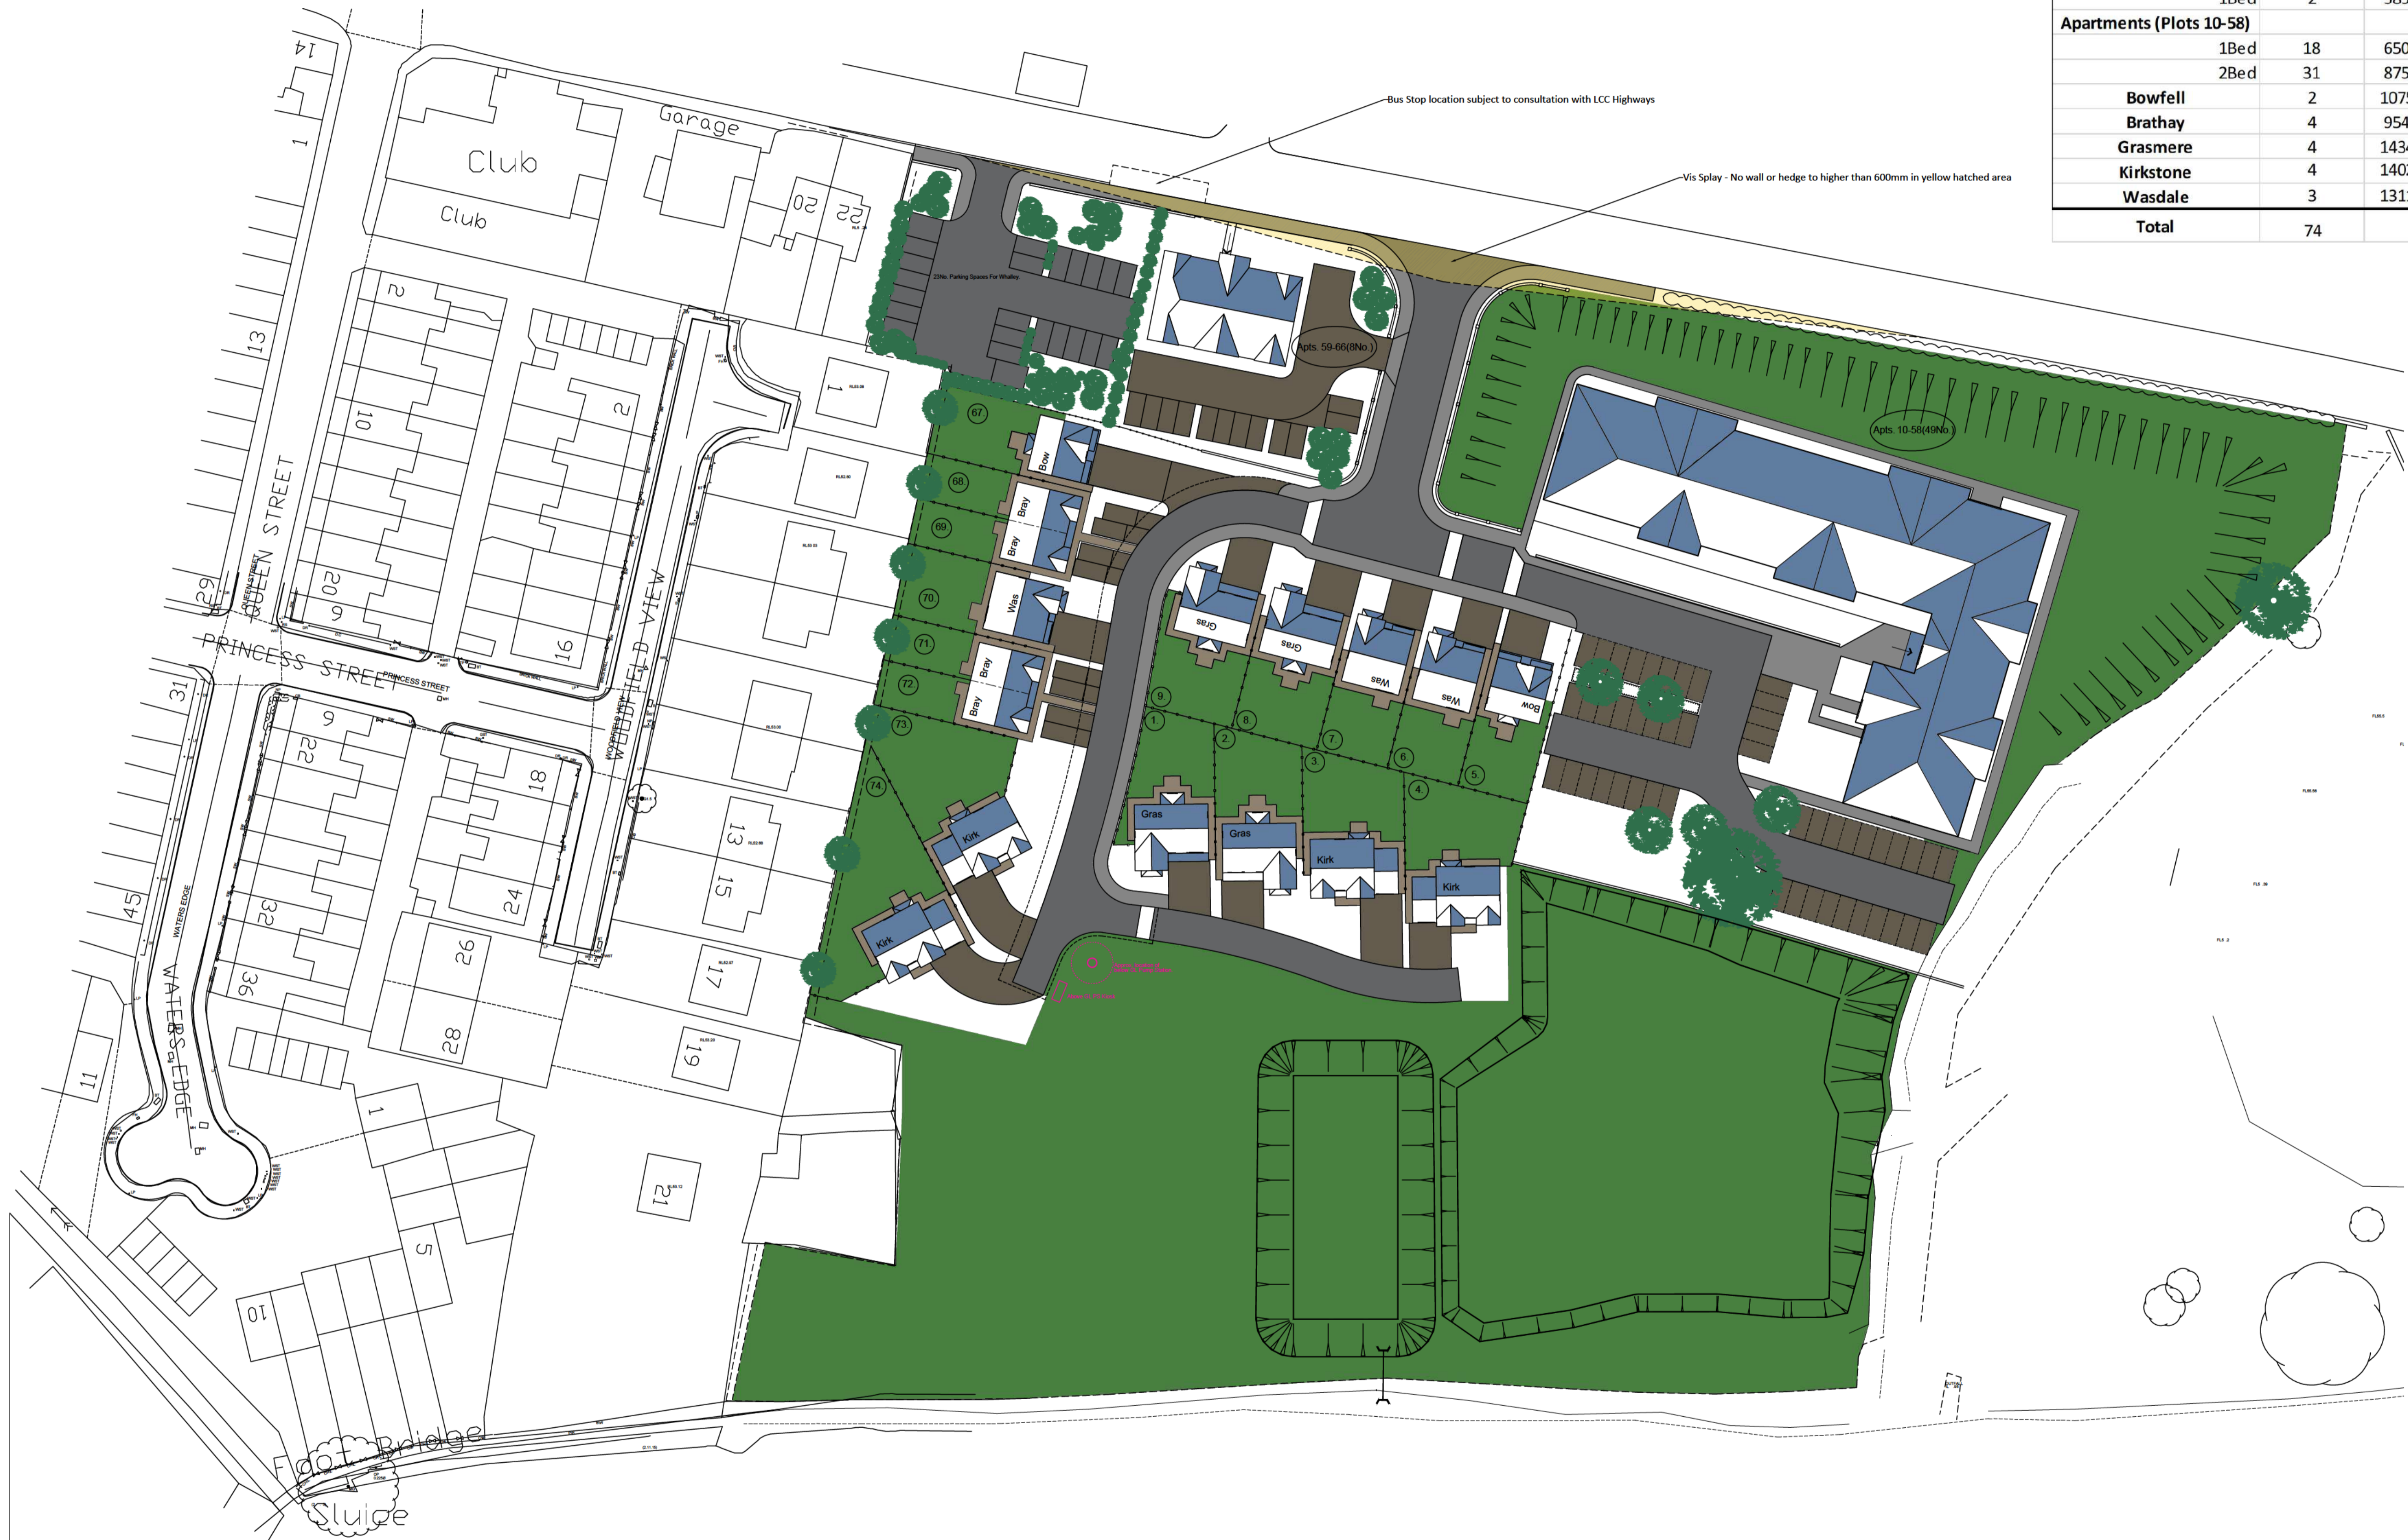
REVISION
G

- G 29/11/22 - Roof layouts on the apartments updated to match house type drawings.
- F 31/10/22 - Pump station added and banking indicated around apartment.
- E 18/10/22 - Layout completed following receipt of engineering data.
- D 22/09/22 - Further redesign following internal discussion.
- C 14/09/22 - Scheme redesigned following flood modelling.
- B 12/07/22 - Scheme redesigned as a single phase. -Public car park accessed off Accrington Road added.
- A 06/08/20 - Apartments over Garages footprint amended -Housing schedule amended for GAR(APTS) -Parking and paths for GAR-(APTS) amended
