## **Outbuildings at Fooden Hall**

### **Bat Report**

| <b>Document:</b> | <b>BOW17.1608 Outbuildings at Fooden Hall Bat Report<br/>August 2024</b> | | | |

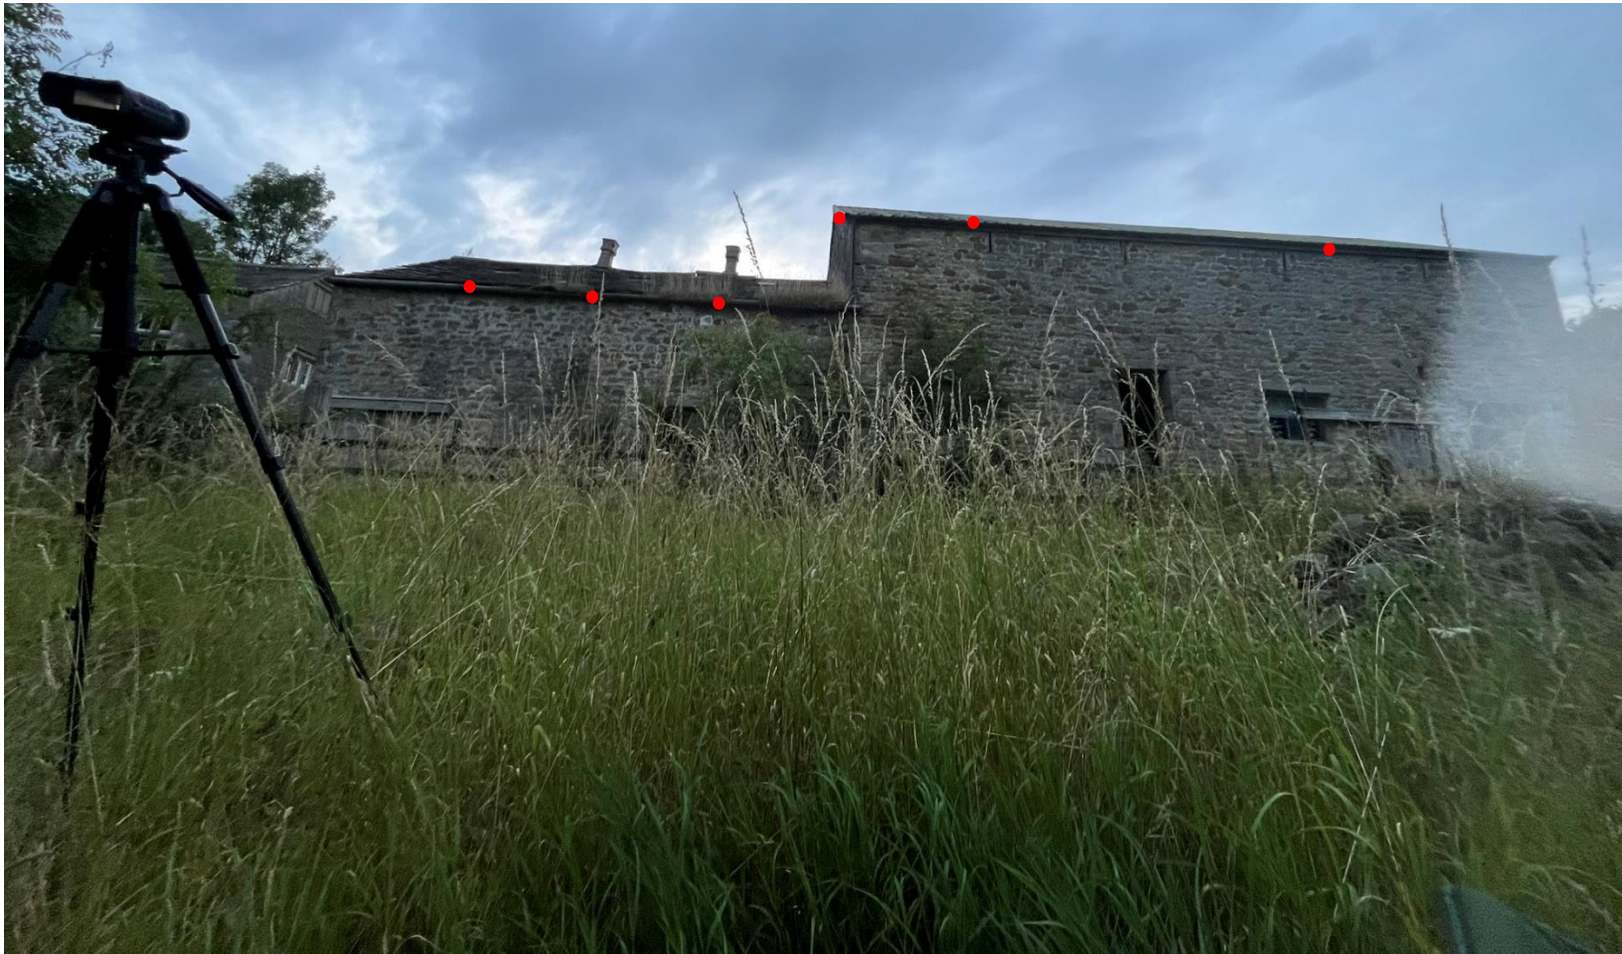
## Appendix C – Roost Plan

- 3.39 In summary, bats were observed emerging from six points overall, three points on building 1 and three points on building 2. The locations are highlighted on the plan in Appendix B and a photograph with emergence points highlighted is provided in Appendix C. A summary of the six emergence points is provided below:

● Emergence Point

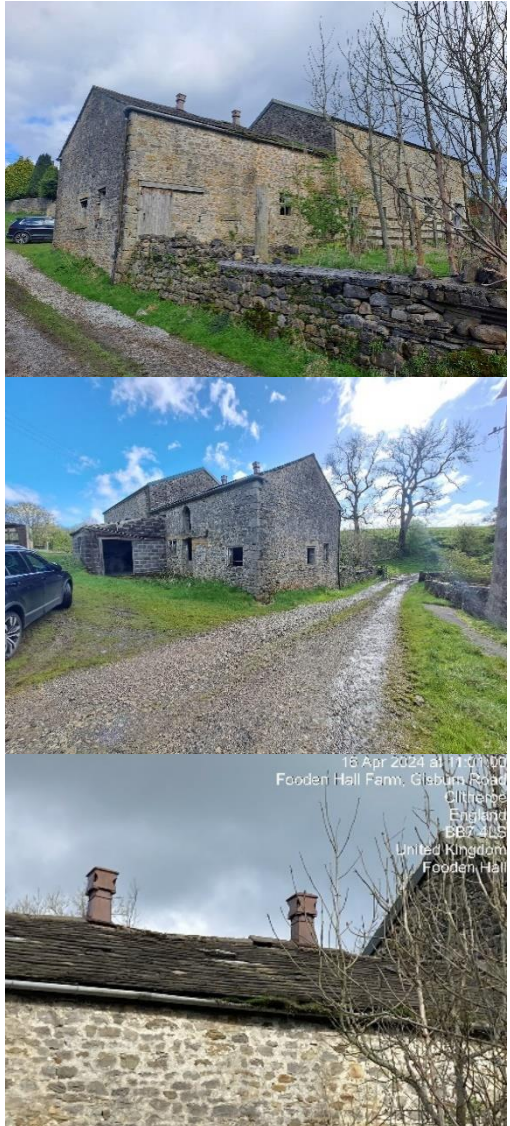
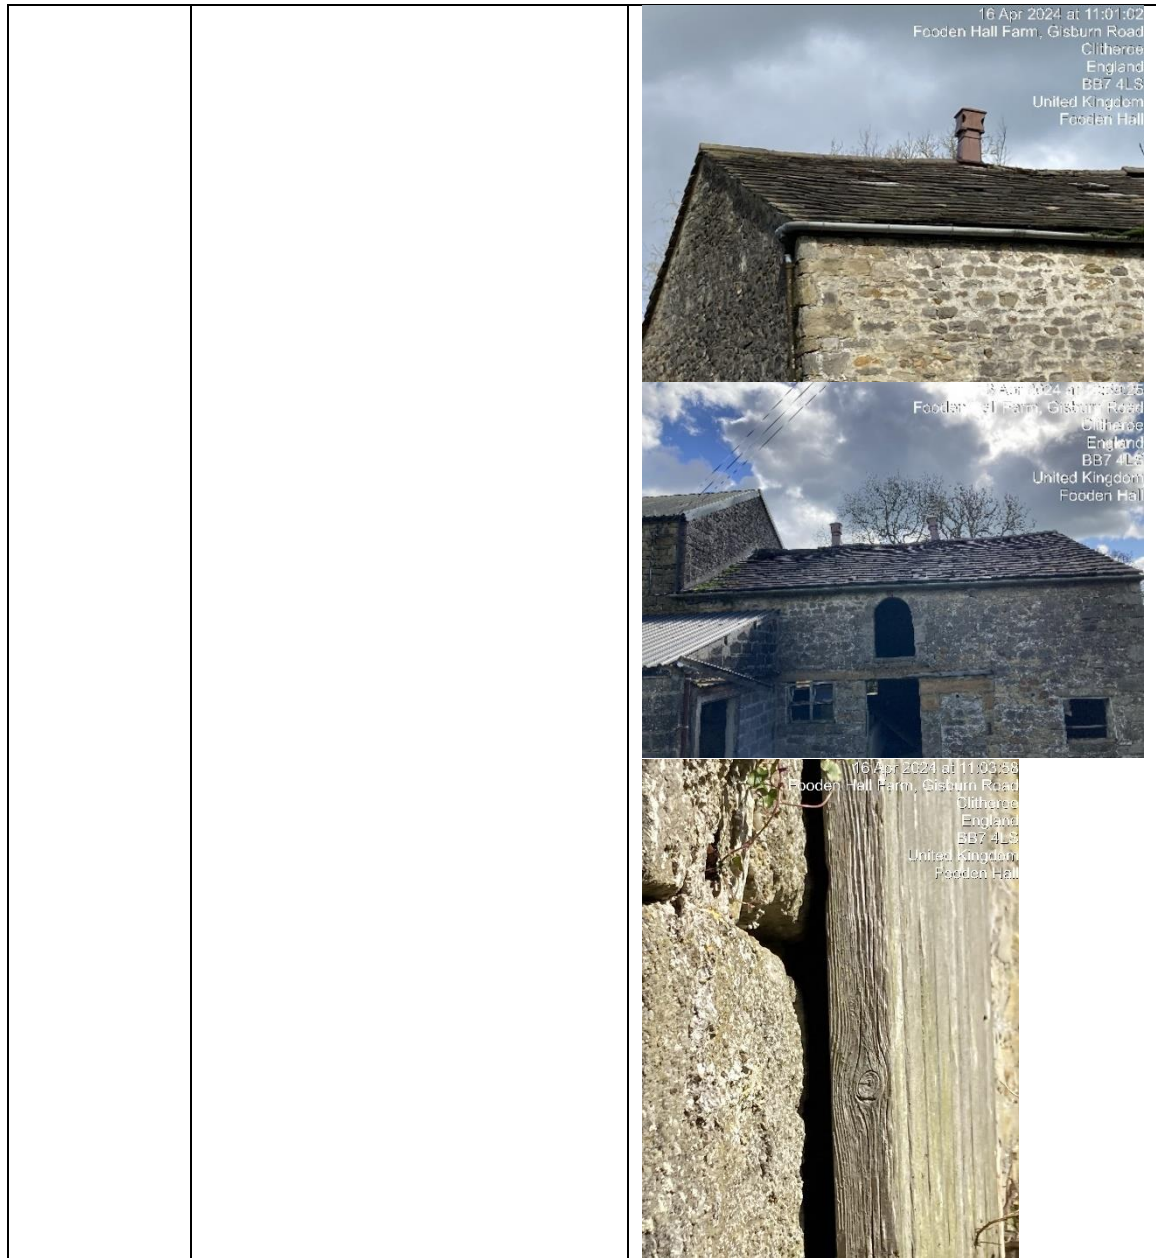
| Feature | Description | Photograph |
|---|---|---|
| Small Barn (external) | <p>The main barn is made up of two buildings. The smaller of the two is joined to the larger on its northeastern aspect. It is a stone two-story building with a tile roof. There are no barge boards/soffits, however there are gutters on the southeast and northwest aspects. There are unsealed windows and doors into the building, as well as some sealed with wood. PRF's include lifted tiles, gaps behind wooden fittings and gaps between the walls and roof. The building was assessed to be of moderate potential for bats. During the emergence surveys, bats were seen emerging from beneath the eaves on the southeast aspect, and a barn owl was seen emerging from the open arched window on the northwestern aspect.</p> | <p>15 Apr 2024 31:11:00 UTC<br/>Fooden Hall Farm, Gisburn Road<br/>Clitheroe<br/>England<br/>BB7 4LS<br/>United Kingdom<br/>Fooden Hall</p> |

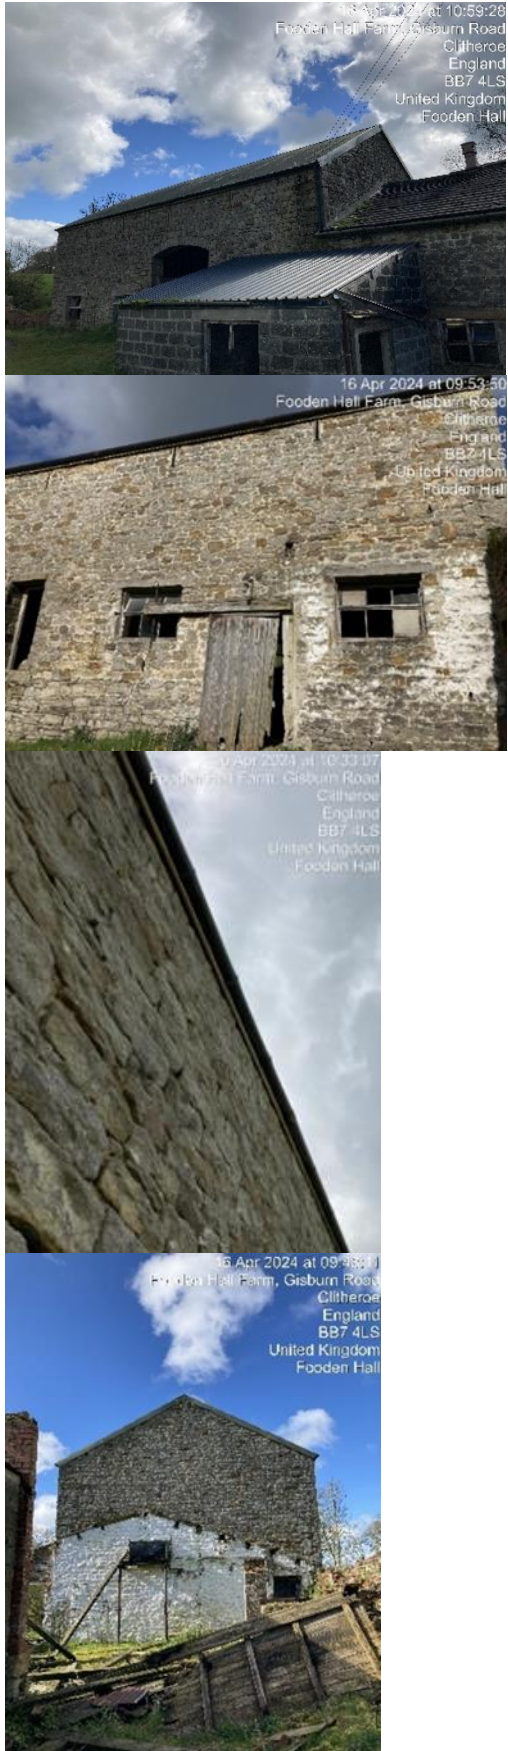
| <p>Large Barn</p> | <p>The larger barn is similar construction to the smaller barn, however the roof has been replaced with a corrugated metal roof. There are also barge boards along the roof. PRF's include the barge boards, unsealed roof, missing mortar and gaps behind wooden fittings. The building was assessed to be of moderate potential for bats. During the surveys there were emergence from beneath the barge boards/the gap between walls and roof. Swallow nests were noted in the eaves.</p> | <p>16 Apr 2024 at 10:59:28<br/>Fooden Hall Farm, Gisburn Road<br/>Clitheroe<br/>England<br/>BB7 4LS<br/>United Kingdom<br/>Fooden Hall</p> <p>16 Apr 2024 at 09:53:50<br/>Fooden Hall Farm, Gisburn Road<br/>Clitheroe<br/>England<br/>BB7 4LS<br/>United Kingdom<br/>Fooden Hall</p> <p>16 Apr 2024 at 10:33:07<br/>Fooden Hall Farm, Gisburn Road<br/>Clitheroe<br/>England<br/>BB7 4LS<br/>United Kingdom<br/>Fooden Hall</p> <p>16 Apr 2024 at 09:58:11<br/>Fooden Hall Farm, Gisburn Road<br/>Clitheroe<br/>England<br/>BB7 4LS<br/>United Kingdom<br/>Fooden Hall</p> |

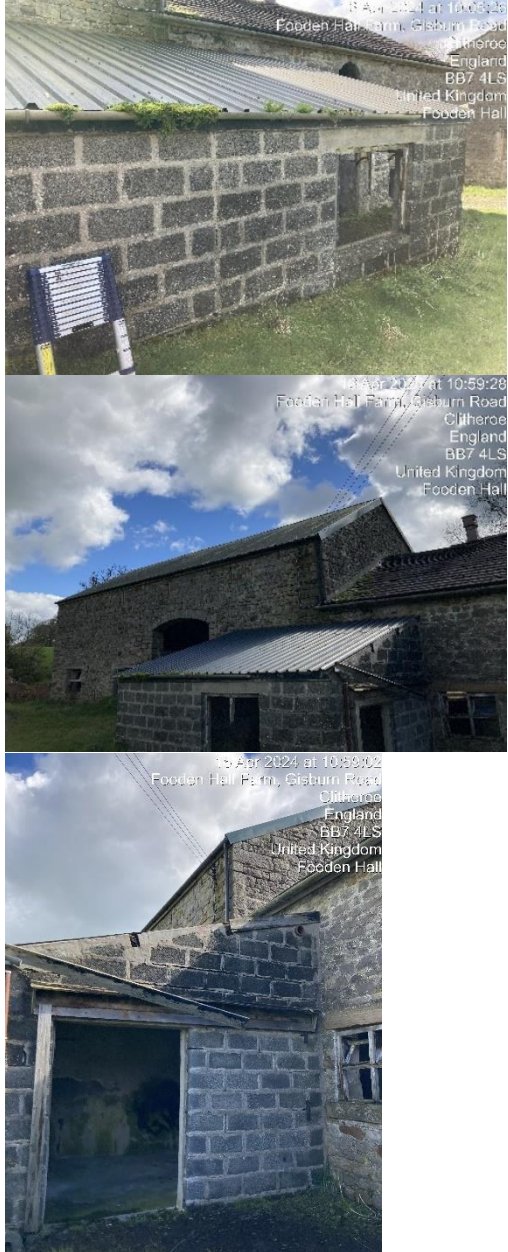
| <p>Extension</p> | <p>There is a small extension on the northwest aspect of the barns. The extension is constructed from breeze blocks, with a corrugated iron roof. PRFs are limited to beneath the lifted wooden barge board and where there is some missing mortar. The extension was assessed of low potential for bats. Ingress is possible into the barns and extension through the eaves, open windows and doors on all elevations. During the survey, one bat was seen briefly foraging within the extension. Swallow nests were noted within the extension.</p> | <p>18 Apr 2024 at 10:58:38<br/>Fooden Hall Farm, Gisburn Road<br/>Clitheroe<br/>England<br/>BB7 4LS<br/>United Kingdom<br/>Fooden Hall</p> <p>18 Apr 2024 at 10:59:28<br/>Fooden Hall Farm, Gisburn Road<br/>Clitheroe<br/>England<br/>BB7 4LS<br/>United Kingdom<br/>Fooden Hall</p> <p>18 Apr 2024 at 10:59:02<br/>Fooden Hall Farm, Gisburn Road<br/>Clitheroe<br/>England<br/>BB7 4LS<br/>United Kingdom<br/>Fooden Hall</p> |

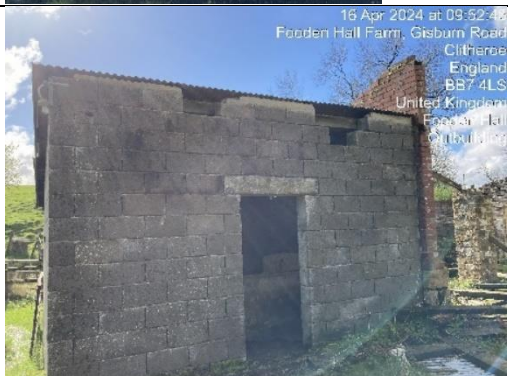
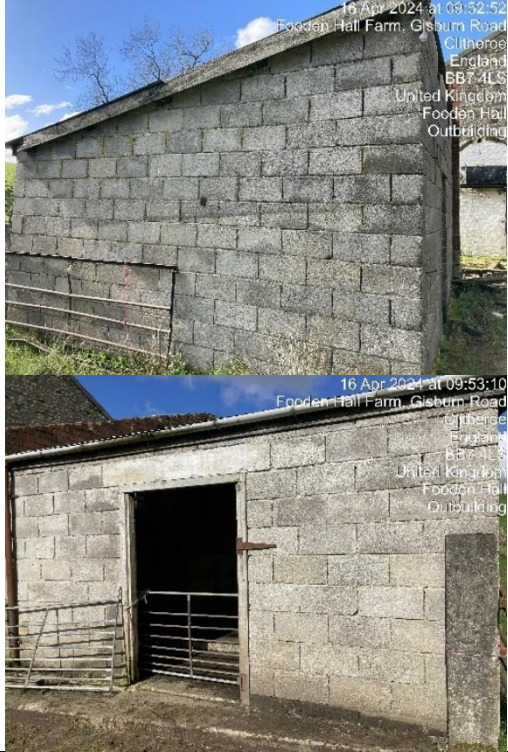
| <p>Breeze block shed</p> | <p>A breeze block shed to the north of the barns. Multiple ingress points are noted but PRFs are limited to gaps beneath the corrugated metal roof and the walls. The shed was assessed as low potential for bats. Swallow nests were found inside the shed. No bats were noted using the building during the survey.</p> | <p>16 Apr 2024 at 09:52:48<br/>Fooden Hall Farm, Gisburn Road<br/>Clitheroe<br/>England<br/>BB7 4LS<br/>United Kingdom<br/>Fooden Hall</p> |

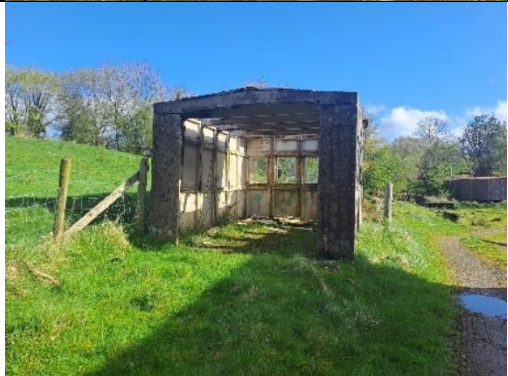
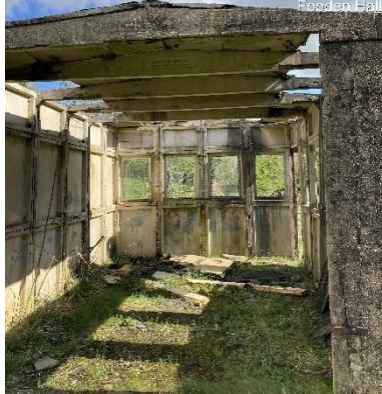
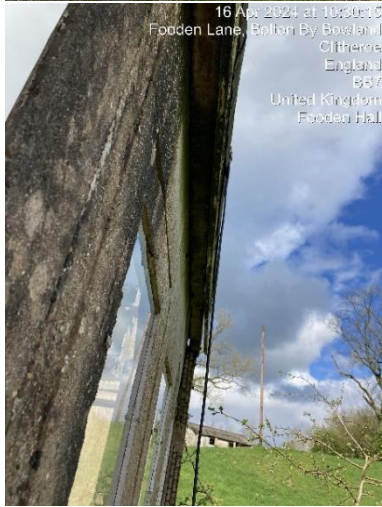
| Concrete shed | <p>A concrete shed is present to the northwest of the barns. The shed is semi-derelict, with PRFs limited to small gaps between concrete blocks and behind barge boards. No bats were seen using this building during the survey.</p> | |

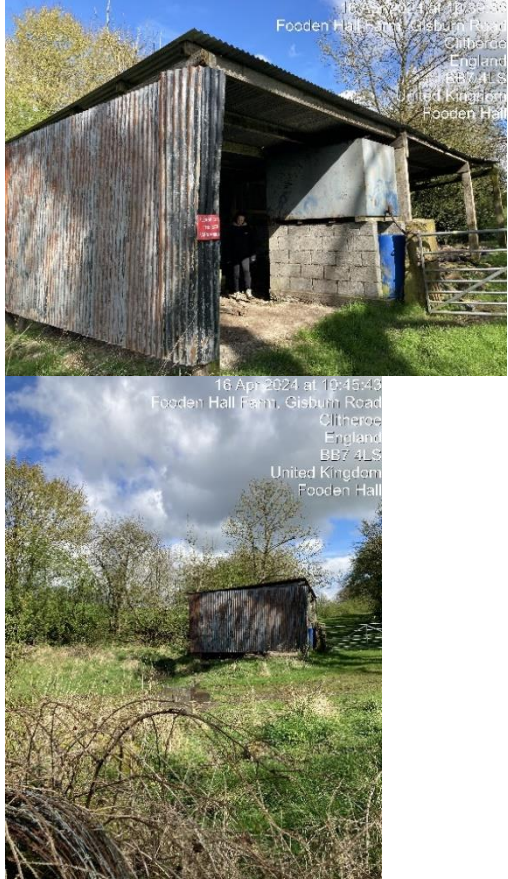
| <p>Metal shed (external)</p> | <p>The northernmost outbuilding is a corrugated metal shed. The shed is open on two sides and quite exposed, with no external PRFs. The shed was assessed as low potential for bats. No bats were seen using the building during any of the surveys.</p> | <p>Fooden Hall Farm, Gisburn Road, Clitheroe, England, BB7 4LS, United Kingdom, Fooden Hall</p> <p>16 Apr 2024 at 10:45:43<br/>Fooden Hall Farm, Gisburn Road, Clitheroe, England, BB7 4LS, United Kingdom, Fooden Hall</p> |

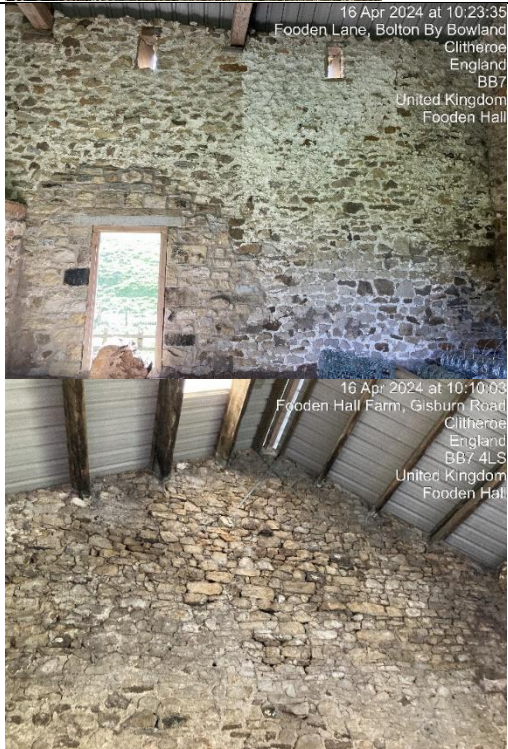
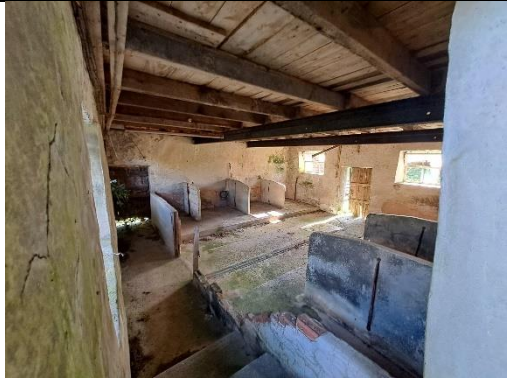
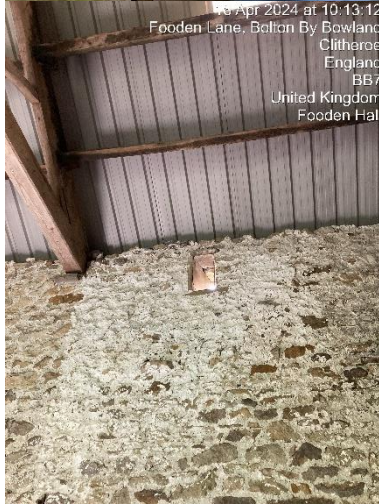
| <p>Large barn (internal)</p> | <p>PRFs included wooden beams, gaps between beams and the ceiling/ roof and small cracks in the inner walls. No evidence of roosting bats was identified during the PRA. Swallow nests were identified in the lower room of the barn.</p> | <p>16 Apr 2024 at 10:23:35<br/>Fooden Lane, Bolton By Bowland, Clitheroe, England, BB7 4LS, United Kingdom, Fooden Hall</p> <p>16 Apr 2024 at 10:10:03<br/>Fooden Hall Farm, Gisburn Road, Clitheroe, England, BB7 4LS, United Kingdom, Fooden Hall</p> |

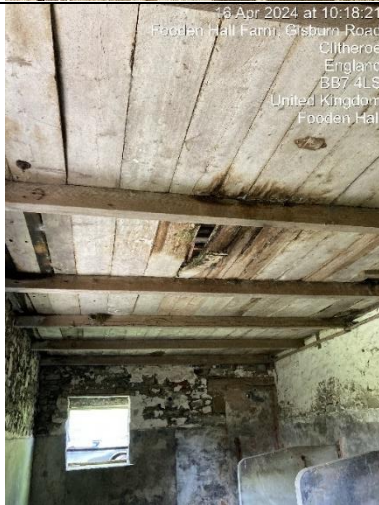
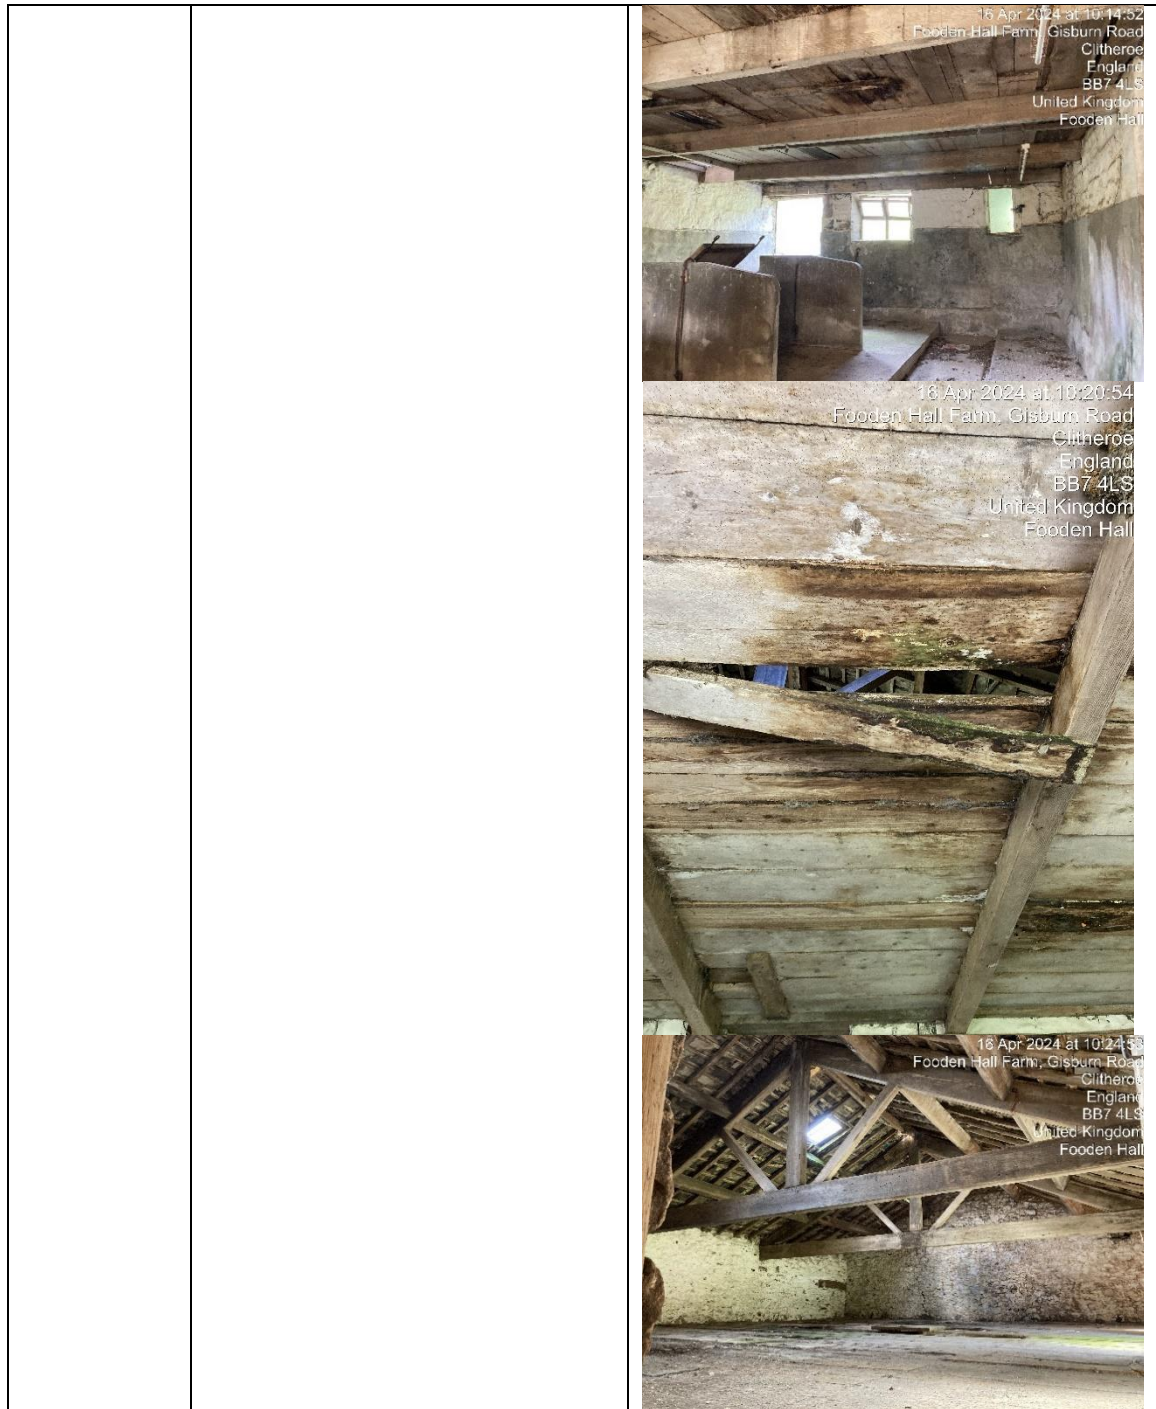
| Small barn (internal) | <p>PRFs included wooden beams and gaps between beams and the ceiling/roof tiles. There was evidence of rot/damp in the wood of the barn, however the barn was mostly dry. No evidence of bats was identified during the PRA, however a barn owl was seen using the gap above the middle a-frame of the roof supports as a day roost. Owl droppings and barn owl feather were also noted here. Swallow nests were present within the lower room of the barn.</p> | <p>16 Apr 2024 at 10:18:21<br/>Fooden Hall Farm, Gisburn Road<br/>Clitheroe<br/>England<br/>BB7 4LS<br/>United Kingdom<br/>Fooden Hall</p> |

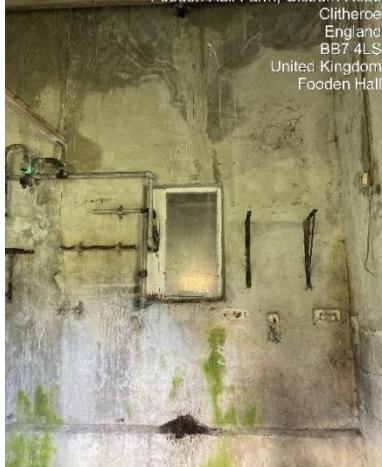
| <p>Extension<br/>(internal)</p> | <p>PRFs were limited to gaps behind the wooden beams. Swallow nests were identified.</p> | <div data-bbox="874 194 1257 689"> <p>16 Apr 2024 at 10:57:04<br/>Fooden Hall Farm, Gisburn Road<br/>Clitheroe<br/>England<br/>BB7 4LS<br/>United Kingdom<br/>Fooden Hall</p> </div> <div data-bbox="874 689 1257 1196"> <p>16 Apr 2024 at 10:54:27<br/>Fooden Hall Farm, Gisburn Road<br/>Clitheroe<br/>England<br/>BB7 4LS<br/>United Kingdom<br/>Fooden Hall</p> </div> |

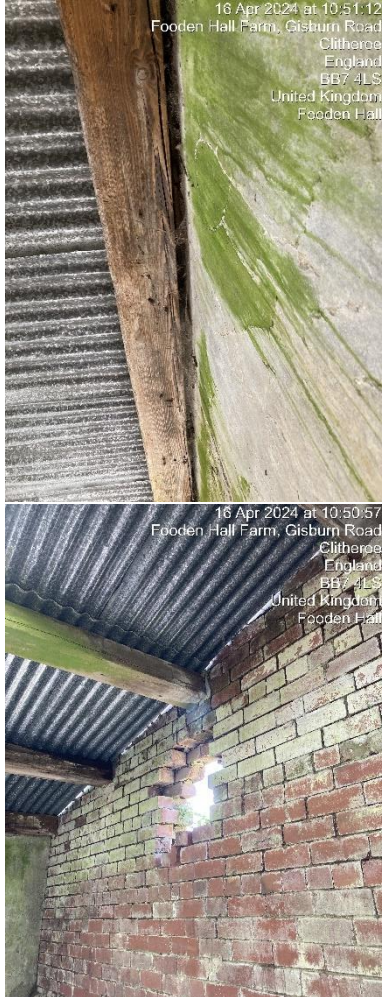
| <p>Breeze block shed (internal)</p> | <p>PRFs were limited to PRF-i in the gap behind the wooden ceiling beams. The shed is largely exposed and of low suitability for bats. No evidence of bats was seen during the PRA. Swallows nests were seen inside the shed.</p> | <p>16 Apr 2024 at 10:51:12<br/>Fooden Hall Farm, Gisburn Road<br/>Clitheroe<br/>England<br/>BB7 4LS<br/>United Kingdom<br/>Fooden Hall</p> <p>16 Apr 2024 at 10:50:57<br/>Fooden Hall Farm, Gisburn Road<br/>Clitheroe<br/>England<br/>BB7 4LS<br/>United Kingdom<br/>Fooden Hall</p> |

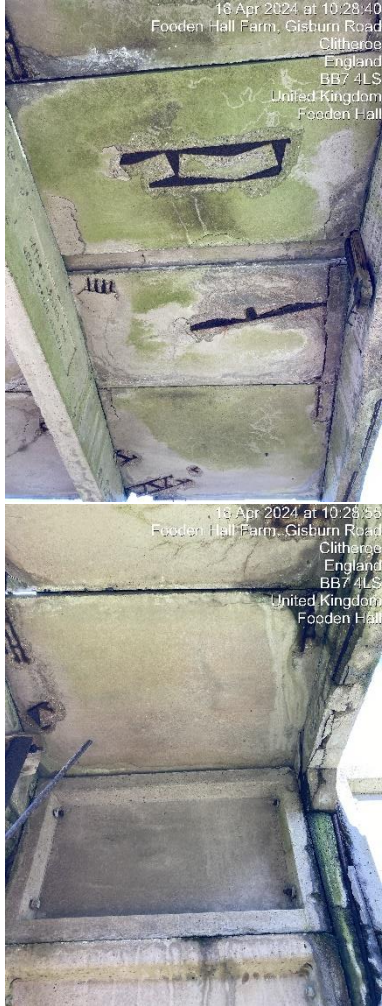
| <p>Concrete shed<br/>(internal)</p> | <p>The shed internally was very exposed and largely unsuitable for bats. Potential PRF-i were present between gaps in the concrete blocks.</p> | |

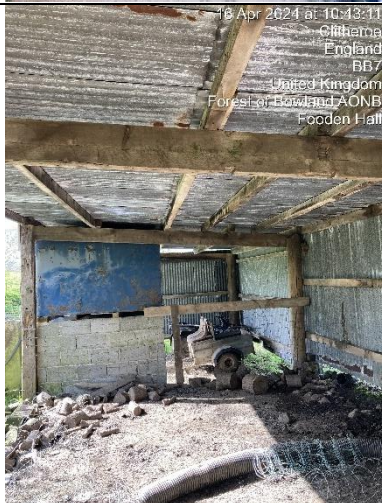
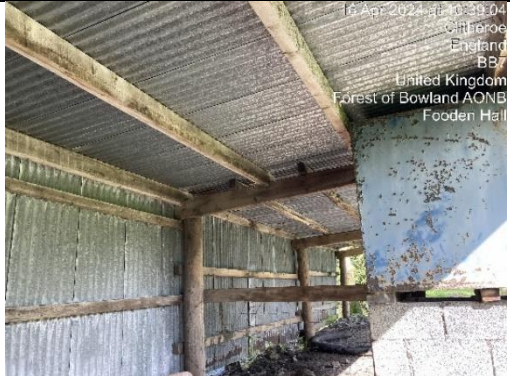
| <p>Metal shed<br/>(internal)</p> | <p>The metal shed is exposed and largely unsuitable for bats, with PRFs limited to gaps behind the wooden frame. Swallows nests were identified inside the shed.</p> | |

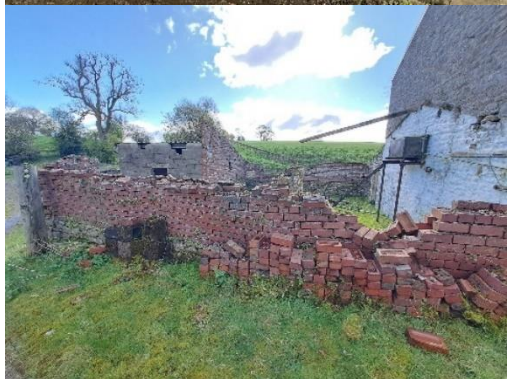
| Demolished building | <p>The remains of a brick building was present top the north of the barns. There were gaps present where there was missing mortar, however given the low value of this for roosting bats and the better value roosting habitat available nearby, this was assessed as having negligible value for bats.</p> | <p>16 Apr 2024 at 09:53:21<br/>Fooden Hall Farm, Gisburn Road<br/>Clitheroe<br/>England<br/>BB7 4LS<br/>United Kingdom<br/>Forest of Bowland<br/>Outbuilding</p> |

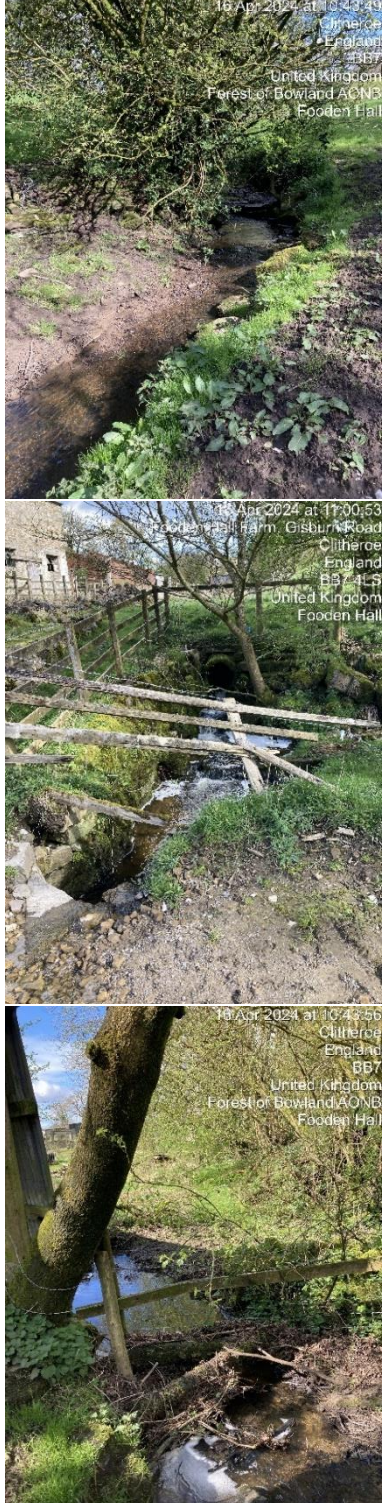
| <p>Watercourse</p> | <p>Fooden Gill runs from the north to the south to the east of the outbuildings. This was lined with trees and vegetation, and was found to provide a commuting corridor for various bat species during the surveys.</p> | <p>16 Apr 2024 at 10:52:43<br/> Clitheroe<br/> England<br/> BB7<br/> United Kingdom<br/> Forest of Bowland AONB<br/> Fooden Hall</p> <p>16 Apr 2024 at 11:00:53<br/> Fooden Hall farm, Gisburn Road<br/> Clitheroe<br/> England<br/> BB7 4L S<br/> United Kingdom<br/> Fooden Hall</p> <p>16 Apr 2024 at 10:42:56<br/> Clitheroe<br/> England<br/> BB7<br/> United Kingdom<br/> Forest of Bowland AONB<br/> Fooden Hall</p> |

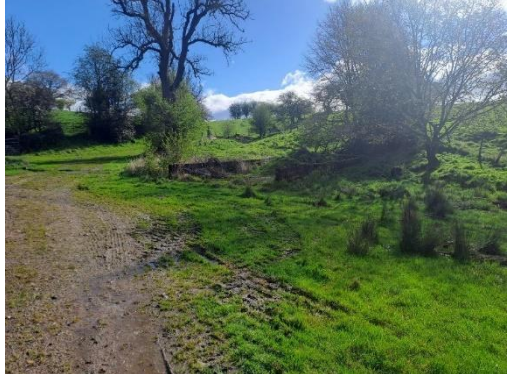
| Vegetation on-site | Vegetation on-site was largely ephemeral ruderal and modified grassland, however to the east of the barns along Fooden Gill there is a strip of grassland with a high sward, which would require a nesting bird check if vegetation clearance is carried out within nesting bird season. | |

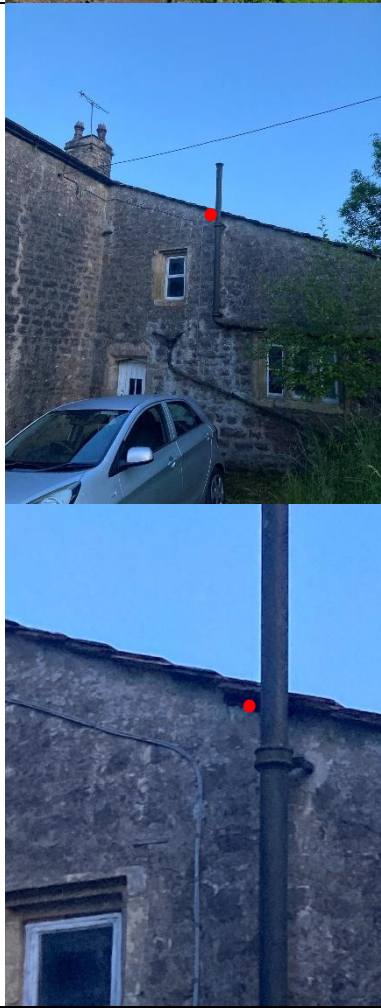
| Fooden Hall | A pipistrelle roost was identified at Fooden Hall, adjacent to the barns. | |

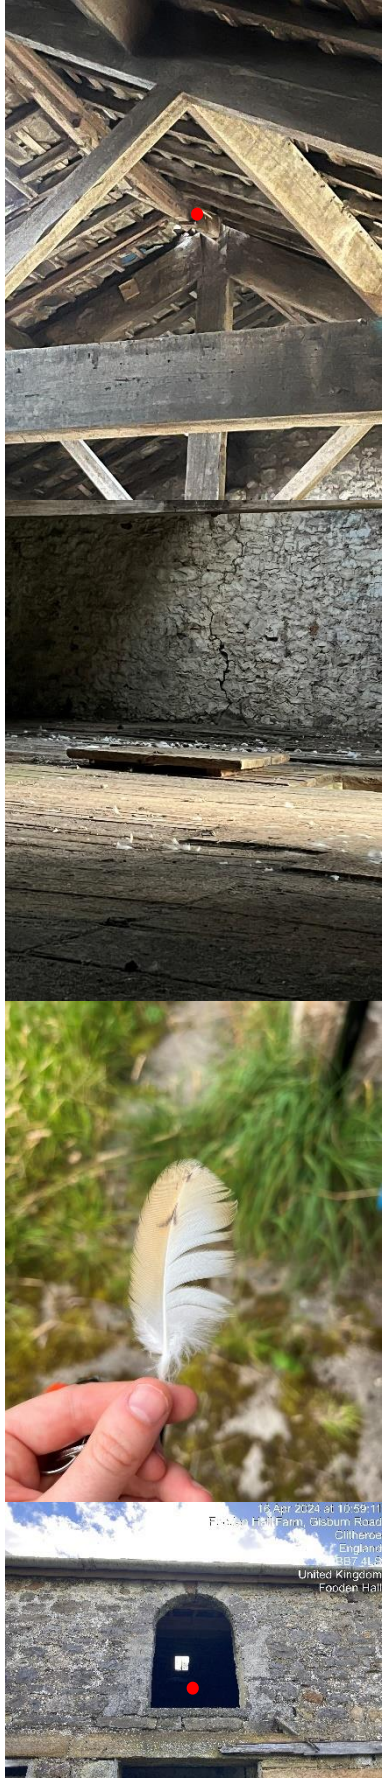
| <p>Barn Owl</p> | <p>No evidence of barn owl was found during the PRA. A barn owl was seen exiting the building through the arched window above the door on the northwest aspect of the barn during the second bat survey. An inspection of the barn during the third bat survey found the barn owl using it as a day roost. The owl was perched in the chimney gap above the A-shaped roof frame (pictured right). Owl droppings and feathers show the owl has been using the barn for some time.</p> | |

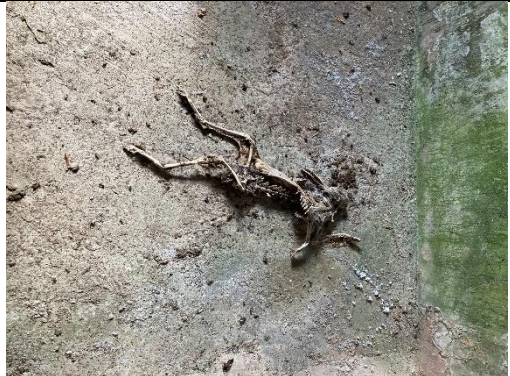
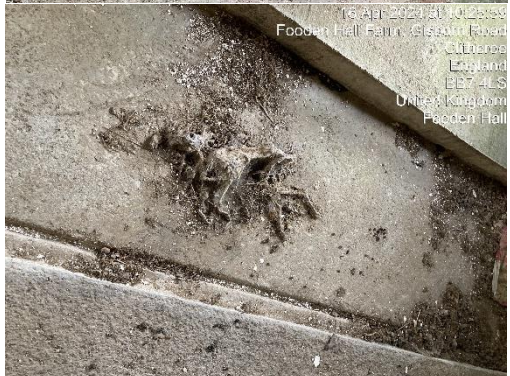
| European hare carcasses | Two dead European hare were found in the basement rooms of buildings 1 and 2. | <p>16 Apr 2024 at 10:28:39<br/>Fooden Hall Farm, Gisburn Road<br/>Clitheroe<br/>England<br/>BB7 4LS<br/>United Kingdom<br/>Fooden Hall</p> |

- 3.32 Two dead European Hare, Biodiversity Action Plan (BAP) species, were observed within the buildings 1 and 2. A live European Hare was seen on the private road to the farm.

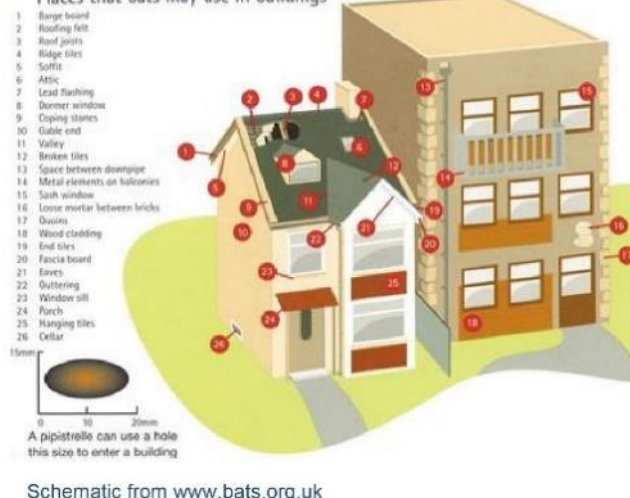
### Places that bats may use in buildings

- The top of gable end or dividing wall;
- The top of chimney breasts;
- Ridge and hip beams and other roof beams;
- Mortise and tension joints;
- All beams/ceilings/pipework (free hanging bats);
- The junction of roof timbers, especially where ridge and hip beams meet;
- Behind purlins;
- Between tiles and the roof lining;
- Under flat felt roofs;
- Under barge boards;
- In cavity walls;
- In cracks in stone or concrete;
- Behind peeling paint/wall coverings;
- Gaps behind window and door frames;
- Between window panes and timber boarding.
- In trees (cracks/holes/ivy cladding).
