Heritage Statement  
to support planning application  
for conversion of redundant farm buildings  
at Fooden Hall, Bolton-by-Bowland

March 2026

STEPHEN HAIGH  
Buildings Archaeologist

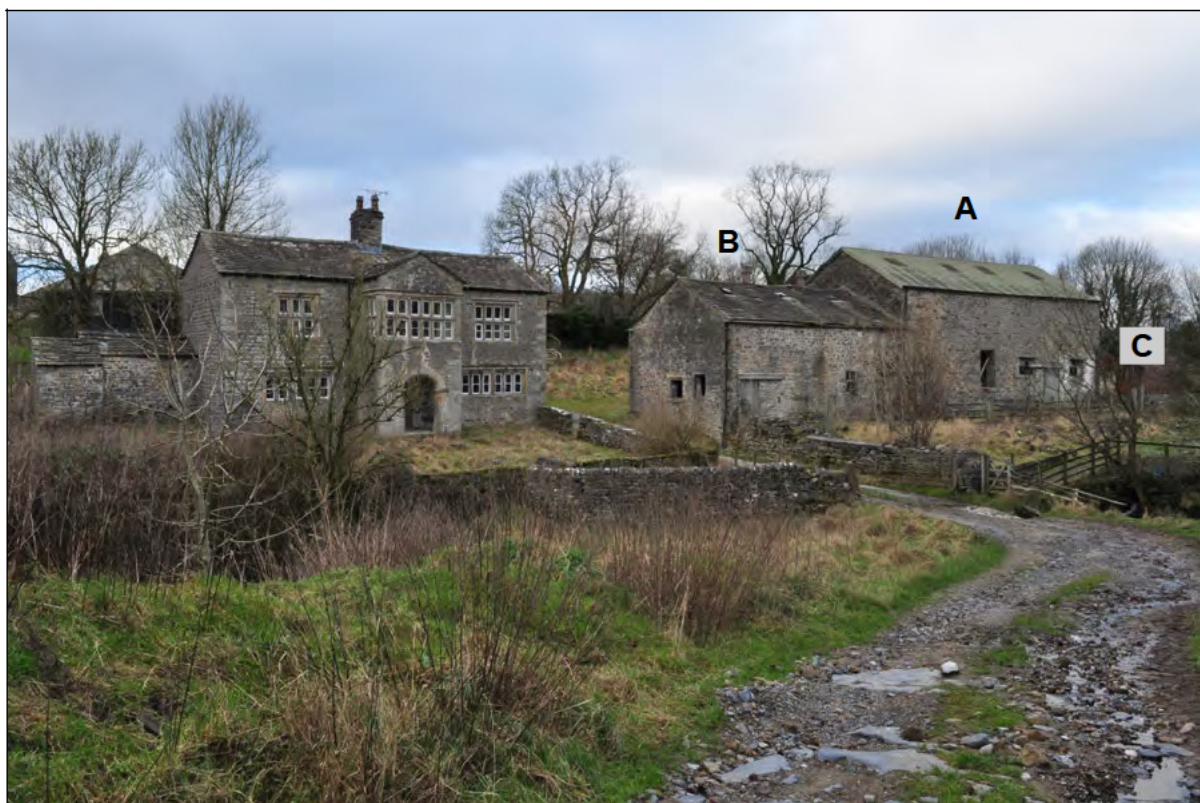
Photo 1: Key view of the Hall, looking north from public footpath. Farm buildings proposed for conversion to right (A, B & C).

- 2.2 Historic England describe Grade II\* listed buildings as "*particularly important buildings of more than special interest*", which make up only about 5.8% of all listed buildings.
- 2.3 Fooden Hall has an extremely well-preserved 17th century exterior (particularly on the south-east front and north-east side) which is almost entirely unencumbered by modern paraphernalia. The contributions to its setting made by the small, walled, front garden, and its situation facing onto a shallow valley and beck are considerable.
- 2.4 The farm buildings proposed for conversion form a linear range comprising two main structures, separated from the Hall by a trackway, and standing roughly in line with it, and they too make a very strong contribution to its setting (photos 1 &

2, below). Public footpaths pass along both sides of the farm buildings, increasing their visual prominence.

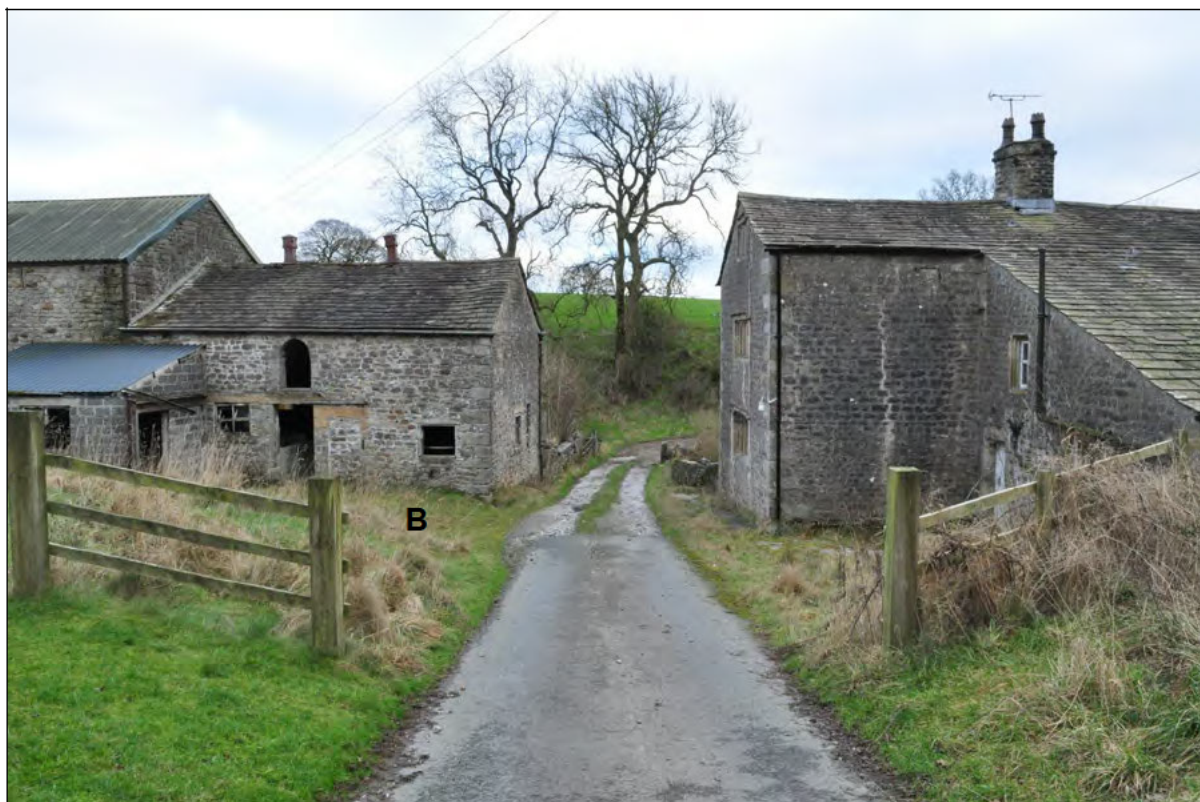
Photo 2: View from the north-west: track separating Fooden Hall (right) from building B (left)

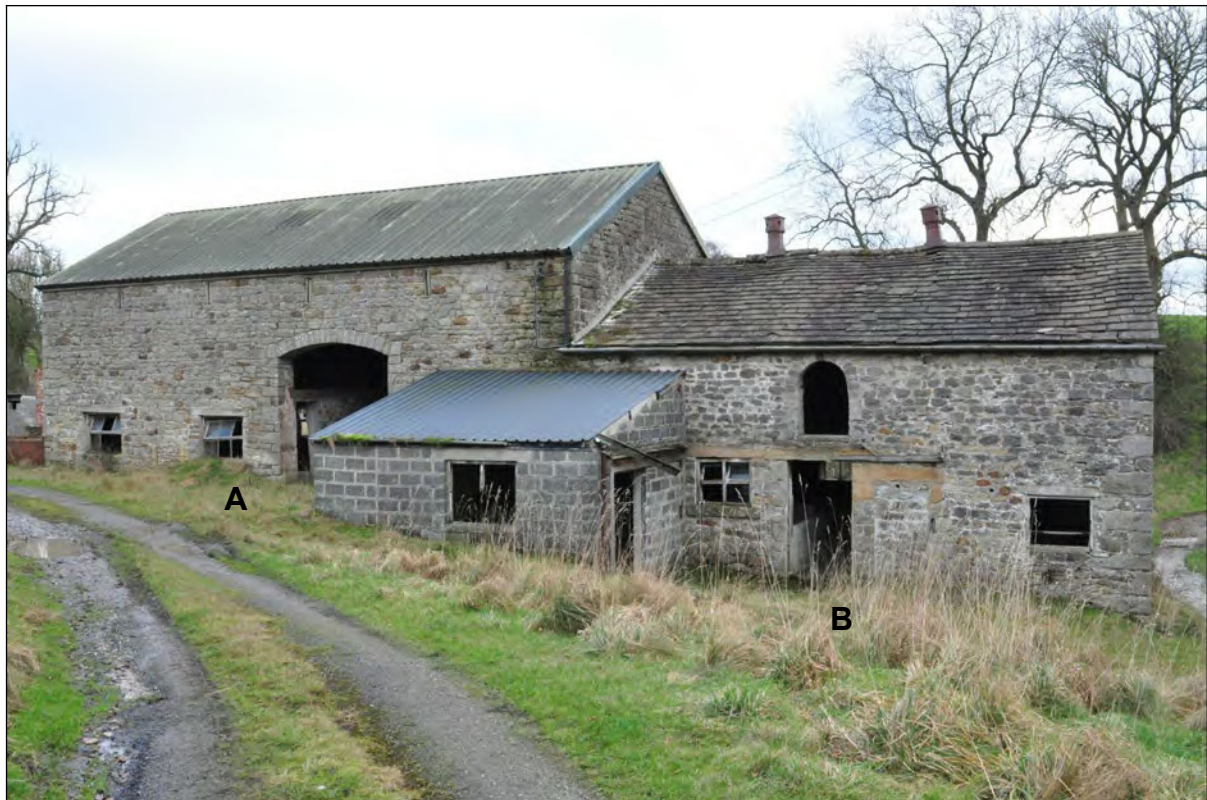
Photo 3: North-west elevations of buildings A (left) and B (right)

- 4.1 Building A bears the date of 1833, painted in red on the collars of two of its four roof trusses. The building faces north-west, and is a combination barn which has a typical arrangement of threshing bay with large cart entrance and rear winnowing doorway in the south-east side (photos 3-5). The north-east end contains a shippin at a lower level, formerly with three gable entrances (photo 6), which have been blocked up and replaced by 20th century openings in the adjoining long sides.

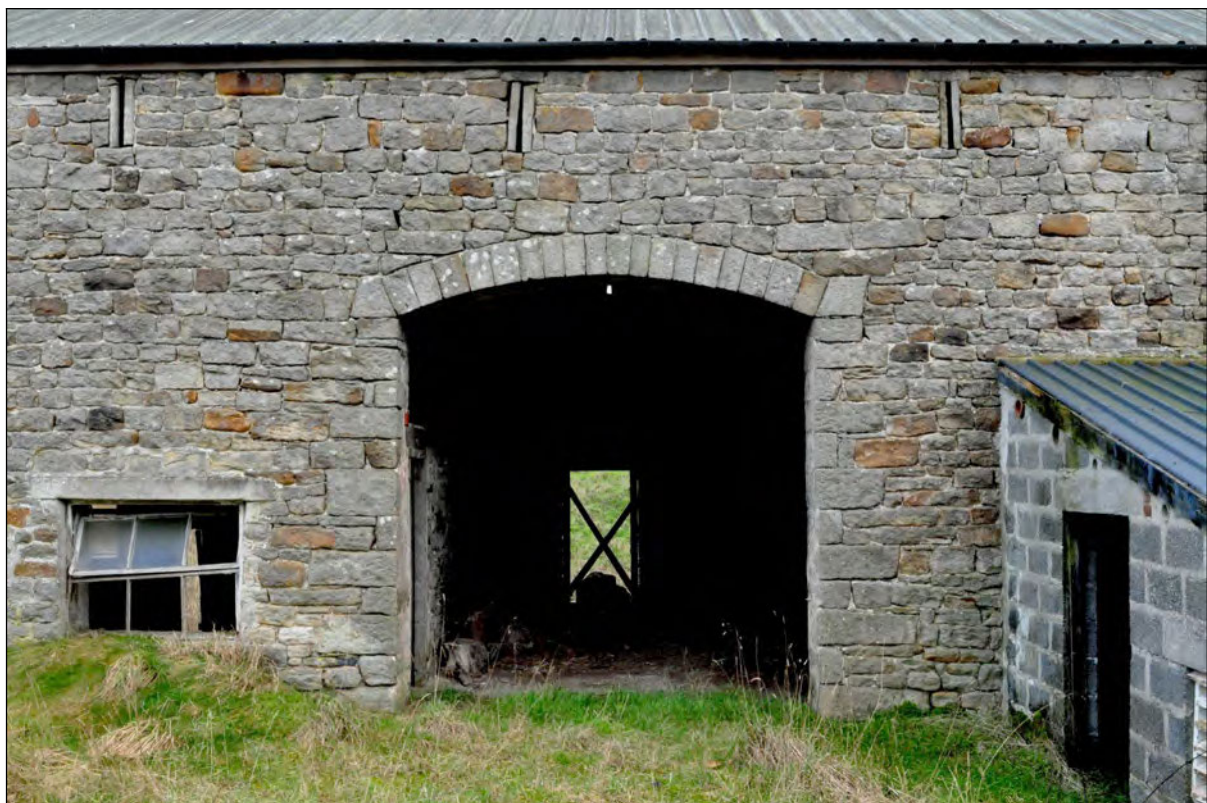
Photo 4: Arched entrance and ventilation slits in north-west elevation of building A

- 4.2 Building A is significant for its largely unaltered exterior of local stone with high solid-to-void ratio, and some original details, including the arched entrance and slit ventilators in the long sides, arranged mostly in rows at a high level, but also (less numerously) lower down in the walls. Inserted ground floor openings in the north-east end are 20th century and considered to be less important, but do show the continuing use of the shippin into this period. The interior is largely modern (photo 7), but the roof trusses remain as impressive features, and are enhanced by the painted date of 1833 (photo 8). The barn's original stone slate roof has been replaced by modern steel sheets, which diminish significance and offer scope for enhancement.

- 6.5 Within the north-west front of unit 1, the arched cart entry would remain open, with the entrance door and glazing set back from it inside the building, an arrangement which would emphasise the opening's size and form, as well as reducing the visual impact of glass within it.

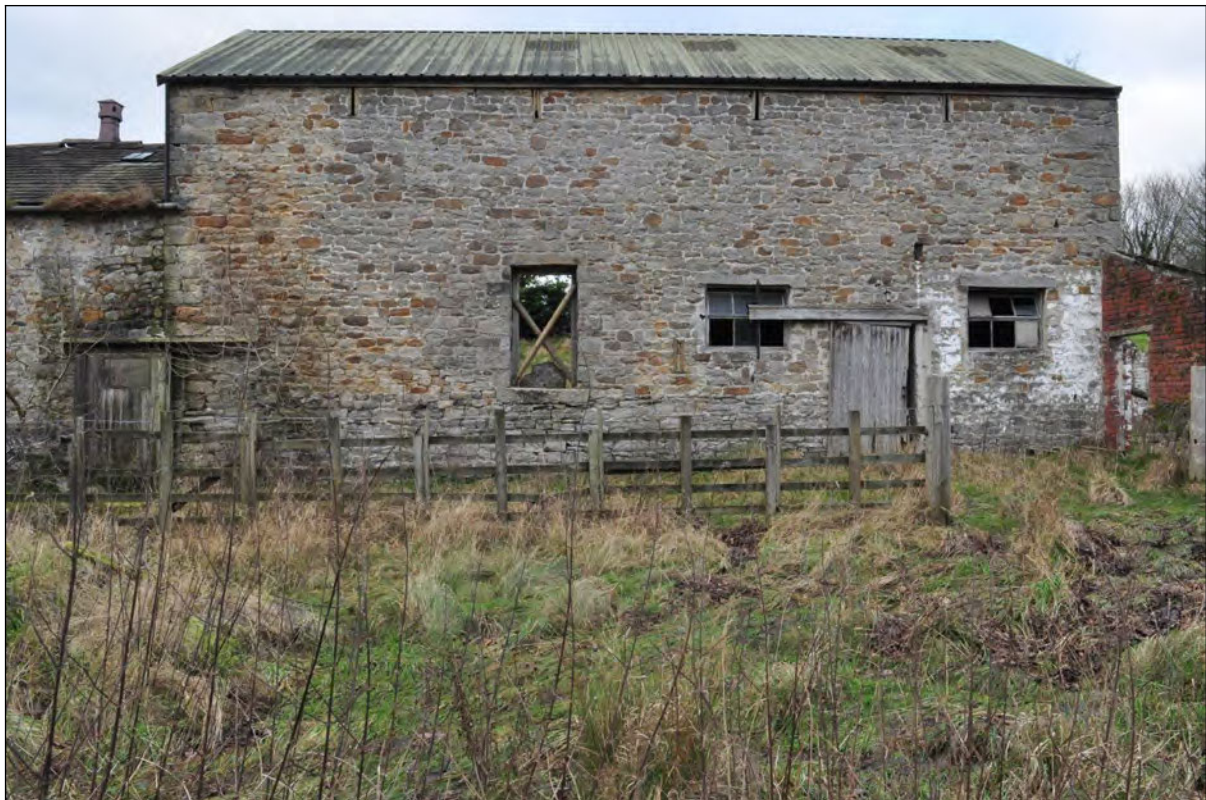
Photo 5: Building A: south-east elevation.

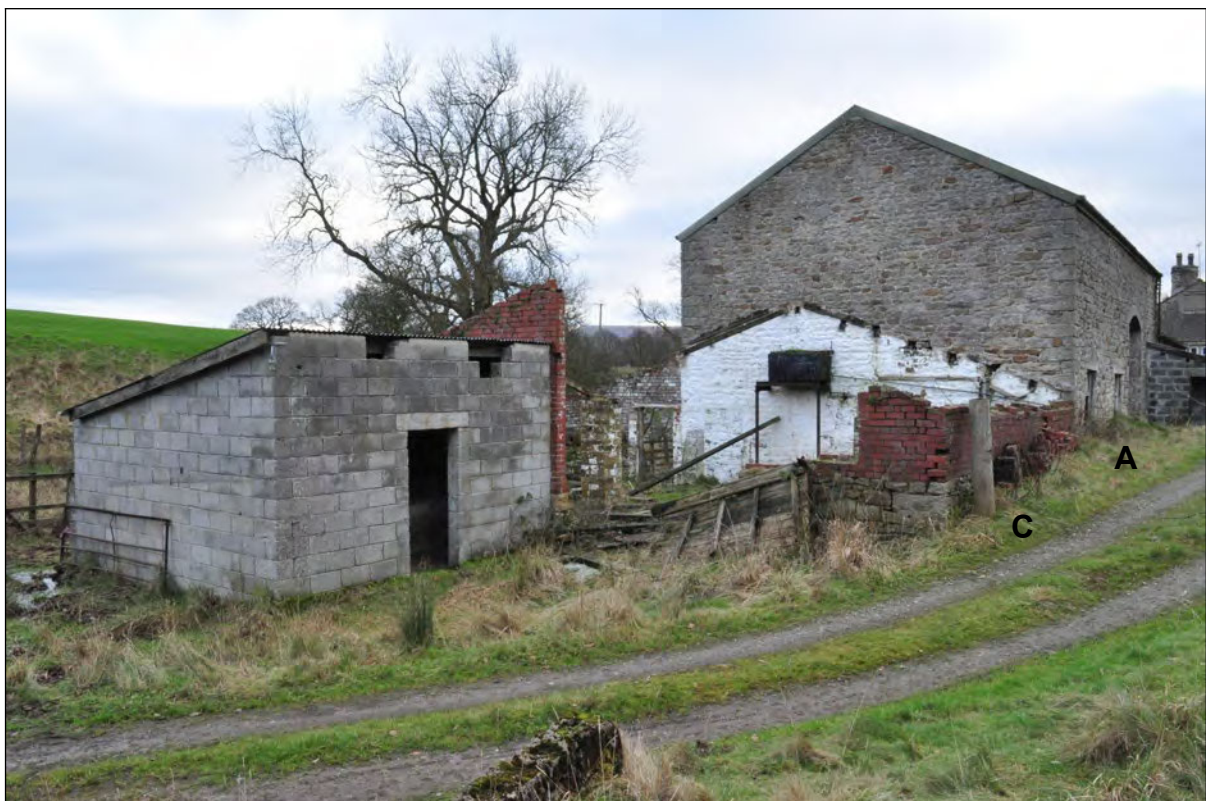
Photo 6: Buildings A & C, looking south. Modern building in foreground would be cleared as part of landscaping

- 6.6 Elsewhere, the conversions would make use of existing openings wherever possible, including the partial re-opening of the three gable doorways in the north-east end of A. This is intended to sustain the perception as historic farm buildings, whose forms arise from their original, agricultural designs. Although a number of new openings would be needed in order to comply with building regulations (mainly in the south-east (rear) elevation), these would not impose on any existing features, and the overall effect would be to retain the high solid-to-void ratio, and not detract from the highly important views of the Hall's front. The open space to the south-east of the new dwellings has been deliberately kept undivided and unencumbered to retain something of the appearance of a farmyard, rather than domestic gardens.

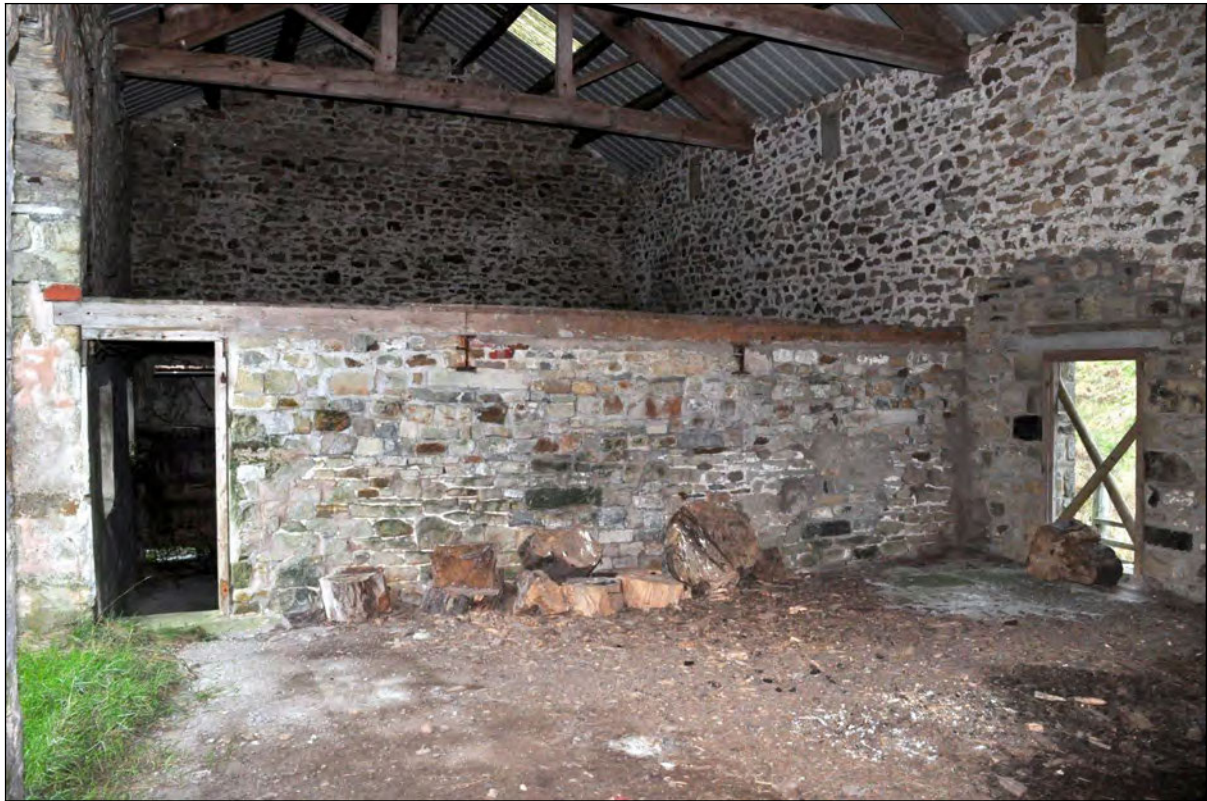
Photo 7: Building A interior: 20th century cross-wall enclosing shippon in north-east end

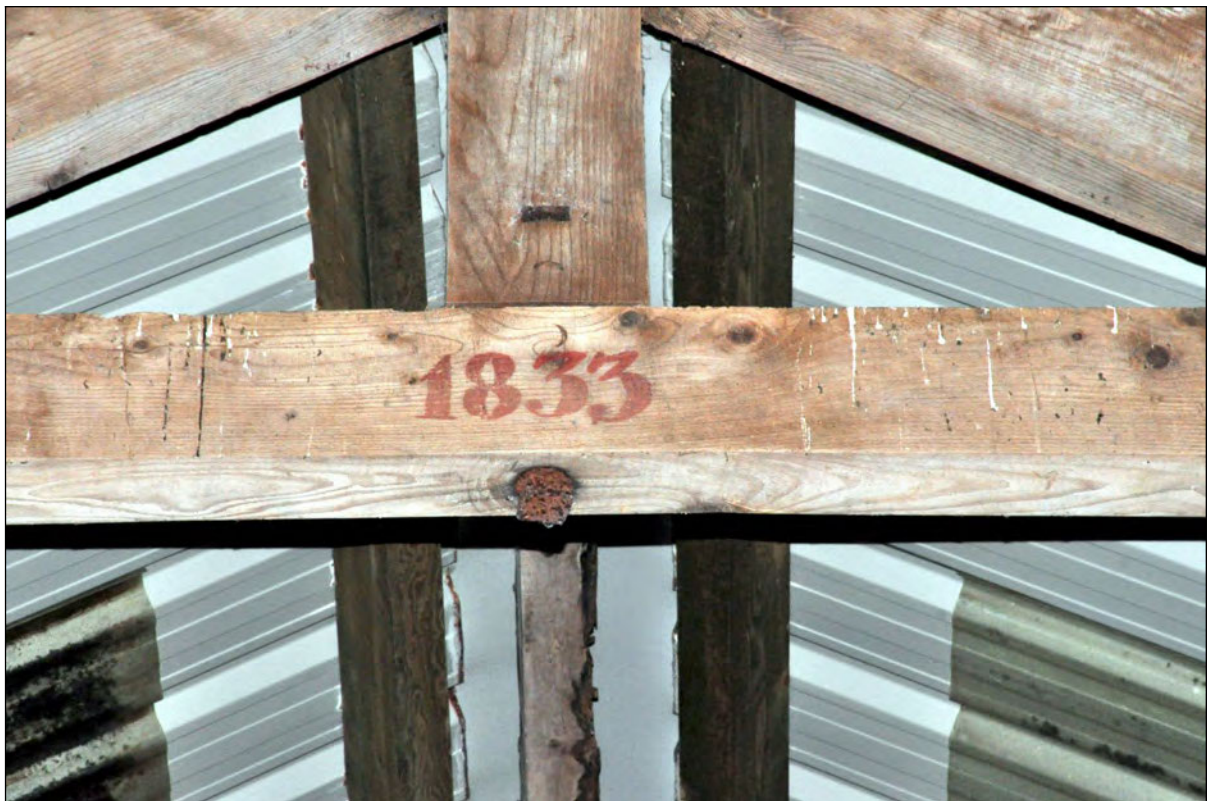
Photo 8: Building A: dated roof timber

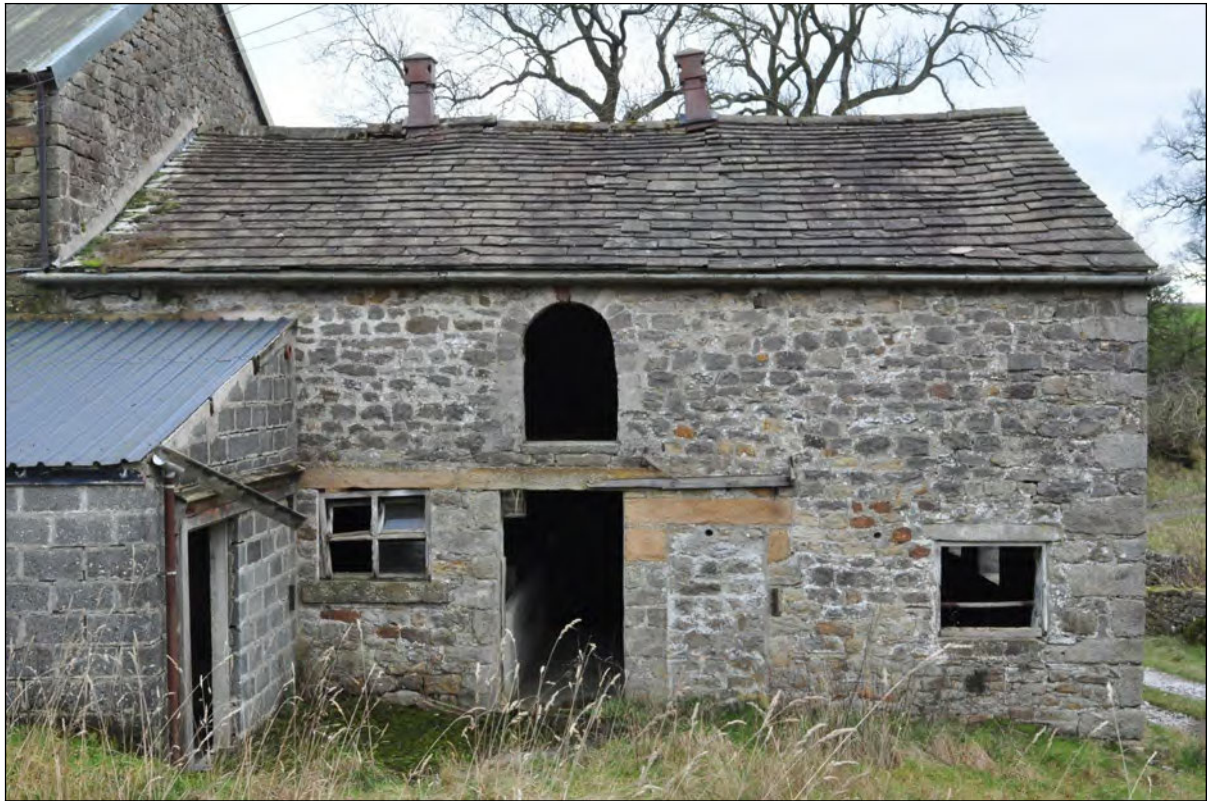
Photo 9: Building B: north-west elevation

- 4.4 Building B is subtly distinct from the barn in terms of its stonework, and retains its original stone slate roof with ventilation cowls (also perhaps original). It has a slightly lower solid-to-void ratio, and a total of four ground floor doorways. These are arranged symmetrically: the two in the north-west side are positioned in the middle of the wall (photo 9), while those in the south-east side are near the outer corners, and these entrances relate to the former layout of animal stalls within the building, set in two rows to either side of the central cross-wall (photo 10). The pattern of windows is less formal and has been subject to some minor change over time, but one notable opening is the small, arched forking hole in the north-west side. The interior has no individual features of interest, but its role in housing livestock remains evident.

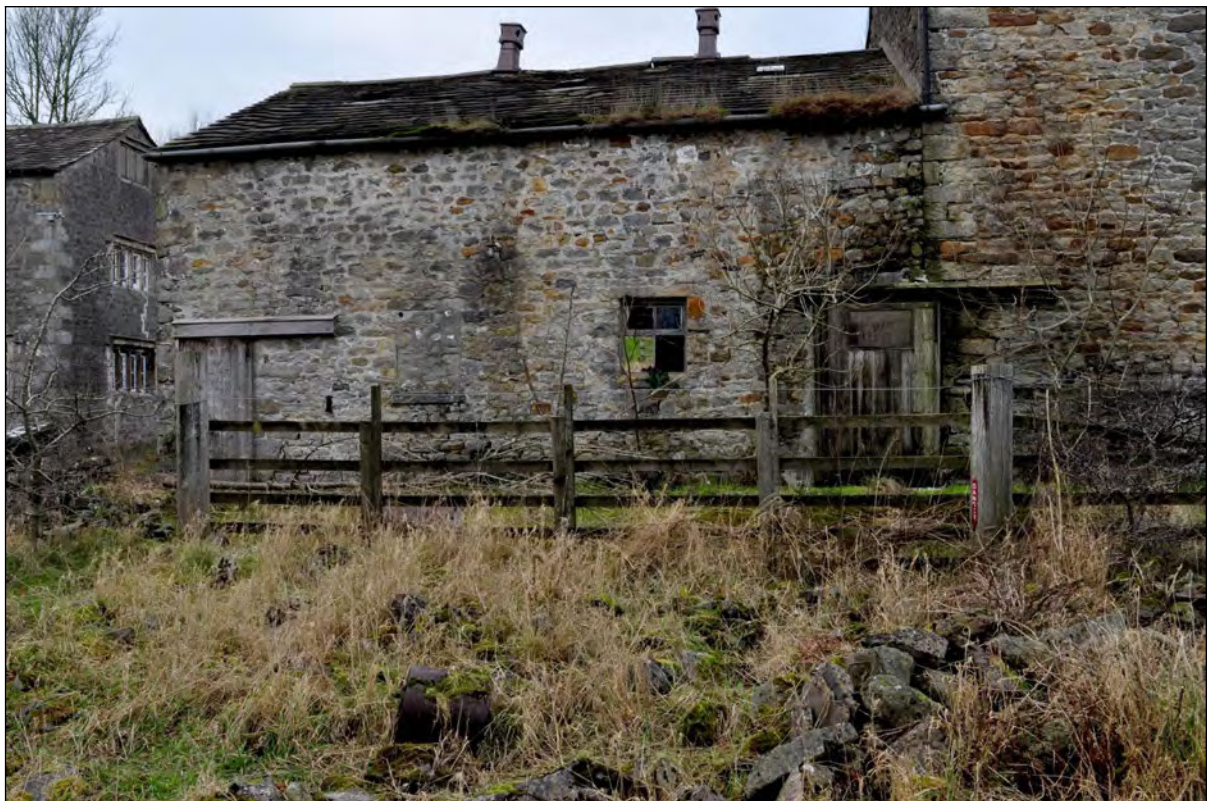
Photo 10: Building B: south-east elevation

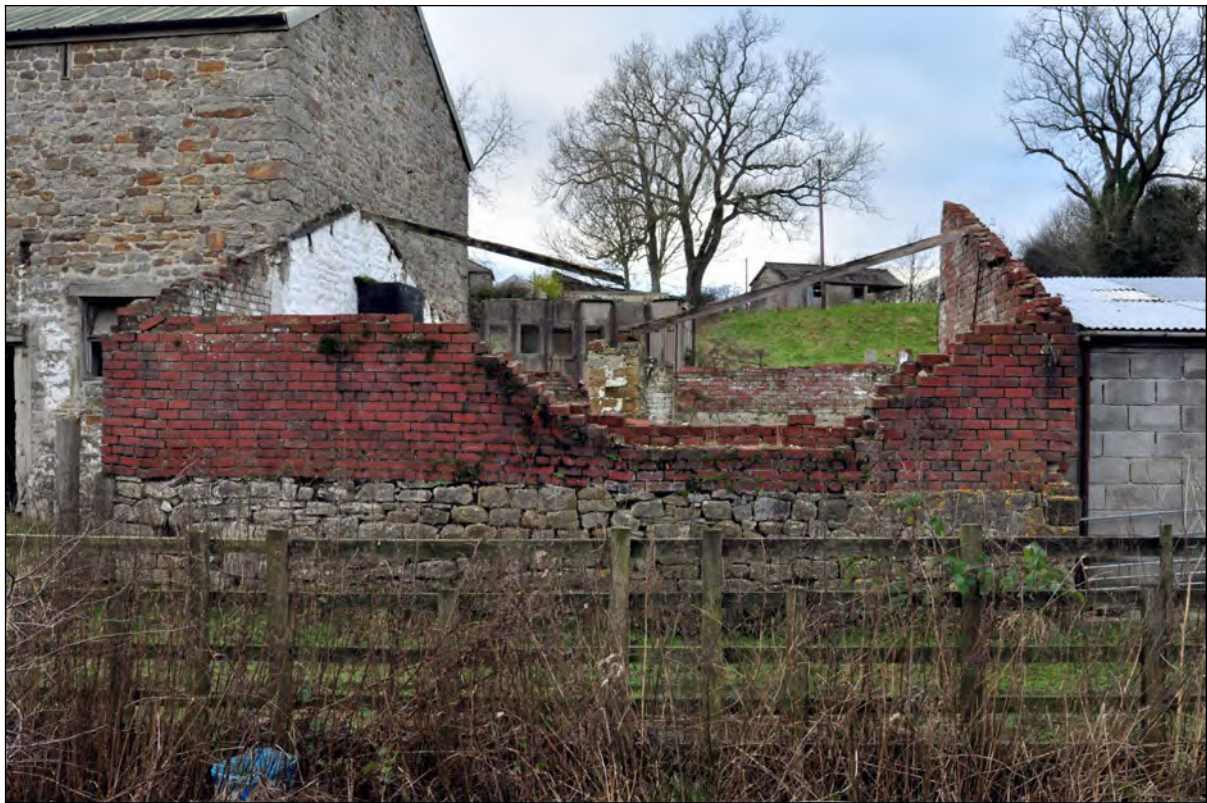
Photo 11: Building C: south-east elevation

- 4.5 Building C is of very low significance but contributes to the linear character of the group. Ordnance Survey maps and the presence of stone within its lower walls suggest it began as a small walled fold-yard, before being made into a brick shippon or similar (photos 11 & 12).

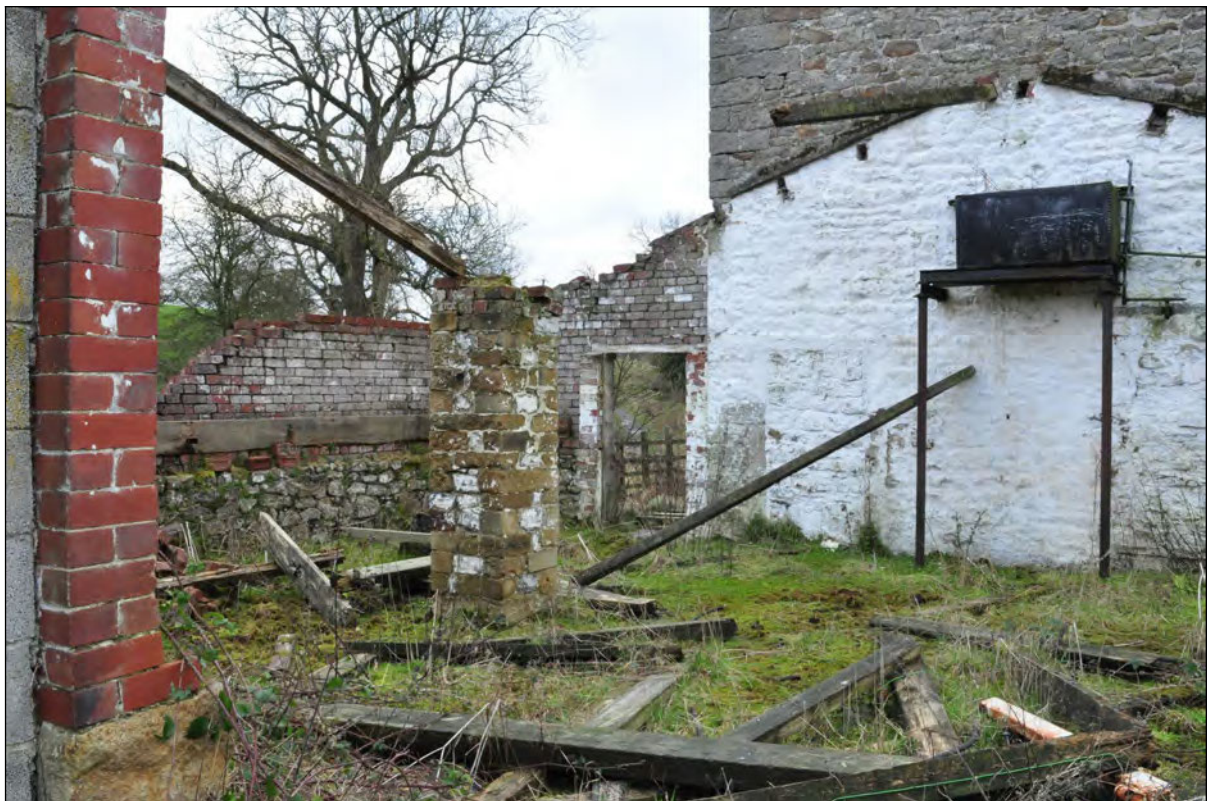
Photo 12: Building C: interior, looking south
