Heritage Statement  
to support planning application  
for conversion of redundant farm buildings  
at Fooden Hall, Bolton-by-Bowland

March 2026

STEPHEN HAIGH  
Buildings Archaeologist

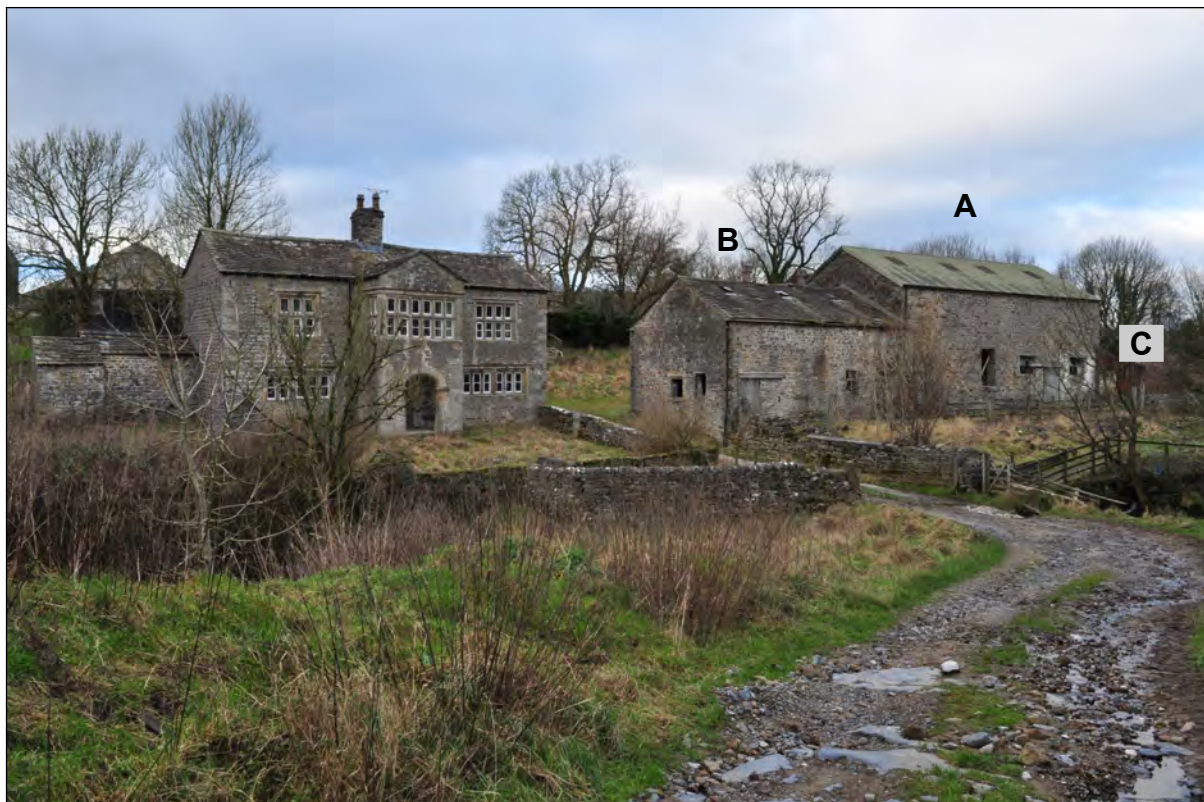
Photo 1: Key view of the Hall, looking north from public footpath. Farm buildings proposed for conversion to right (A, B & C).

- 2.2 Historic England describe Grade II\* listed buildings as "*particularly important buildings of more than special interest*", which make up only about 5.8% of all listed buildings.
- 2.3 Fooden Hall has an extremely well-preserved 17th century exterior (particularly on the south-east front and north-east side) which is almost entirely unencumbered by modern paraphernalia. The contributions to its setting made by the small, walled, front garden, and its situation facing onto a shallow valley and beck are considerable.
- 2.4 The farm buildings proposed for conversion form a linear range comprising two main structures, separated from the Hall by a trackway, and standing roughly in line with it, and they too make a very strong contribution to its setting (photos 1 &

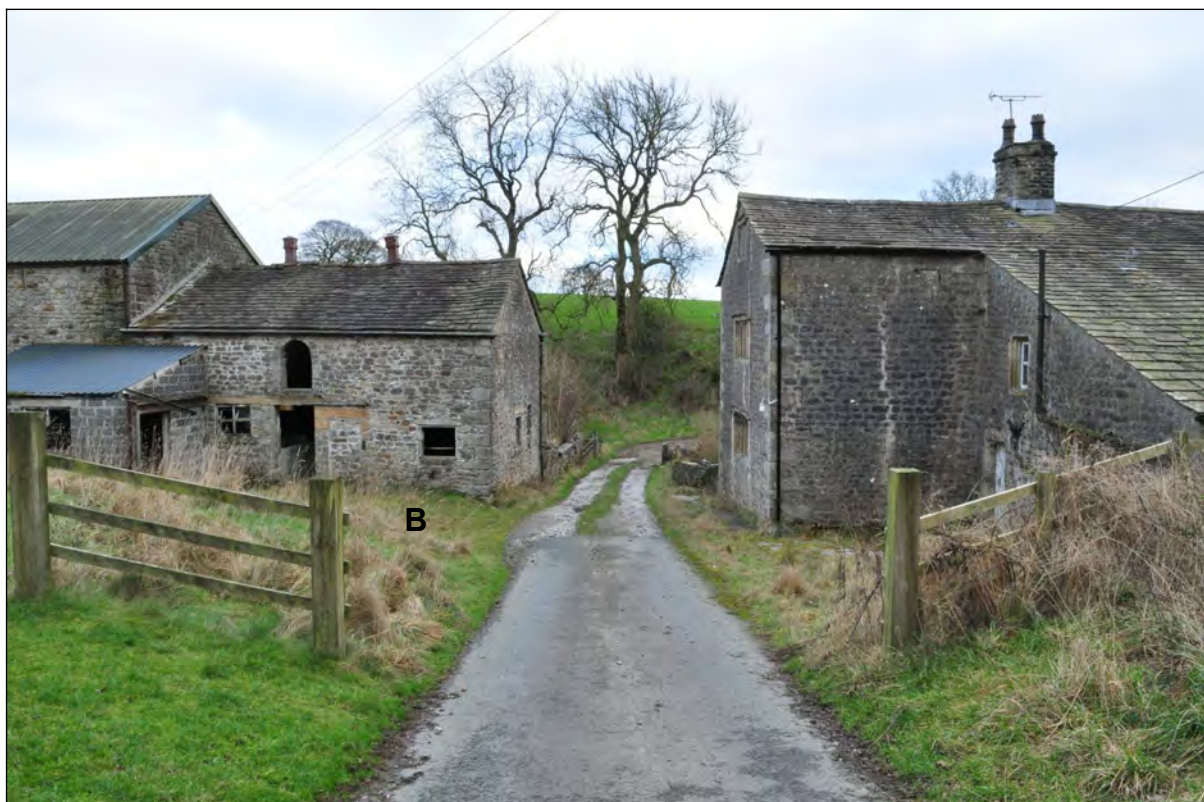
Photo 2: View from the north-west: track separating Fooden Hall (right) from building B (left)

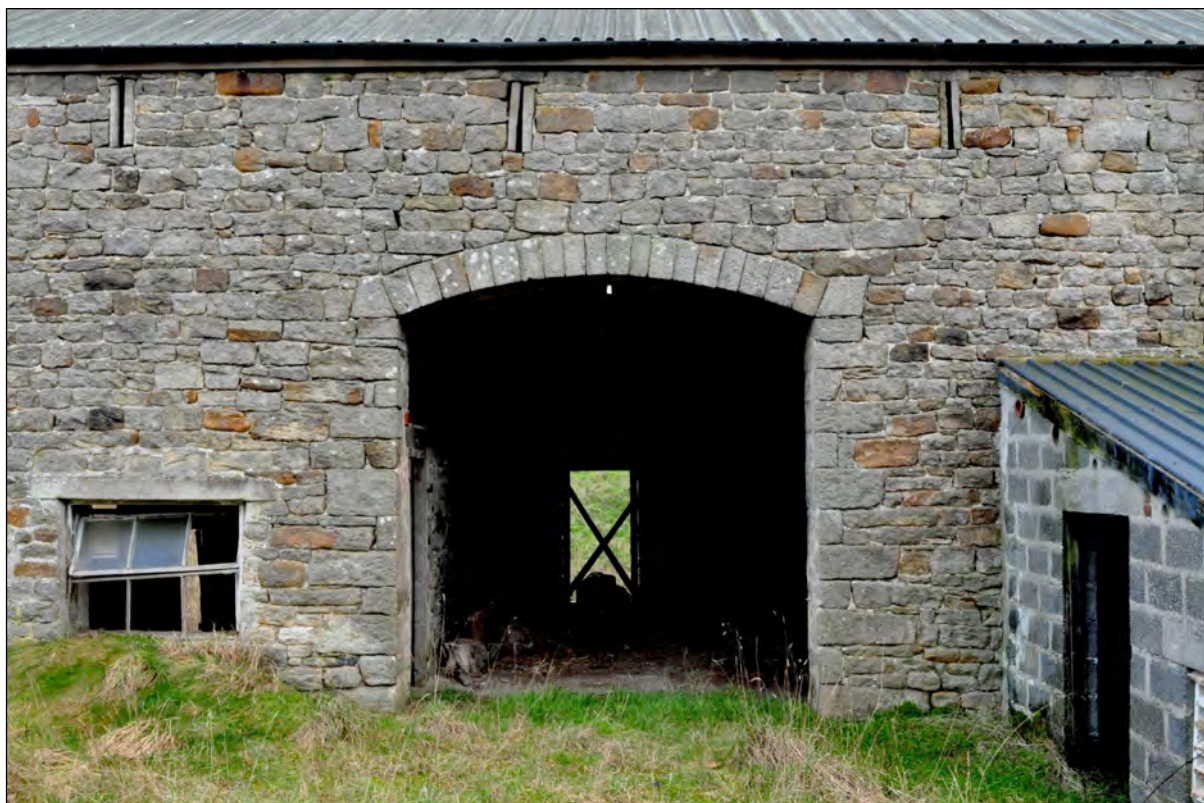
Photo 4: Arched entrance and ventilation slits in north-west elevation of building A

- 4.1 Building A bears the date of 1833, painted in red on the collars of two of its four roof trusses. The building faces north-west, and is a combination barn which has a typical arrangement of threshing bay with large cart entrance and rear winnowing doorway in the south-east side (photos 3-5). The north-east end contains a shippin at a lower level, formerly with three gable entrances (photo 6), which have been blocked up and replaced by 20th century openings in the adjoining long sides.

- 4.2 Building A is significant for its largely unaltered exterior of local stone with high solid-to-void ratio, and some original details, including the arched entrance and slit ventilators in the long sides, arranged mostly in rows at a high level, but also (less numerous) lower down in the walls. Inserted ground floor openings in the north-east end are 20th century and considered to be less important, but do show the continuing use of the shippin into this period. The interior is largely modern (photo 7), but the roof trusses remain as impressive features, and are enhanced by the painted date of 1833 (photo 8). The barn's original stone slate roof has been replaced by modern steel sheets, which diminish significance and offer scope for enhancement.

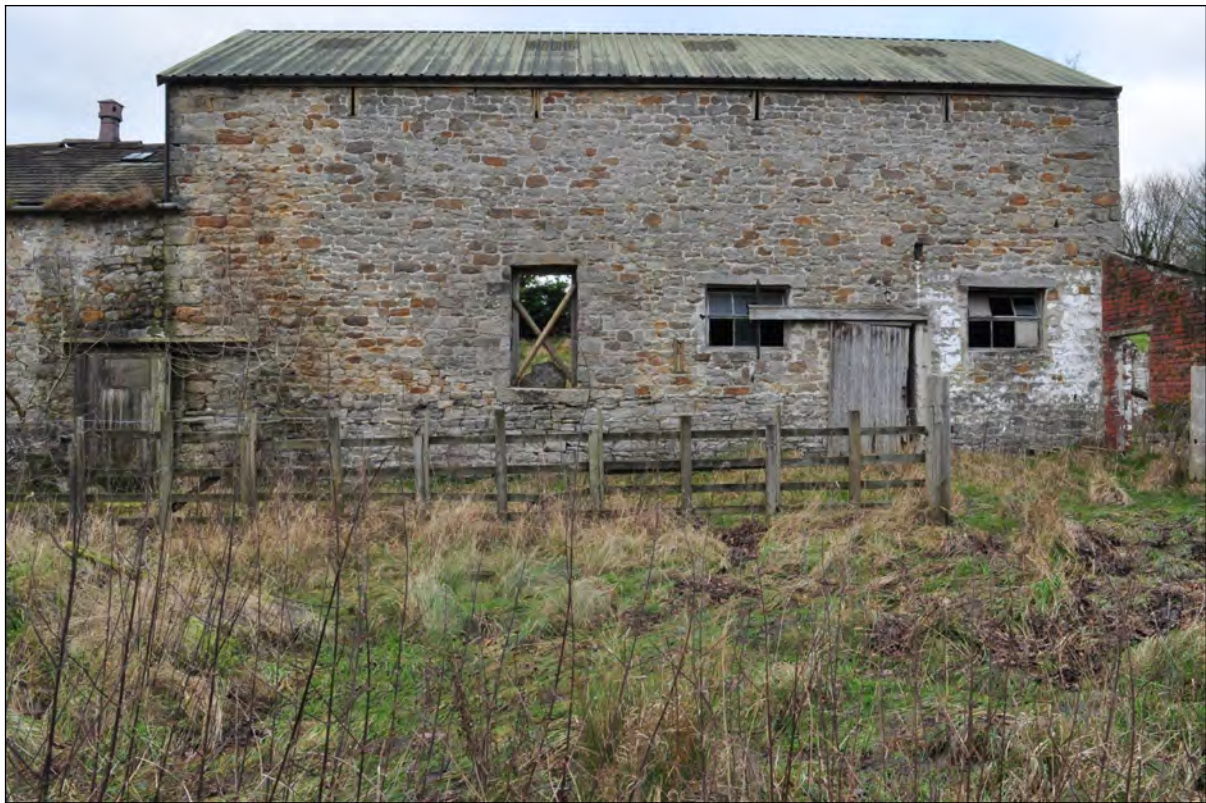
Photo 5: Building A: south-east elevation.

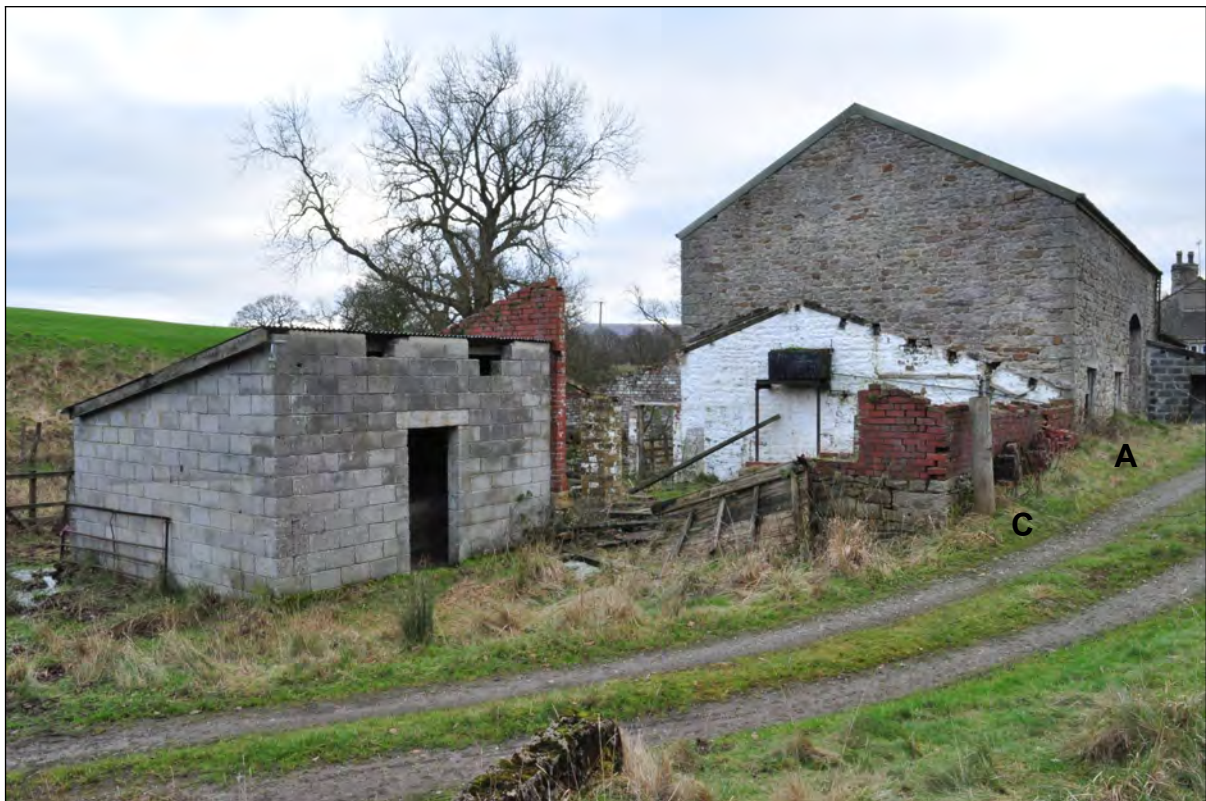
Photo 6: Buildings A & C, looking south. Modern building in foreground would be cleared as part of landscaping

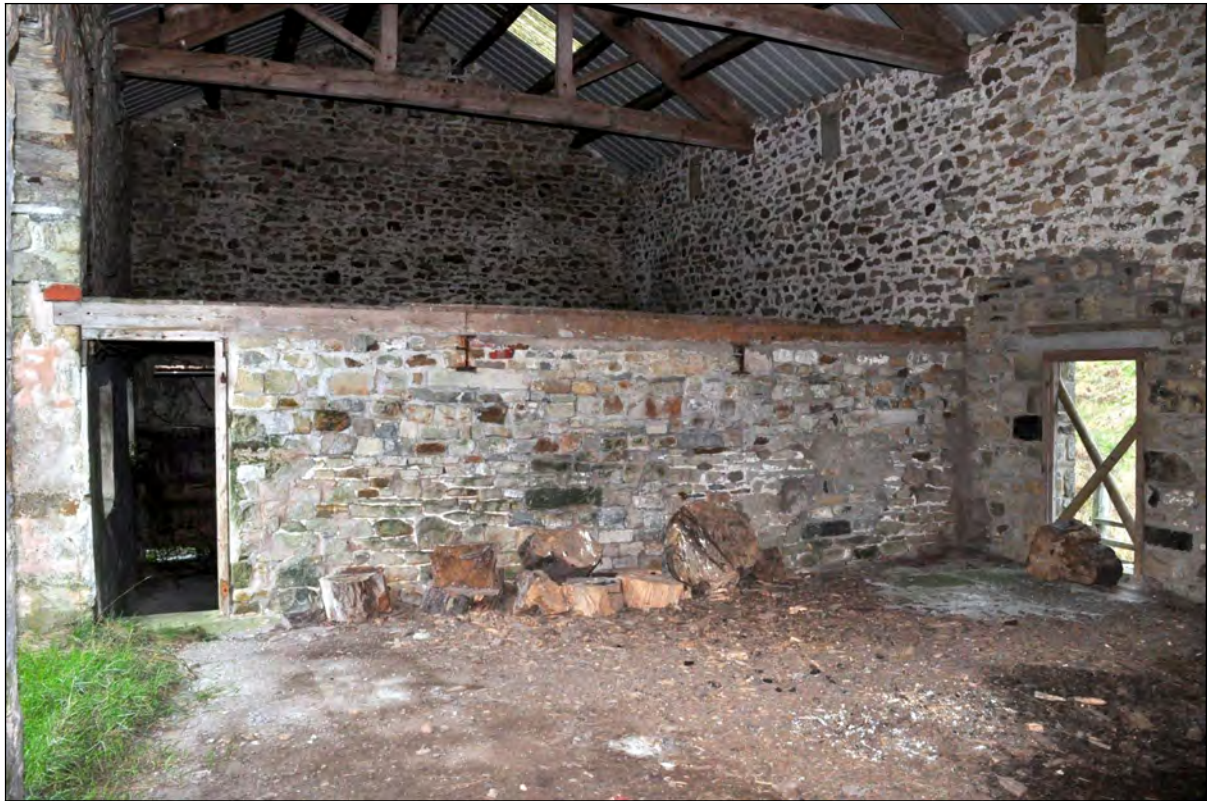
Photo 7: Building A interior: 20th century cross-wall enclosing shippon in north-east end

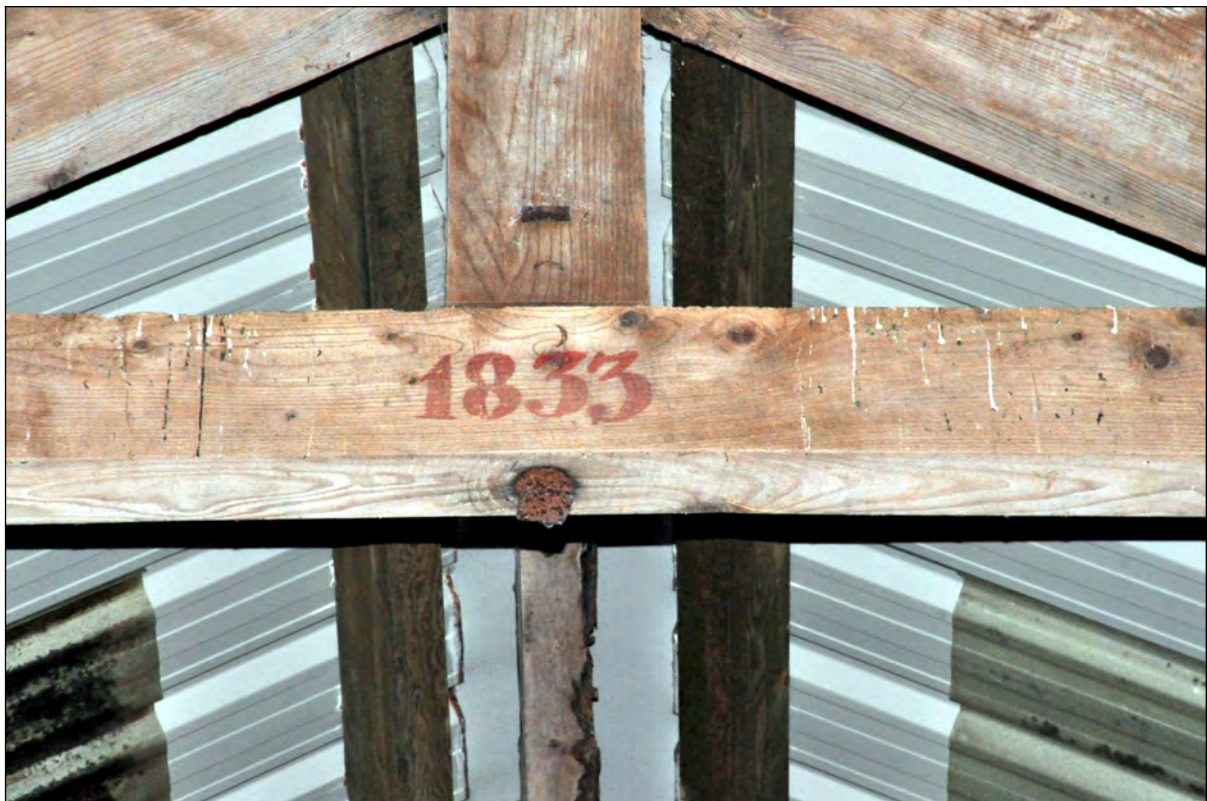
Photo 8: Building A: dated roof timber

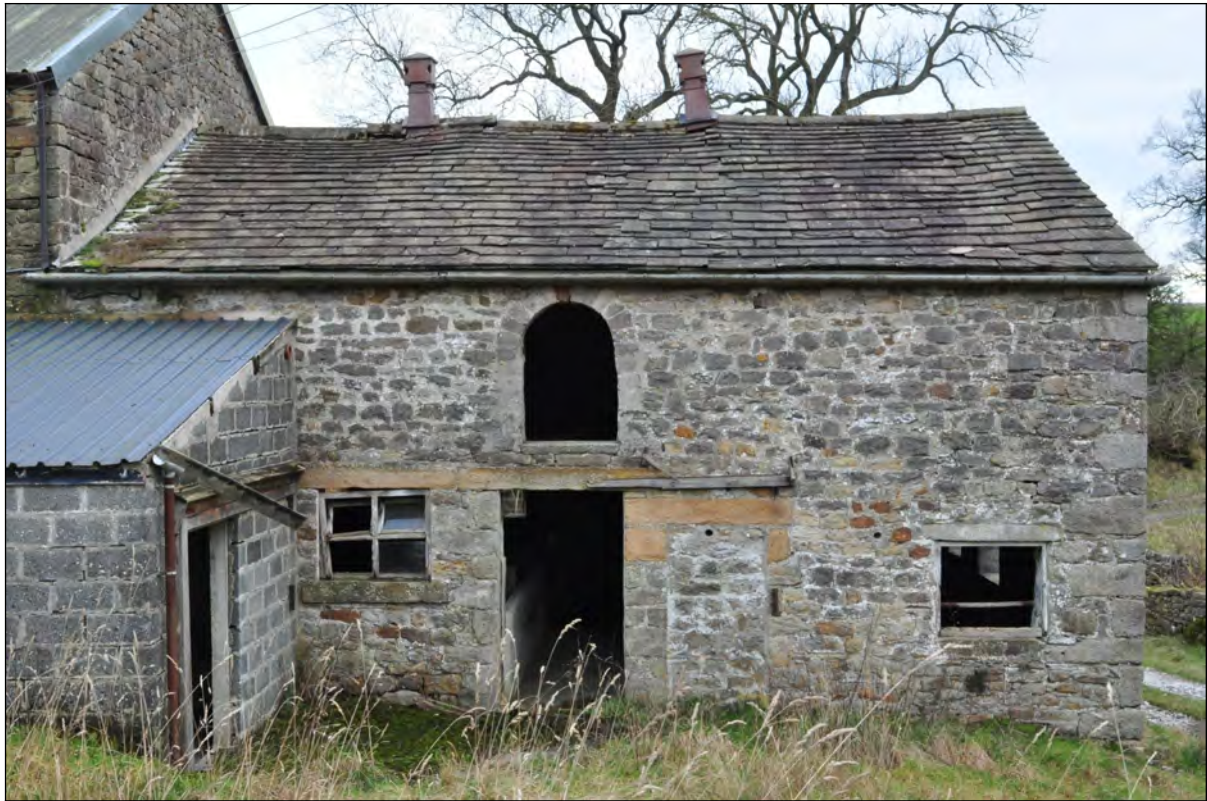
Photo 9: Building B: north-west elevation

- 4.4 Building B is subtly distinct from the barn in terms of its stonework, and retains its original stone slate roof with ventilation cowls (also perhaps original). It has a slightly lower solid-to-void ratio, and a total of four ground floor doorways. These are arranged symmetrically: the two in the north-west side are positioned in the middle of the wall (photo 9), while those in the south-east side are near the outer corners, and these entrances relate to the former layout of animal stalls within the building, set in two rows to either side of the central cross-wall (photo 10). The pattern of windows is less formal and has been subject to some minor change over time, but one notable opening is the small, arched forking hole in the north-west side. The interior has no individual features of interest, but its role in housing livestock remains evident.

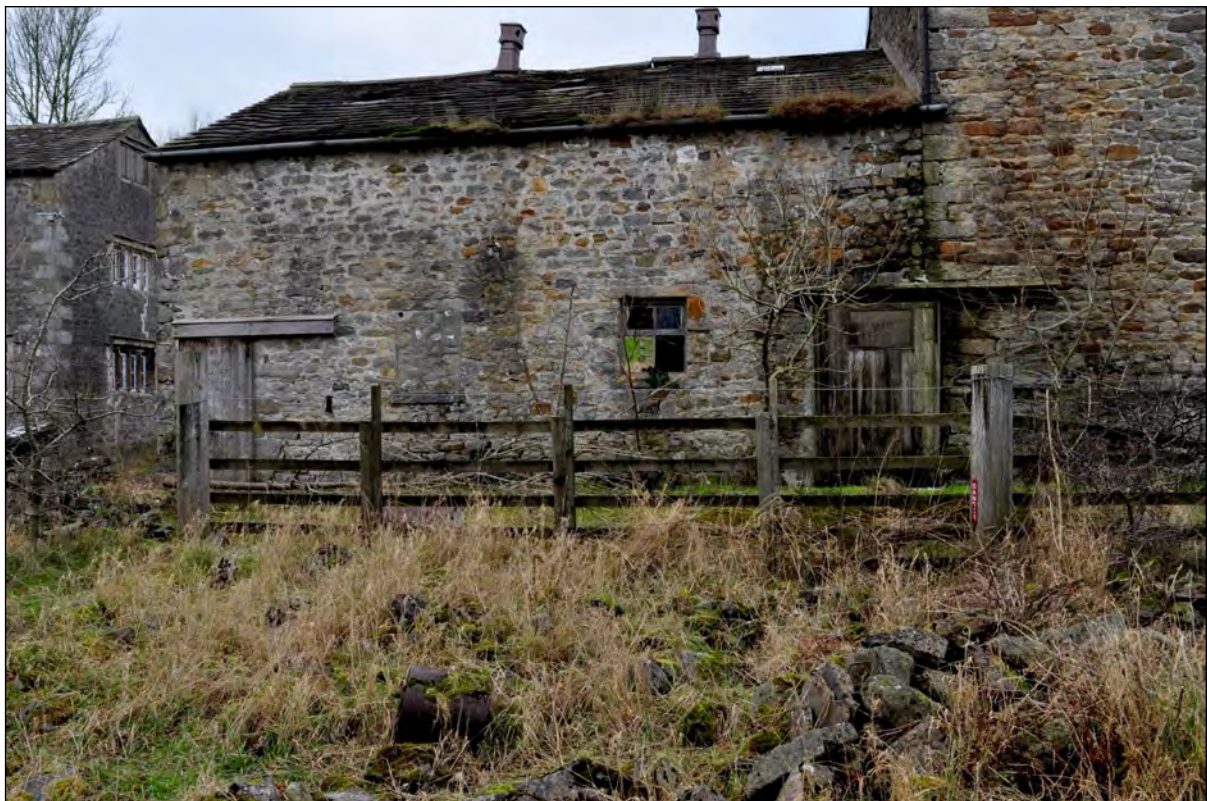
Photo 10: Building B: south-east elevation

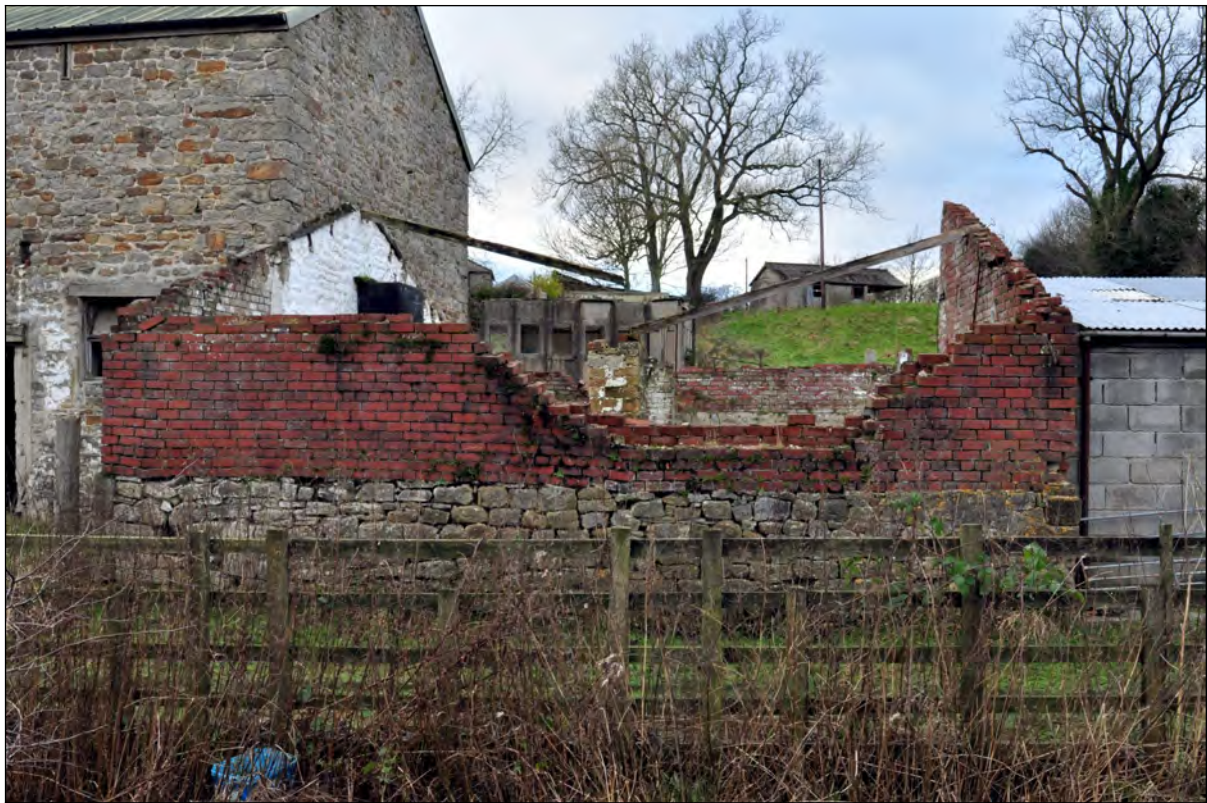
Photo 11: Building C: south-east elevation

- 4.5 Building C is of very low significance but contributes to the linear character of the group. Ordnance Survey maps and the presence of stone within its lower walls suggest it began as a small walled fold-yard, before being made into a brick shippon or similar (photos 11 & 12).

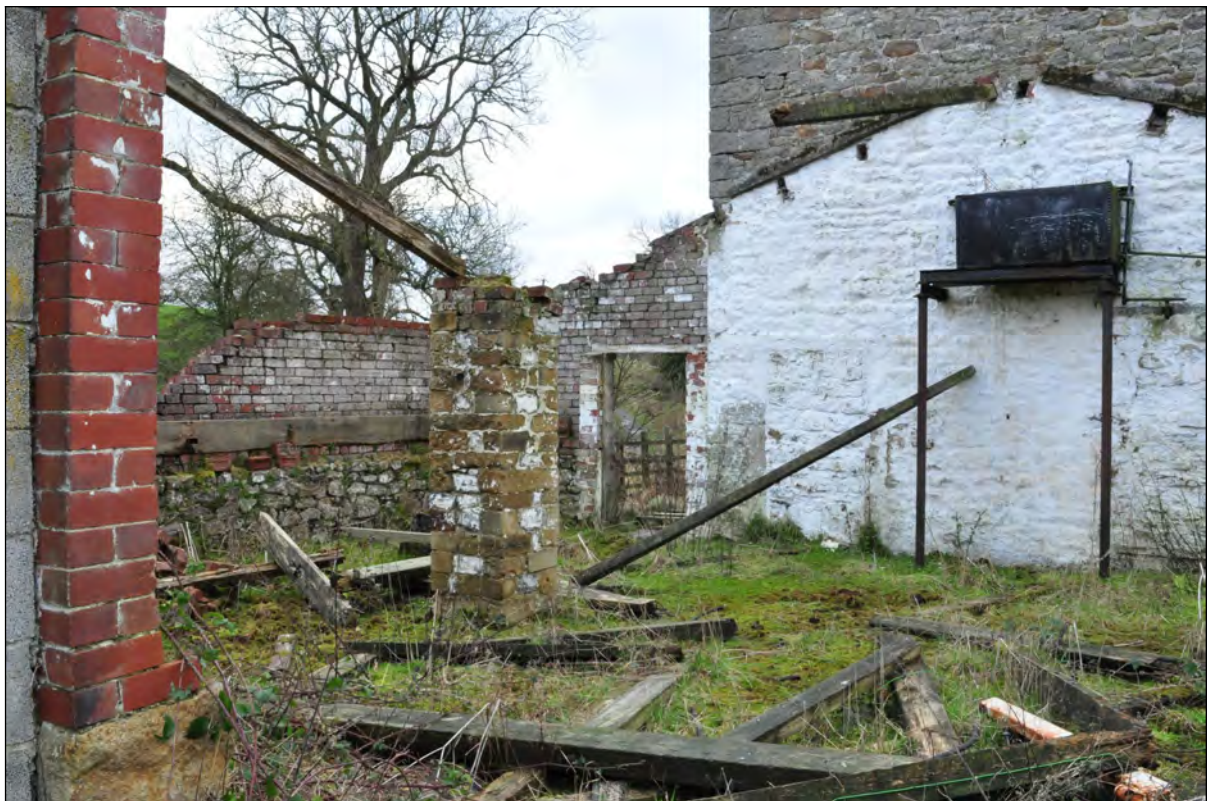
Photo 12: Building C: interior, looking south
