**Bat Survey Report and Method Statement
European Protected Species (Bats)**

**Fields Farm,
Mearley,
Pendleton,
Clitheroe BB7 1PU**

09.05.2025

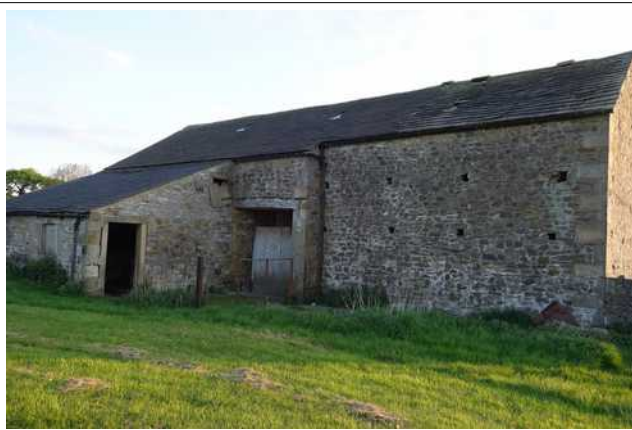
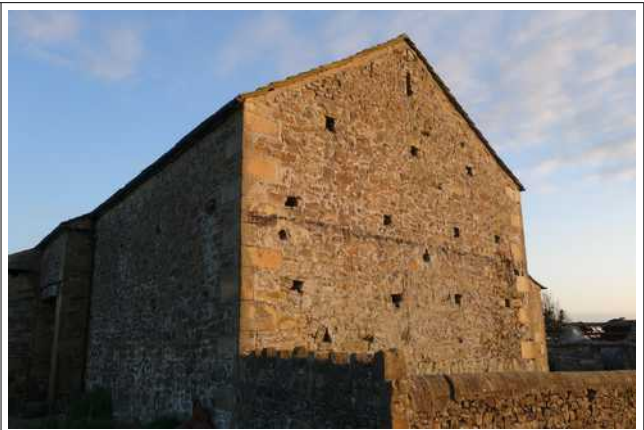
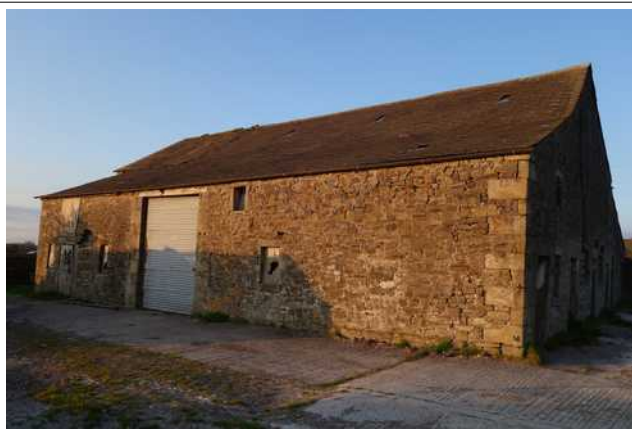
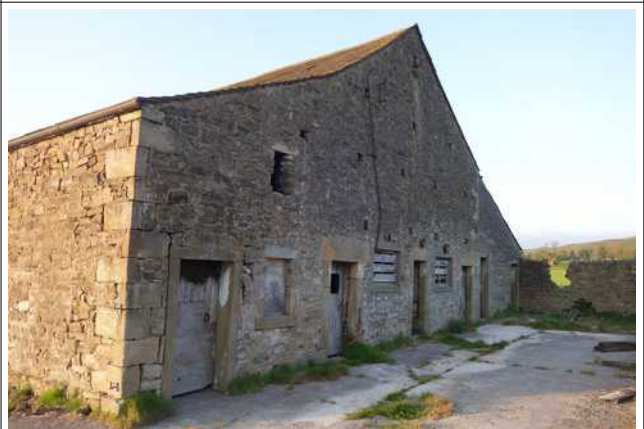
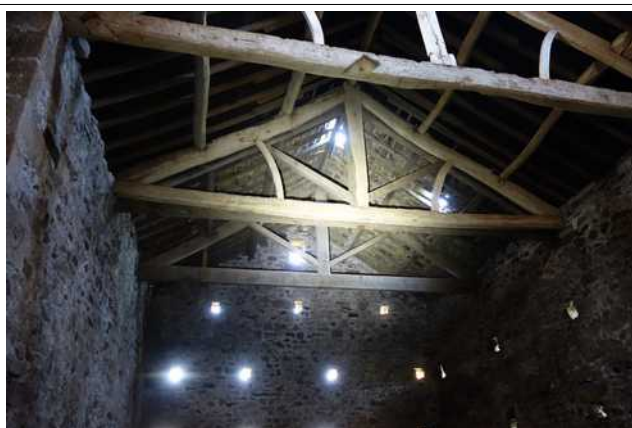
The building consists of a detached two storey stone barn with a double pitched slate roof.

External walls are generally well pointed with some gaps on wall tops. Iopeninings are present on gable ends. Roof slates are generally close fitting with no obvious missing, lifted or slipped slates present. Ridge tiles are pointed and well sealed. Roof slates are partially lined with a bituminous roofing felt.

The building was assessed as offering low bat roost potential when surrounding habitat was taken into consideration.

Two outbuildings were assessed as offering negligible bat roost potential.
