**Proposed development at Wharf Farm, Green Lane, Chipping, Lancashire PR3 2TQ**

Thank you for your request for an updated bat survey relating to a proposed development at the above site.

We understand the proposed development will involve the demolition of an existing bungalow.

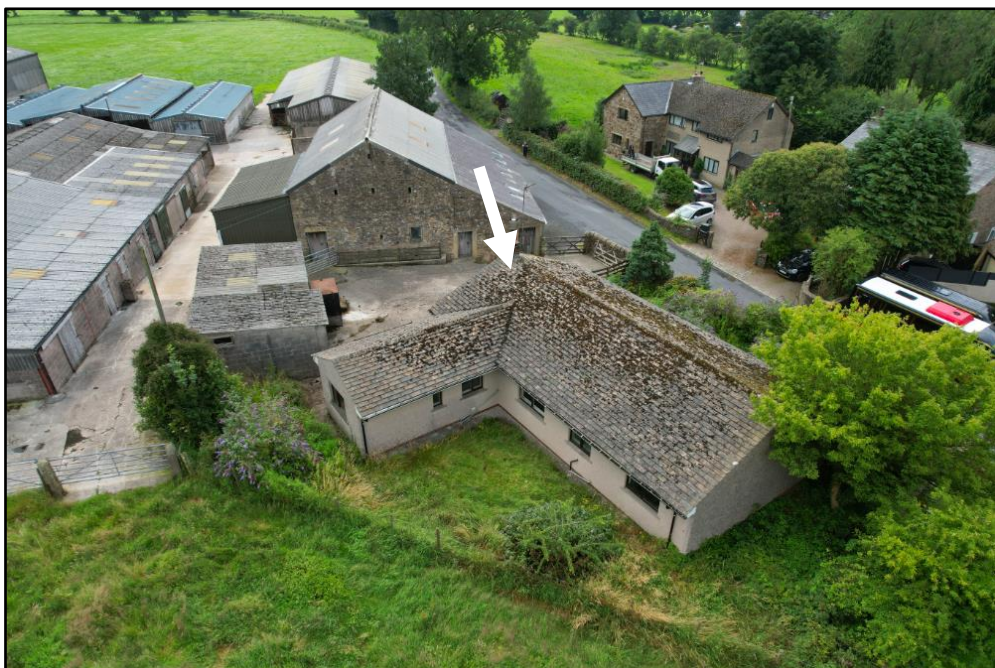
***Oblique aerial taken in 2025 showing bungalow building (white arrow).***

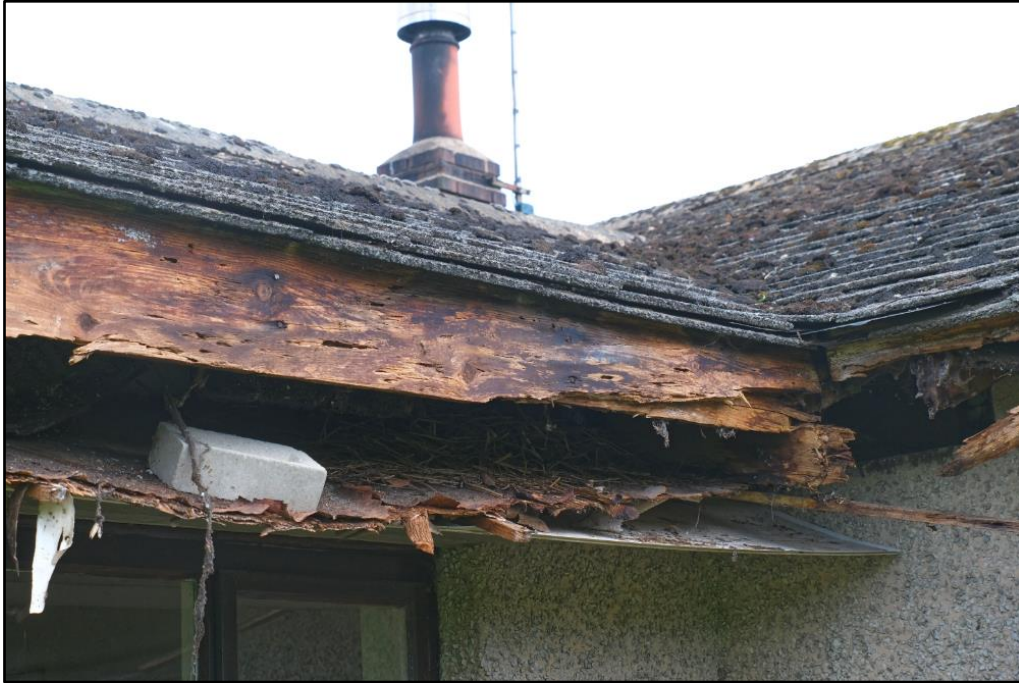
The bungalow building is an unoccupied dwelling, constructed of brick and rendered walls with dual pitched roof sections covered with cement tiles. There are no cavities associated with external walls and the roof coverings are largely intact with only a very small number of gaps present. There is a sealed metal flue, brick-based chimney associated with a kitchen aga which is sealed with no suitable gaps present. All the windows and doors are timber framed and although some gaps were observed none of these are suitable for use by bats or birds. Most of the roof edges are also well sealed with timber and upvc soffits, and mortared gable verges. However, since the 2025 survey the soffits to the north and west elevations (rear of the property) are either missing or falling away from the roof edge. The lack of soffits at this location has created sheltered ledges which are suitable for use by nesting birds.

There are old, unoccupied bird nests present amongst the fallen soffits to the north and west (rear) elevations.

*Image showing west (rear) elevation of bungalow with soffits missing June 2026.*

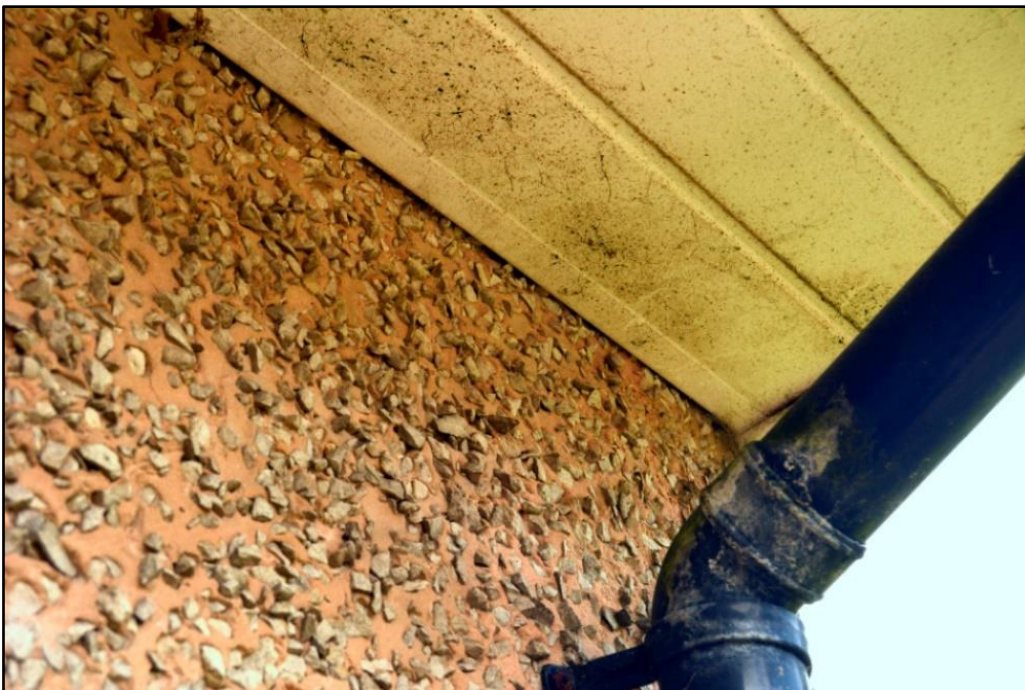
*Close up image showing sealed upvc soffit on pebble dashed rendered walls of bungalow, June 2026.*

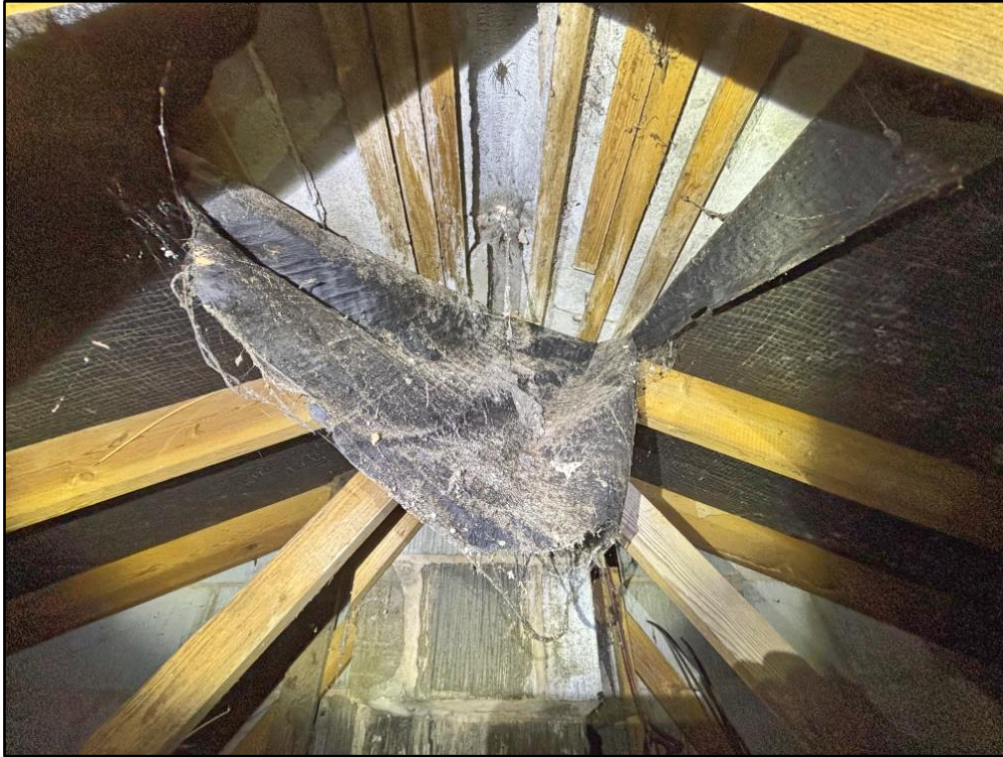
There is a large, single roof void running east to west. The roof is underlined with a perished bitumastic hessian roof liner which is sagging and torn in places. There is no ridge beam and the roof space is cluttered due to the presence of roof trusses and layers of deep rock wool throughout. The lack of soffits along the north and west has introduced more light, and draughts into the roof void, further reducing the likelihood of use by roosting bats.

*Image of roof void showing sagging and torn roof liner, June 2026.*

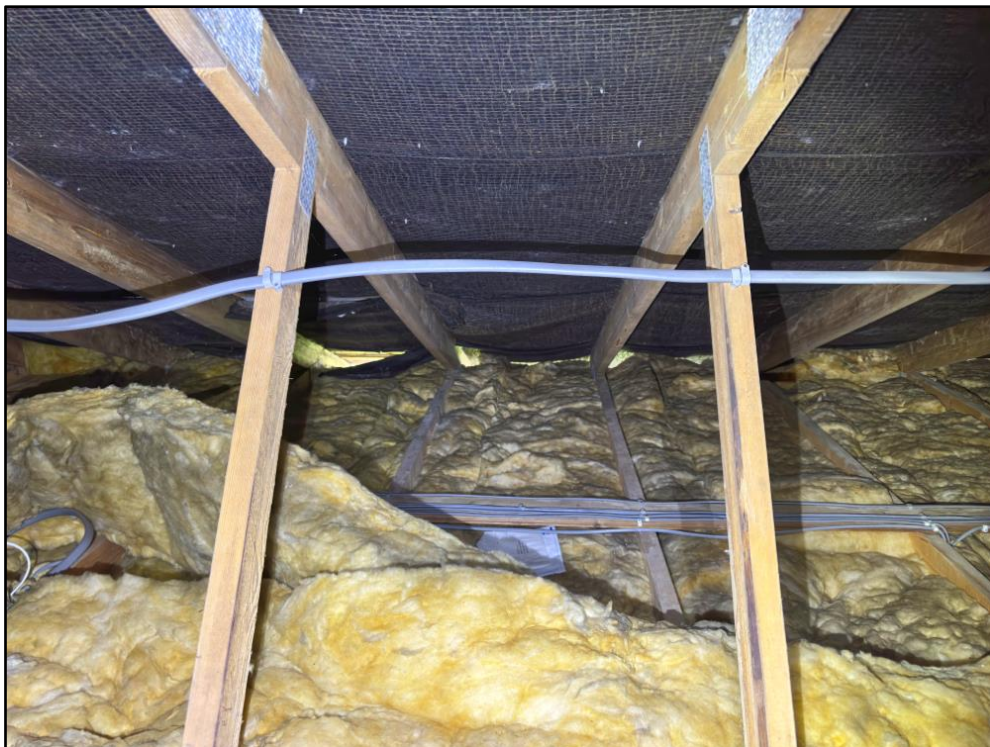
*Image of roof void showing layers of rock wool as well as light spillage along the roof edge due to missing soffits, June 2026.*

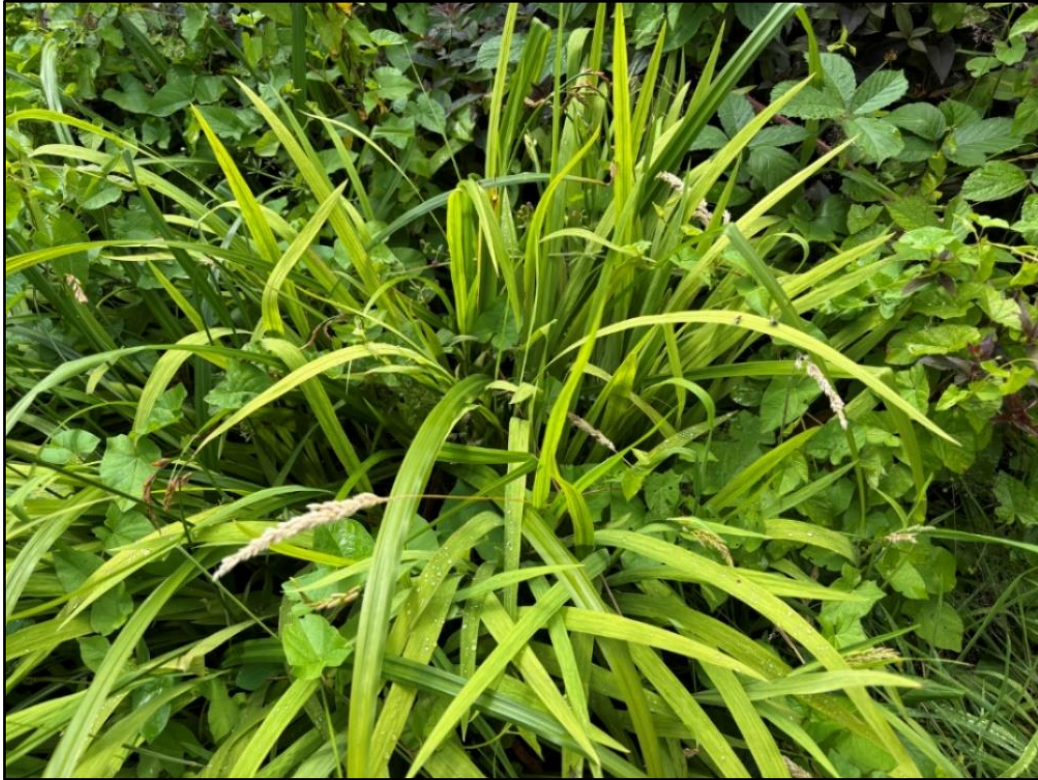
Montbretia *Crocasmia x crocosmiiflora* was found amongst the garden planting during 2025 survey. This plant is listed as an invasive non-native plant species on Schedule 9 of the of the Wildlife and Countryside Act 1981 (as amended).

Montbretia was not confirmed present in 2026, however it is likely to have been hidden beneath and/or obscured amongst the overgrown dense vegetation which has developed due to a lack of garden maintenance.

*Image of Montbretia found present amongst the garden planting in July 2025.*

| Non-native invasive species | Impacts, Issues and Rationale | Action Required |
|---|---|---|
| Montbretia | <p>There are <u>predicted</u> impacts as a result of the presence of non- native plant species; Montbretia.</p> <p>The proposed development will involve an amount of ground disturbance which could result in the spread of Montbretia which is listed on Schedule 9 of the Wildlife and Countryside Act 1981 (as amended). Section 14(2) of the Wildlife and Countryside Act 1981(as amended) prohibits 'planting' or 'causing to grow' in the wild of any plant listed in Part 2 of Schedule 9.</p> <p>Environmental Protection (Duty of Care) Regulations 1991. Any waste containing non-native invasive plant species is classified as controlled waste.</p> | <p><b>Advice (mitigation):</b> The best approach to control the spread of non-native species within small development sites is to avoid any disturbance of the plants and/or ground around them. <b>At all times</b></p> <p><b>Advice (mitigation):</b> If the risk of disturbance to Montbretia cannot be avoided, working methods including control, removal and safe disposal of the plant species must be adopted. For this site, hand digging of individual plants may be sufficient. If larger areas are likely to be disturbed, specialist advice may be required in order to prevent further spread. <b>Prior to commencement of any work.</b></p> <p><b>Advice (mitigation):</b> All people working at the proposed development site should be made aware of the legal issues associated with non-native invasive species and their own responsibilities as regards implementation of precautionary measures. <b>Prior to any work commencing</b></p> <p><b>Advice (mitigation):</b> All arisings from non-native plant species left in situ (i.e. plants that have been retained during development) as part of normal gardening practises (e.g. cut, pruned and/or removed) should be disposed of responsibly. This advice also applies to infected soils, which ideally should not be exported off site or moved within the site, to prevent spread of non-native invasive species into unaffected areas.</p> |

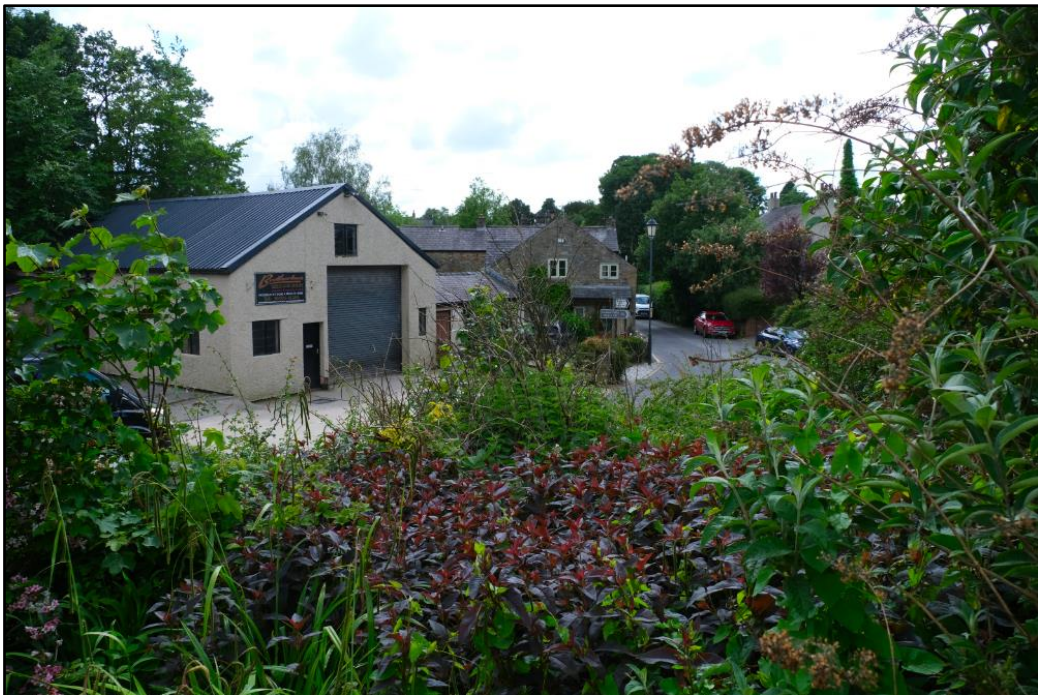
There is high potential for nesting birds to be present within the bungalow, the vegetated garden and the adjacent farm buildings. Some of these features (vegetation and farm buildings) are close enough to the proposed works for any nesting birds to be potentially subject to disturbance.

*Dense garden vegetation with potential to support nesting birds, June 2026.*

| Protected species | Impacts, Issues & Rationale | Action Required |
|---|---|---|
| Nesting birds | <p>There are <u>no predicted</u> impacts (disturbance, damage and destruction) to nesting birds, nests and eggs as a result of the proposed works.</p> <p>It is advised that there is <u>high potential</u> for birds to be nesting within the building, garden vegetation and adjacent farm buildings during the bird nesting season (February to September).</p> <p>Under the Wildlife and Countryside Act 1981 (as amended), wild birds are protected from being killed, injured or captured, while their nests and eggs are protected from being damaged, destroyed or taken.</p> <p>There is no provision under the Wildlife and Countryside Act 1981 (as amended) for licensing the disturbance of nesting birds or the destruction of nests which are in use for the purpose of development.</p> <p>If enforcement action were taken the developer would need to rely on the 'incidental result of an otherwise lawful operation' defence if it were not possible to avoid an offence being committed. This defence can only be tested in court and it is therefore important to ensure all possible mechanisms for avoiding an offence are considered.</p> | <p><b>Advice (mitigation):</b> It is advised that the most appropriate way to address the risk to nesting birds is:</p> <p>Avoid demolition works during the nesting season.</p> <p>Or</p> <p>If works cannot be delayed, the proposed work area should be carefully checked, immediately prior to works commencing. Checks should be carried out by a suitably experienced ecologist. If the risk of nesting birds remains, then monitoring for nesting bird activity should continue for the duration of works. <b>Prior to any work commencing (checks) and throughout works in nesting season (monitoring).</b></p> <p><b>Advice (mitigation):</b></p> <p>If works are to be undertaken during the nesting season, all people working at the proposed development site should attend a toolbox talk delivered by an appropriately experienced person, to be made aware of the likelihood of encountering nesting birds and how to identify them, the legal protection of nesting birds and their own responsibilities as regards implementation of precautionary measures. <b>Prior to any work commencing.</b></p> <p><b>Advice (mitigation):</b> If birds are found to be nesting within or in close proximity to the work area during proposed works, it will be necessary to stop and establish an exclusion area. The extent of the exclusion area, which should be determined by a suitably experienced ecologist, will depend on the bird species and the nature of the proposed works. <b>At all times.</b></p> |

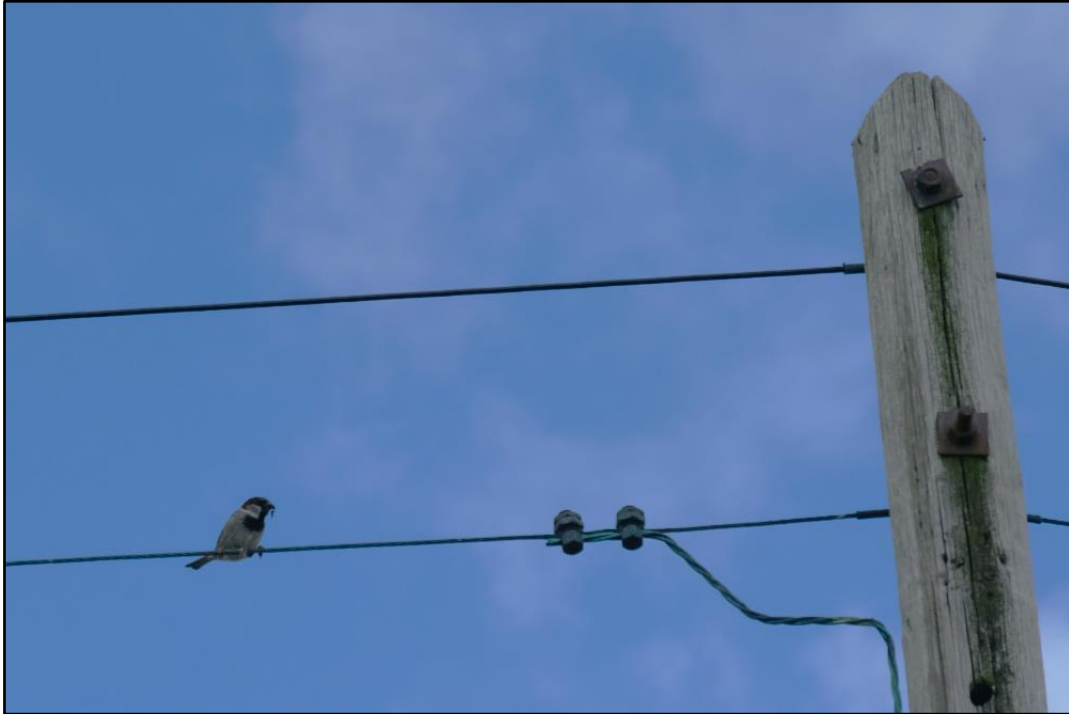
House sparrows were seen collecting food from the garden and seen entering the adjacent farm buildings.

*Image showing House sparrow carrying food*
