Proposed development at Wharf Farm, Green Lane, Chipping, Lancashire PR3 2TQ

Thank you for your request for a bat survey relating to proposed development at the above site.

We understand the proposed development will involve the demolition of an existing bungalow and the conversion of an existing barn building.

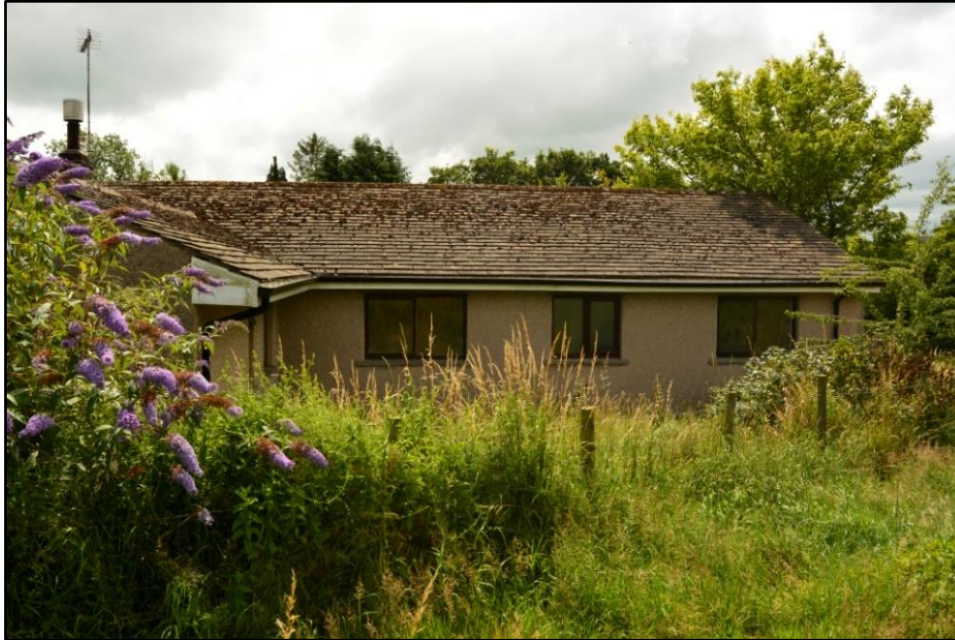
Building 1 – The bungalow is an unoccupied dwelling, constructed of brick and rendered walls with dual pitched roof sections covered with cement tiles. There are no cavities associated with external walls and the roof coverings are largely intact although a very small number of gaps are present. There is a sealed metal flue, brick-based chimney associated with a kitchen aga which is sealed with no suitable gaps present. All the windows and doors are timber framed and although some gaps were observed none of these are suitable for use by bats or birds. The roof edges are also well sealed with upvc soffits and mortared gable verges.

Image showing north (rear) elevation of bungalow (B1)

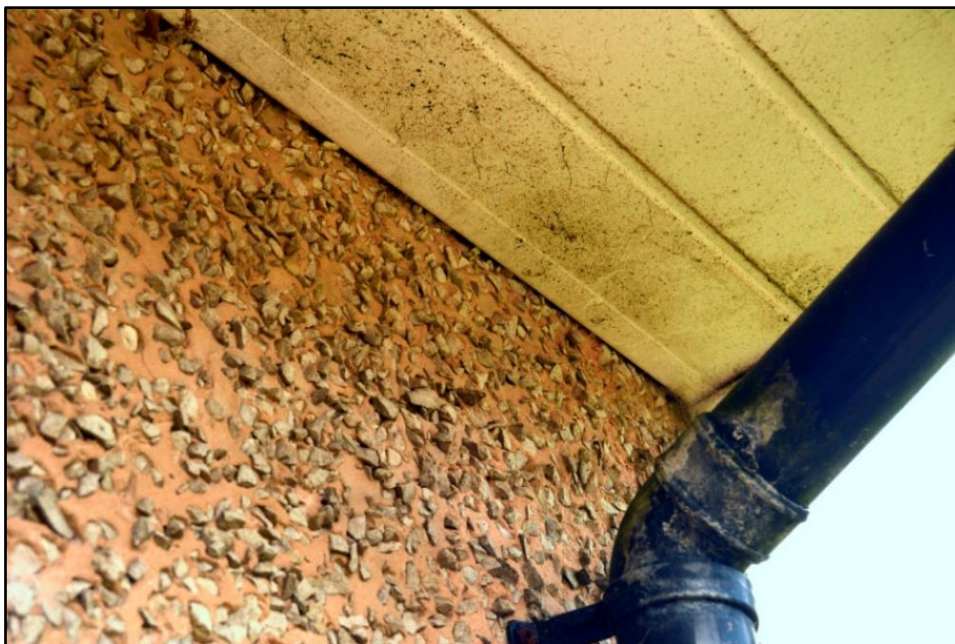
Close up image showing sealed upvc soffit on pebble dashed rendered walls of bungalow

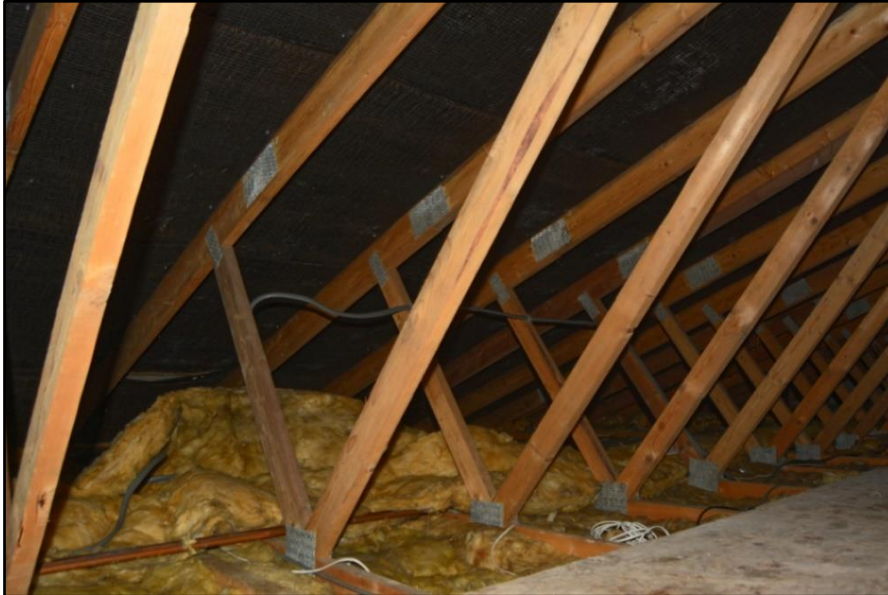
There is a large, single roof void running east west. The roof is underlined with a perished bitumastic hessian roof liner which is showing signs of sagging. A few small holes in the liner and in the roof were observed from inside the roof void. Deep rock wool is present throughout. There is no ridge beam and the roof space is cluttered due to the presence of roof trusses.

Image showing bungalow roof void, cluttered with roof trusses.

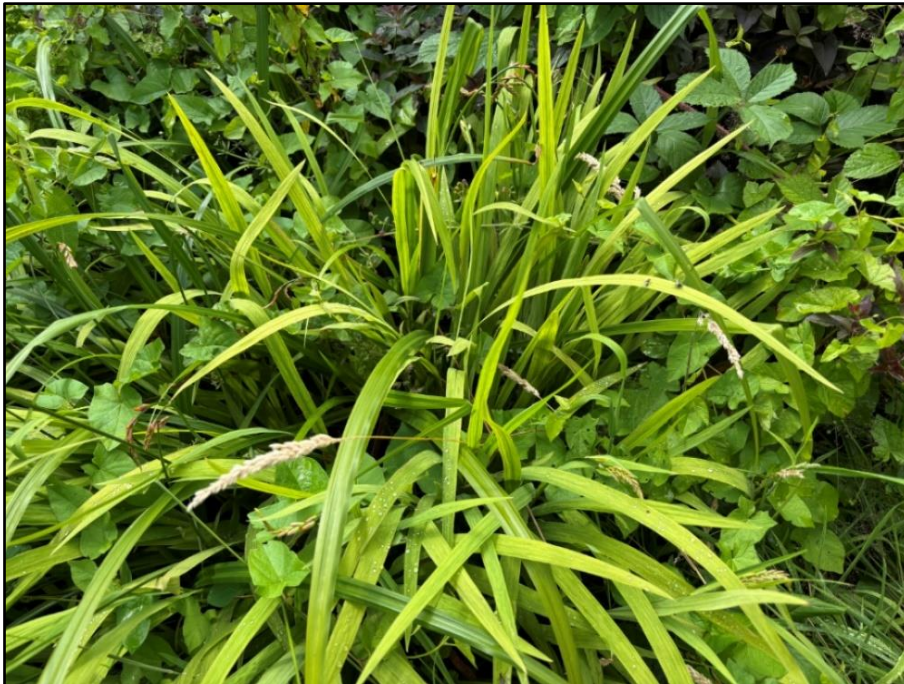
Montbretia *Crococsmia x crocosmiiflora* is present within the bungalow garden. This plant species is listed as an invasive non-native plant species on Schedule 9 of the of the Wildlife and Countryside Act 1981 (as amended).

Image of Montbretia present in garden planting of bungalow

Non-native invasive species	Impacts, Issues and Rationale	Action Required
Montbretia	<p>There are <u>predicted</u> impacts as a result of the presence of non- native plant species; Montbretia.</p> <p>The proposed development will involve an amount of ground disturbance which could result in the spread of Montbretia which is listed on Schedule 9 of the Wildlife and Countryside Act 1981 (as amended). Section 14(2) of the Wildlife and Countryside Act 1981(as amended) prohibits ‘planting’ or ‘causing to grow’ in the wild of any plant listed in Part 2 of Schedule 9.</p> <p>Environmental Protection (Duty of Care) Regulations 1991. Any waste containing non-native invasive plant species is classified as controlled waste.</p>	<p>Advice (mitigation): The best approach to control the spread of non-native species within small development sites is to avoid any disturbance of the plants and/or ground around them. At all times</p> <p>Advice (mitigation): If the risk of disturbance to Montbretia cannot be avoided, working methods including control, removal and safe disposal of the plant species must be adopted. For this site, hand digging of individual plants may be sufficient. If larger areas are likely to be disturbed, specialist advice may be required in order to prevent further spread. Prior to commencement of any work.</p> <p>Advice (mitigation): All people working at the proposed development site should be made aware of the legal issues associated with non-native invasive species and their own responsibilities as regards implementation of precautionary measures. Prior to any work commencing</p> <p>Advice (mitigation): All arisings from non-native plant species left in situ (i.e. plants that have been retained during development) as part of normal gardening practises (e.g. cut, pruned and/or removed) should be disposed of responsibly. This advice also applies to infected soils, which ideally should not be exported off site or moved within the site, to prevent spread of non-native invasive species into unaffected areas.</p>

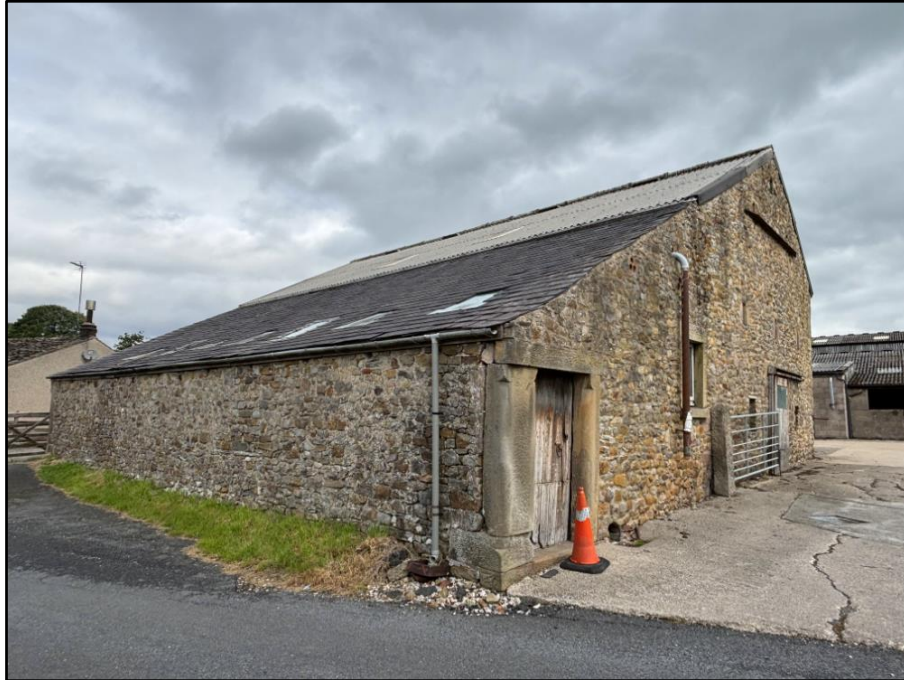
Building 2 – The barn is a former haybarn which includes a shippon as well as an adjoining open shelter along the north east elevation. The building has a cat slide roof covered with corrugated asbestos sheets and slate on the lower, south west elevation. The roof is unlined and roof lights are present within both the slate and sheet coverings. The walls are constructed of stone and there are a series of eye holes and clay pipe vents within the walls. Some of the wall cavities, ledges and lintels associated with the internal and external stone walls have potential for use by bats and nesting birds.

Image of barn (B2) showing south east (farm entrance) and south west (roadside) elevations

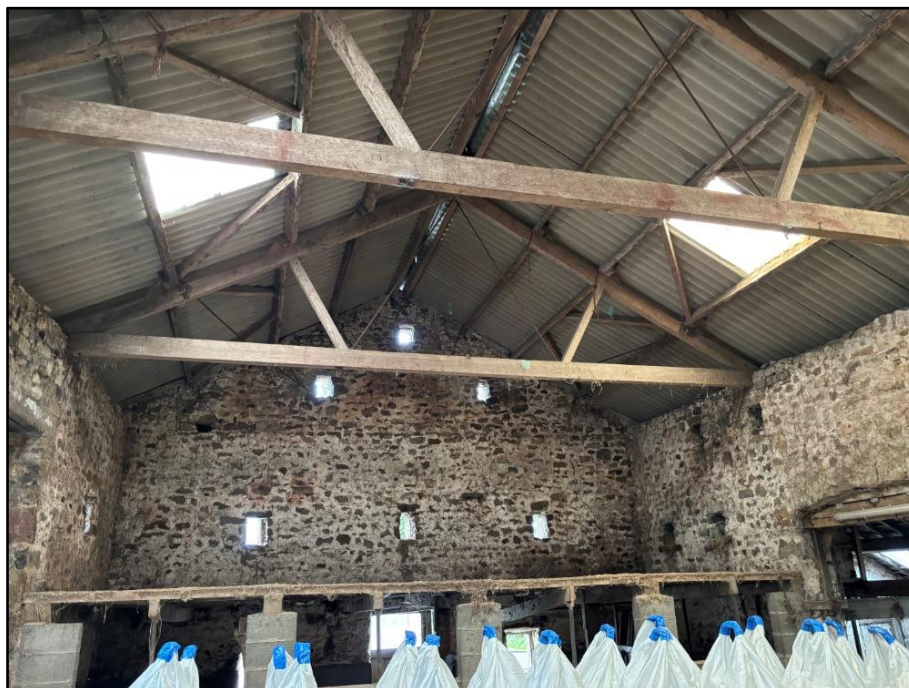
The barn is currently used for temporary storage, it is light, open and draughty with no roof voids. Suitable dark sheltered spaces for use by bats are limited to wall cavities and lintels associated with eye holes.

Internal view of haybarn showing roof underside and wall vents (eye holes)

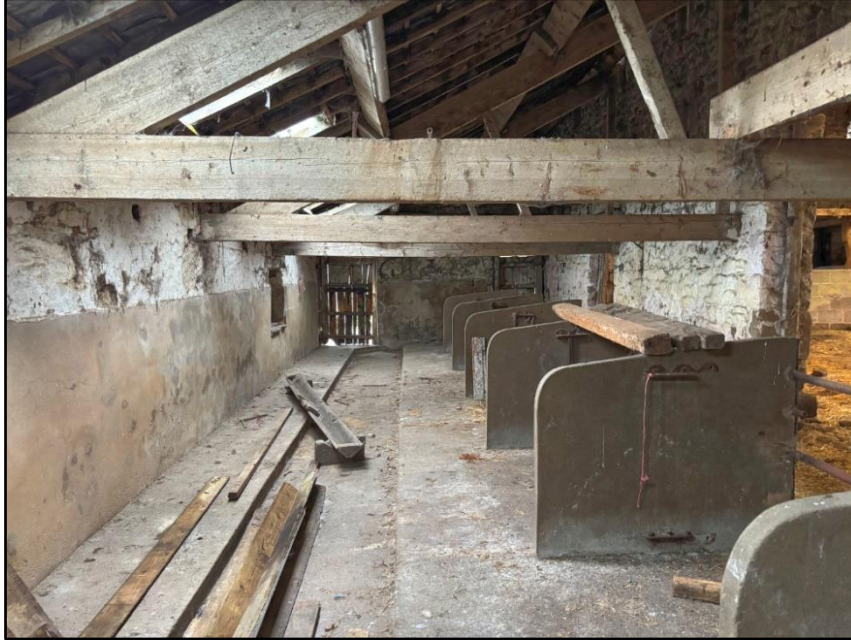
Internal view of Shippon showing light conditions due to presence of roof lights

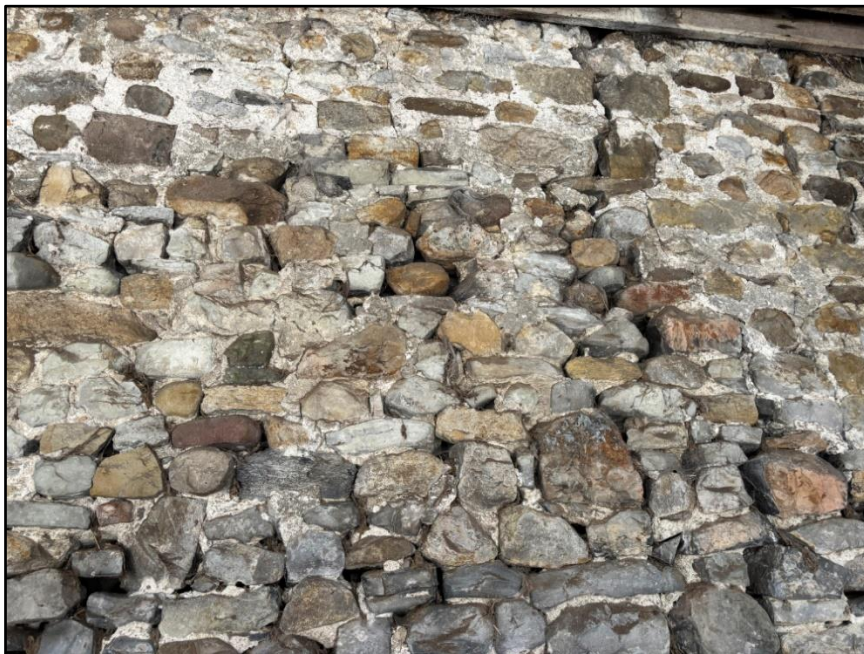
Three unoccupied small bird nests were found within stone wall cavities.

Example of wall cavities (PRFs) in barn

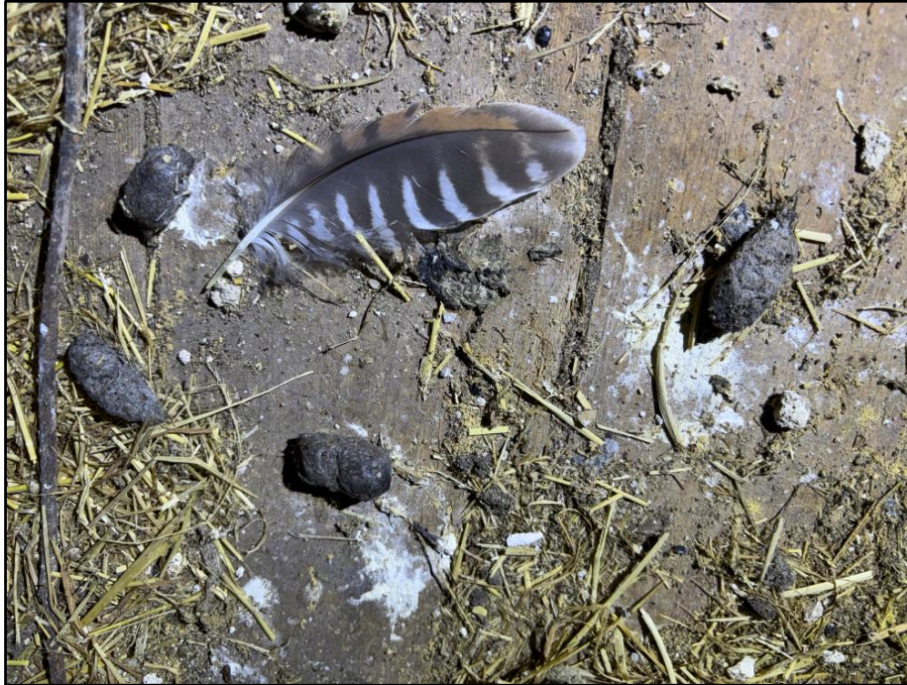
Kestrel pellets, a single kestrel feather and white dropping splashes were found inside the barn and white dropping splashes were also present on the south east external gable wall.

Image showing kestrel signs (pellets, droppings and feather) in barn

Species	Impacts, Issues & Rationale	Action
Nesting birds	<p>There are <u>predicted</u> impacts (disturbance, damage and destruction) to nesting birds, nests and eggs as a result of the development.</p> <p>There is high potential for barn owls to occupy the barn building at any time.</p> <p>Barn owls are included in Schedule One of the Wildlife & Countryside Act 1981 which affords them protection against disturbance whilst nesting. Specifically, under Part 1, Section 1 (5) it is an offence intentionally or recklessly to:</p> <ul style="list-style-type: none"> • Disturb any wild bird included in Schedule 1 while it is building a nest or is in, on or near a nest containing eggs or young • Disturb dependent young of such a bird <p>There is high potential for other bird species to be nesting in the barn building, adjacent farm buildings and bungalow garden vegetation during the bird nesting season (February to September).</p>	<p>Advice (mitigation): All people working at the proposed development site should be made aware of the likelihood of encountering barn owls and other nesting birds, and should be made aware of the legal protection of barn owls and nesting birds and their own responsibilities as regards implementation of precautionary Prior to any work commencing.</p> <p>Advice (mitigation): A pre-commencement check should be undertaken by an ecologist, to check for any use by barn owls. Prior to any work commencing</p> <p>Advice (mitigation): It is advised that the most appropriate way to address the risk to nesting birds is:</p> <ul style="list-style-type: none"> • Avoid working on the buildings and/or in close proximity to vegetation during the nesting season • Or If works cannot take place outside the nesting season, the following measures should be adopted: <ul style="list-style-type: none"> • All people working at the site should attend a tool box talk by an ecologist • All areas for removal/disturbance should be carefully checked by an ecologist, immediately prior to works commencing. • If the risk of nesting birds remains, then monitoring for nesting bird

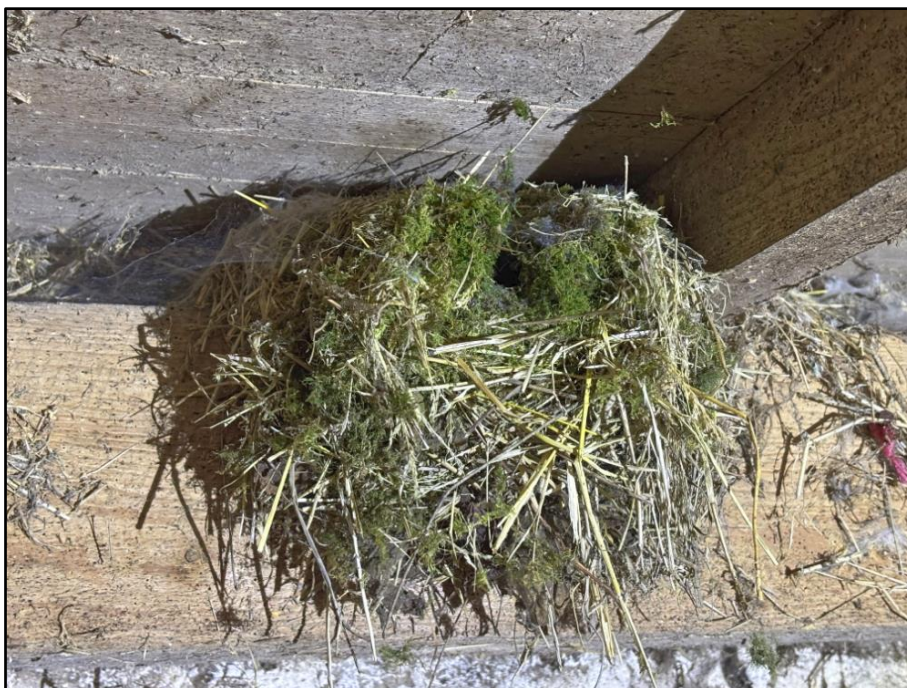
Image showing example of bird nest found beneath hayloft floor in barn

Species	Impacts, Issues & Rationale	Action
Nesting birds continued	<p>Under the Wildlife and Countryside Act 1981 (as amended), wild birds are protected from being killed, injured or captured, while their nests and eggs are protected from being damaged, destroyed or taken.</p> <p>There is no provision under the Wildlife and Countryside Act 1981 (as amended) for licensing the disturbance of nesting birds or the destruction of nests which are in use for the purpose of development.</p> <p>If enforcement action were taken the developer would need to rely on the 'incidental result of an otherwise lawful operation' defence if it were not possible to avoid an offence being committed. This defence can only be tested in court and it is therefore important to ensure all possible mechanisms for avoiding an offence are considered.</p>	<ul style="list-style-type: none"> activity should continue for the duration of works. <p>Prior to any work commencing (checks) and throughout works in nesting season (monitoring)</p> <p>Advice (mitigation): If nesting birds are found at the proposed development site, or close enough to cause unlawful activities as a result development works, it will be necessary to delay works or seek advice as to whether or not any development can proceed lawfully at that time. Under these circumstances, work must stop until advice has been sought from an appropriately experienced Ecologist. Prior to any work commencing (checks) and throughout works in nesting season (monitoring)</p> <p>Recommendation (mitigation and compensation): It is recommended that bird nesting features and/or nest boxes should be installed on or within the refurbished barn building. 1 x kestrel/barn owl box, 3 x house sparrow boxes and 2 swallow nest cup should be installed to help maintain nesting provision for birds. Post development</p>
