**BAT SURVEY  
AT  
RIDINGS COTTAGE  
WHALLEY OLD ROAD  
BILLINGTON  
BB7 9JF**

**DATE AND TIME OF VISIT  
3<sup>RD</sup> March 2026. 10.00am**

**REFERENCE NO. 7129**

Proposed conversion of existing garage to form a dwelling.

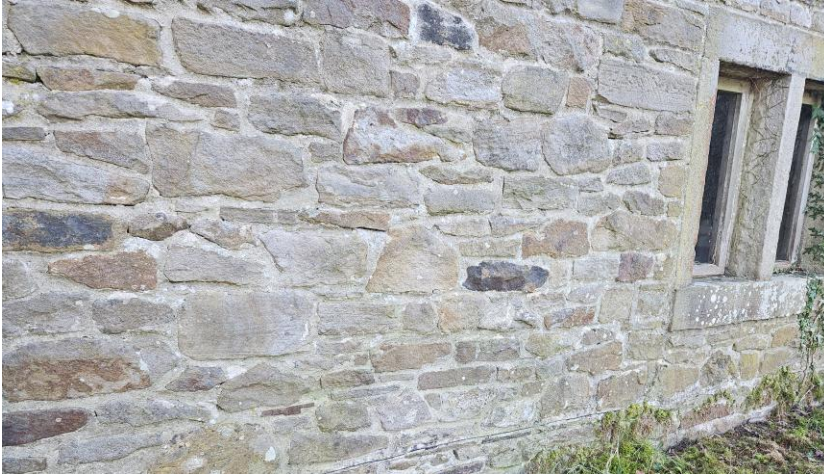
The walls are random stone with a block backing

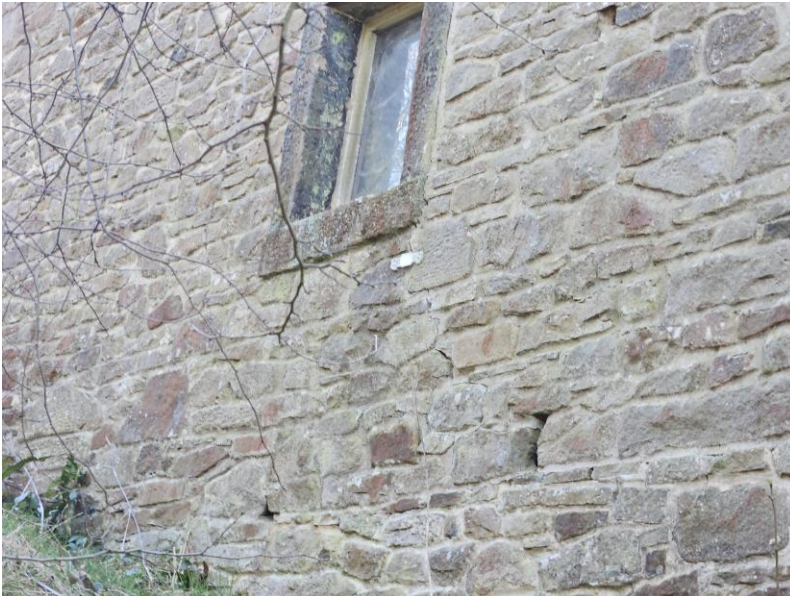
The walls are generally well pointed and do not any cracks or crevices with the potential to provide roost habitat.

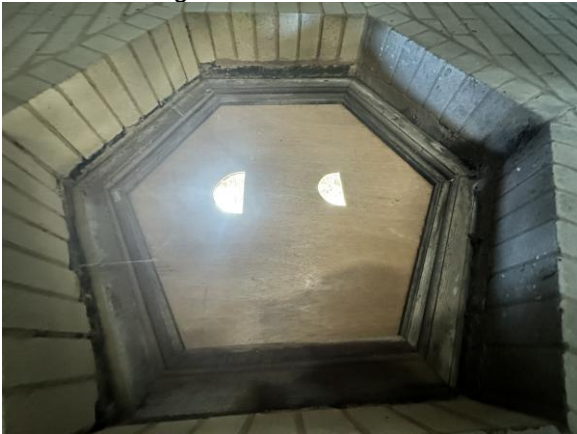
The timber infill to the circular window in the front gable has a couple of holes which provide access into the building

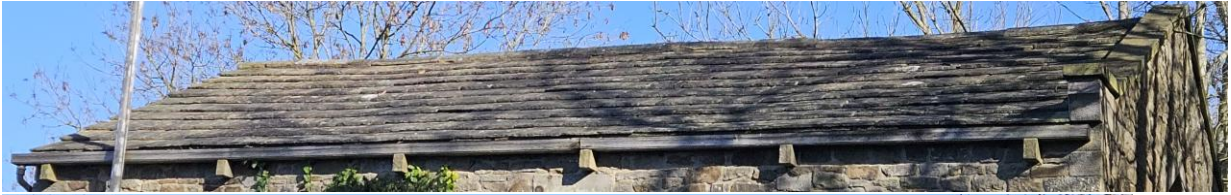
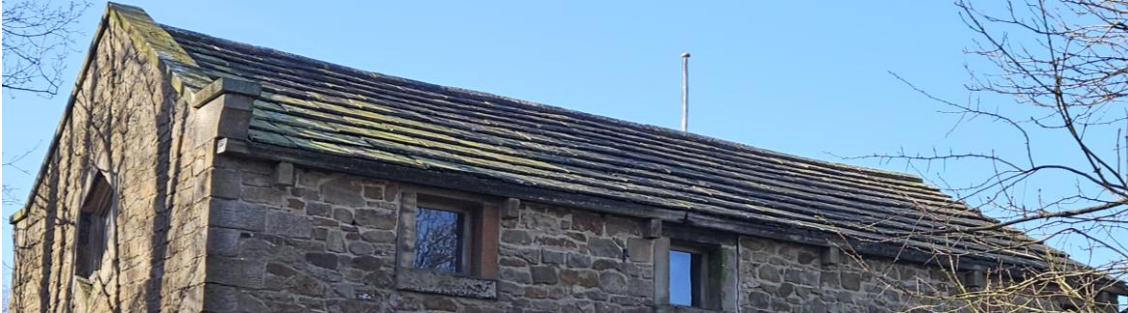
The roof is pitched with a grey slate finish. With stone copings to the front southeast elevation. Pointed verge to the northwest gable.

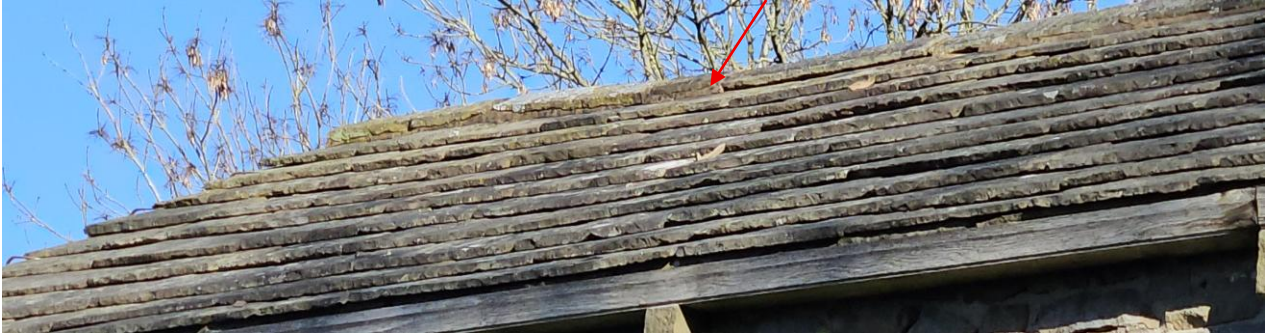
The roof was examined from ground level with the aid of binoculars. All slates were present with no slipped or any significant gapping present. The ridge tiles were well pointed

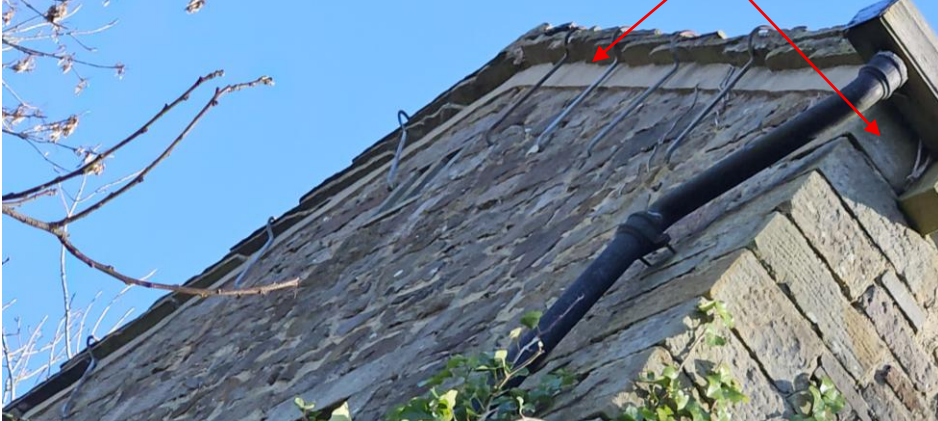
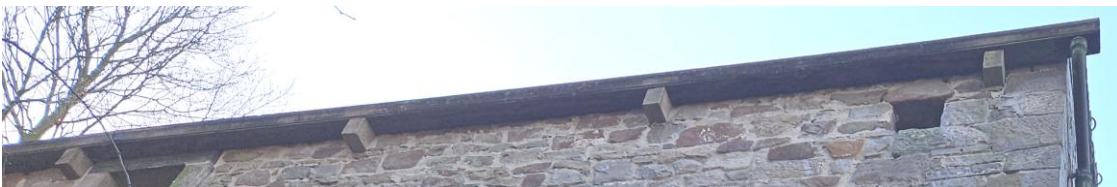
The verge is tight fitting the pointing to the verge and the eaves is in excellent condition

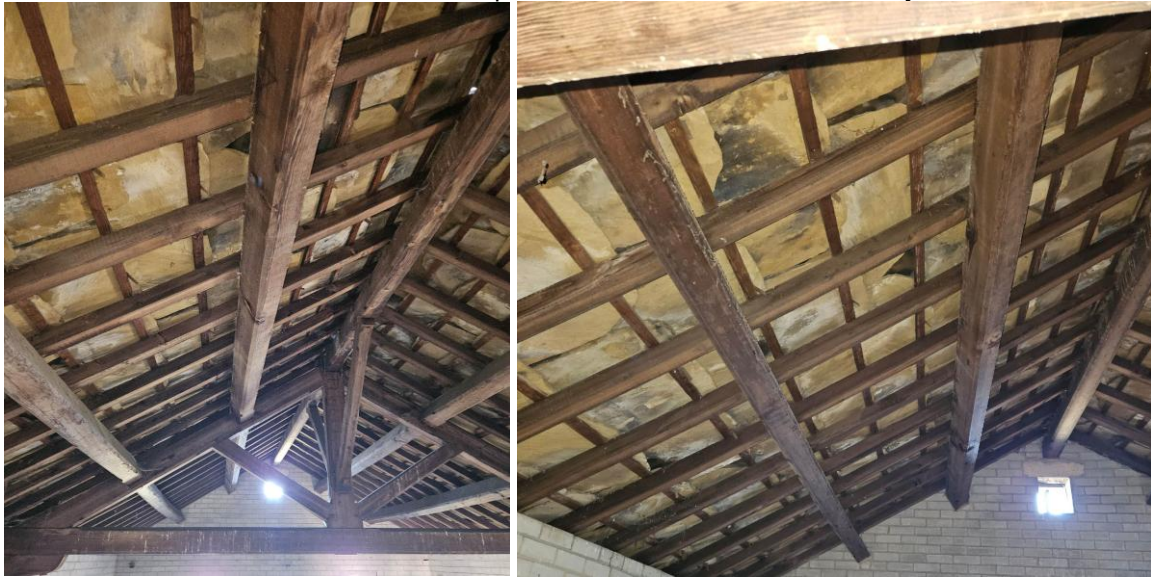
There is no enclosed roof space in the building all the structure is fully visible. It is a timber purlin, truss, rafter and batten roof. It was possible to inspect from the first floor. All timbers were in excellent condition, no rot, cracks or crevices were present. The slate was fixed directly over the rafters.

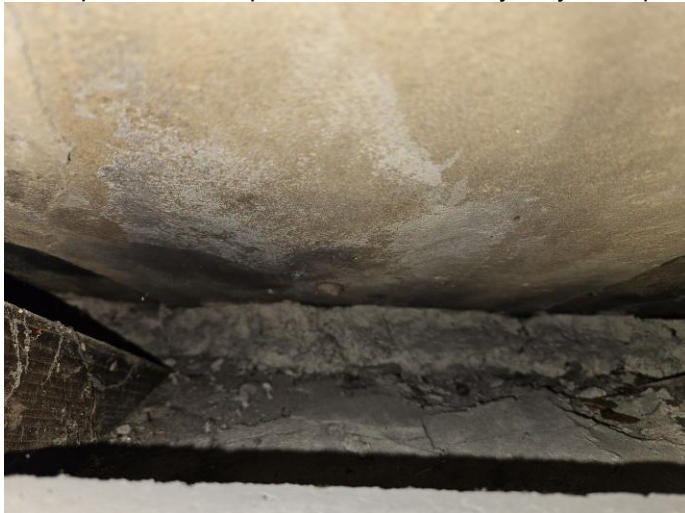
It was possible to inspect the eaves closely they were pointed internally and very well sealed.

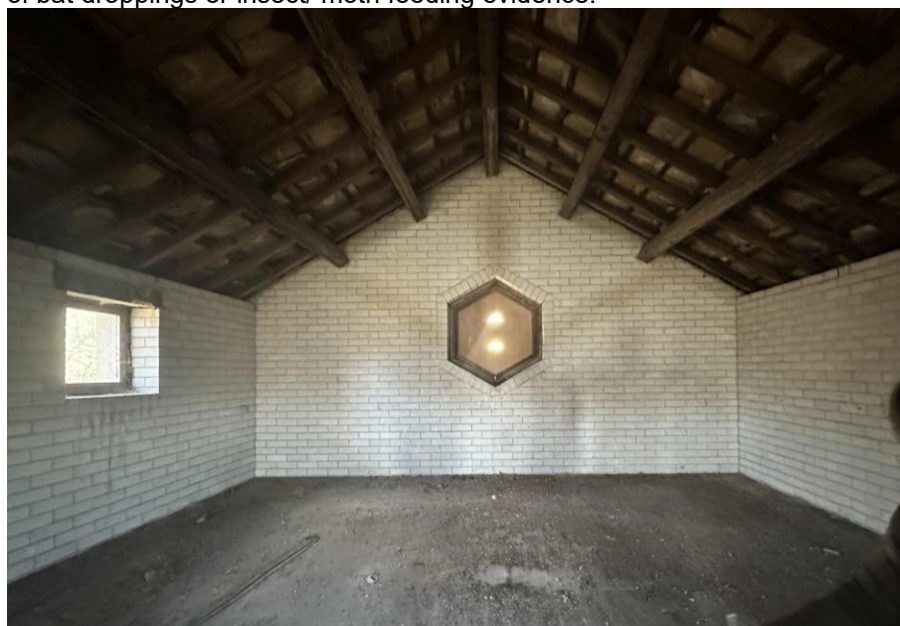
The interior walls and roof structure and all internal floors and surfaces were examined for any of the below listed evidence of current or historic bat presence, including the sill beneath the gable round window, the result was negative.

The walls did not provide any potential bat roost habitat. All the floors were dusty but had no evidence of bat droppings or insect/ moth feeding evidence.
