**Moor Close Farm, Rimington**

**BAT SURVEY REPORT**

**July 2026**

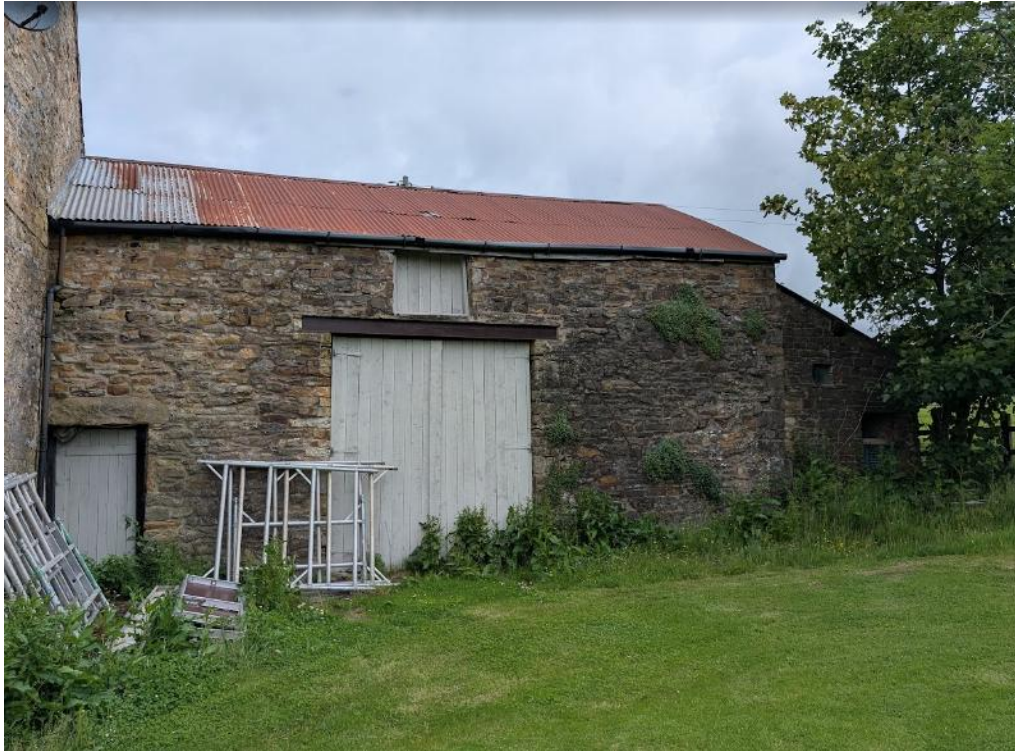
**Plate 1.1. Barn**

The barn dates from the early 19<sup>th</sup> century and is a stone construction. There are three sections comprising the original stone barn, a small attached stone outbuilding and a later extension used as a garage. The original barn is currently disused.

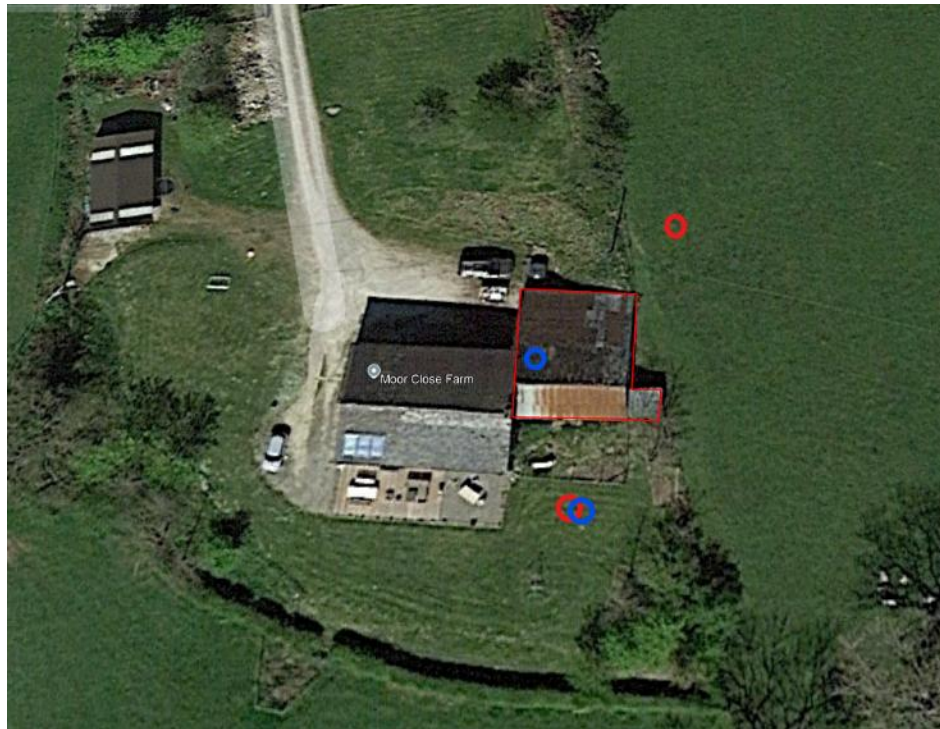
**Survey  
positions**

In consideration of the size, layout, and aspects of the structure, for the first visit, two survey positions were used to obtain clear sightlines of all potential roost features identified during the preliminary roost assessment. A single survey position was considered sufficient for the second visit as potential roost features were focused on the south elevation. However, for the second visit an NVA system was also placed inside the barn. These survey positions enabled surveyors to record any bats emerging from the building, including species and numbers, should a roost be present.

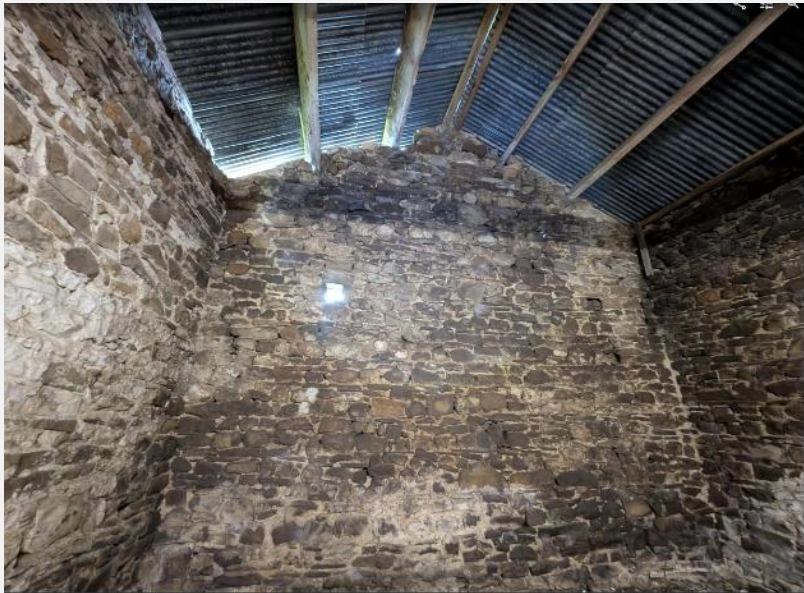
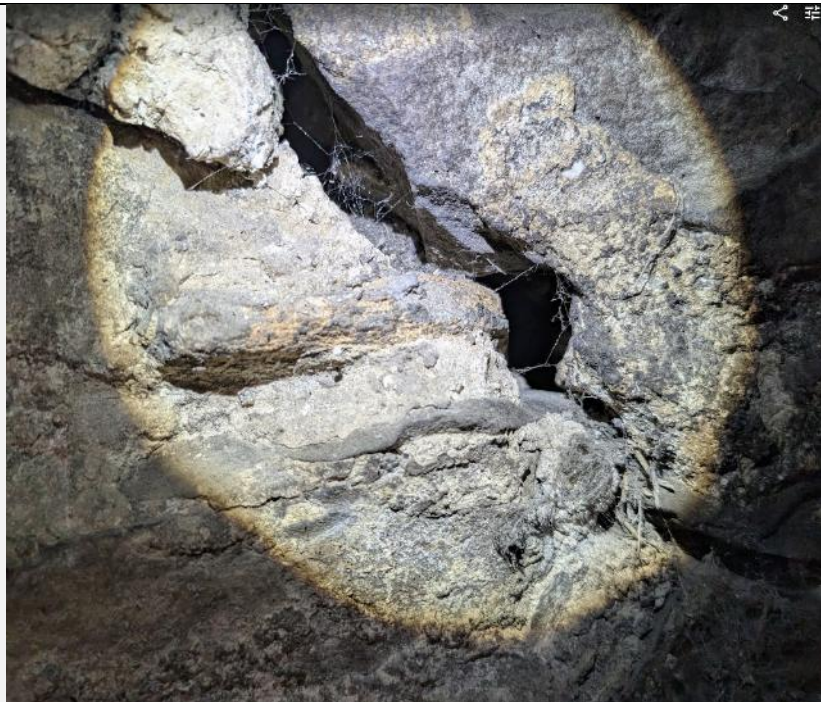
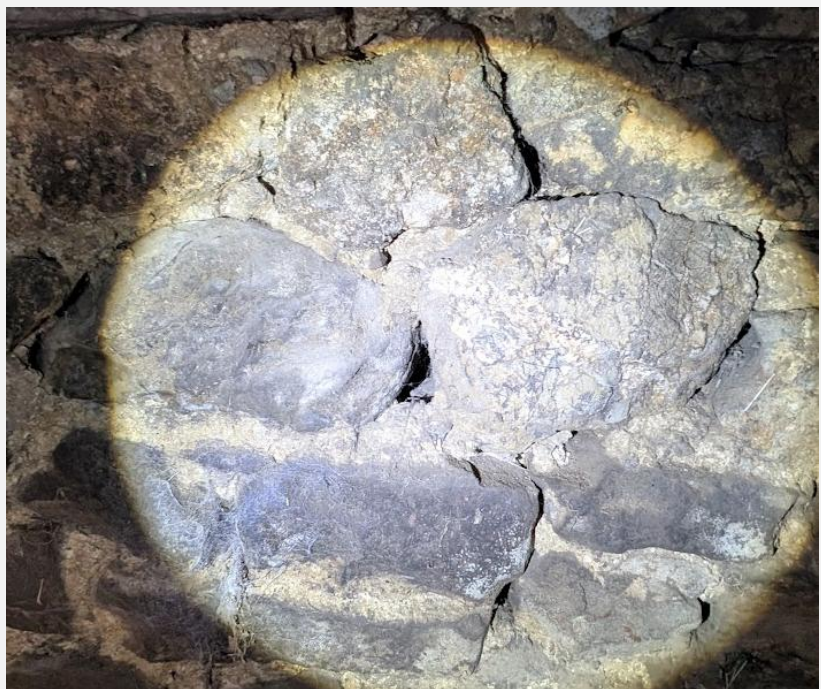
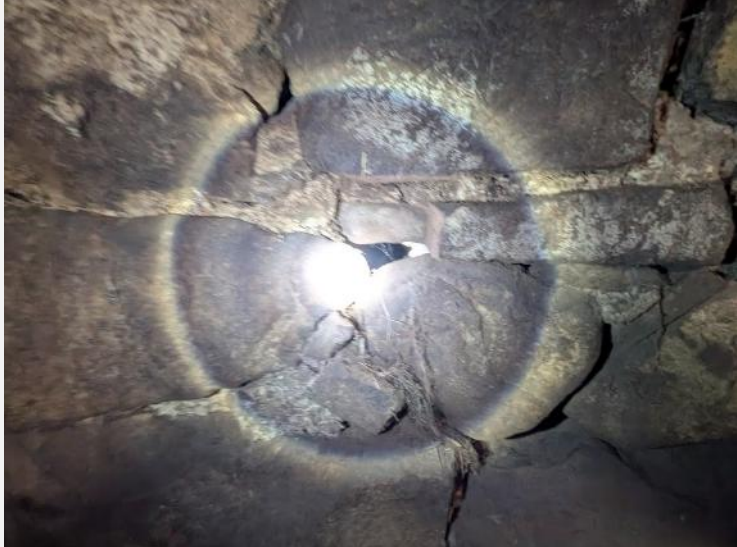
The barn is open from floor to ceiling with no haylofts. The conditions were relatively dark. The majority of the inner stonework of the barn was solidly pointed. However, the pointing of the eastern inner wall along with a corner of the western inner was degraded. Most of the gaps were not recessed and approximately ten suitable gaps for bats were recorded throughout the stonework. There was also one gap under a timber purlin on the west wall. These potential roost features were considered to be the main areas of suitability for bats.

| <p><b>Plates 3.1a – 3.1d</b></p> <p>Examples of cavities in stonework.</p> | |

- With respect to the deep stone crevices in the inner and outer stonework, it is advised that any development works should avoid the hibernation period for bats (November to February / March). Any works potentially affecting bat roosts should be undertaken in the main active period (April to mid-October).

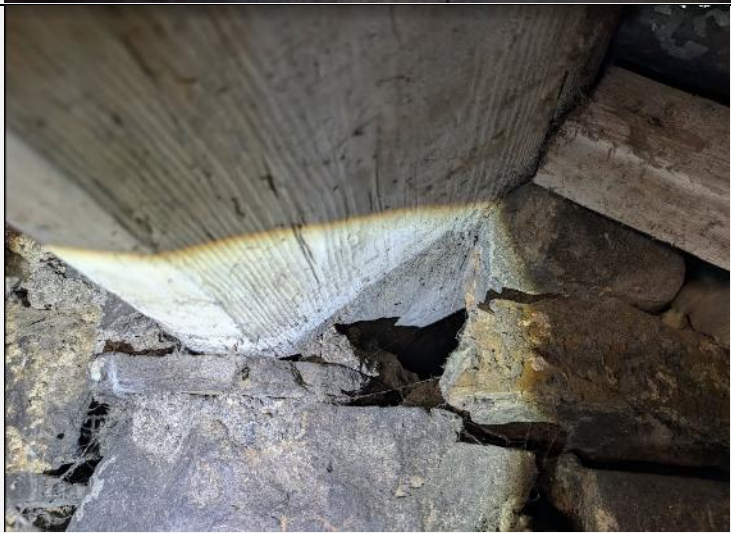
| <p><b>Plate 3.2.</b></p> <p>Gap under purlin on east wall.</p> | |

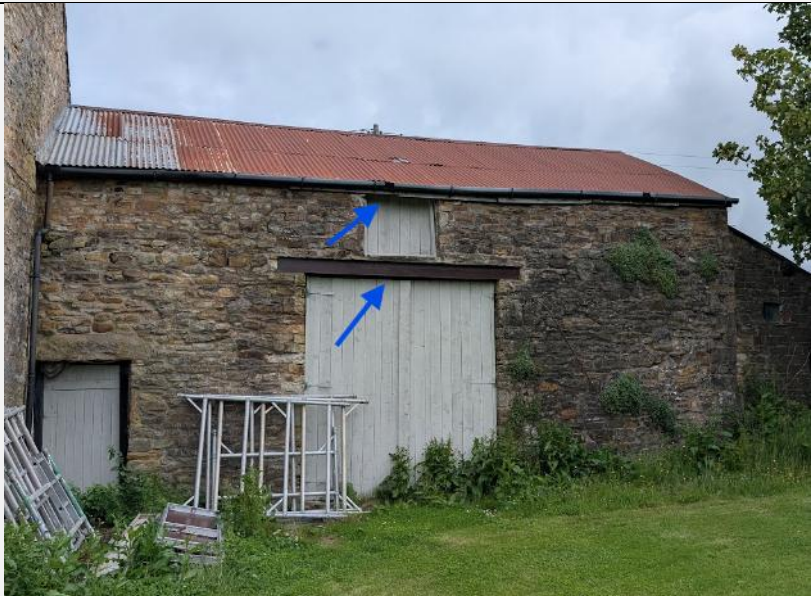
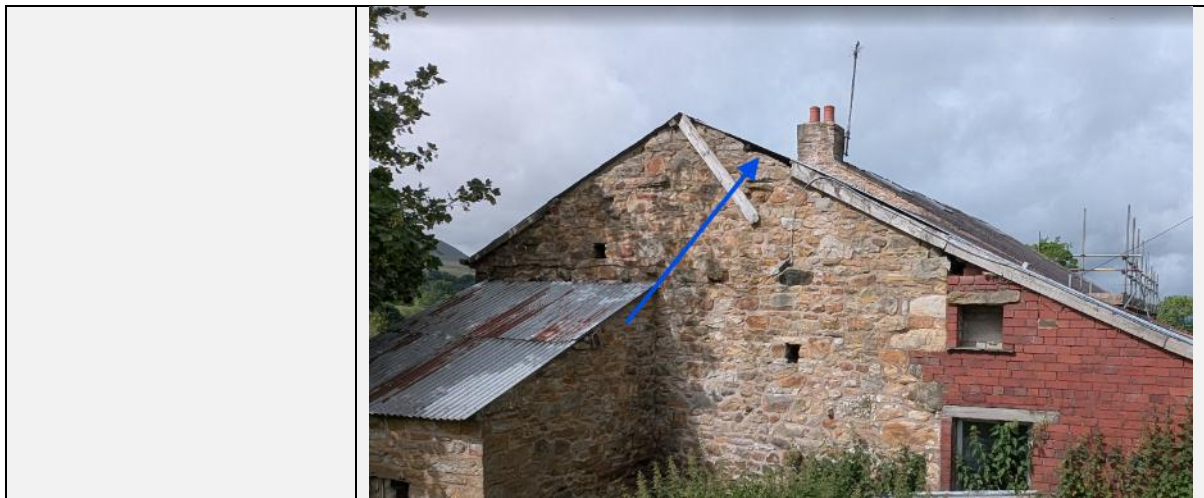
There were numerous open gaps at the roof verge on the east elevation allowing potential access for bats into the internal space. There were also gaps around the main entrance and an upper floor window aperture on the south elevation which provide access to the internal features of the barn.

| <p><b>Plates 3.3a – 3.3b.</b></p> <p>Gaps leading to inner space of barn.</p> | |

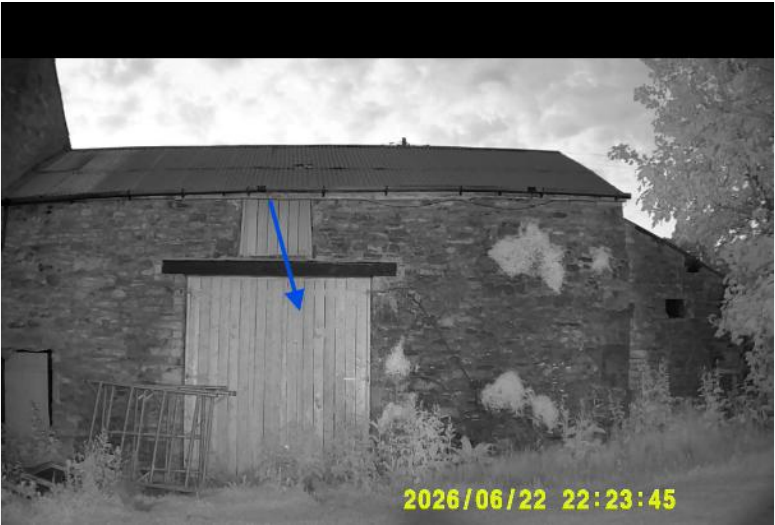
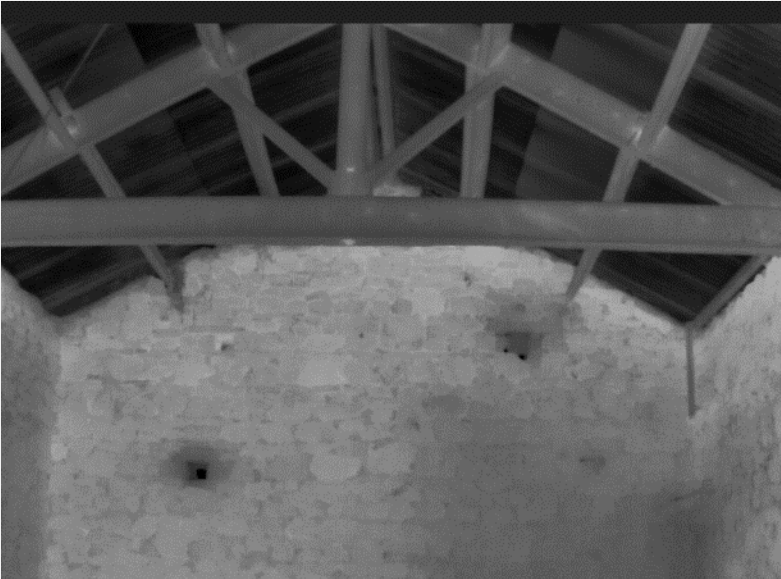
A *Myotis* bat species was observed to emerge from the barn around the timber boarding on the upper aperture on the south elevation at 22:23 (38 minutes after sunset). Prior to emergence, a bat was seen flying inside the barn. This pre-emergence flight activity is common for *Myotis* species (Natterer's bat, whiskered bat, Brandt's bat or Daubenton's bat). The recorded bat call was not of a sufficient quality to confidently confirm species.

A *Myotis* species was again observed to emerge from the same location at 22:04 (31 minutes after sunset). The NVA placed within the inside of the barn covered the east sections; however, the bat did not emerge from this end of the barn. It is therefore likely that the roost point is within a crevice in the western wall.

| Date | Description | Location |
|---|---|---|
| 22 June and 14 July 2026 | Emergence of Myotis bat species from upper window aperture. | |
| | <p>Species highly likely to be whiskered bat as confirmed during second visit.</p> <p>Bat recorded flying within barn for 3 mins prior to emerging.</p> | |

- A single bat box (Greenwoods two cavity bat box) is to be fixed onto the wall of the barn upon completion of the external renovation work as suitable compensation for the whiskered bat roost.

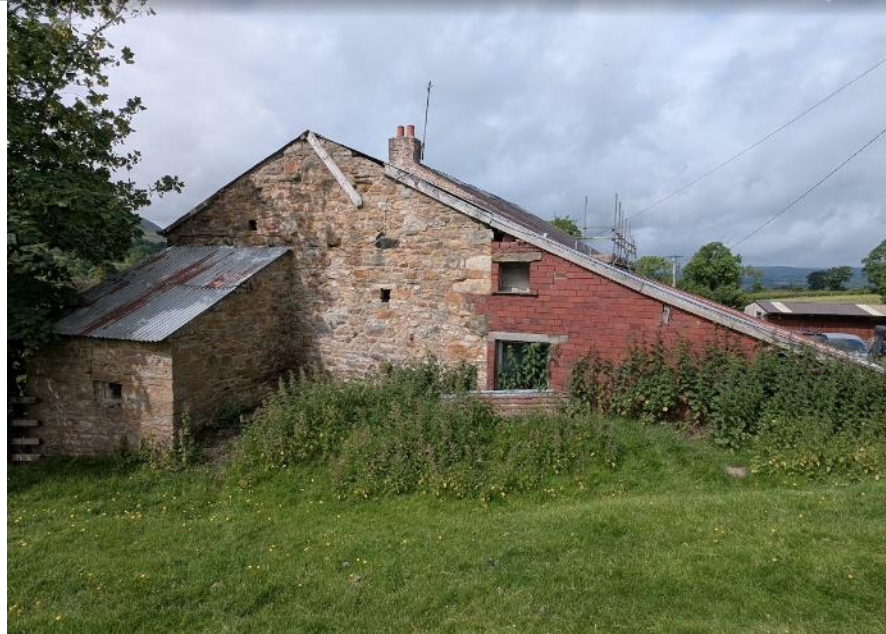
**Photo 1.**

East elevation.

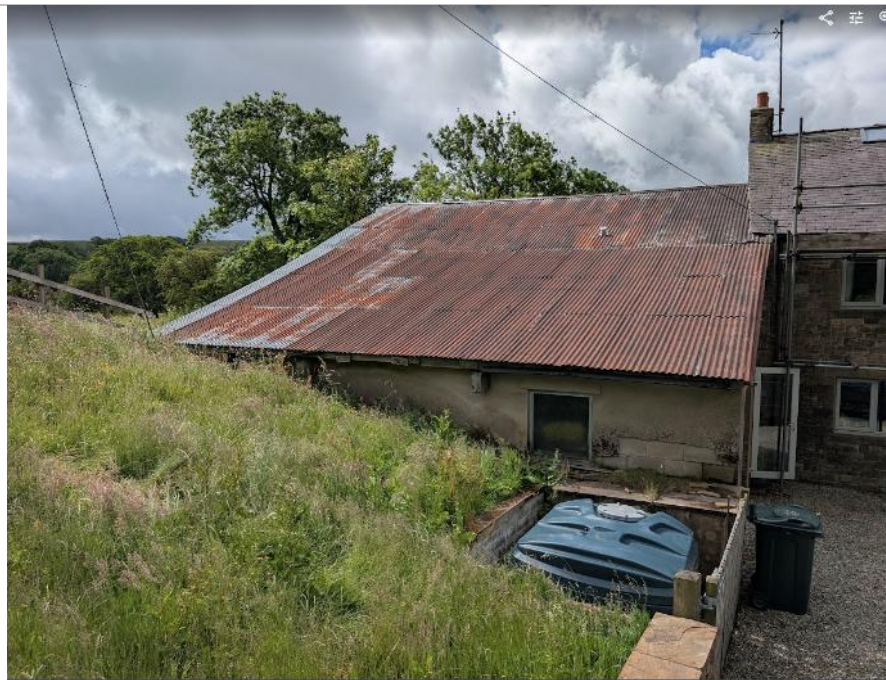
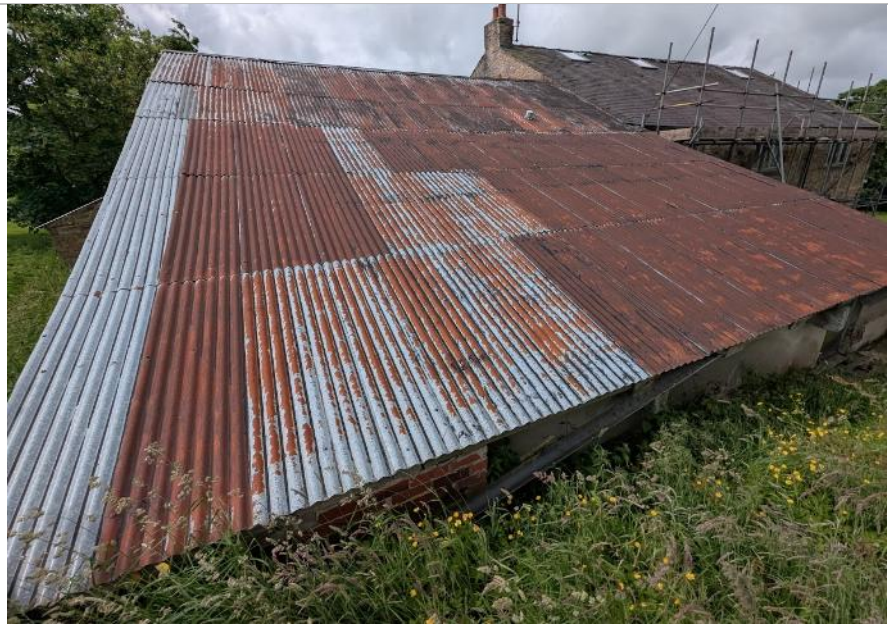
**Photos 2a – 2b.**

North elevation.

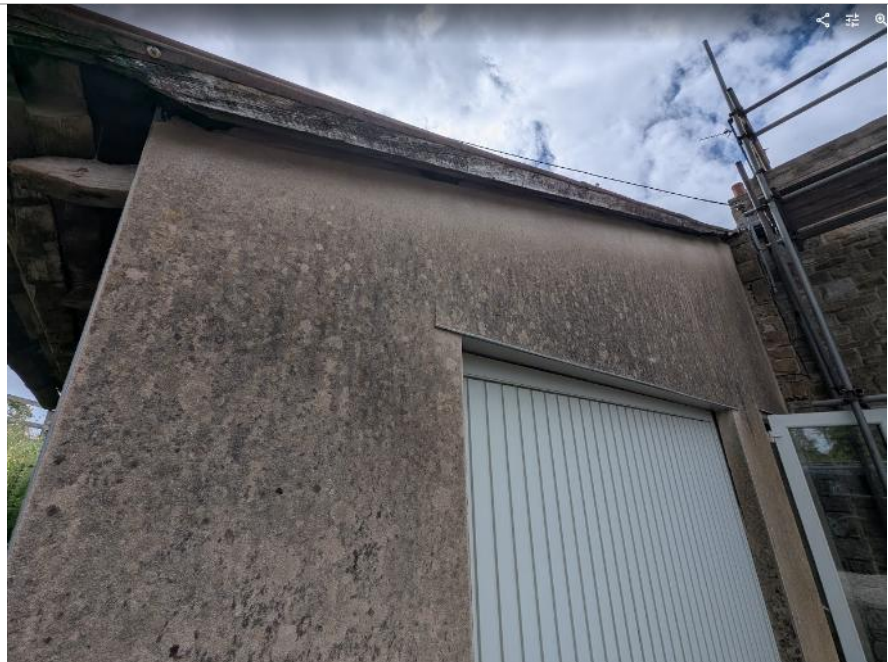
**Photo 3.**  
West elevation.

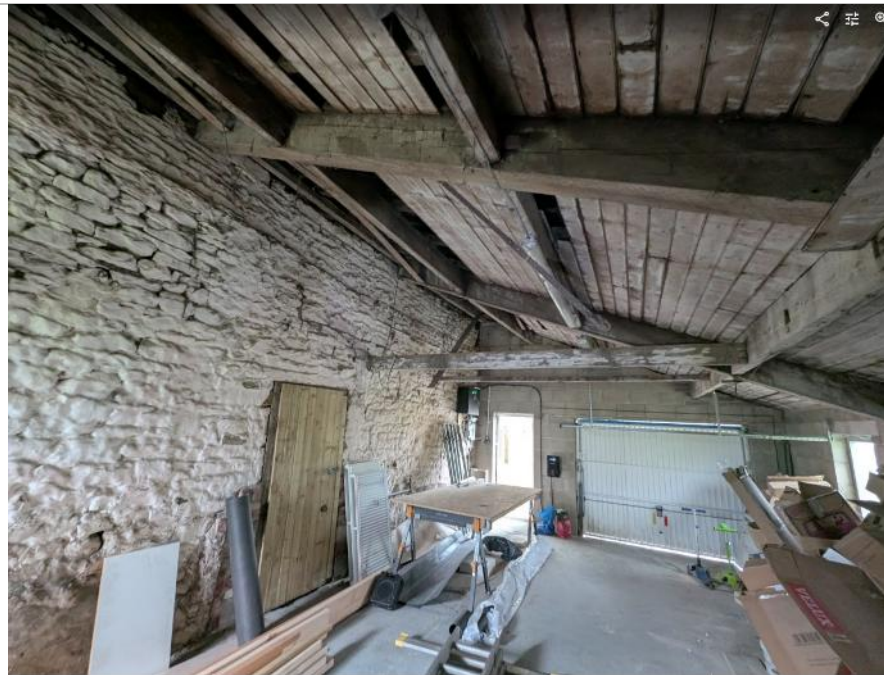
**Photo 4.**

The internal space of the garage was very light throughout and the garage is actively used. No potential roost features were observed in the walls or roof underside.

Internal space of  
garage.

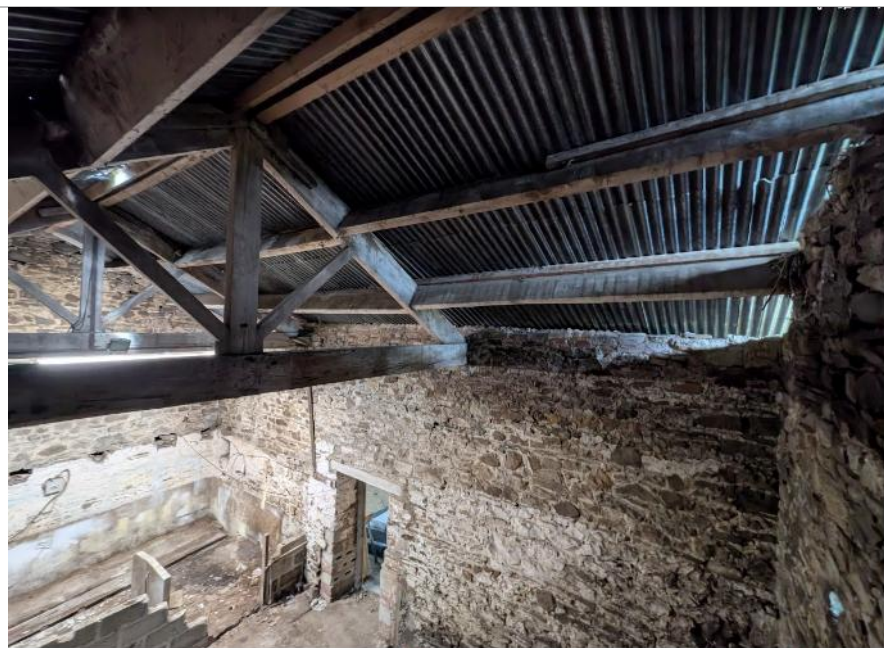
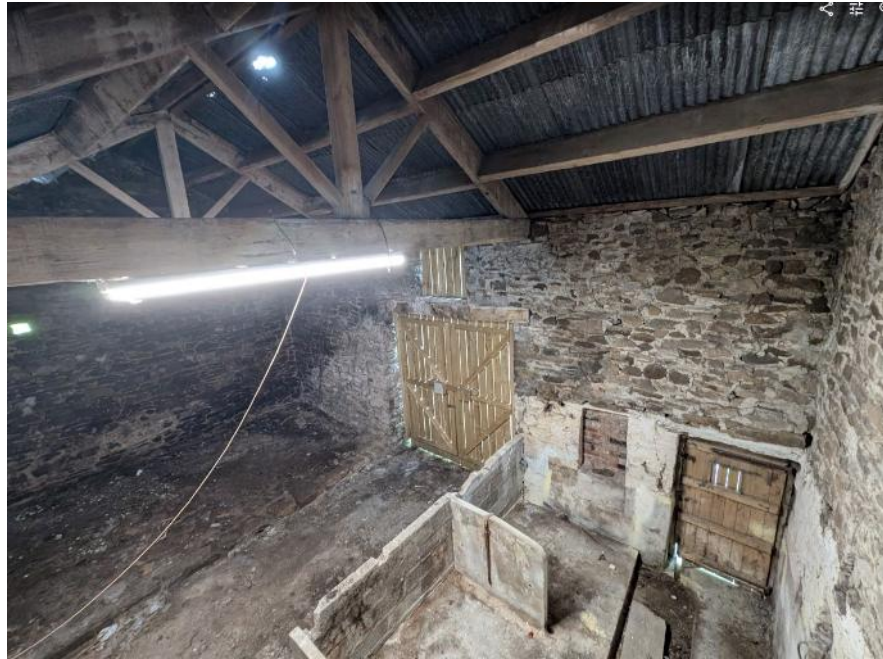
**Photos 5a – 5b**

Internal space of  
barn.

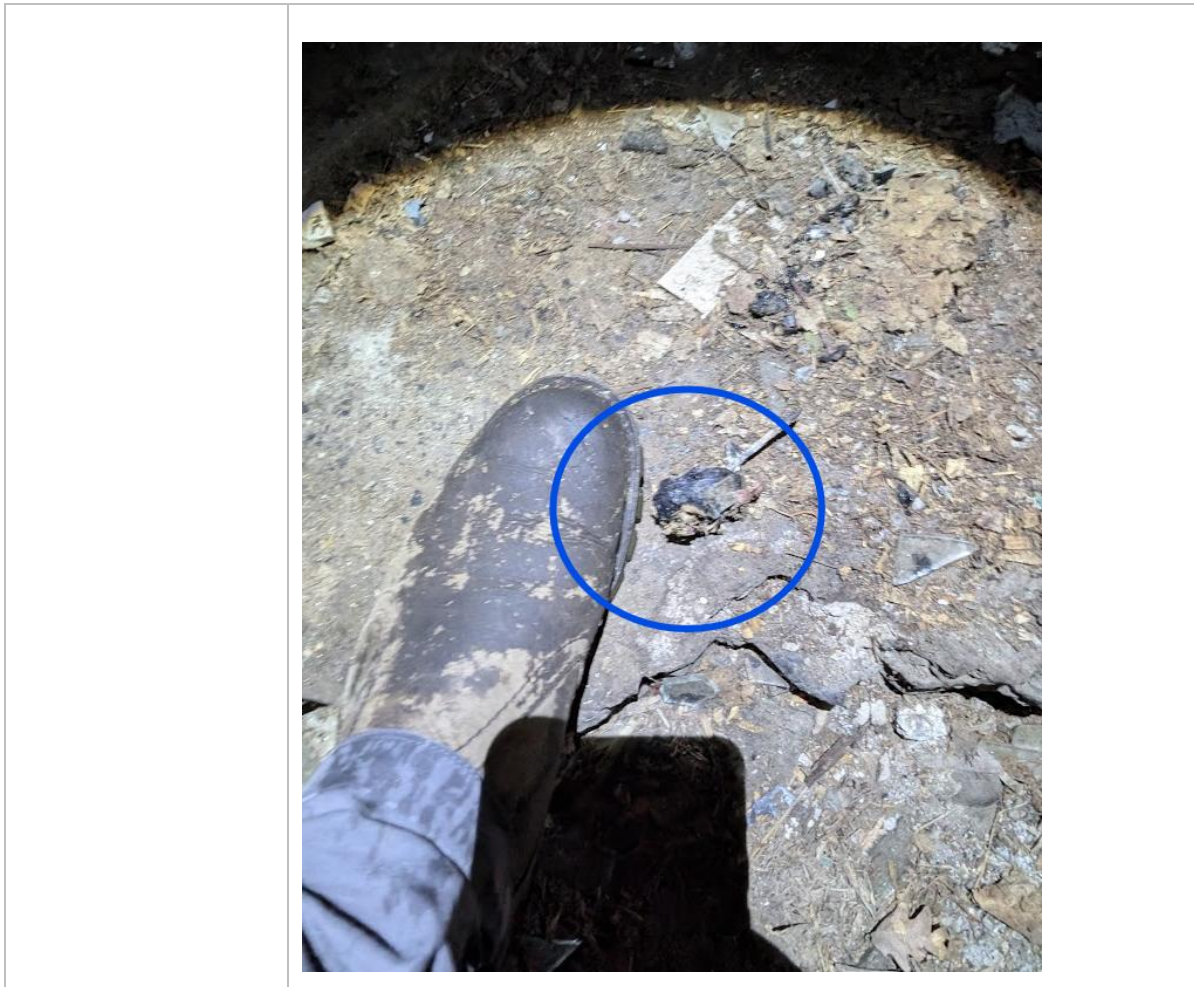
**Photos 6a – 6c**

- An active jackdaw's nest on a wall ledge within the garage.
- A former jackdaw's nest on a wall ledge of the barn.
- A disused swallow's nest on a roof timber in the barn.

A single, old barn owl pellet was observed on the floor of the barn. There was also a small extent of light faecal splashing on a roof timber. This evidence suggests that the barn was a very occasionally used roosting site. It does not appear to have been used by barn owl for some time.

6a: Inactive swallows' nest.

6b: Location of jackdaw nest.

6c: Old barn owl pellet.

It is typically recommended that any works with the potential to affect bird nests are undertaken outside the main nesting-bird season (March–August inclusive). Where this is not achievable, any works that may impact nesting birds must be preceded by a nesting-bird check undertaken by a suitably qualified ecologist. If an active nest is identified, it must be left undisturbed and retained in situ until it is no longer in use.

A barn owl box is recommended to be installed in one of the mature trees located within the grounds of the site.
