**BAT SURVEY, AT -**

22 CLITHEROE ROAD  
WHALLEY

DATE AND TIME OF VISIT  
9th Oct 2025 9.00am

REFERENCE NO 7240

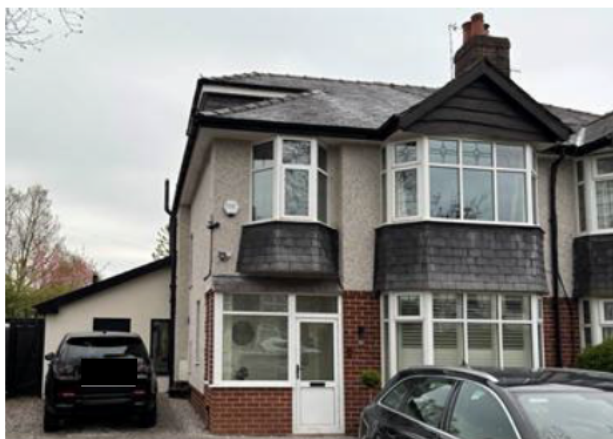
Front Elevation

The building is a semi-detached dwelling probably dating from the 1930's. A single storey side lean-to extension has been added, and the roof space has been converted to form bedroom accommodation with a dormer window.

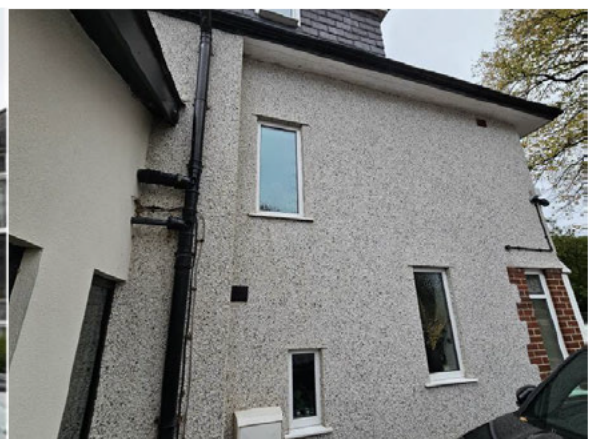
Side elevation.

The location of the proposed extension.

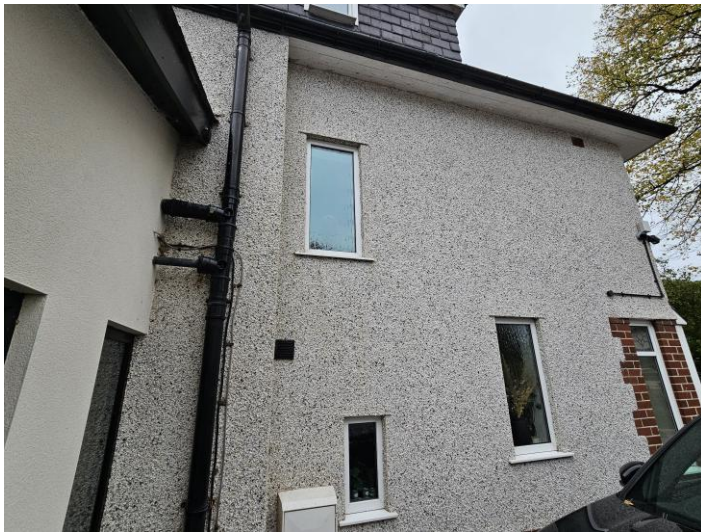
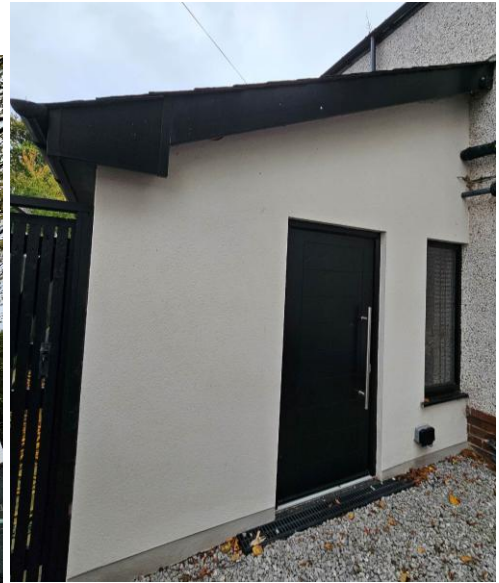
The side wall which will be affected by the proposed extension has a pebble dash render finish over brick. The front elevation of the lean-to has a K Rend finish over blockwork.

The side elevation being affected by the proposed extension      The front elevation of the lean-to

The walls are in perfect condition with no cracks or crevices suitable for bat ingress.

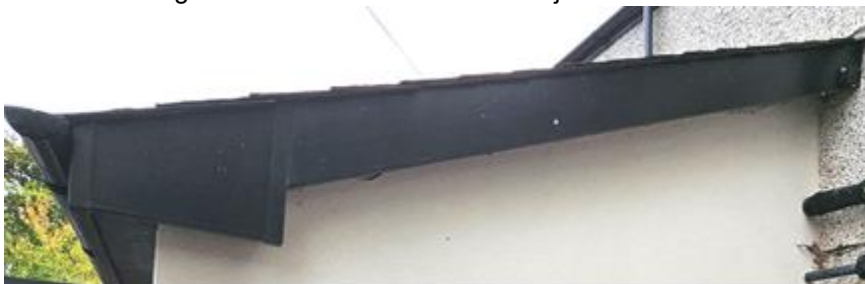
The new lean-to roof has a blue slate finish. With upvc barge boards, fascia's to the side and soffits to the overhang. The roof is flashed into the adjacent wall.

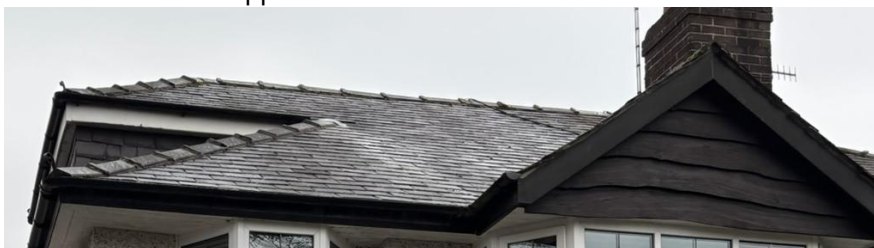
The main roof is a hipped blue slate structure. With a dormer formed in the hipped side of the roof.

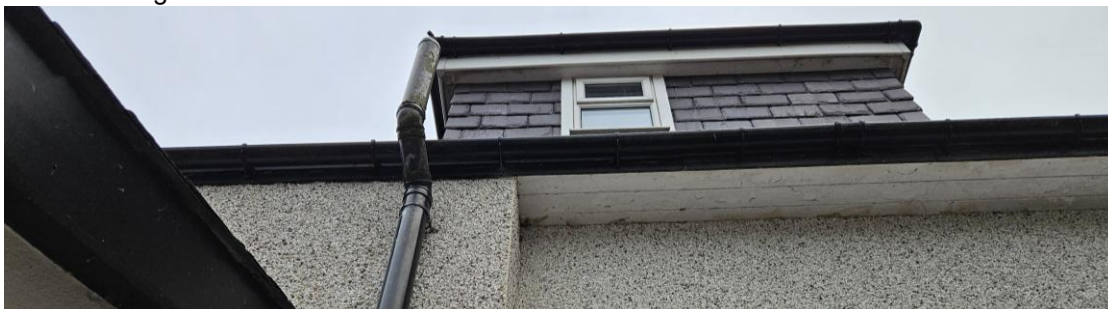
The overhang to the eaves has timber fascia's with boarded soffits.

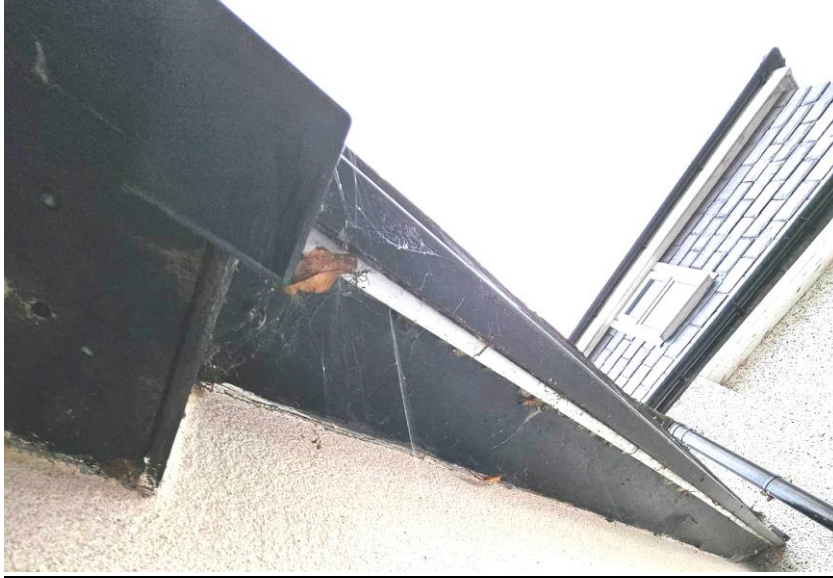
The lean-to roof is relatively new and in perfect condition all abutments are very tight fitting as are the slates and flashings. No access points, cracks or crevices are present in this roof.

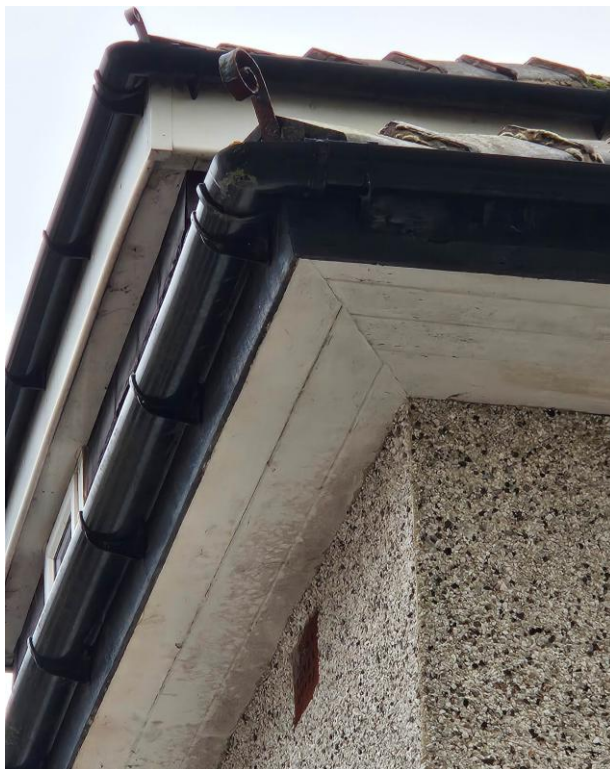
The main roof fascia's and soffits are in good condition. all very tight fitting. The slates are tight fitting and hip/ ridge tiles are in good condition as is the pointing. The roof did not provide any access points or crevices with the potential to provide roost potential for bats.

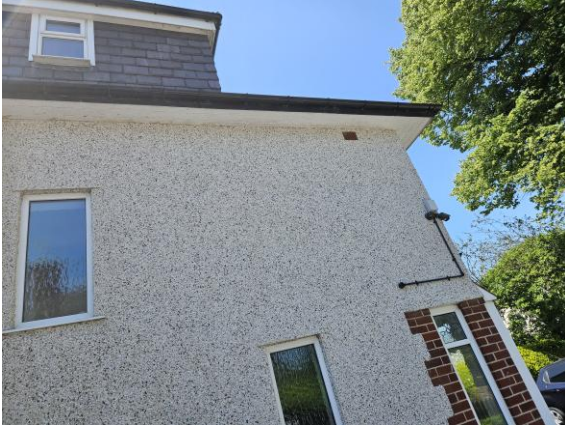
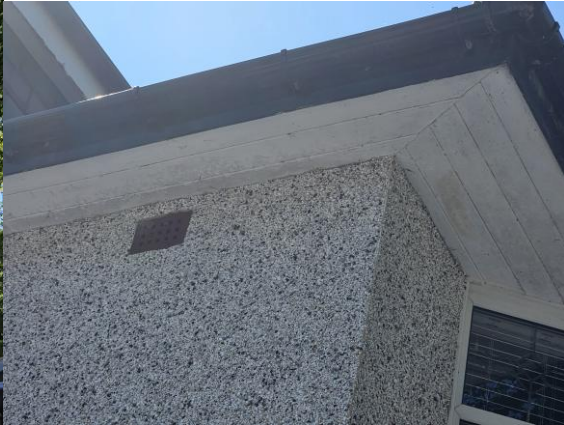
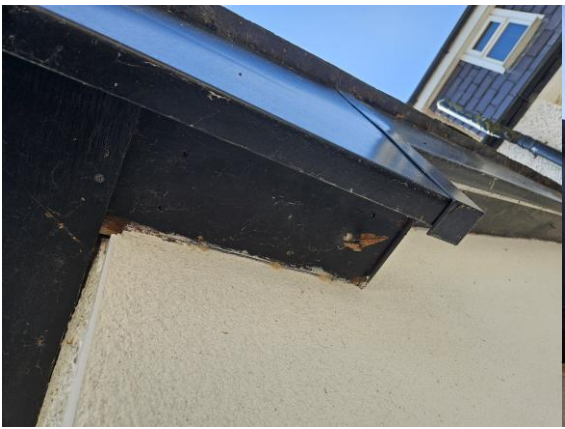
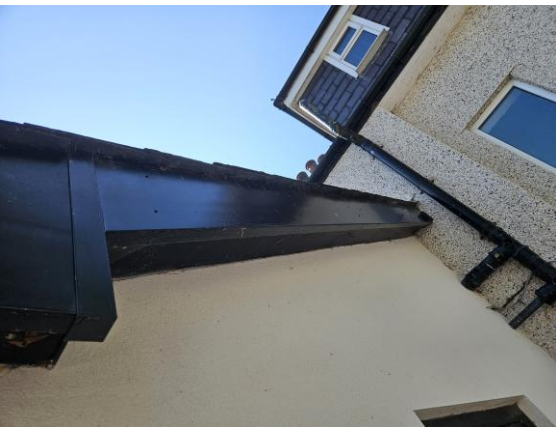
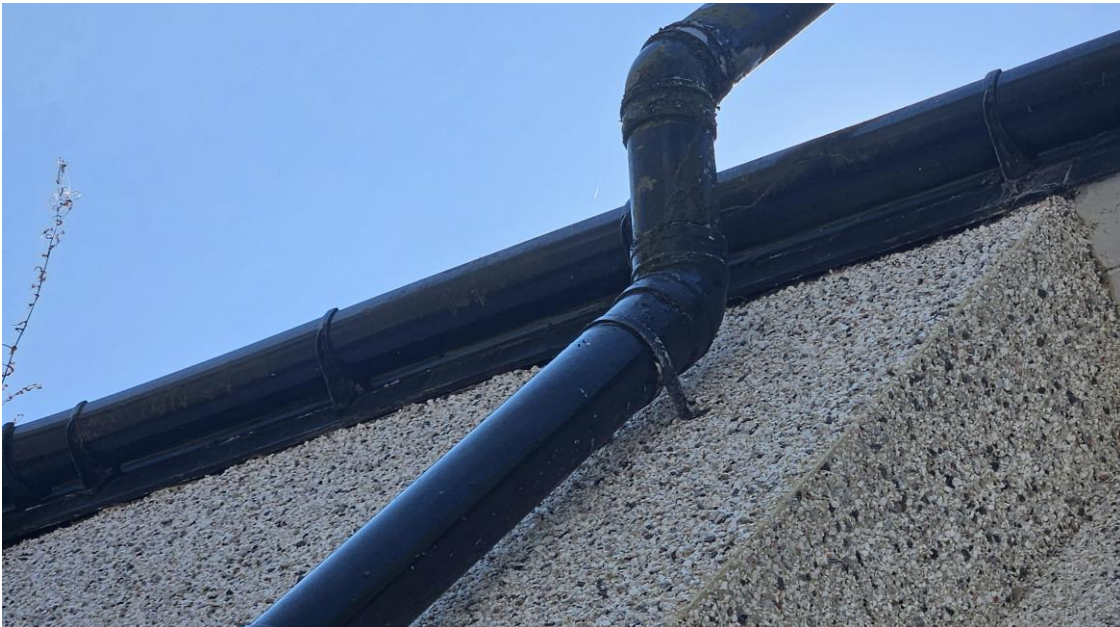
### **2026 UPDATED IMAGES**

The walls and roof structure adjacent to the proposed extension were examined to update the previous scoping survey. The status of the building was unchanged .

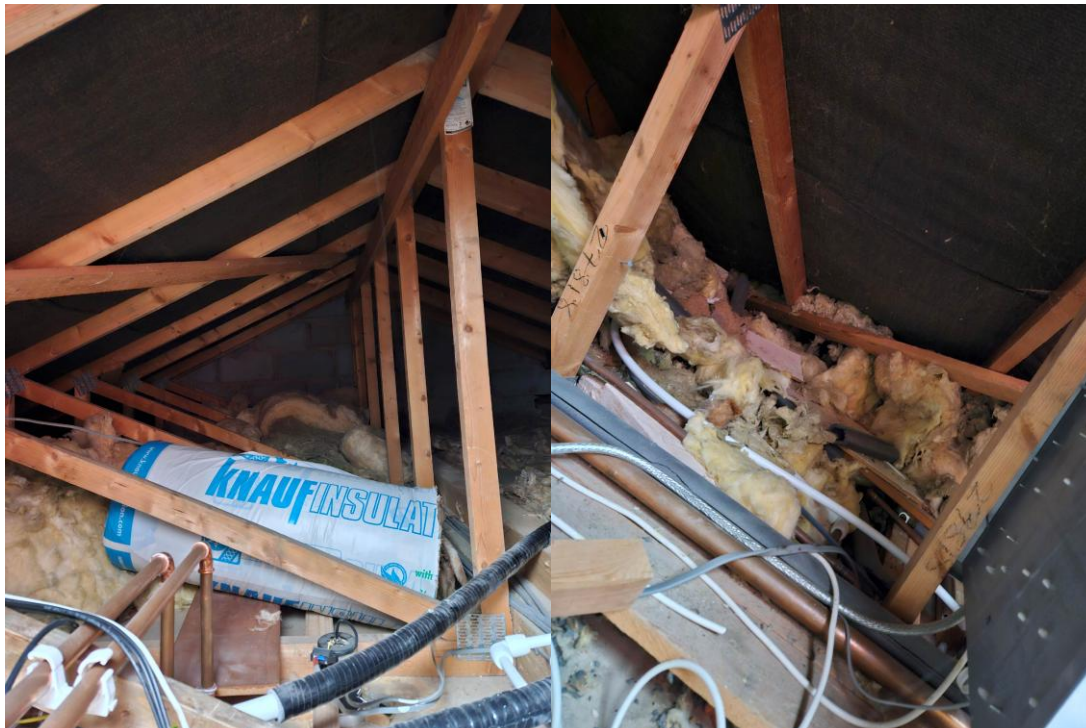
The roof space in the lean-to was examined from a ceiling hatch, the timber structure was in excellent condition as was the felt.

Insulation quilt was present; all surfaces were clean and free from dropping or feeding evidence. The space does not provide any high value roost habitat.
