**Re: Proposed roof replacement work at 57 Downham Road, Chatburn, BB7 4AU.**

We understand that the survey is required as part of a listed building consent relating to roof replacement works at the above property.

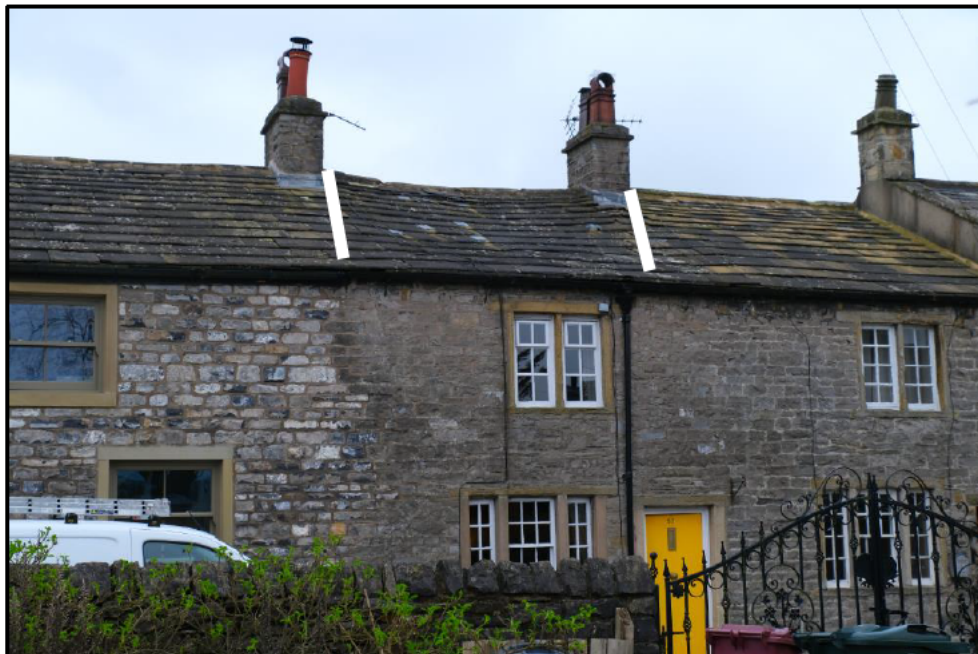
*Image showing north (front) elevation at 57 Downham Road. White lines indicate roof area of survey building.*

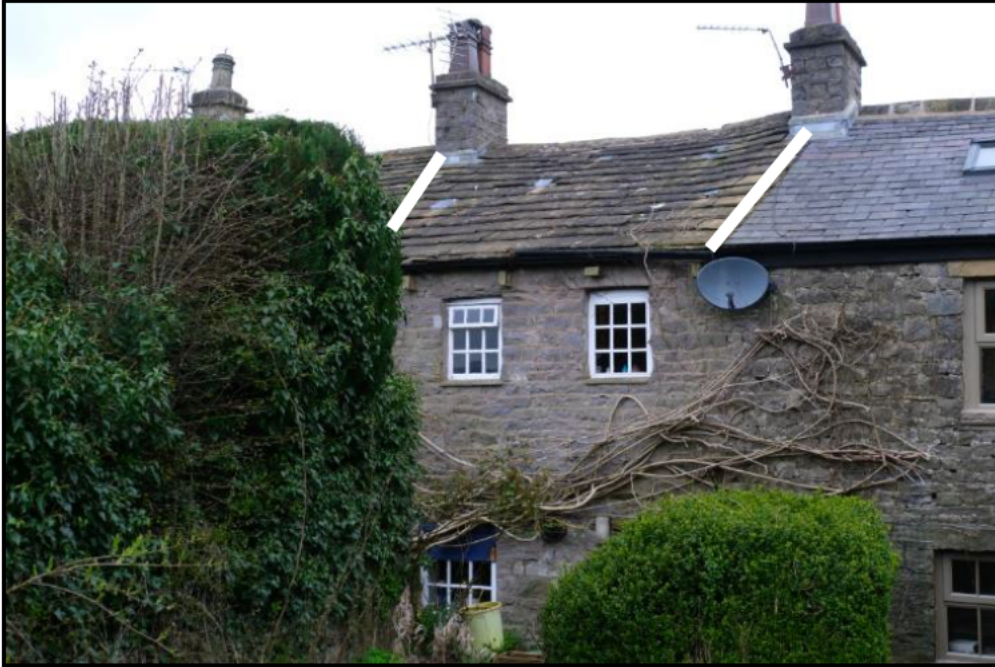
There is high potential for nesting birds to utilise the survey property, adjacent properties as well as garden vegetation during the nesting season (February to September). Garden vegetation (including climbers on external walls) is close enough to the proposed works for any nesting birds to be potentially subject to disturbance.

*Image showing south (rear) elevation at 57 Downham Road. White lines indicate roof area of survey building. Image also shows close proximity of garden vegetation, including wall climbers, all of which are suitable for use by nesting birds.*

| Protected species | Impacts, Issues & Rationale | Action Required |
|---|---|---|
| Nesting birds | <p>There are <u>predicted</u> impacts (disturbance, damage and destruction) to nesting birds, nests and eggs as a result of the proposed works.</p> <p>It is advised that there is high potential for birds to be nesting at the property, adjacent properties and within garden vegetation during the bird nesting season (February to September).</p> <p>Under the Wildlife and Countryside Act 1981 (as amended), wild birds are protected from being killed, injured or captured, while their nests and eggs are protected from being damaged, destroyed or taken.</p> <p>There is no provision under the Wildlife and Countryside Act 1981 (as amended) for licensing the disturbance of nesting birds or the destruction of nests which are in use for the purpose of development.</p> <p>If enforcement action were taken the developer would need to rely on the 'incidental result of an otherwise lawful operation' defence if it were not possible to avoid an offence being committed. This defence can only be tested in court and it is therefore important to ensure all possible mechanisms for avoiding an offence are considered.</p> | <p><b>Advice (mitigation):</b> It is advised that the most appropriate way to address the risk to nesting birds is:</p> <p>Avoid working during the nesting season.<br/>Or<br/>If works cannot be delayed, the proposed work area should be carefully checked, immediately prior to works commencing. Checks should be carried out by a suitably experienced ecologist. If the risk of nesting birds remains, then monitoring for nesting bird activity should continue for the duration of works. <b>Prior to any work commencing (checks) and throughout works in nesting season (monitoring).</b></p> <p><b>Advice (mitigation):</b><br/>If works are to be undertaken during the nesting season, all people working at the proposed development site should attend a toolbox talk delivered by an appropriately experienced person, to be made aware of the likelihood of encountering nesting birds and how to identify them, the legal protection of nesting birds and their own responsibilities as regards implementation of precautionary measures. <b>Prior to any work commencing.</b></p> <p><b>Advice (mitigation):</b> If birds are found to be nesting within or in close proximity to the work area during proposed works, it will be necessary to stop and establish an exclusion area. The extent of the exclusion area, which should be determined by a suitably experienced ecologist, will depend on the bird species and the nature of the proposed works. <b>At all times.</b></p> |

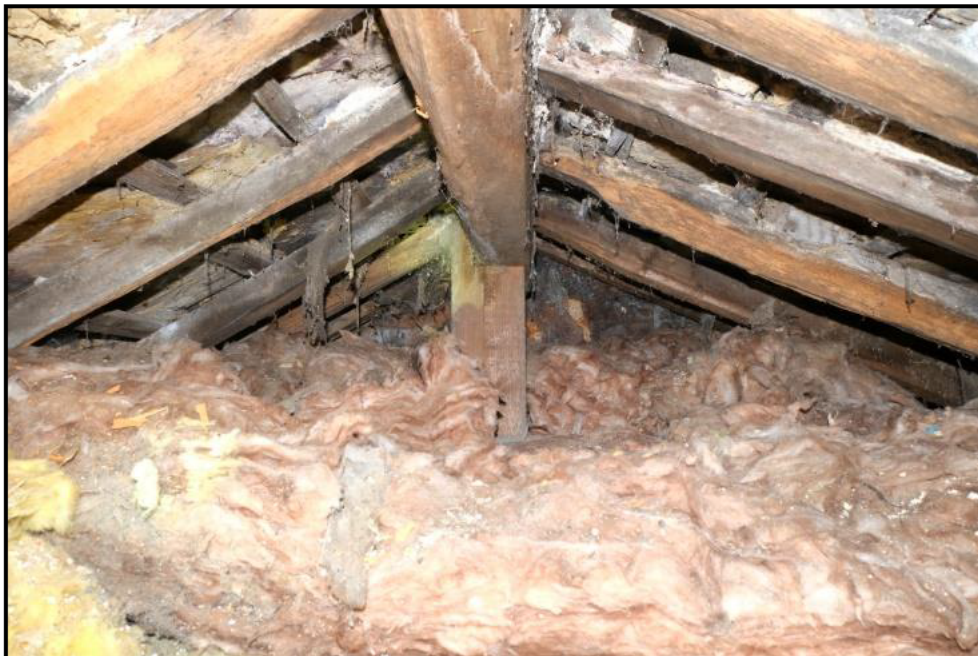
There is a single, small, shallow roof void with old and more recent rock wool insulation densely laid on the roof void floor and filling most of the void. The roof void is supported by timber roof supports, which are in a poor state of repair, particularly at the ridge. Other than a single, discrete section of membrane along part of the ridge (most likely from a previous repair), the rest of the roof is unlined with numerous gaps visible. The poor state of the roof makes the roof void light and draughty and these conditions are generally regarded as unfavourable for use by roosting bats.

*Image showing shallow roof void, no liner and deep rock wool present.*

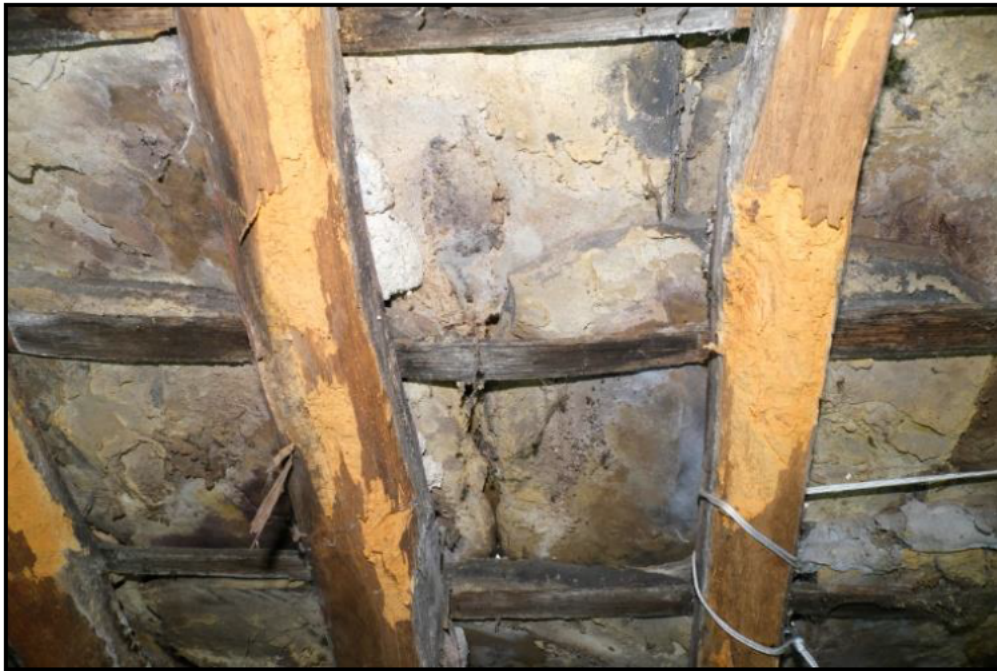
*Image showing close up of roof underside, no liner and worn roof timbers.*

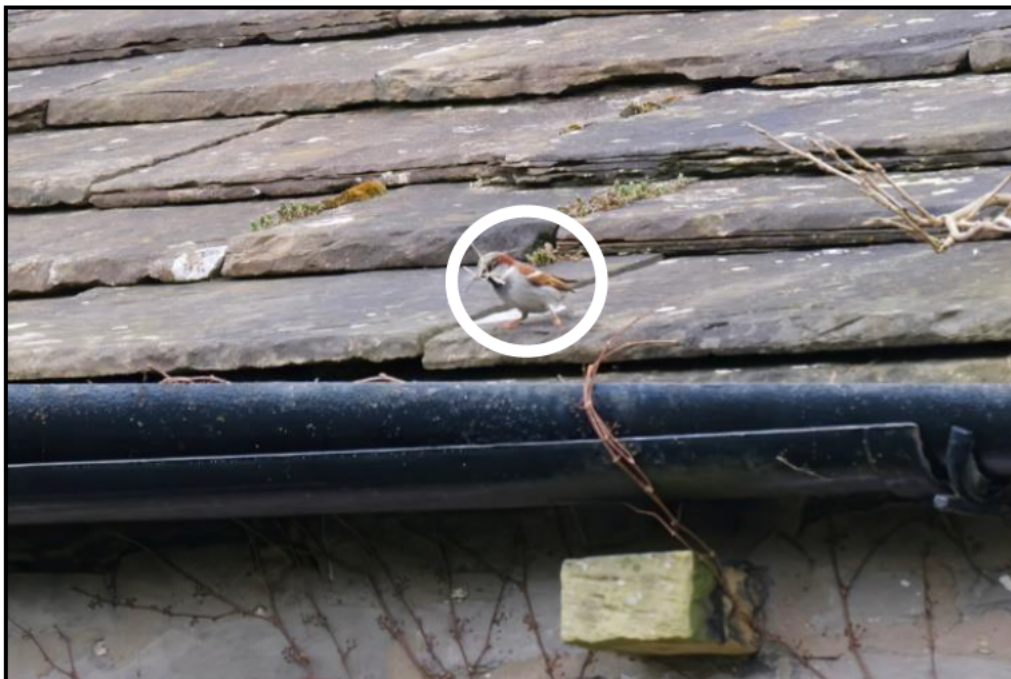
A house sparrow was seen perched on the roof at the rear of the property with nesting material in its beak and a second house sparrow was seen entering and leaving the underside of the roof edge at the front of the property.

*Image showing house sparrow with nesting material perched on roof of 57  
Downham Road.*

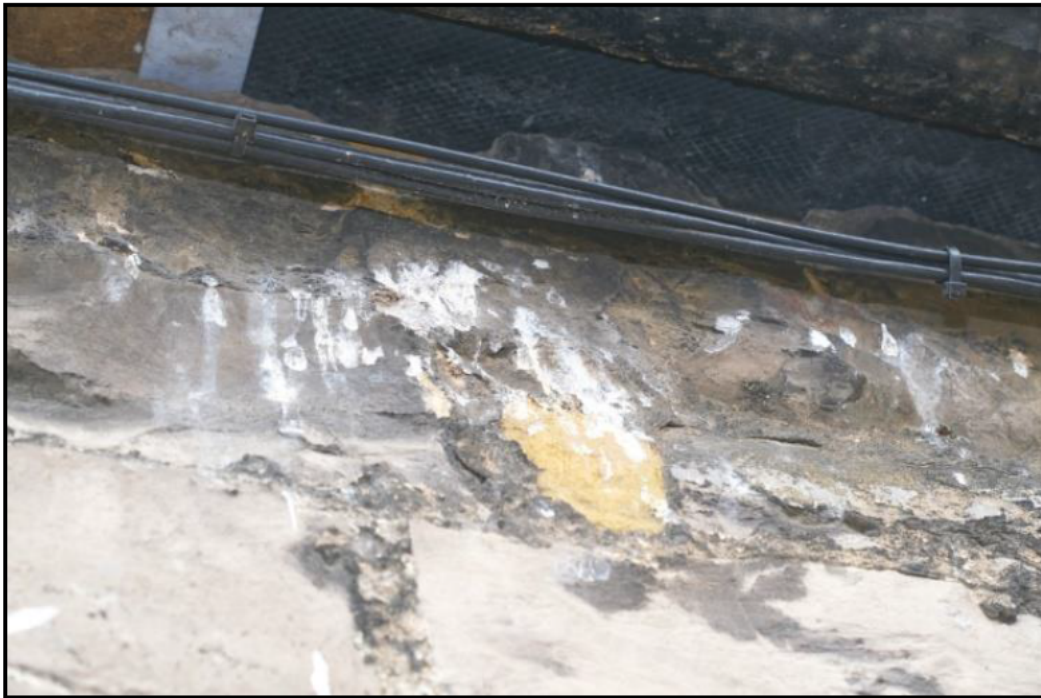
In addition, a starling was seen entering and leaving the underside of the roof edge at number 55, a collared dove was perched on an adjacent chimney and jackdaws were seen nest building in a neighbouring chimney to the west.

*Image showing bird droppings below roof edge located at 55 Downham Road (immediate adjacent 57 Downham Road). A starling was seen entering this location during the survey.*

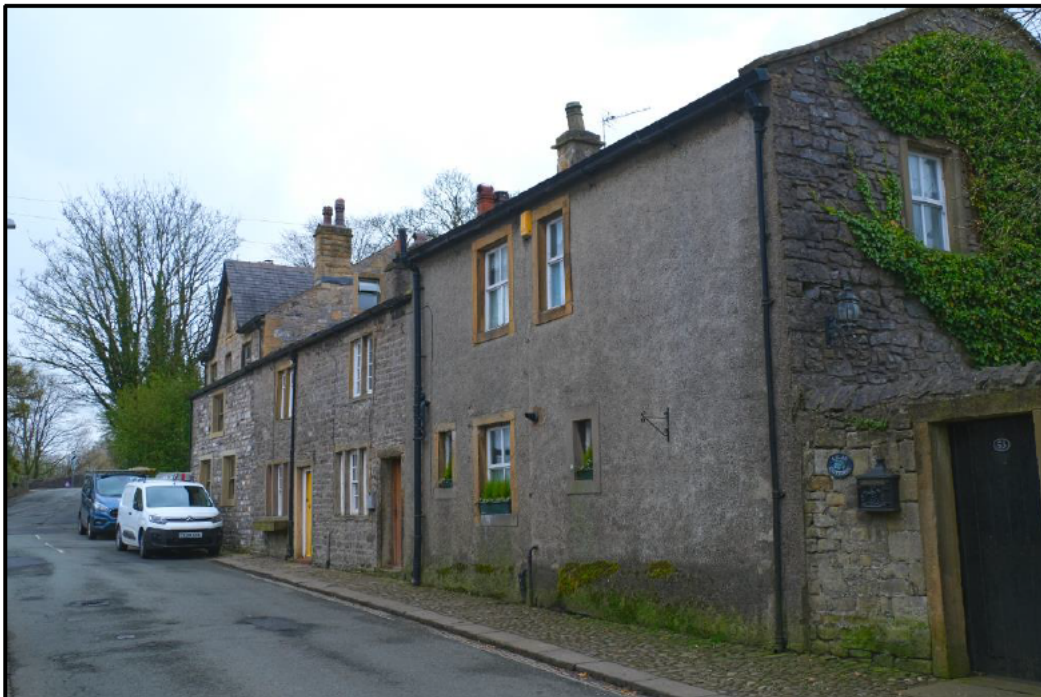
*Image showing 57 Downham Road (yellow door) in context with neighbouring properties and road side location.*
