**STRUCTURAL DESIGN REPORT**

**Proposed Ridge Beam Replacement Works**

**57 Downham Road, Chatburn, Clitheroe, BB7 4AU**

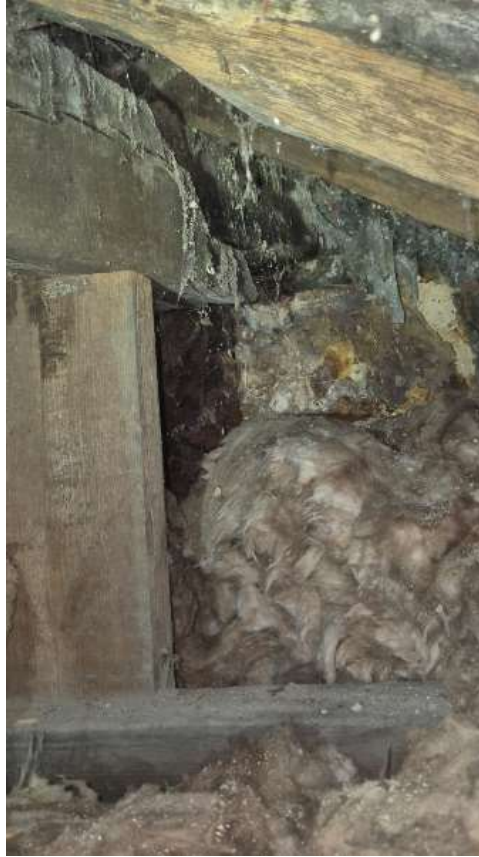
The installed support post appears relatively modern in comparison to the surrounding historic timber structure and does not appear consistent with the original roof construction methodology.

*Figure 2: Ridge beam support installed by others.*

The support arrangement appears crude and non-engineered in nature and is therefore considered likely to represent a retrospective remedial support introduced following failure of the original ridge member.

The current vertical support arrangement appears to represent a later retrospective remedial support rather than part of the original historic roof construction.

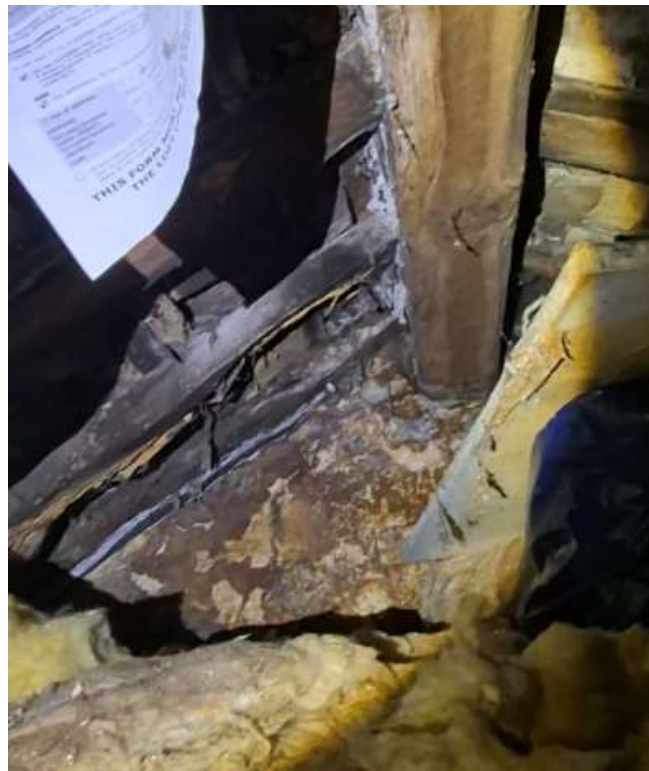
*Figure 3: ridge beam supported by party wall.*

The original roof arrangement is therefore understood to have historically comprised a spanning ridge beam bearing into masonry support locations at either end of the structure.

Photographic inspection also identified localised moisture staining and deterioration adjacent to ridge bearing areas, likely associated with historic water ingress over an extended period.
