PERCOLATION REPORT

Hothersall Lane, Hothersall

26170-FP-001

DART
ENGINEERS LTD
CIVIL AND STRUCTURAL
ENGINEERING

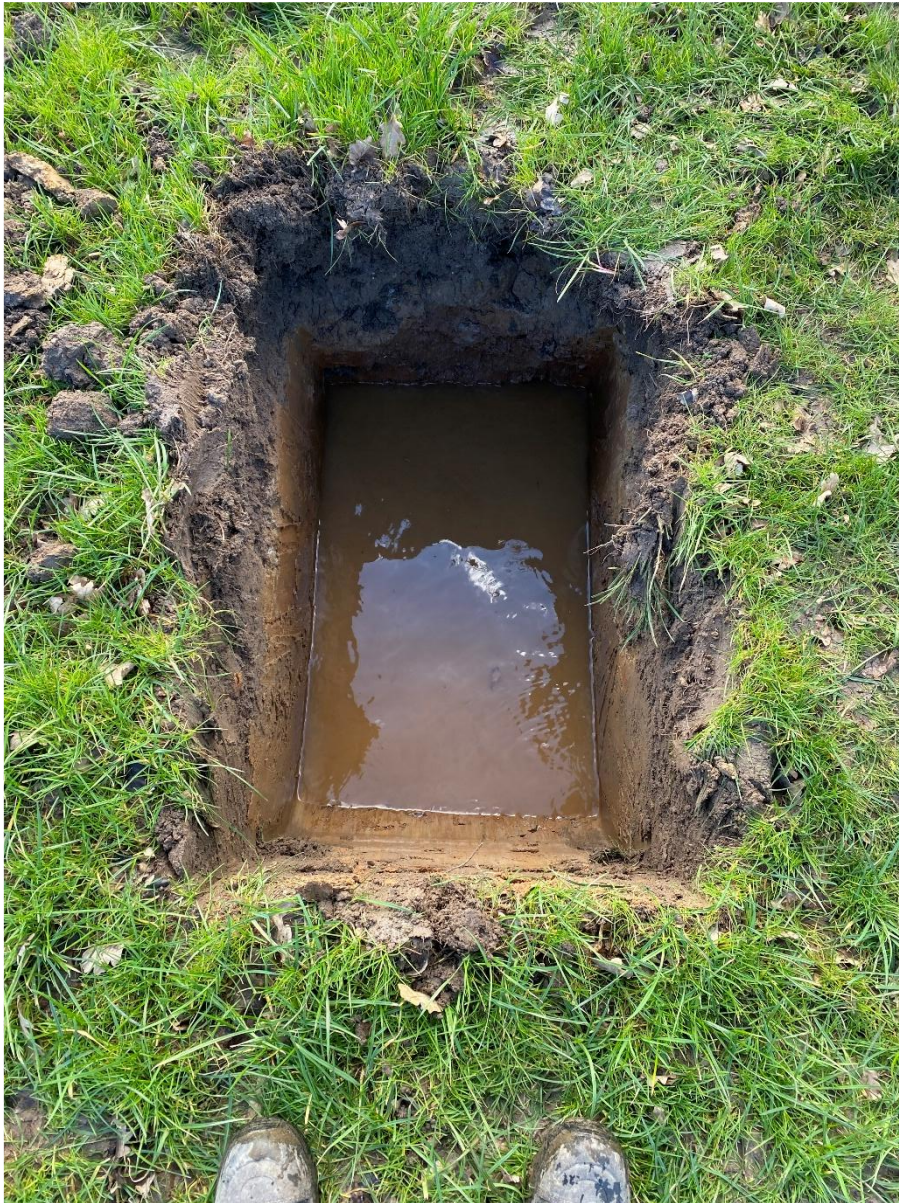
Appendix B – Percolation Photograph

For Test 1 (Test Pit 1), water was filled to a depth of 400mm, the water level dropped 0mm after 2 hours of testing.

Calculation sheet 1 shows that the infiltration rates are not high enough and do not satisfy BRE 365 requirements. Therefore, Infiltration methods of drainage will not be viable for this site and strategy.
