24028-PWAG-00-XX-LTR-G-7000-P01

## Re: Mine Entry Investigation at Whalley Road.

| Project | LAND NORTH OF WHALLEY ROAD | | | |
| Title | MINE ENTRY INVESTIGATION PLAN | | | |

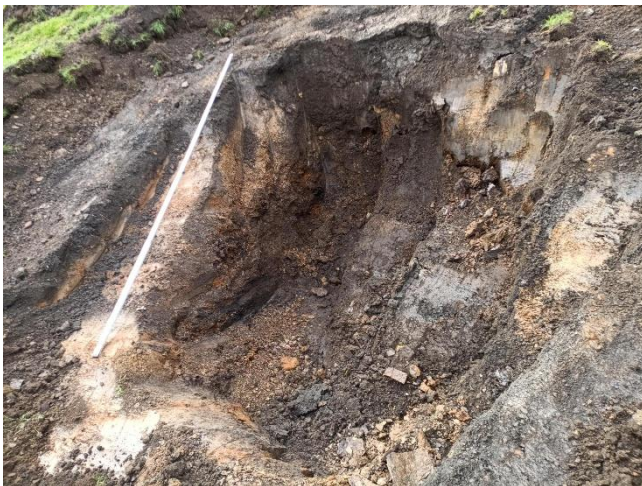
The shaft (376434-002) was located by excavating the centre of a bell pit surface feature. Approximately 0.5 m of made ground (mining spoil) was scraped back to expose an extremely weak moderately weathered thinly bedded orangish brown and light grey mudstone with moderate rust staining and the bedding was undulated / wavy. The dip and strike was recorded between 60/162SE and 52/165SE. The entry comprised of darker material within the rock, when excavated into there was approximately 0.5 m of waste, comprising bin bags containing hay and grass cuttings, this was then underlain by more mining spoil. The shaft was roughly circular and the diameter was measured as 3 m east to west and 4 m north to south. Figure 1 and 2 show photographs of the shaft.

Figure 1 Looking west at 376434-002

The zone of influence from the mineshaft and adit entrance does not affect any of the proposed plots, however they are still located within public open space. If the shaft collapsed there is the potential for creating a hazardous depression or hole at surface. Therefore, the mineshaft should be treated by capping. The treatment required for the adit will depend on its depth and location beneath the development.

The investigation carried out located the mine entry 376434-002 (shaft) and was unable to locate mine entry 376434-001 (adit). The shaft does not pose a risk to the proposed properties, however, poses a minor risk to the public open space, therefore should be treated. To treat the shaft, it should be capped. The MRA should be consulted within the capping process and agree to the proposed cap designs.

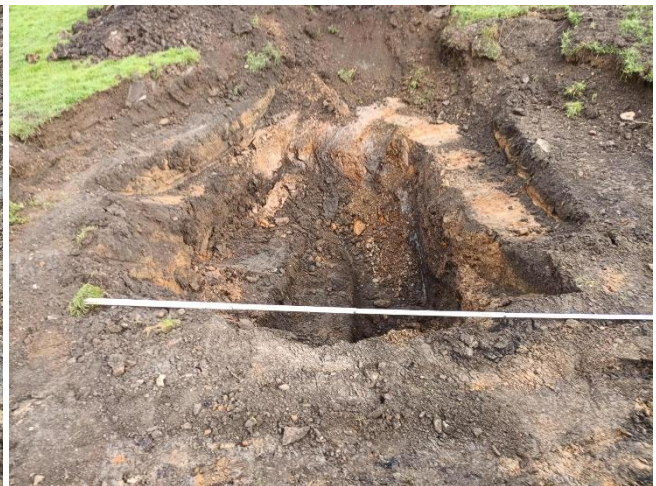
Figure 2 Looking north at 376434-002

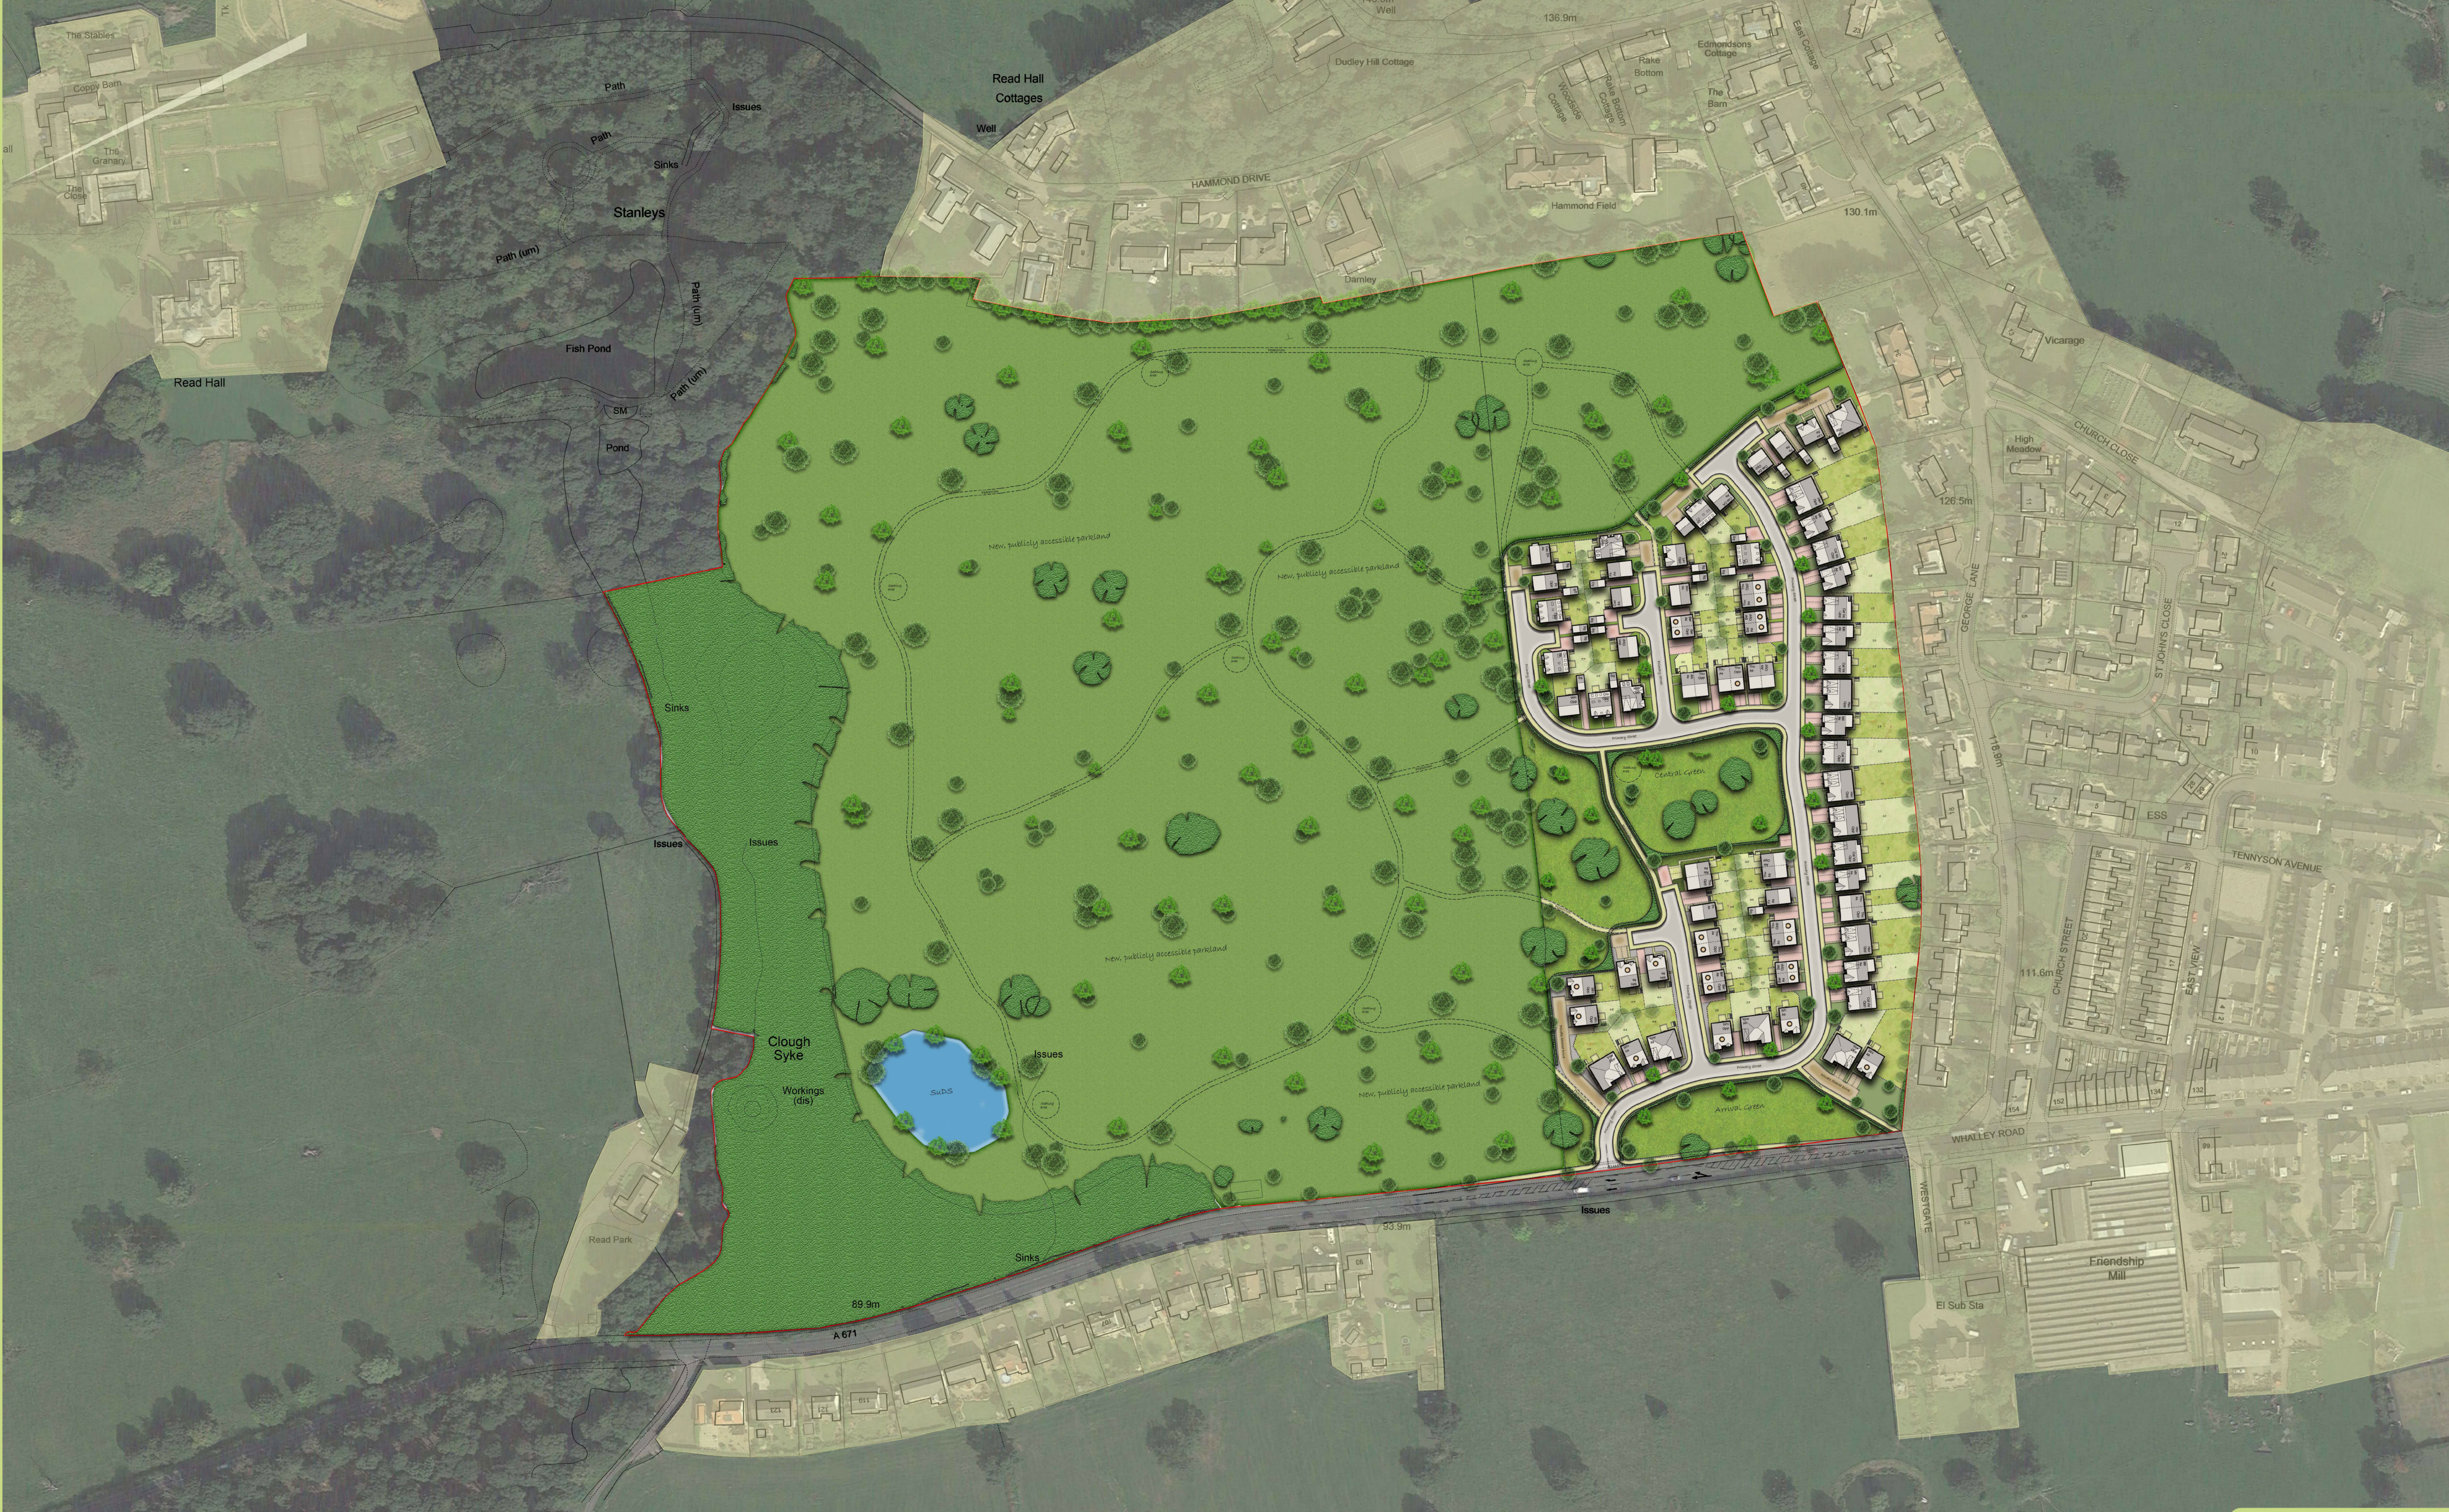
| <b>Drawing No.</b> | 23-154-P02 | <b>Rev.</b> | - |

PWA Geo-Environmental Ltd (PWAG) was commissioned by Applethwaite Limited to undertake an investigation in order to locate two mine entries for a proposed residential development located at land off Whalley Road. The two mine entries had been previously recorded by the Mining Remediation Authority (MRA) in the northeast of the site. The development is proposed to be a 77 residential detached and semidetached housing development with significant area of the site being dedicated to public open space. A proposed layout is included as drawing no 23-154-P02 within **Enclosure 1**.

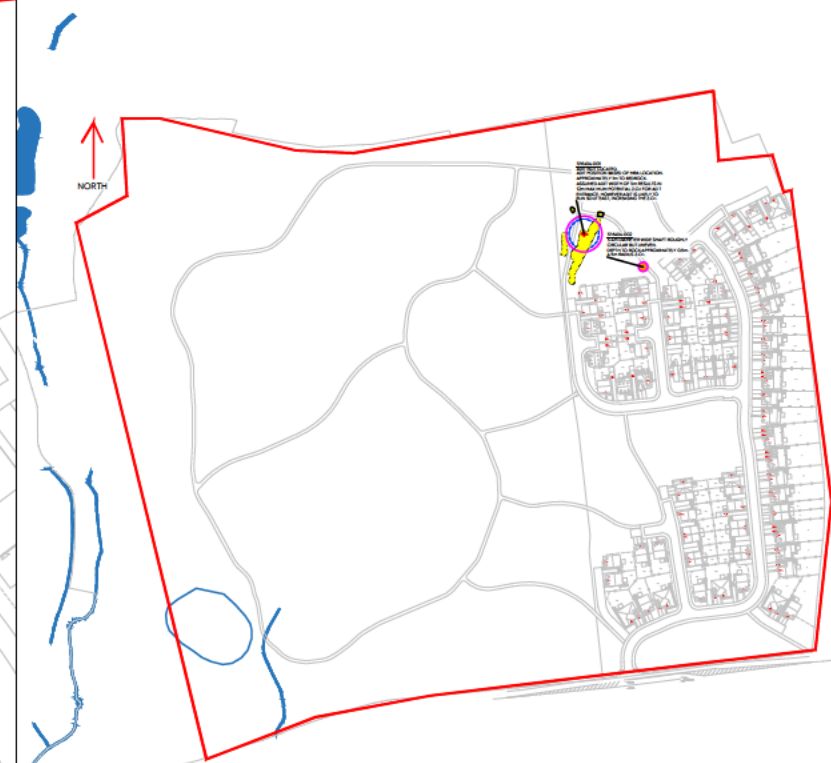
376434-002  
3-4m DIAMETER WIDE SHAFT ROUGHLY  
CIRCULAR BUT UNEVEN.  
DEPTH TO ROCK APPROXIMATELY 0.5m.  
4.5m RADIUS Z.O.I.
