## Proposed Artificial Grass Pitch Edisford Playing Pitches Edisford Road Clitheroe

## Flood Risk Assessment

Revision 0: June 2026  
R-FRA-31271-01-0

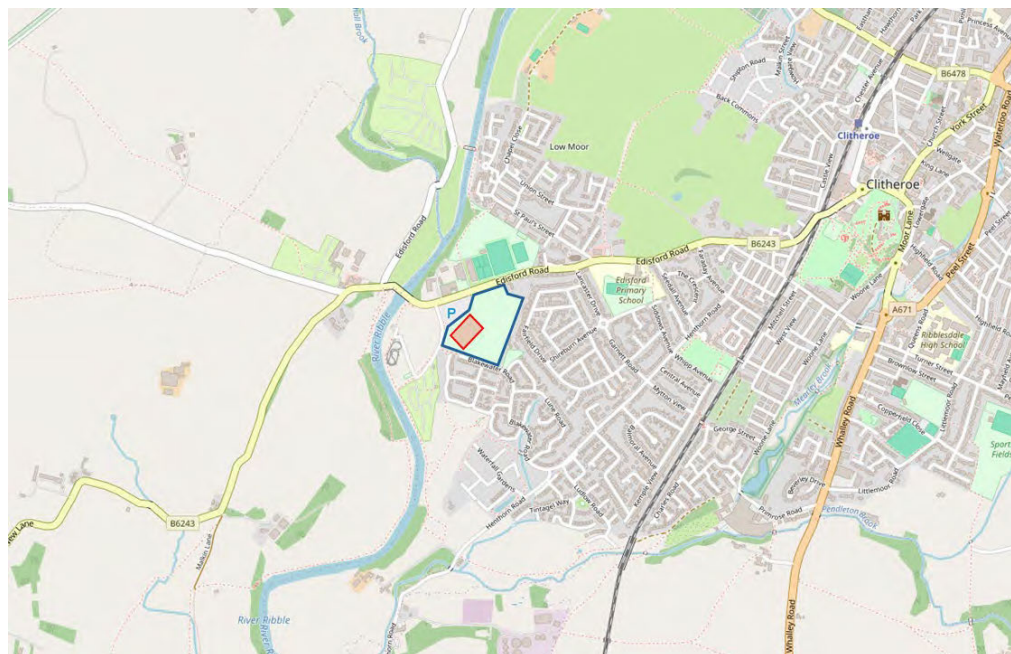
**Figure 1.1 Site Location Plan**  
*Source: OpenStreetMap, obtained 05.02.2026*

1.1.2 The proposed AGP is located at Edisford Playing Pitches, Edisford Road, Clitheroe, as shown in Figure 1.1 below. Clitheroe is located circa 13km north-west of Burnley and approximately 15km north-east of Blackburn. The National Grid Reference for the site is E372830 N441320.

- 3.1.1 The proposed AGP is located at Edisford Playing Pitches, Edisford Road, Clitheroe, as shown in Figure 1.1. The site is bound by the B6242 (Edisford Road) and Edisford Road car park to the north (beyond which is the Roefield Leisure building and Edisford Sports Complex; including Ribblesdale Pool and Ribble Valley 3G pitches), a residential area to the south and east and an access road to a camping and caravanning site to the west.
- 3.1.2 A watercourse is located to the north of the site, between the proposed pitch and adjacent car park to the north. The watercourse flows to the south-west, where it connects to the River Ribble.

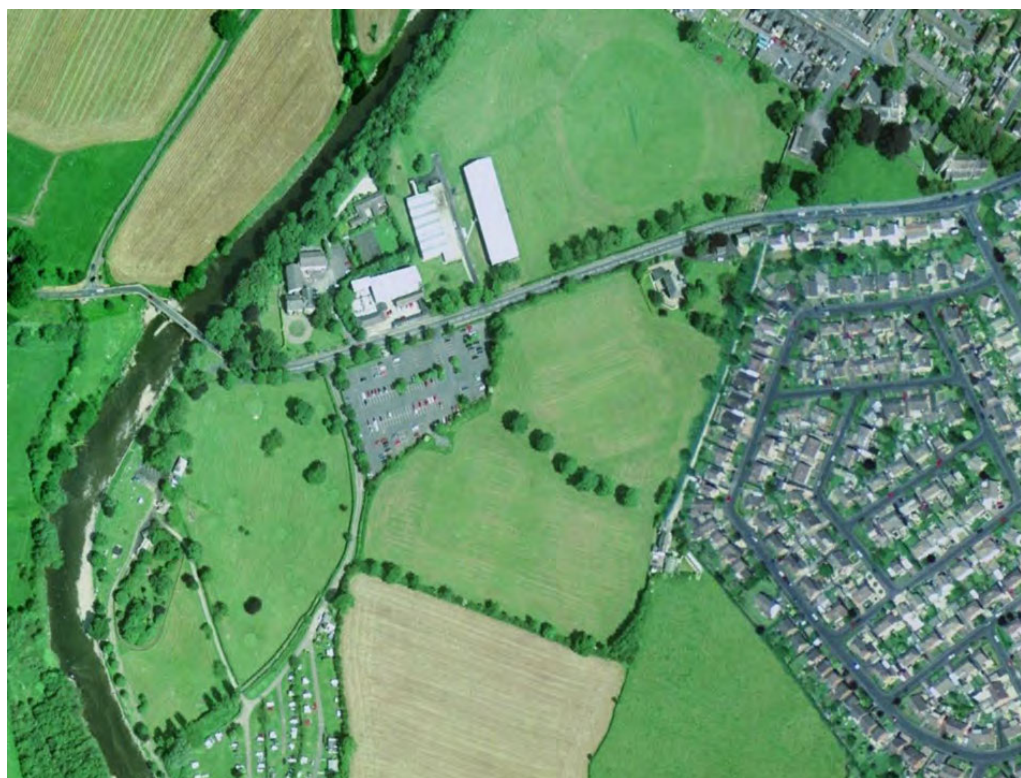
*Figure 3.1 Aerial Imagery dated December 2000*  
*Source: Google Earth Pro, obtained 27.05.2026*

- 3.2.1 The site is currently comprised of existing grass pitches, as shown on the topographical survey enclosed in **Appendix A**.
- 3.2.2 Aerial imagery dating back to December 2000 is shown in Figure 3.1 below, with the most recent aerial imagery (dated September 2025) shown in Figure 3.2 below. It can be seen that the site has remained comparable during this time.

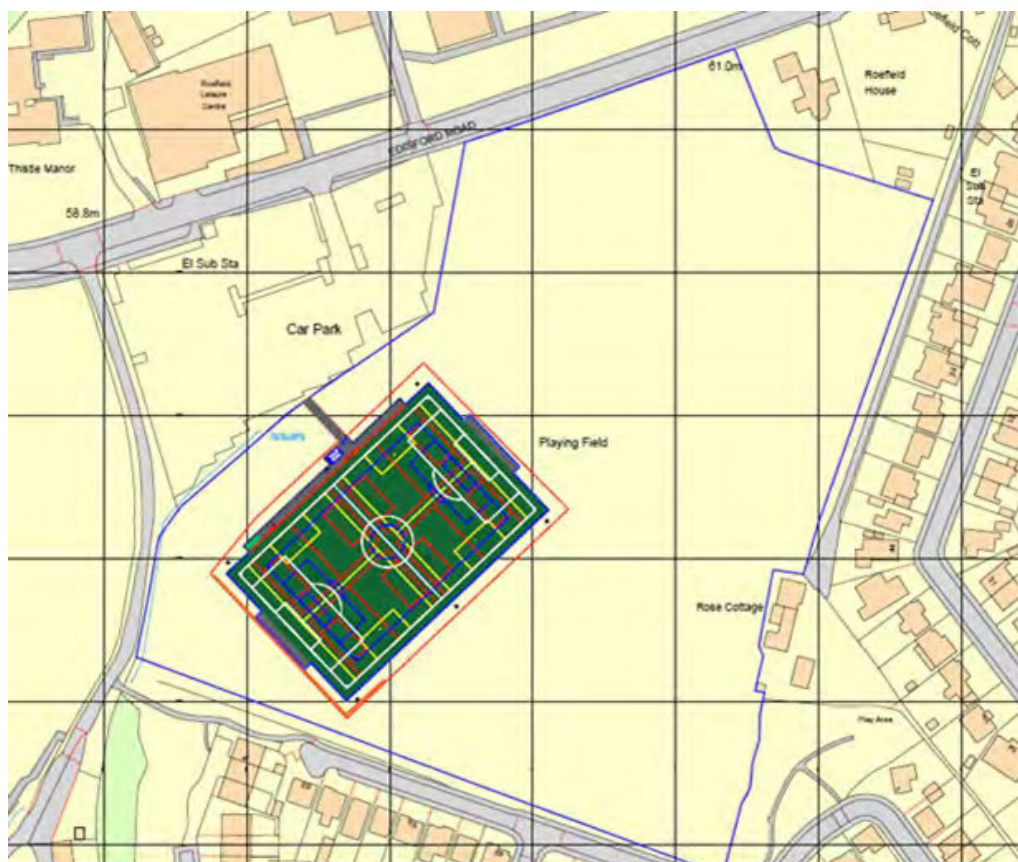
**Figure 3.3 Proposed Site Layout (AGP)**

3.6.1 The proposed development will comprise of an Artificial Grass Pitch (AGP) and a small toilet block adjacent to the pitch. The proposed development layout is shown on the plan in Figure 3.3 below.

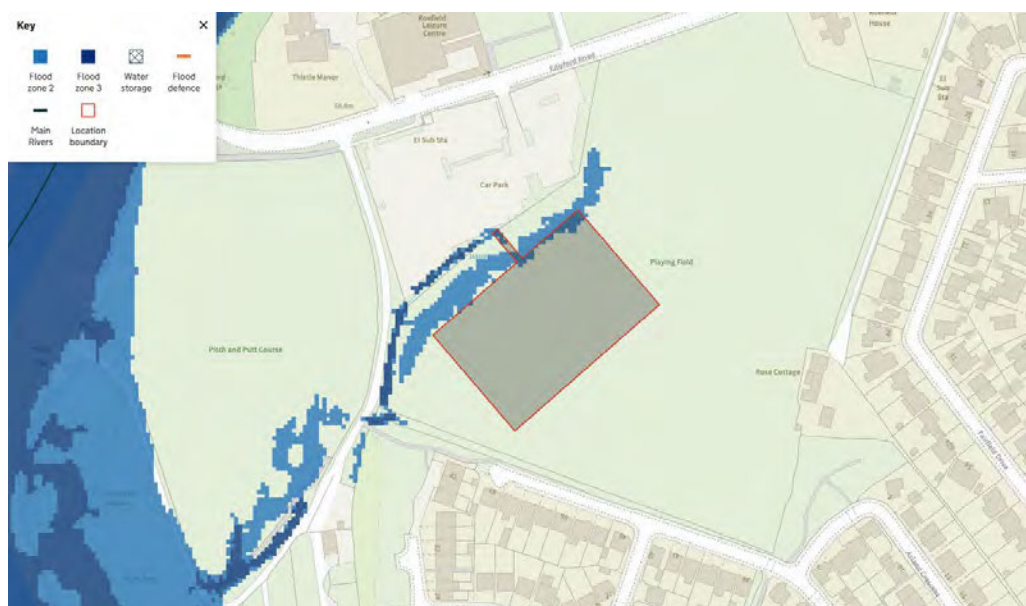
**Figure 4.1 Flood Map for Planning - Flood Zones (given year)**  
**Source: GOV.UK website, obtained 02.06.2026**

- 4.1.1 An extract of the Environment Agency's Flood Map for Planning (Flood Zones) is provided below in Figure 4.1. The flood map was extracted from the GOV.UK website on 28<sup>th</sup> May 2026. The approximate application site boundary is shown in red. The map indicates that the proposed AGP is located predominantly within Flood Zone 1 (Low Probability) and at a low risk of flooding from rivers or the sea. The north-western edge of the pitch is shown to encroach slightly into an area of Flood Zone 2 (Medium Probability), as associated with the watercourse in this location.

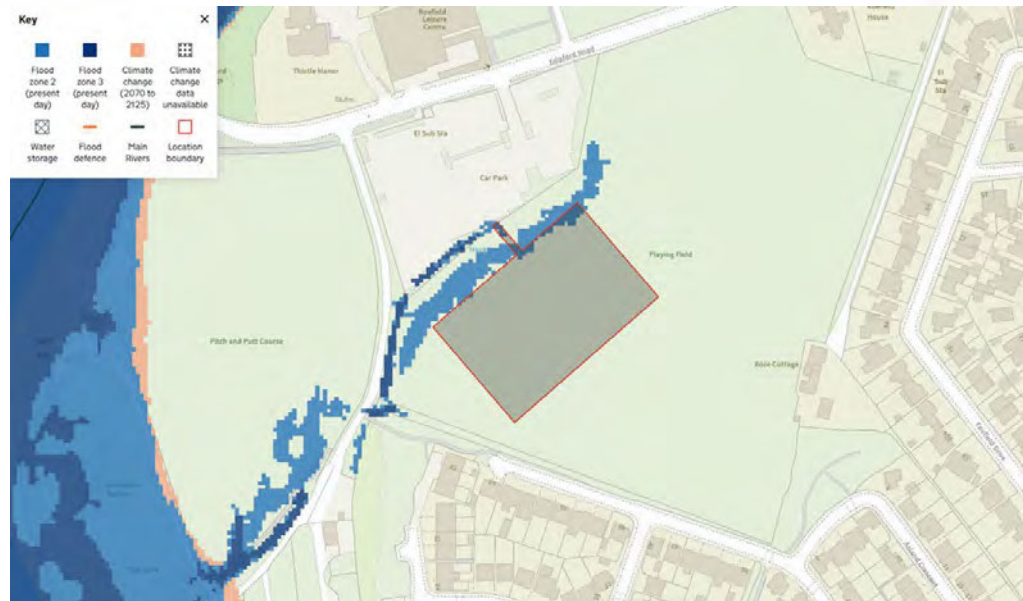
**Figure 4.2 Flood Map for Planning - Flood Zones (2070 2125)**  
Source: GOV.UK website, obtained 02.06.2026

- 4.1.2 The latest mapping also includes an allowance for climate change (2070 to 2125), as shown in Figure 4.2 below. The mapping shows that the AGP remains at a comparable risk of flooding when accounting for an additional allowance for climate change.

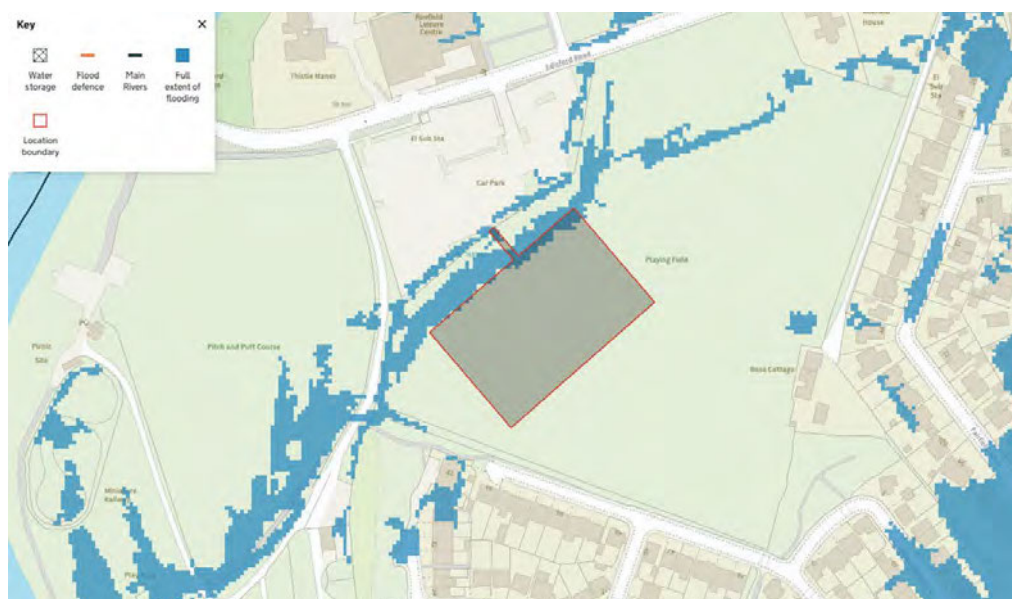
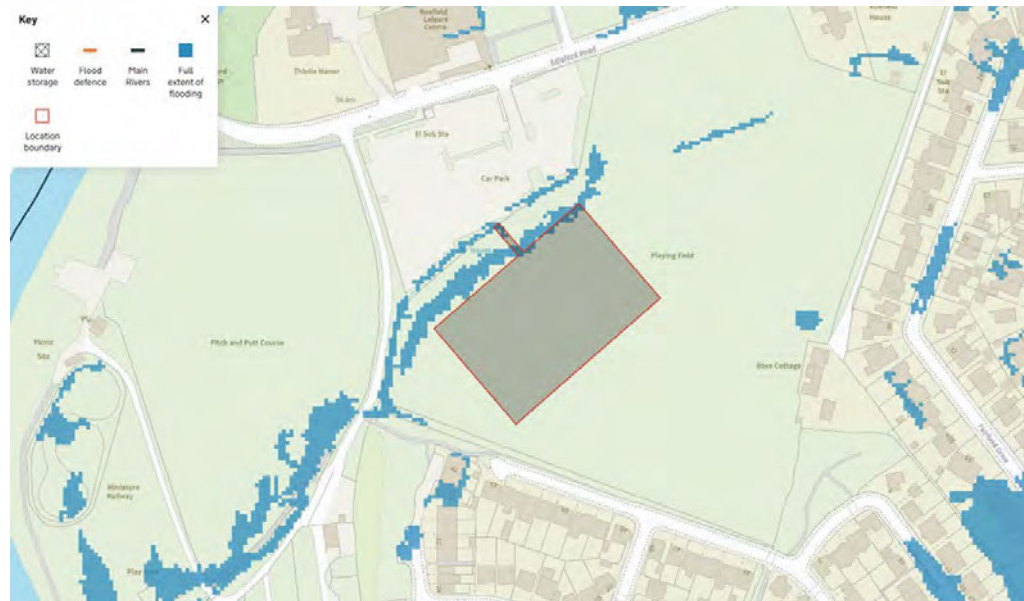
- 4.2.2 The latest mapping also includes an allowance for climate change (2061 to 2125), as shown in Figure 4.4, Figure 4.5, Figure 4.6 below. The extent of the yearly chance of flooding is comparable to the non-climate change scenario.

- 4.2.3 With an allowance for climate change, the north-western edge of the pitch is shown to extent slightly into the 1 in 1000 year (low), 1 in 100 year (medium) and 1 in 30 year (high) extent of surface water flood risk.

- 4.2.4 As shown in the four figures above and depicted on the plan enclosed in **Appendix D**, the proposed pedestrian access of the AGP is shown to be located in an area at a low (1 in 1000 year) and medium (1 in 100 year) chance of surface water flooding. The proposed pedestrian access location of the AGP correlates to the existing pedestrian access of the playing fields. Therefore, the level of flood risk will remain comparable to the existing on-site arrangement, regardless of the development proposals. It should also be noted that the AGP is categorised as Water Compatible development. It is therefore deemed that the level of flood risk is acceptable for the proposed use of this site.

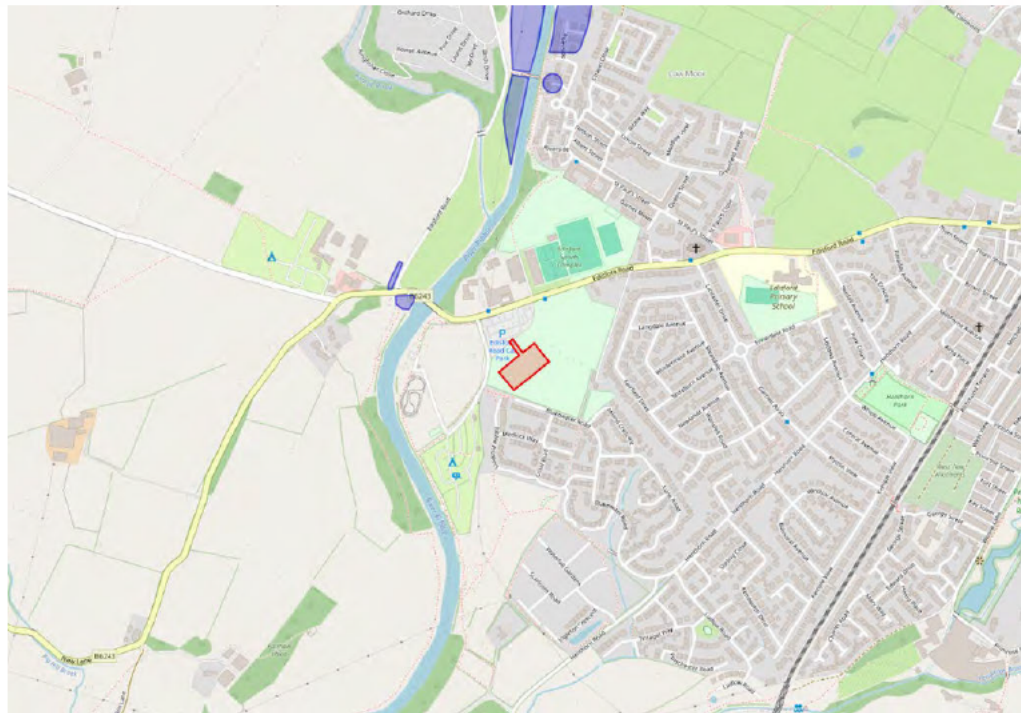
Figure 4.8 Historic Flood Mapping

- 4.6.1 Figure 4.8 below displays a map showing historic flooding events around the western area of Clitheroe and the surrounding hinterland, as published by the Environment Agency. As depicted, the mapping shows no recorded flooding incidents located within the proposed site boundary.

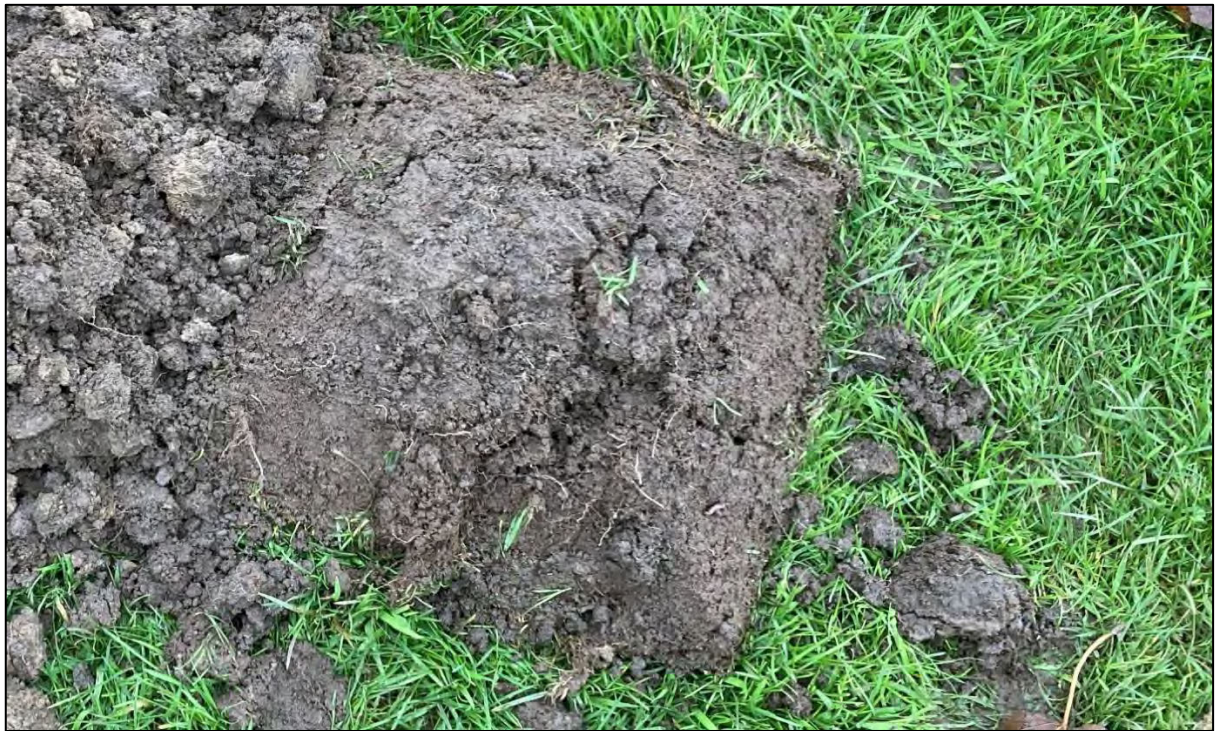
*Figure 5-A: Topsoil extracted from HP02*

5.2.2 Topsoil comprised brown, sandy, slightly gravelly clay with frequent rootlets.

5.2.3 A photograph of topsoil deposits encountered is presented below.

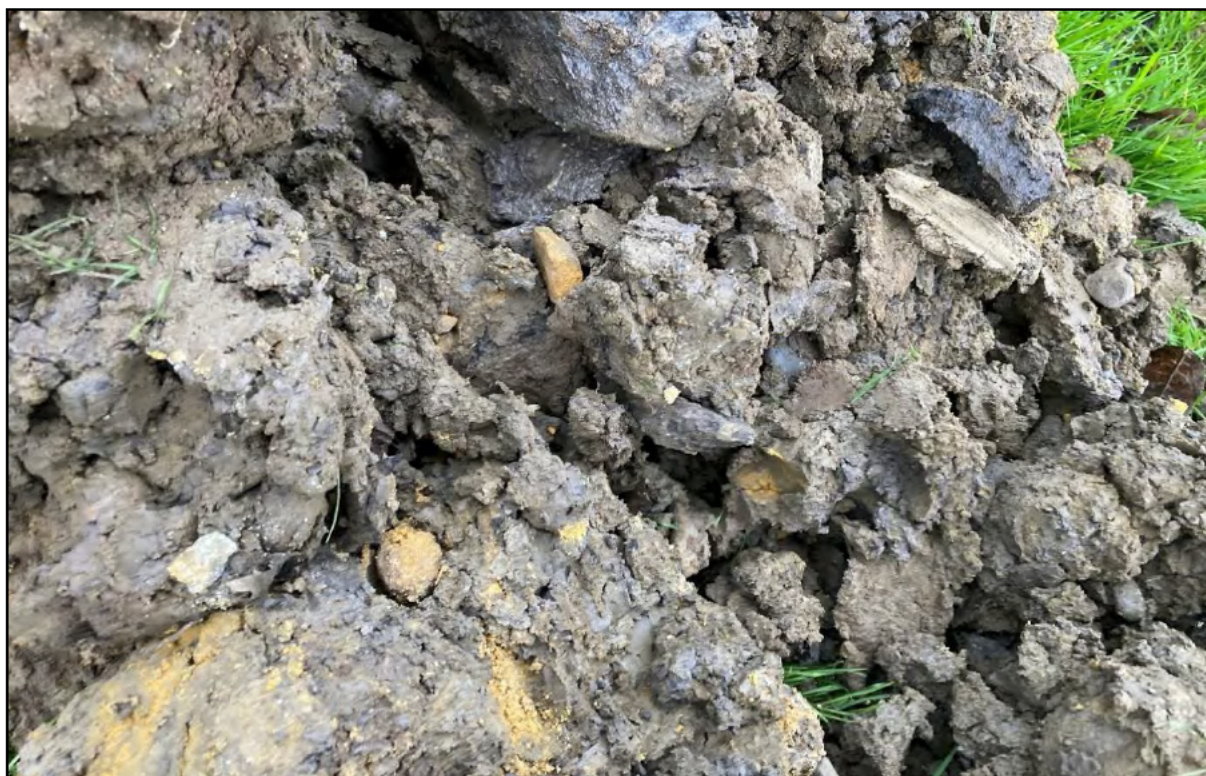
Figure 5-B: Devensian Till extracted from HP04

- 5.3.1 Devensian Till was encountered underlying the Topsoil in all exploratory positions, however the base of the deposit was not encountered, with a maximum excavated depth ranging from 1.00 m to 1.20 m bgl.
- 5.3.2 Devensian Till was typically a firm grey mottled orangish brown slightly sandy, gravelly clay with a low to medium cobble content of siltstone. The gravels comprised siltstone, sandstone and mudstone. Trial pits HP03 to HP06 terminated due to the cobble content between depths of 1.00-1.15m.
- 5.3.3 A photograph of the Devensian Till Deposits generally encountered on site is presented below.

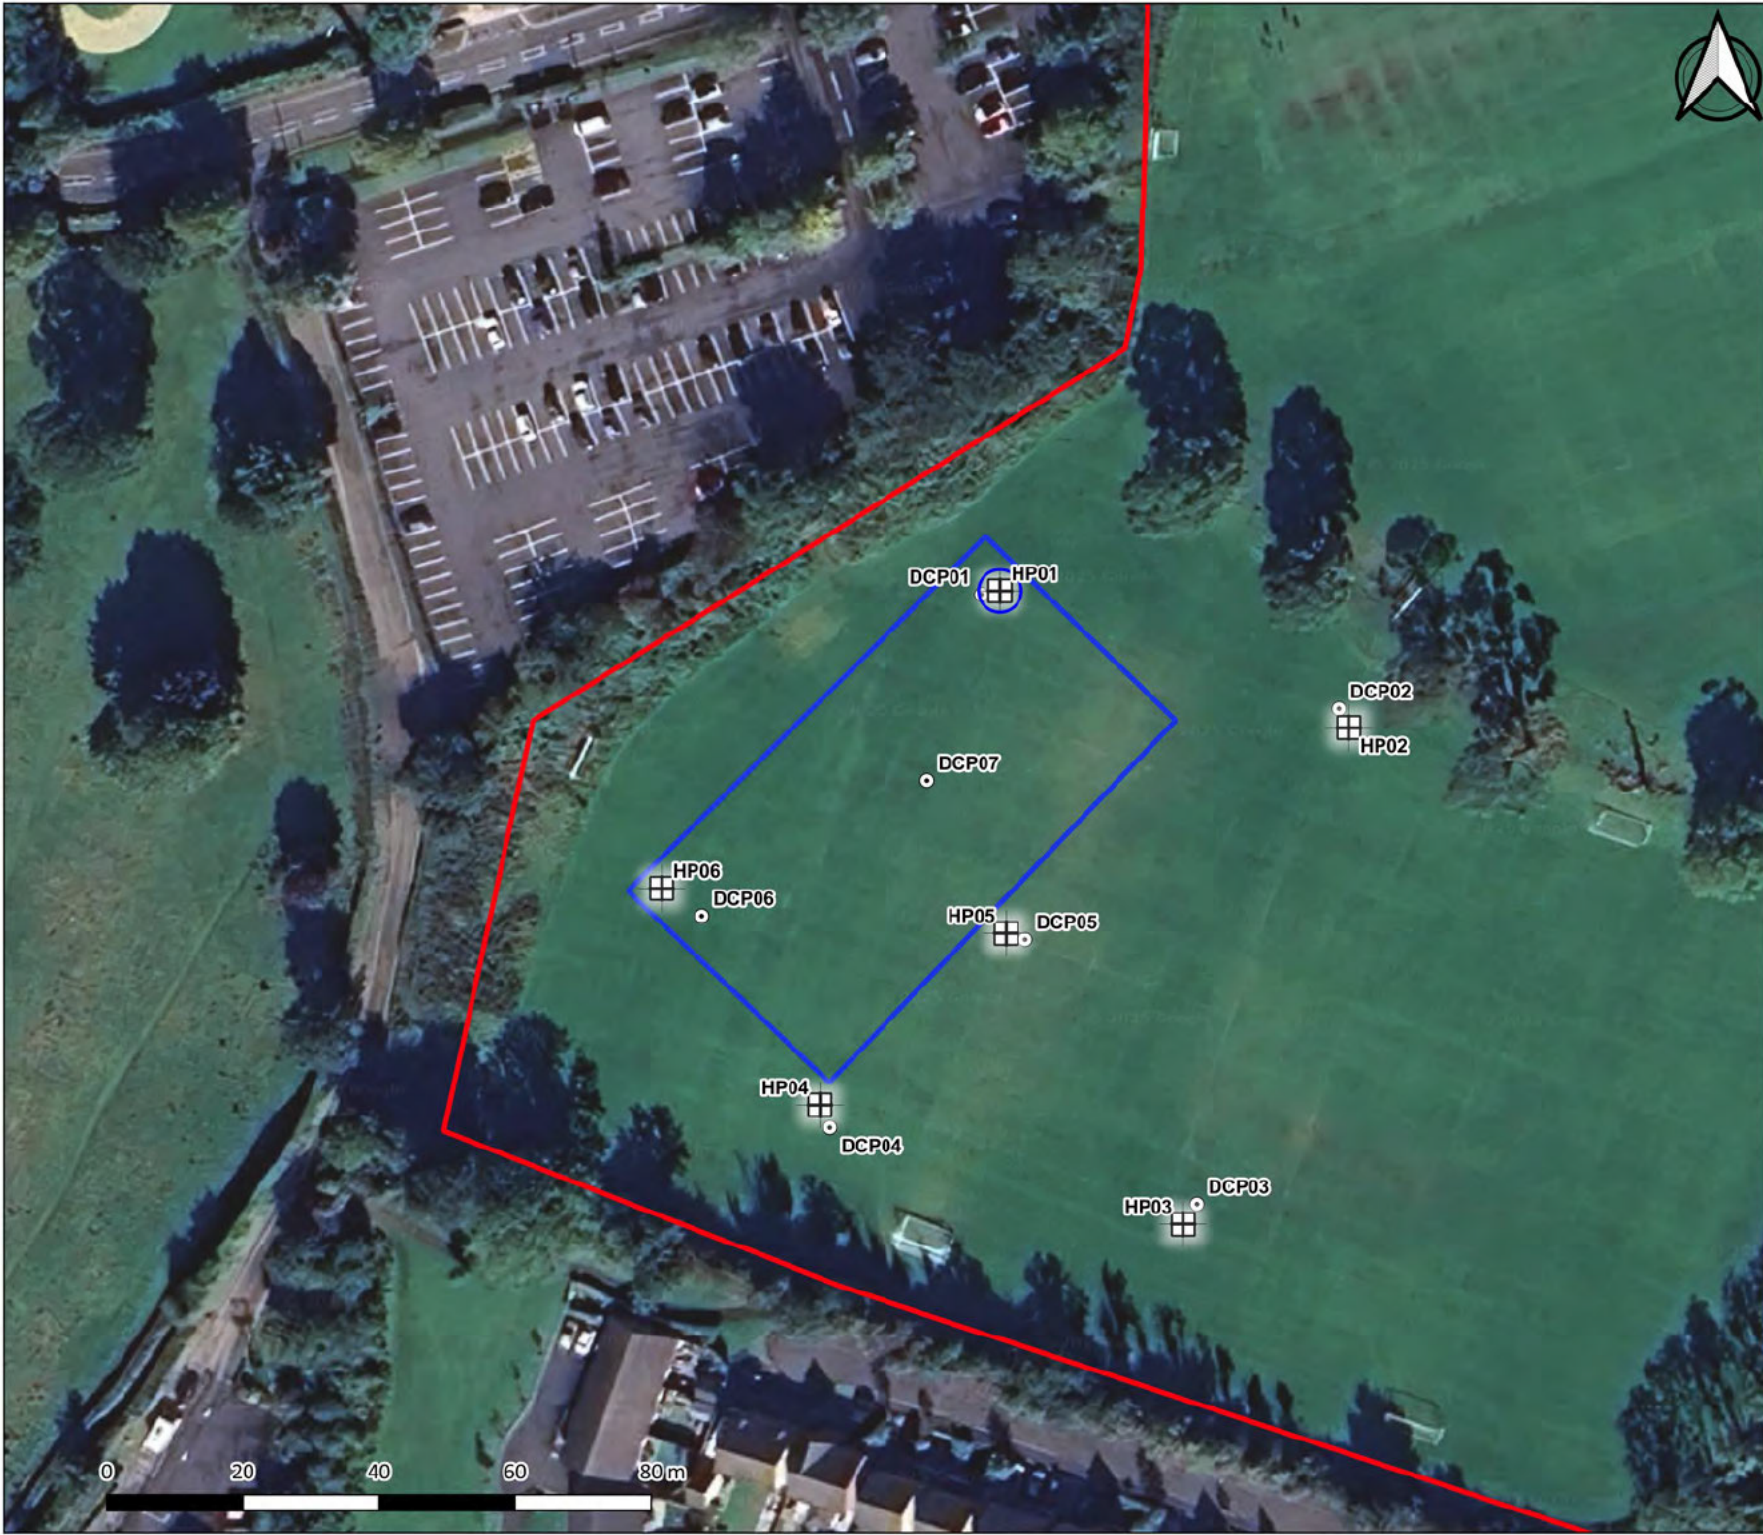
- Key:
- Site Boundary
  - Proposed AGP Footprint
  - Hand Pit
  - Dynamic Cone Penetrometer (DCP) Test
  - Soakaway Testing
