**BAT SURVEY
AT
VICTORIA BUILDINGS
10 KING STREET
CLITHEROE**

REFERENCE NO 7106

EMERGENCE SURVEY UPDATE

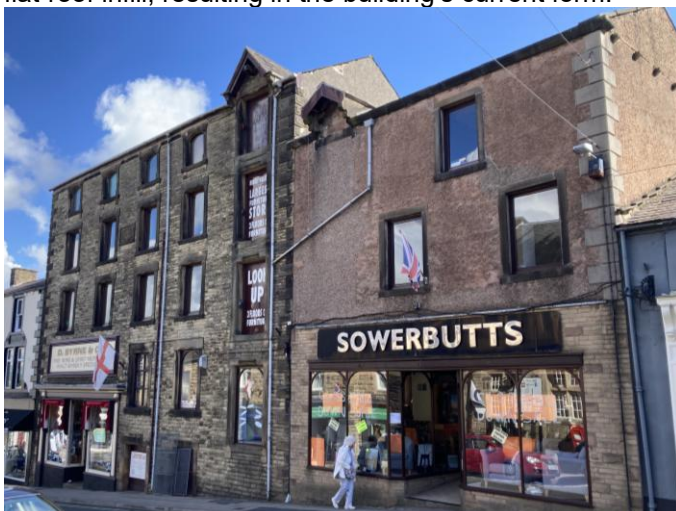
Front King Street Elevation.

The section of the building being affected by the proposed scheme are not visible from the front.

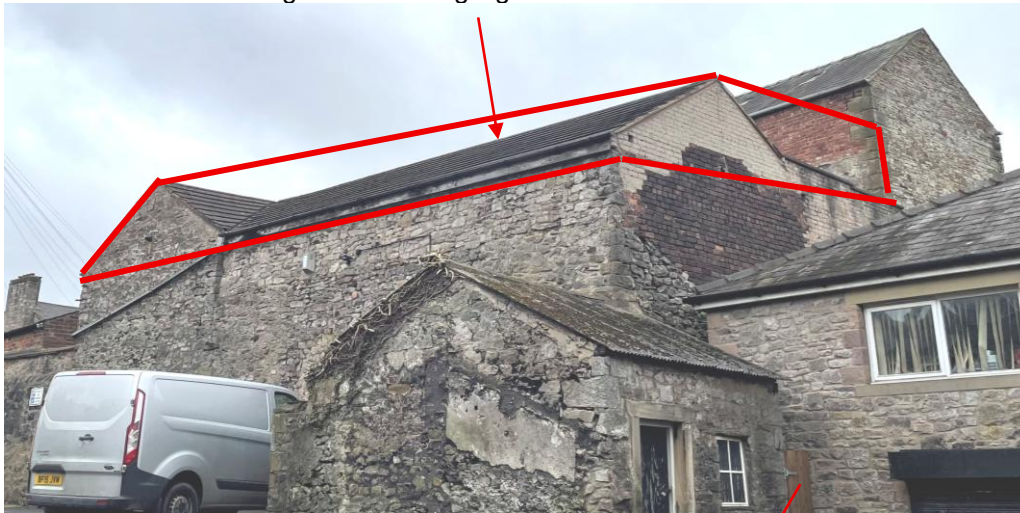
Rear northeast Elevation.

The section of roof being affected is highlighted in red

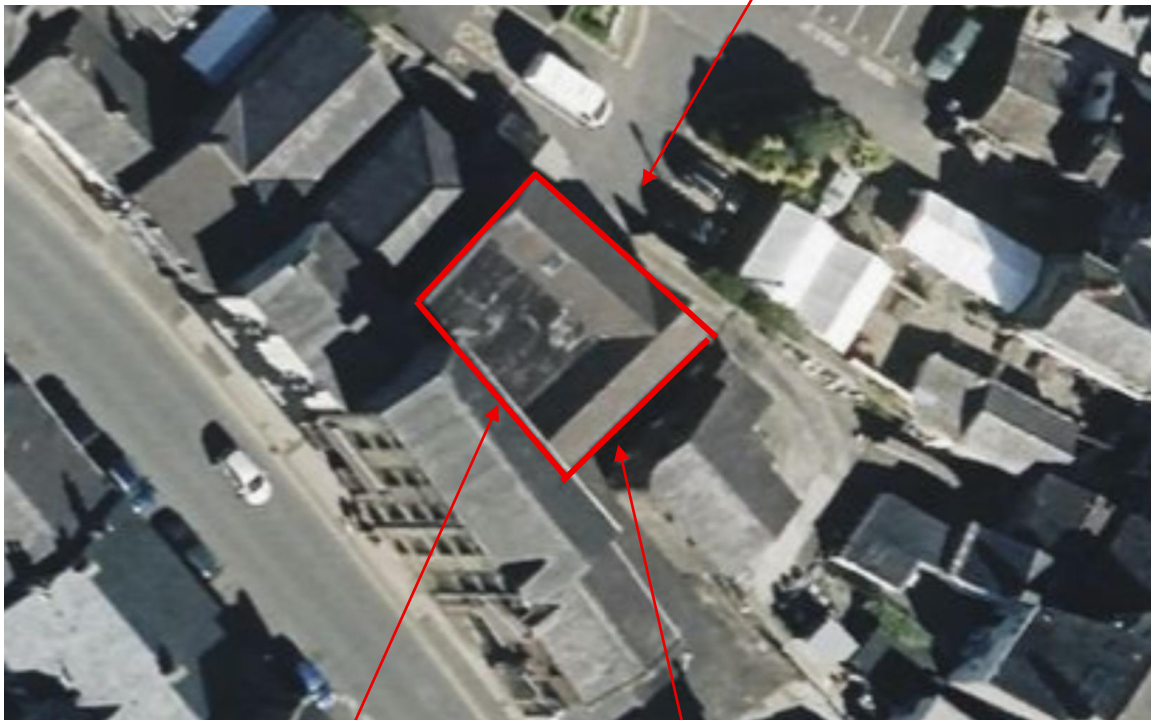
The section of roof being affected is highlighted in red

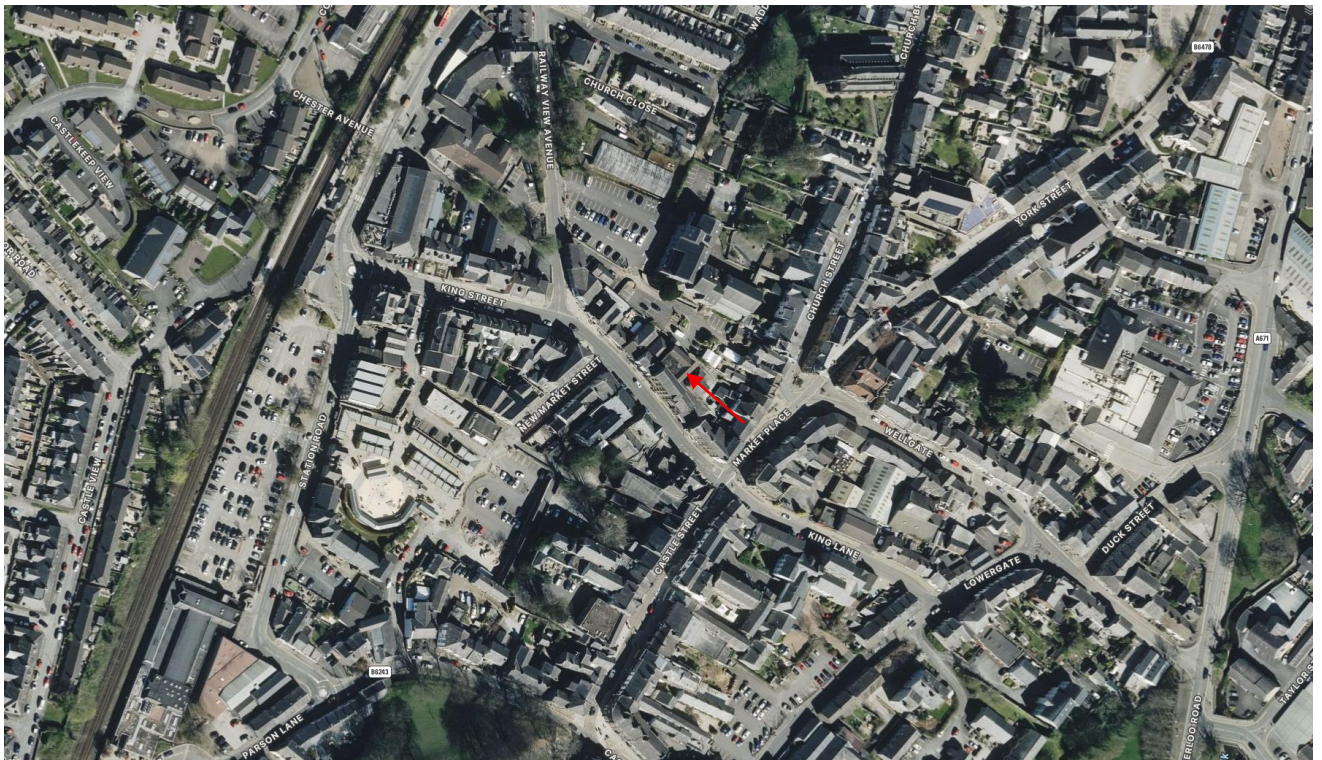
The building is in the urban centre of Clitheroe with King Street to the front and a public car park adjacent to the rear.

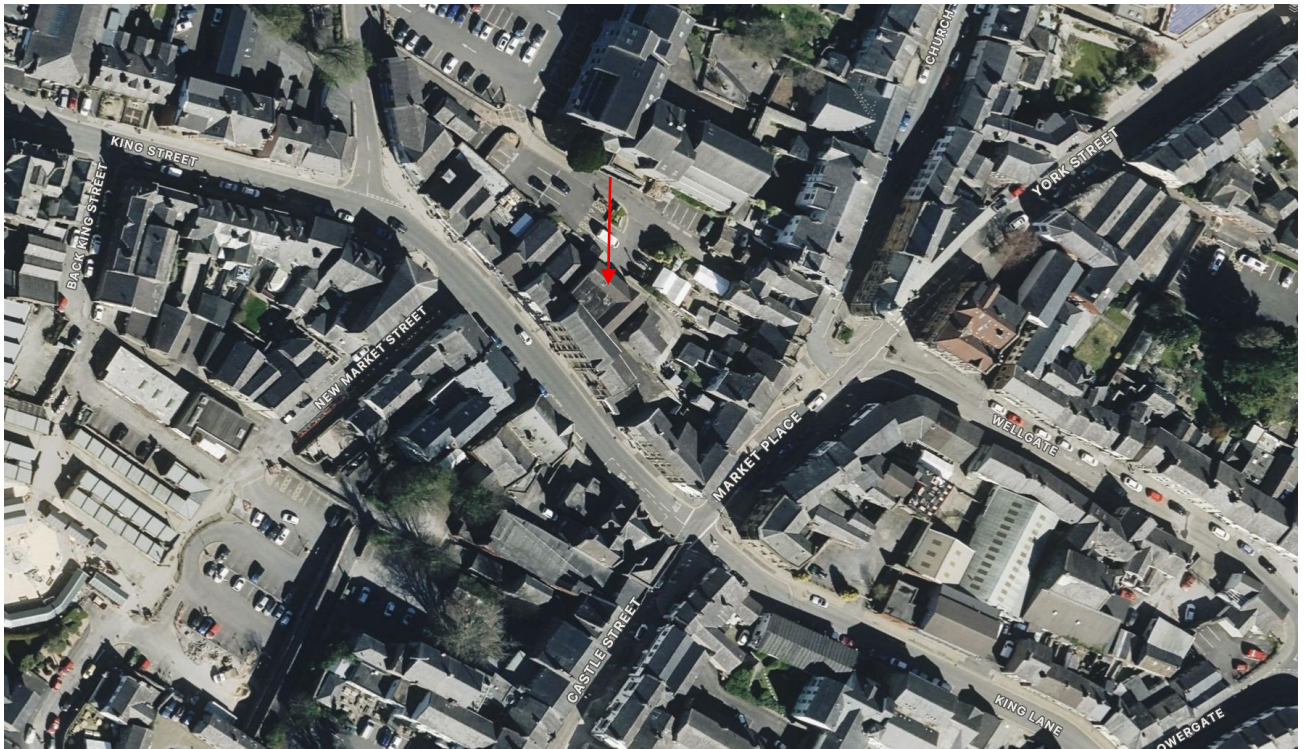
The rear sections of the building being affected by the proposal are random stone to the northeast elevation.

It appears that the existing random stone northwest gable wall required repairing and it has been rebuilt with brickwork which is partially painted.

The brick gable wall had some missing bricks and had sections without pointing.

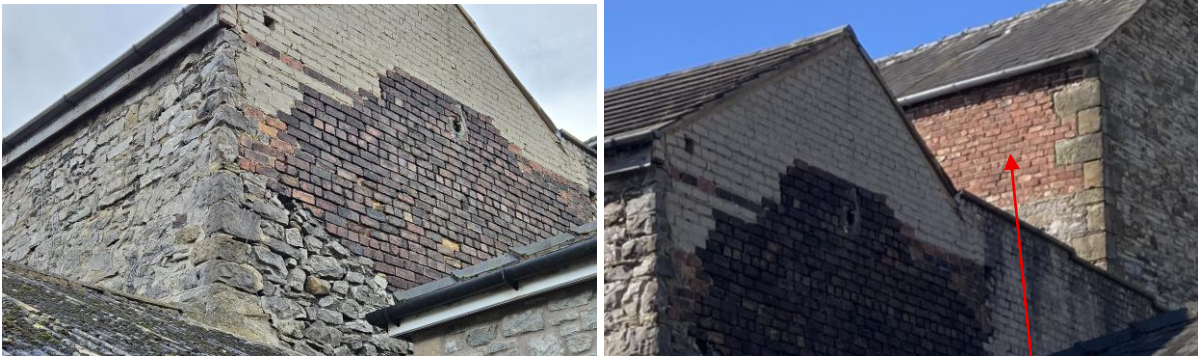
The southeast elevation is random stone, but it appears new windows have been added at some stage, and the wall is better maintained than the rear elevation.

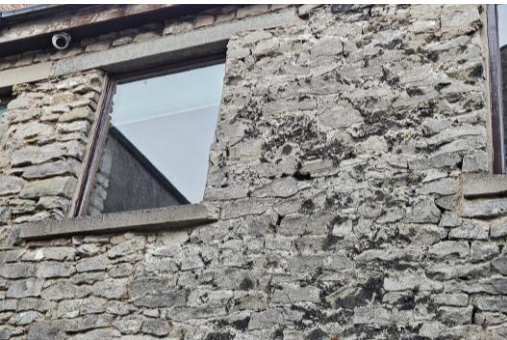
The southeast elevation stonework and pointing is in reasonable condition and does not provide any access points.

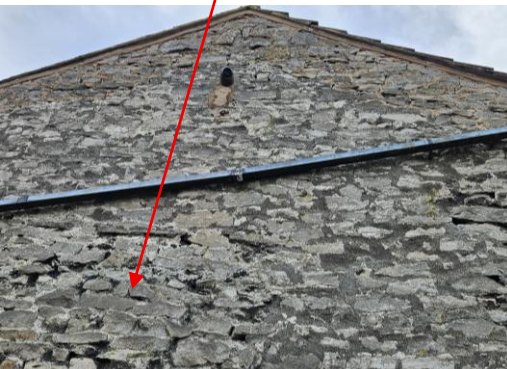
The rear northeast wall had sections of dislodged / deeply recessed pointing which could not be closely inspected.

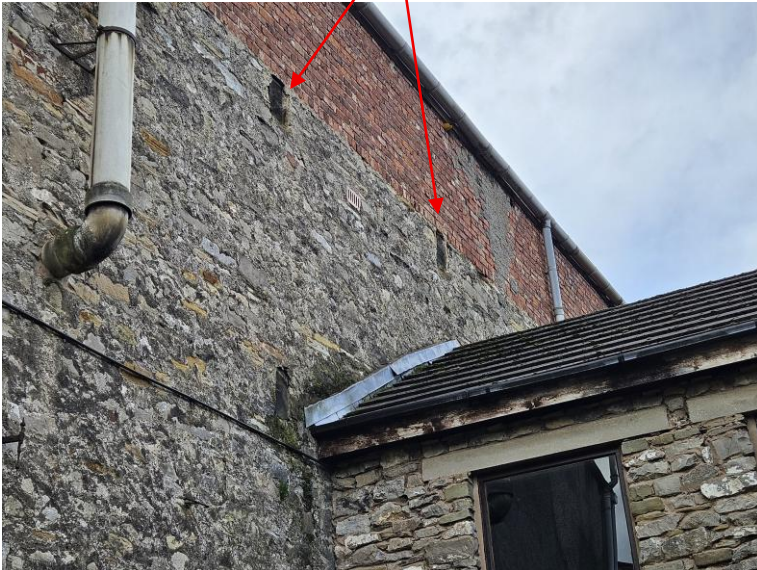
Some recesses and holes are present in the rear wall of Victoria Buildings which will be covered by the proposed second floor extension. It was not possible to closely inspect the cavities.

The rear wall of the Victoria building had some potential to host crevice dwelling bats. Gaps were present where pointing was missing together with a couple of bricks.

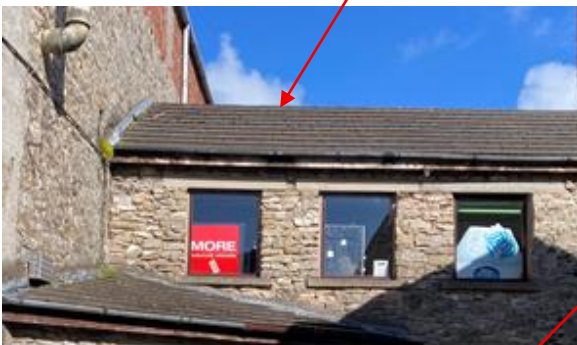
The roof structure consists of two pitched roofs which are joined with 2no.valley gutters forming an L shape which abuts a flat roof on 2 sides.

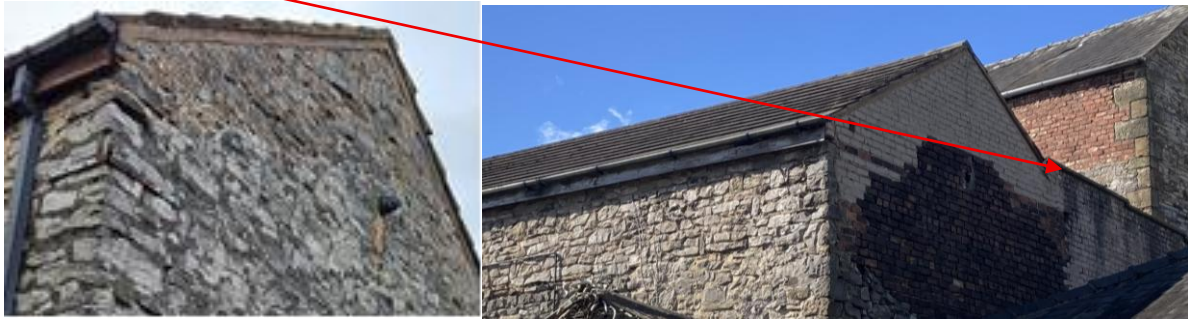
Northeast gable wall

The flat roof also abuts the rear wall of the main Victoria building and has a parapet wall on the northwest side.

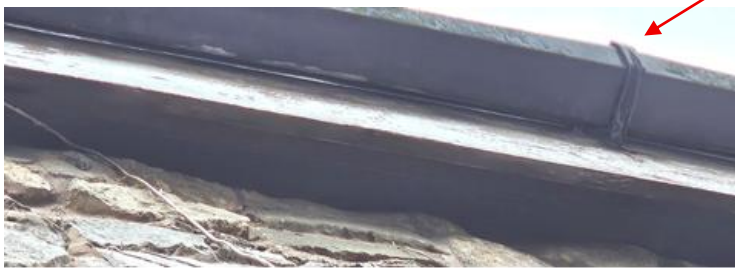
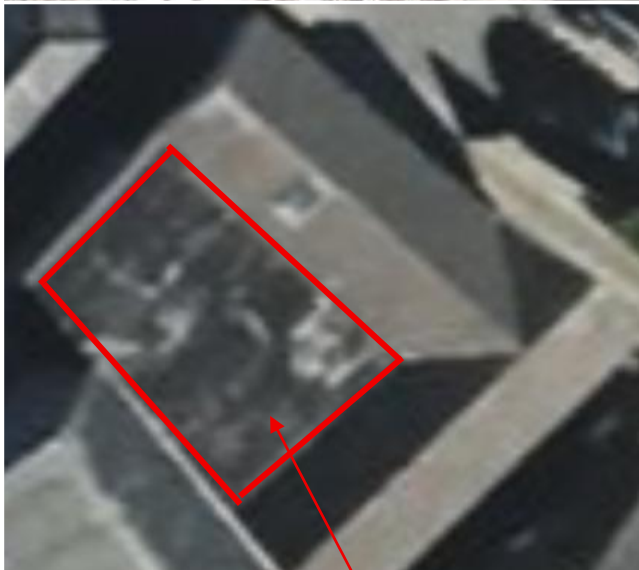
Timber fascia boards are present with a slight overhang with timber soffits.

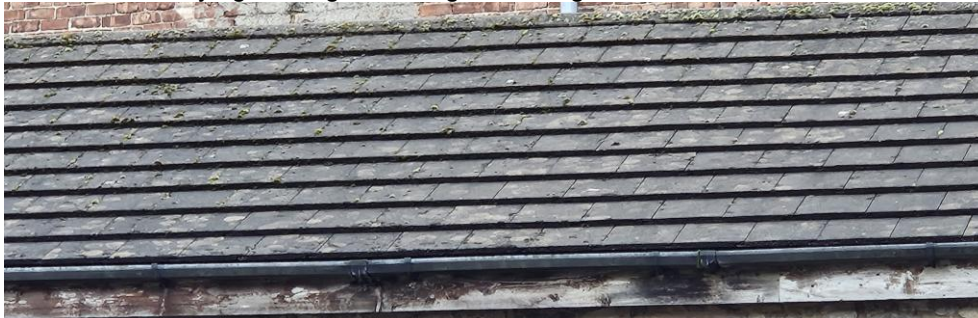
There are only 2 pitches visible from ground level, the southeast and northeast. both have a tile finish which are in very good tight-fitting condition with some marginal moss and lichen present. The ridge tiles are also very tight fitting. The verges to the gables are well pointed with no cracks or crevices.

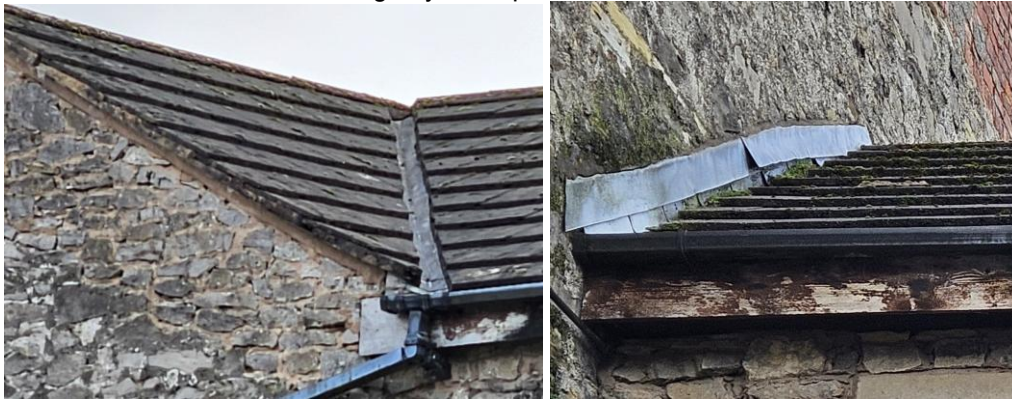
Lead flashings are present to the valleys and the abutment of the roofs with the rear wall of Victoria buildings. The flashings are in reasonable condition and tight fitting with only a small, lifted lap, which could be discounted from having any roost potential.

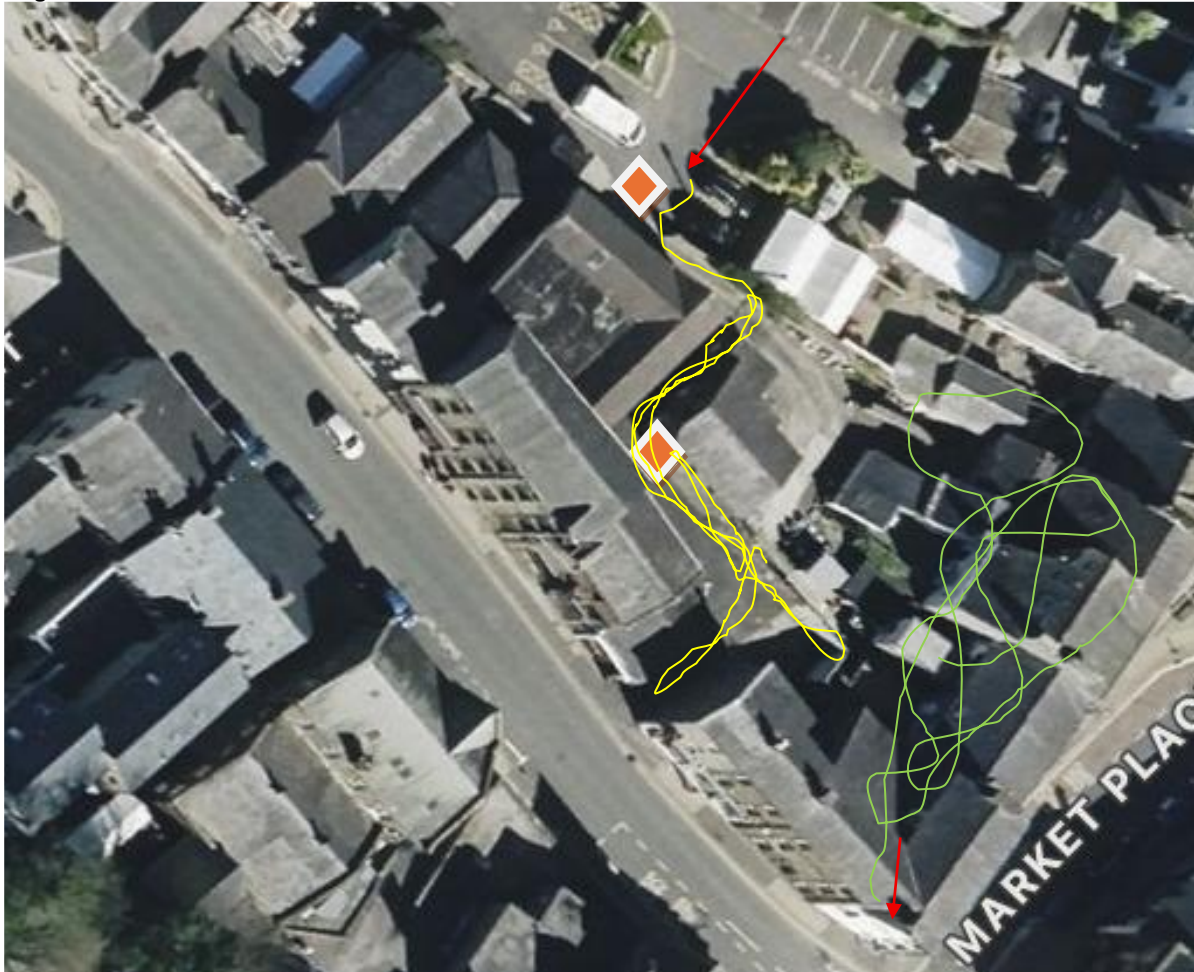
Fig :1

The evening emergence survey commenced at 8.30pm two no. surveyors were positioned as shown below.

8.45pm - 1 no Pipistrelle bat forage activity commenced it did not emerge from the building it appeared from the carpark direction (NE) → The forage activity commenced as Indicated by the yellow line which followed the path behind Victoria building and turning down the ginnel towards King street before returning this continued for approx. 20/ 25 mins before the concentration of activity moved to the south east over the rear yard areas and roof pitches of the shops on Castle street indicated by the green line this activity continued for 35/40 mins before it ceased at approx. 9.00pm no further activity was recorded its exit direction was SW .

The recorded activity during the survey was isolated to just one Pipistrelle appearing from the north east direction towards Victoria buildings and eventually exiting the location in a south westerly direction.

No bats were observed emerging from the building during the dusk emergence survey. The only activity recorded comprised a single Pipistrelle bat commuting and foraging within the surrounding area, with flight activity originating from the north-east and no association with the building itself identified.

The construction of the new extension will not impact on any local bat population by removing or destructing any high value roost potential, forage or commute routes; the observed commute / forage routes as indicated on fig 1 will be unaffected.
