**Aisled Barn, Downham**

**BAT SURVEY REPORT**

**December 2025**

**Report Ref:** 159\_01

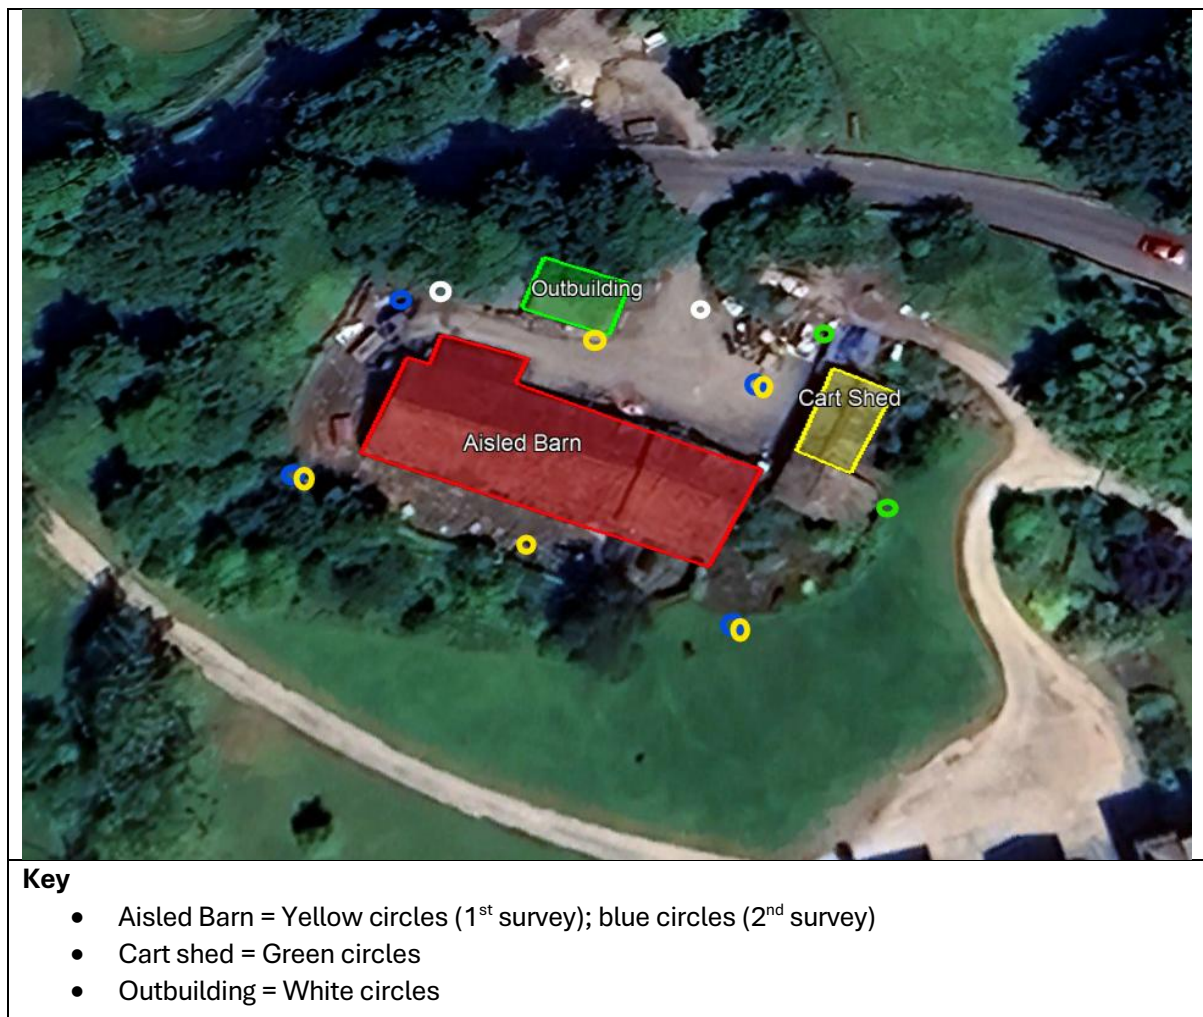
**Figure 2.1. Building Plan & Survey Positions**

Dusk emergence surveys were undertaken over the course of five visits in 2024 and 2025. The dates of each survey are included in Table 2.2. Figure 2.1 provides a plan of the buildings and an overview of the survey positions adopted for each building.

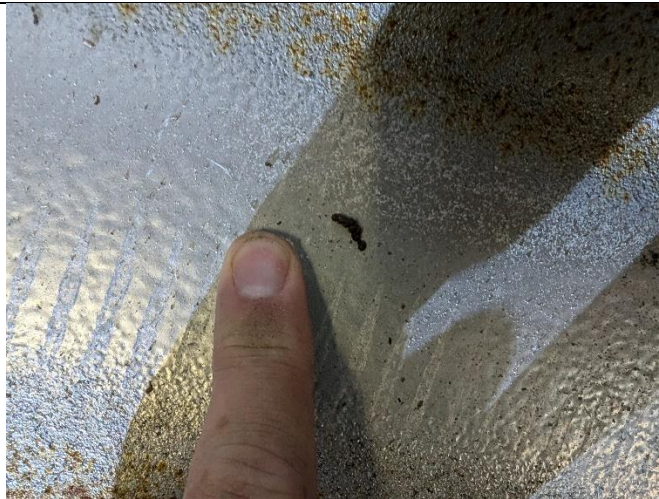
**Photo 3.2**  
Bat dropping in aisled barn.

One bat dropping was found on a tarpaulin on the ground floor. This dropping could not be attributed to a certain bat species. In addition, this dropping could not be attributed to a potential roost site as bats often forage in large barns.

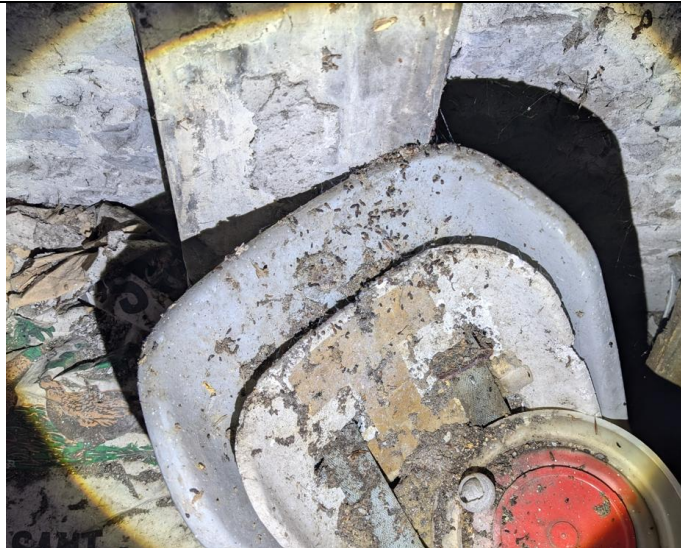
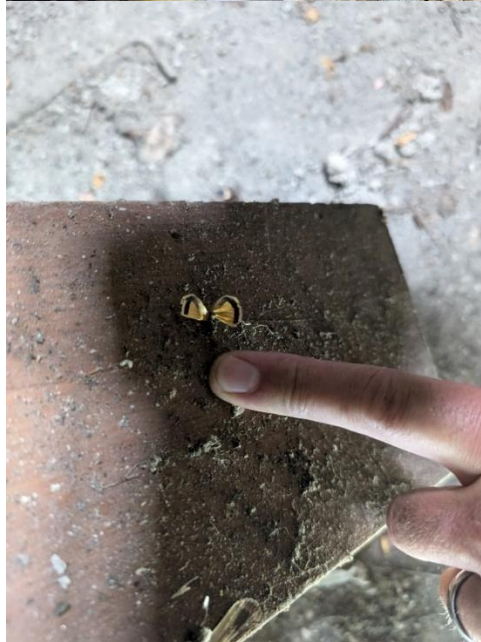
**Photos 3.3a & 3.3b**  
Droppings and feeding remains within upper floor of central section.

- Bat droppings were scattered on the central upper floor section with an accumulation of droppings below the ridge on the east wall. There were also feeding remains (yellow underwing moths) within the same location. The droppings and feeding remains were attributed to brown long eared bats.
- The corpse of a brown long-eared bat was identified between the wall and the roof rafter in the central upper floor.
- Accumulations of bat droppings (brown long-eared bats) were identified throughout the loft floor of the former stables.

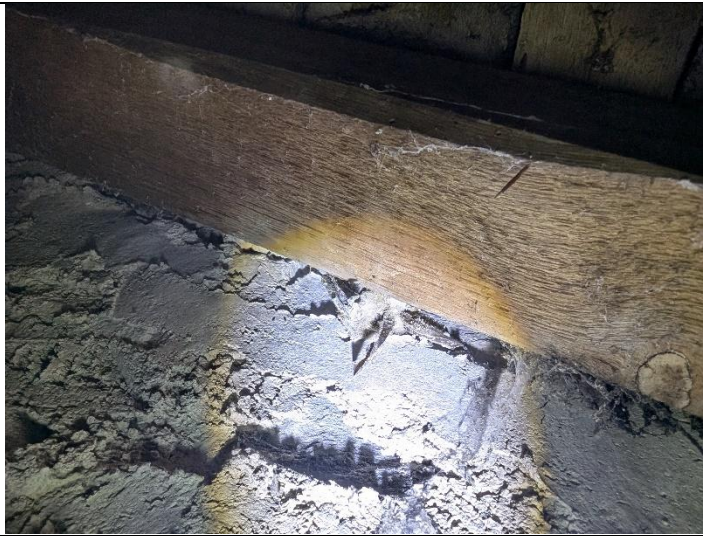
**Photo 3.4**

Dead brown long-eared bat within upper floor of central section.

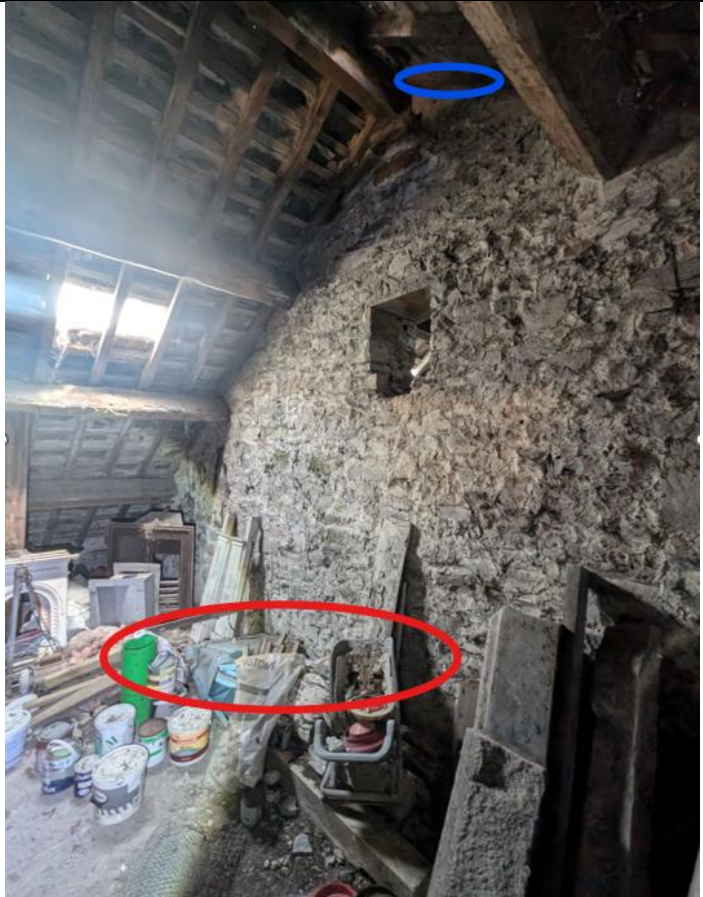
**Photo 3.5**

Location of dead bat (blue) and bat droppings / feeding remains (red).

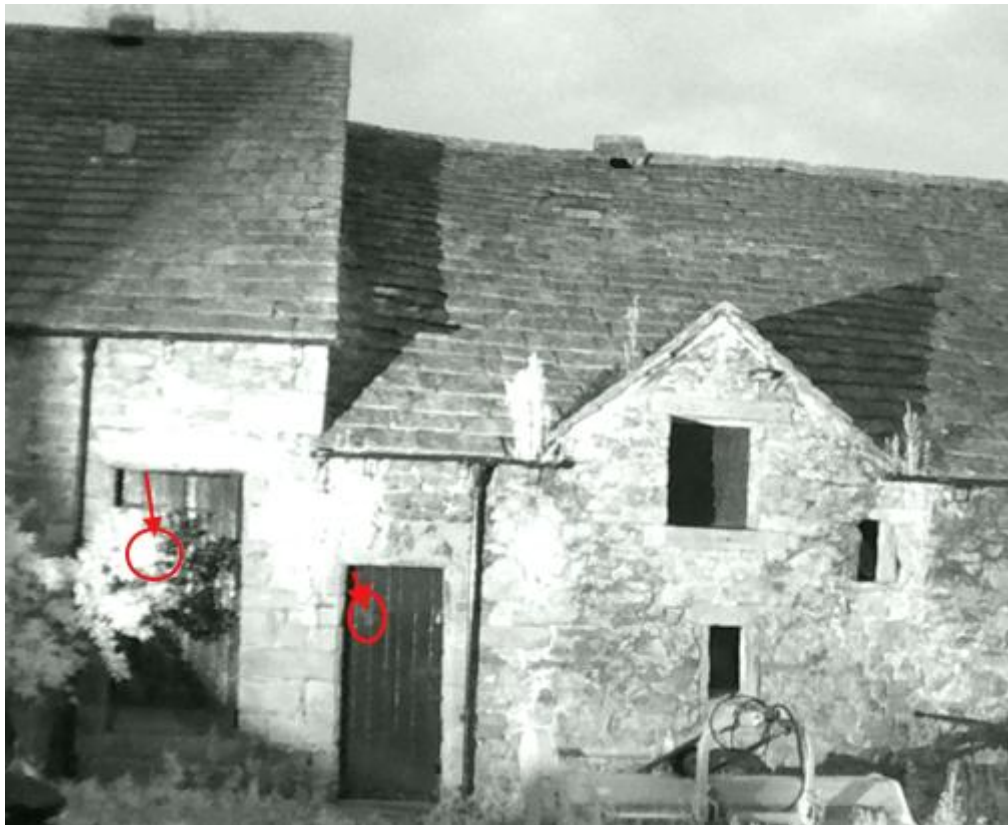
A total of eight brown long-eared bats emerged from the barn. A total of six bats emerged from the circular aperture on the east gable and two bats emerged from above the small door on the front (north) of the aisled barn.

**Image 3.2**  
Emergence point of 1 brown long-eared bat (front door access to loft - left of photo) on 25<sup>th</sup> July and 2 brown long-eared bats on 29<sup>th</sup> August.

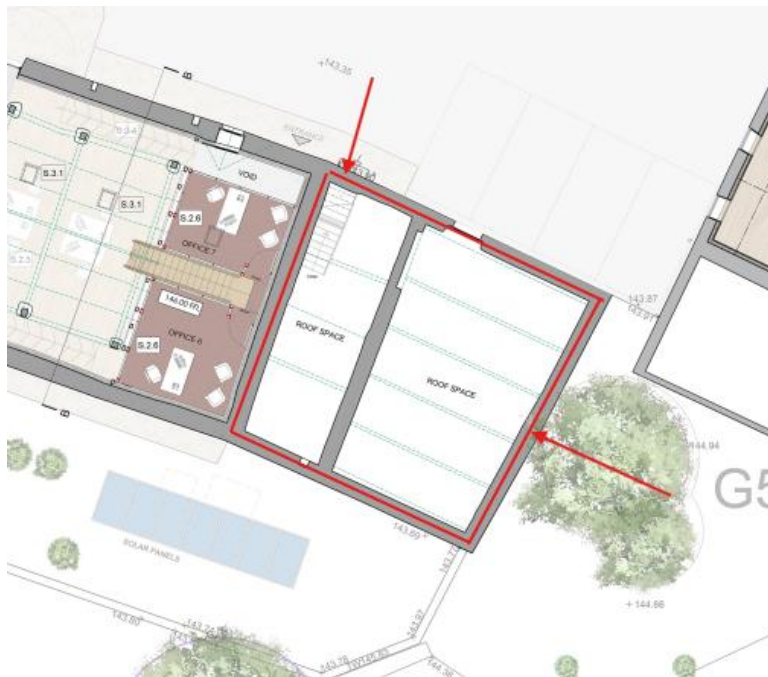
**Figure 4.1. Retention of loft space, roost and access points.**

The applicant has decided that the best course of action is to retain the bat roost in-situ (see Figure 4.1). The loft area above the workshop and the upper floor area accessed via an external doorway are to be retained. In addition, the roof is also not to be touched within these locations. Leaving these sections of the barn will result in the retention of the main roosting areas. In addition, the main roost access point (aperture on the east gable) will be retained. This retention will result in the avoidance of significant potential impacts to the bat roost. Other secondary impacts can be avoided / minimised via non-licensable mitigation measures.

A wildlife-sensitive lighting scheme is recommended. Although an increase in night-time lighting within the main yard is expected post-development, no lighting will be directed towards the primary roost access point on the east gable. Existing flightlines will remain unfragmented.

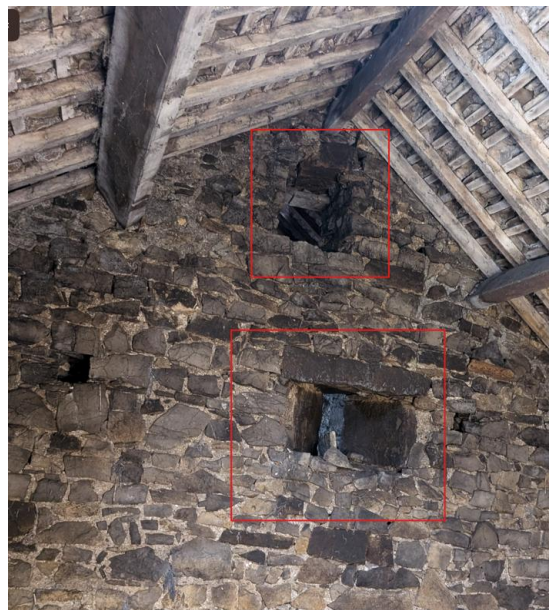
**Photo 4.1.**

Fly through access to the aisled barn from the main roost site.

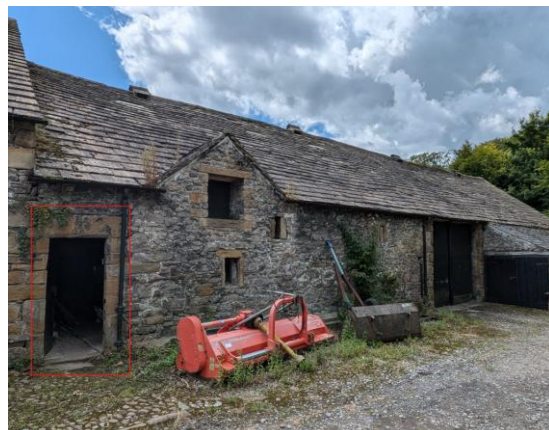
**Photo 4.2.**

Whilst the main roost area is not within the aisled barn; one secondary roost access point is. For brown long-eared bats, it is typically the case that the whole barn is listed as a roost site as this species utilises the entire building for pre-emergence activity. Under the provisions of the legislation, the blocking of access and the internal wall gaps would constitute damage to the roosting site.

Secondary roost exit point on the aisled barn.

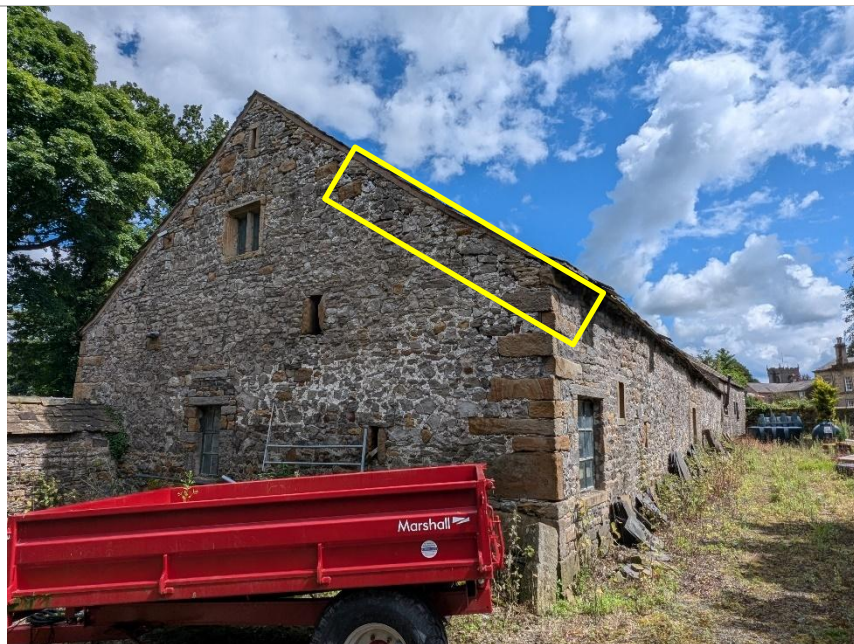
The external stonework was generally in good condition and well pointed on the north (front) and east elevations. However, several deep crevices were present on the west gable due to missing mortar, particularly beneath the south-west roof verge. Additional gaps were noted within the central section of the stonework on the rear (south) elevation. The barn has a traditional stone slate roof. Some maintenance had previously been undertaken on the former stable section, and the dry-verge pointing here appeared in good condition. In contrast, several slipped, missing and lifted slates were present on the aisled section. As is typical of stone-slated roofs, small crevices were present between the irregular slates throughout. The roof lacks an underlining, which reduces the likelihood of crevice-dwelling species (e.g., pipistrelles) roosting within the roof structure.

**Photo 4.**  
South-west  
elevation  
(several gaps in  
stonework).

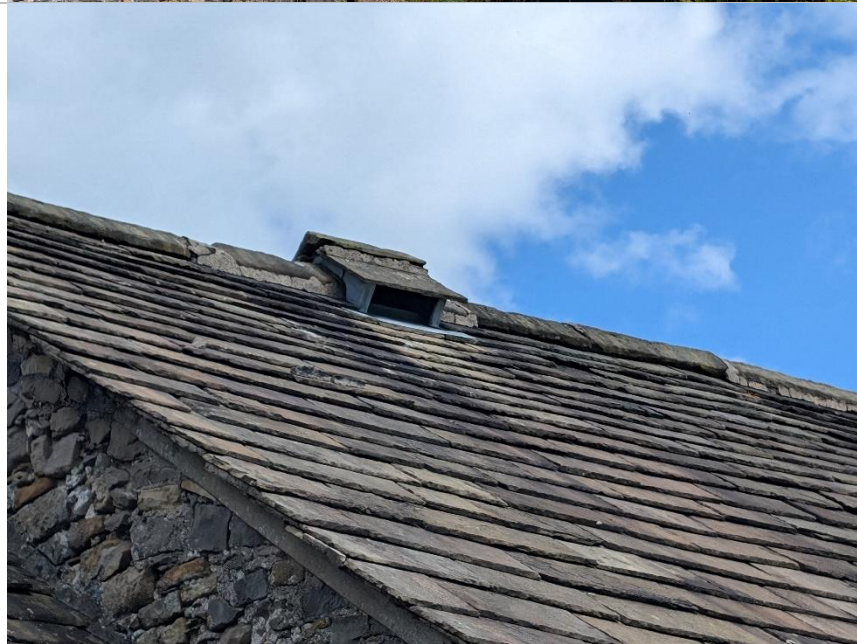
The roof ridge on both sections contains six large, evenly spaced air vents. These did not appear to be meshed and therefore provide direct flight access for bats to enter and exit the barn. Additional access points included a circular aperture on the upper east gable and gaps around the main barn door and stable doors.

**Photo 6.**  
Close up of air  
vents.

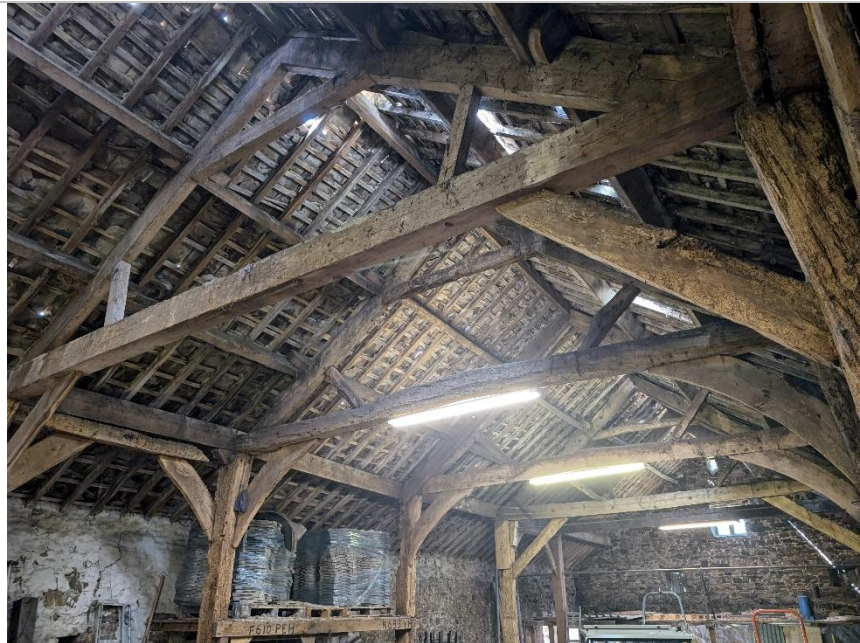
The aisled barn is regularly used as part of the farm and contains several strip lights fixed to the roof timbers. Numerous daylight gaps were visible throughout the roof due to the slipped and missing slates.

**Photo 7.**  
Roof framework  
of aisled barn  
(with lights).

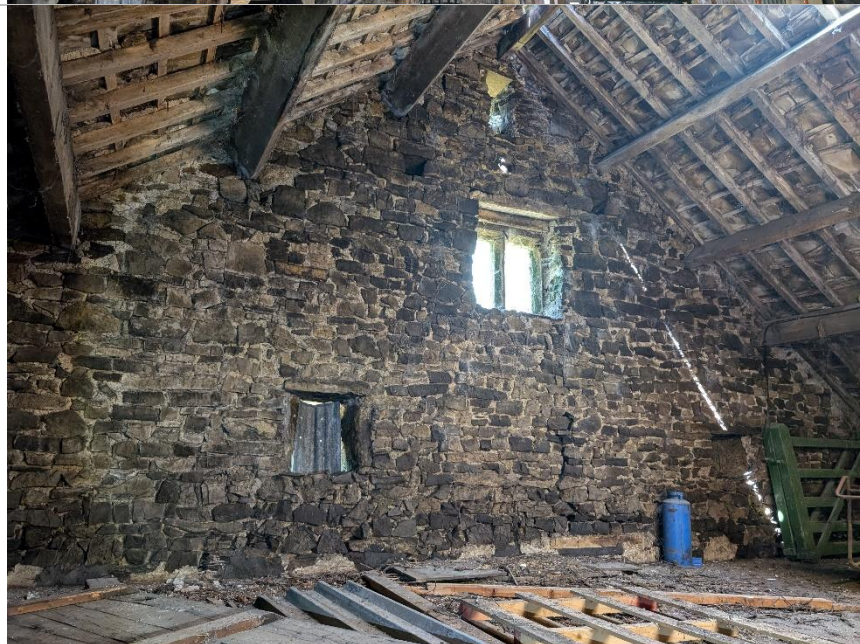
Both the west gable and the east wall of the aisled barn contained a small number of gaps in the stonework; however, these areas could not be accessed safely due to the unstable hay loft floors.

**Photo 8.**  
Internal view of  
west gable wall.

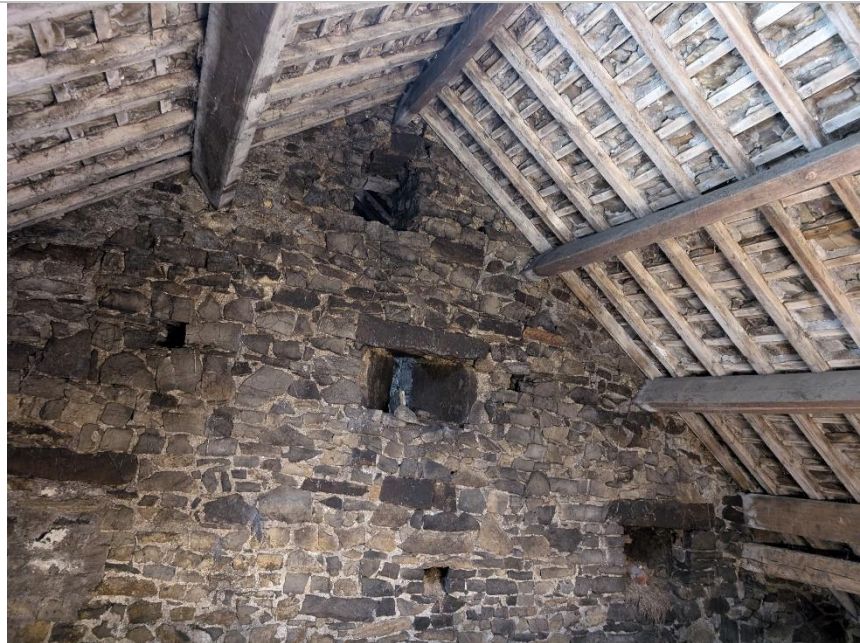
**Photo 9.**  
Dividing wall  
(with open  
aperture).

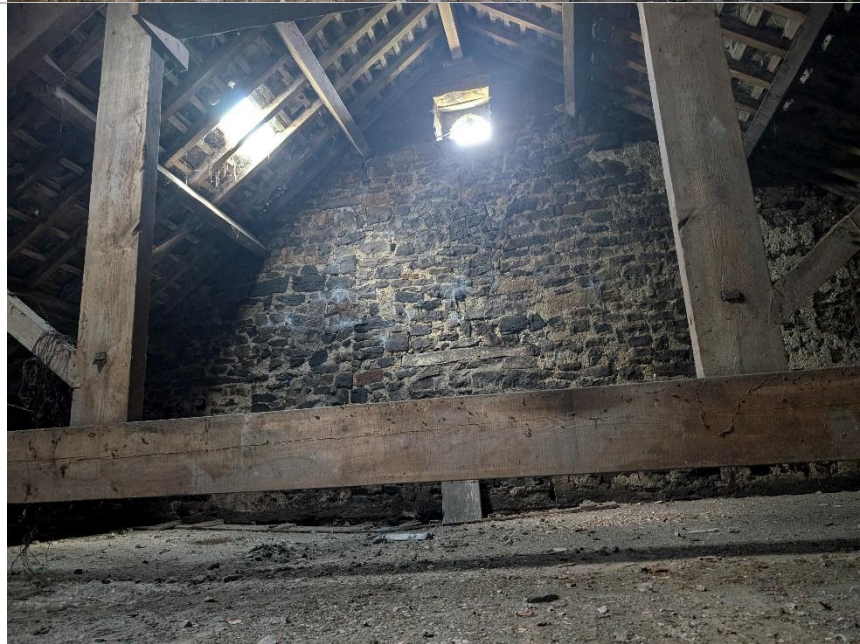
**Photo 10.**  
Loft of  
workshop  
(former stables)  
with circular  
window  
aperture (main  
roost egress  
point).

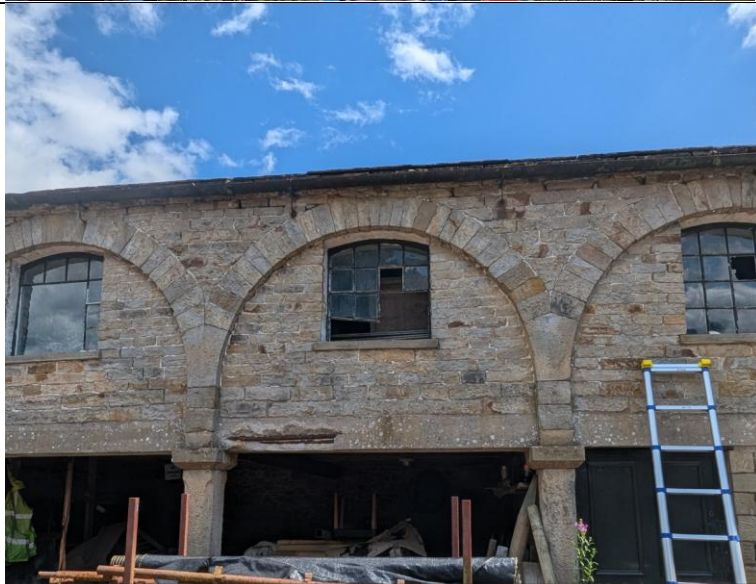
**Photo 2.**

Several potential gaps were present within the stonework beneath the roof verge on the west elevation (above the arches), although these could not be closely inspected. The upper level contains three windows on the west aspect, two of which were broken, providing potential flight access into the upper room.

West elevation.

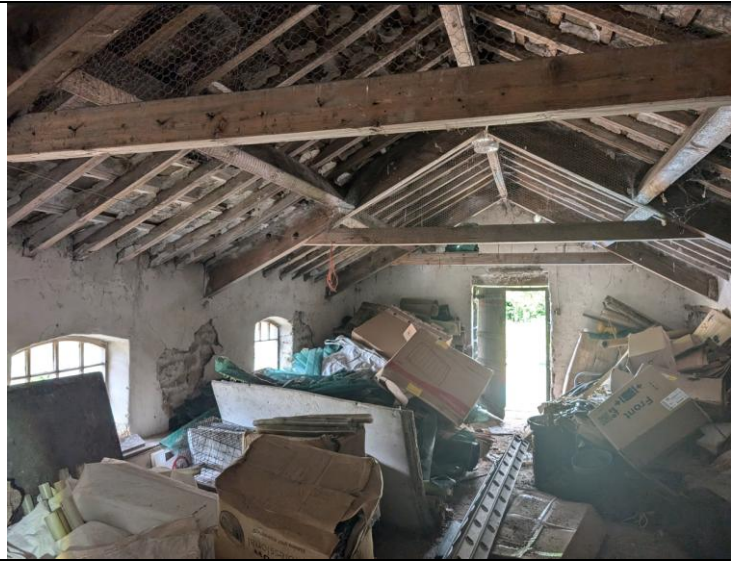
The upper level comprised a single open room. The internal stonework was rendered. The roof lacked an underlining, and chicken-wire mesh had been fixed to much of the timber roof framework. A small section of the roof was clad with timber boards, creating a crevice between the boards and the roof

**Photo 4.**  
View of upper level.

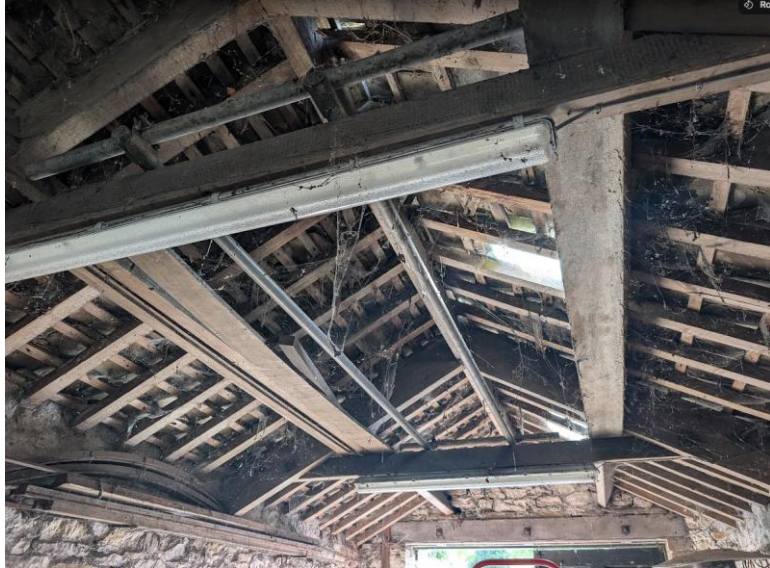
Small gaps were present throughout the roof due to slightly lifted and slipped slates, and there were notable gaps beneath the ridge tiles. Internally, the whitewashed walls appeared to be in good condition. Two recessed gaps were present within the stonework, both of which were fully inspected. Much of the internal stonework and the timber roof frame were covered in a heavy layer of cobwebs.

**Photo 3.**  
View of roof.
