## Ground Investigation Report

Proposed LED Floodlit Artificial Grass Pitch

Langho FC, Langho

Document no.: STX7133-R02-Rev\_A

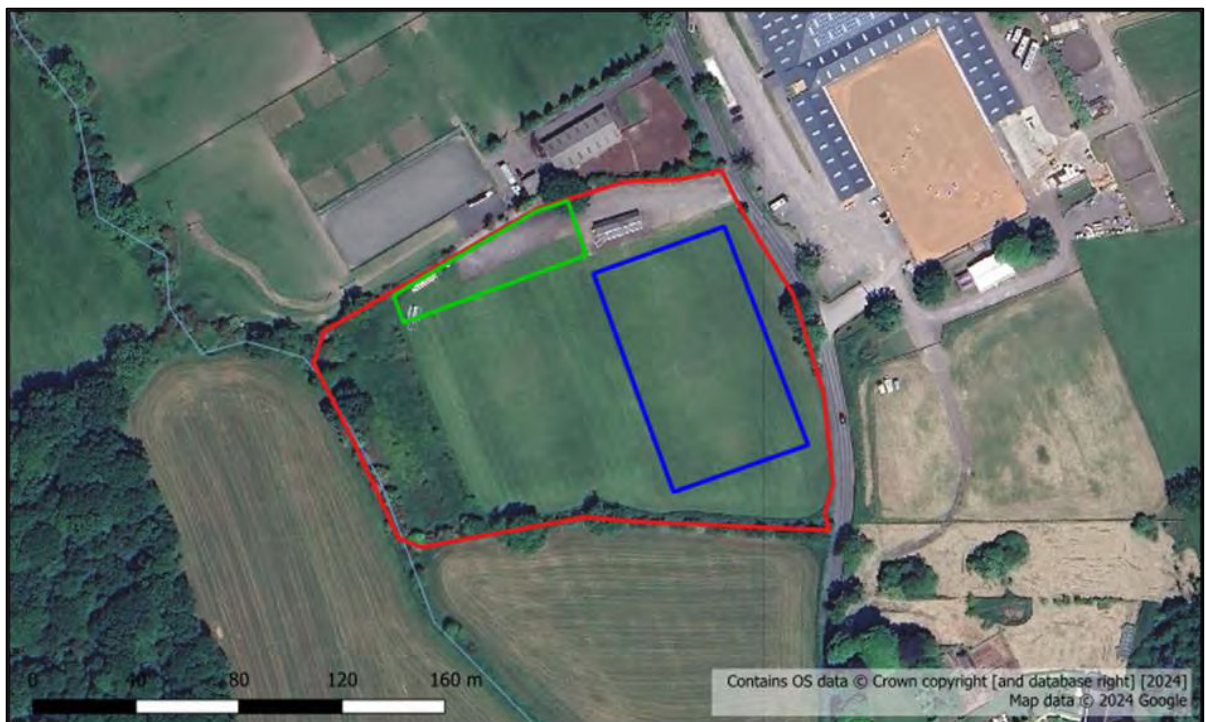
Figure 2-A: Aerial photograph of wider site boundary (red), AGP footprint (blue) and car park extension (green)

2.2.2 An aerial image showing the approximate site boundary and approximate development footprint is presented below, followed by a table summarising the key site features. A site plan is provided within Appendix A.

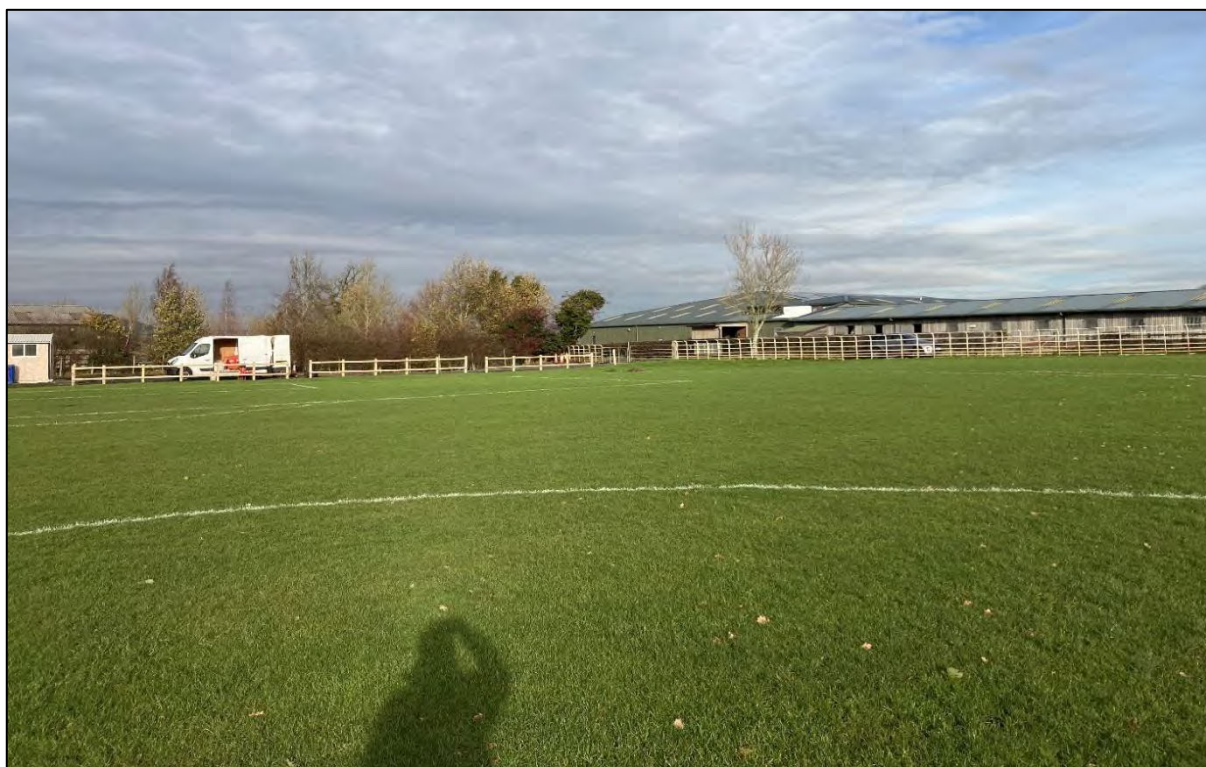
*Figure 2-B: Photograph of northern area of pitch, facing northeast*

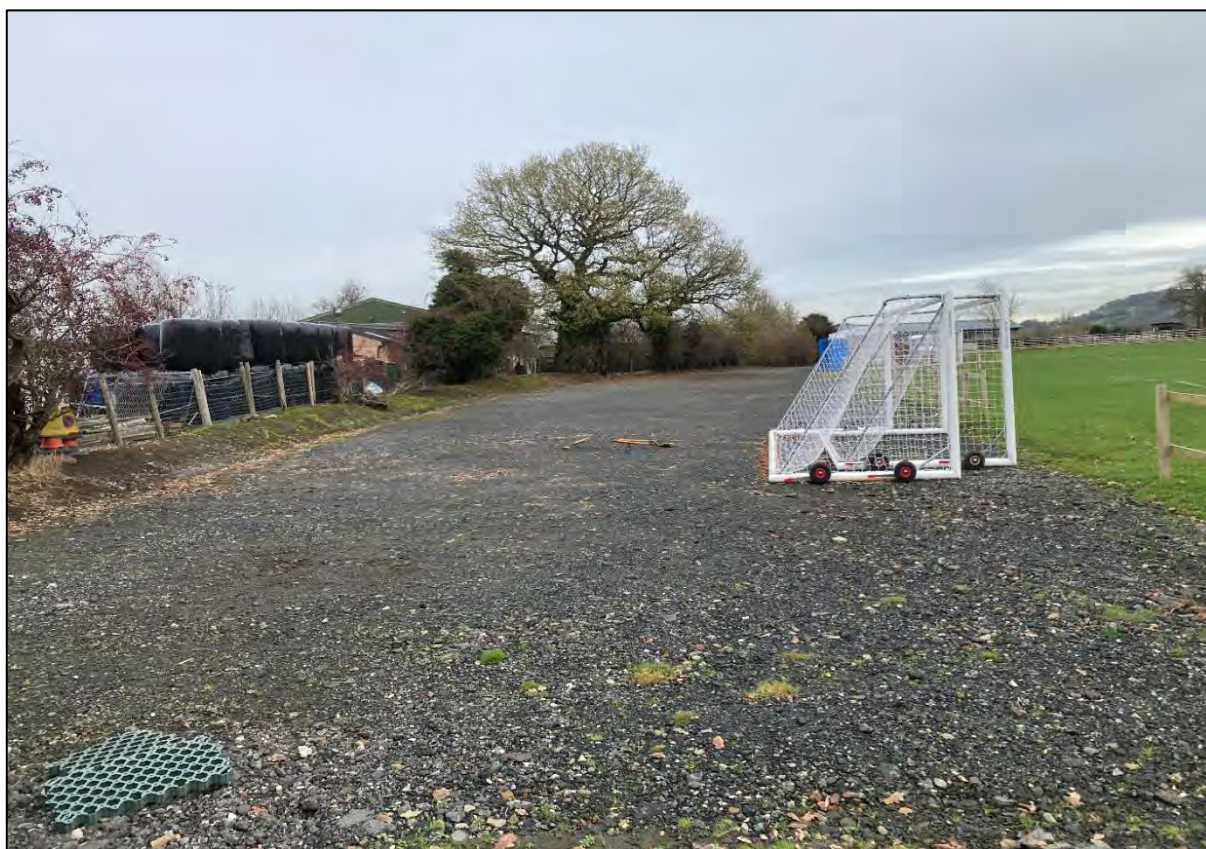
*Figure 2-C: Photograph of proposed car park area, facing east*

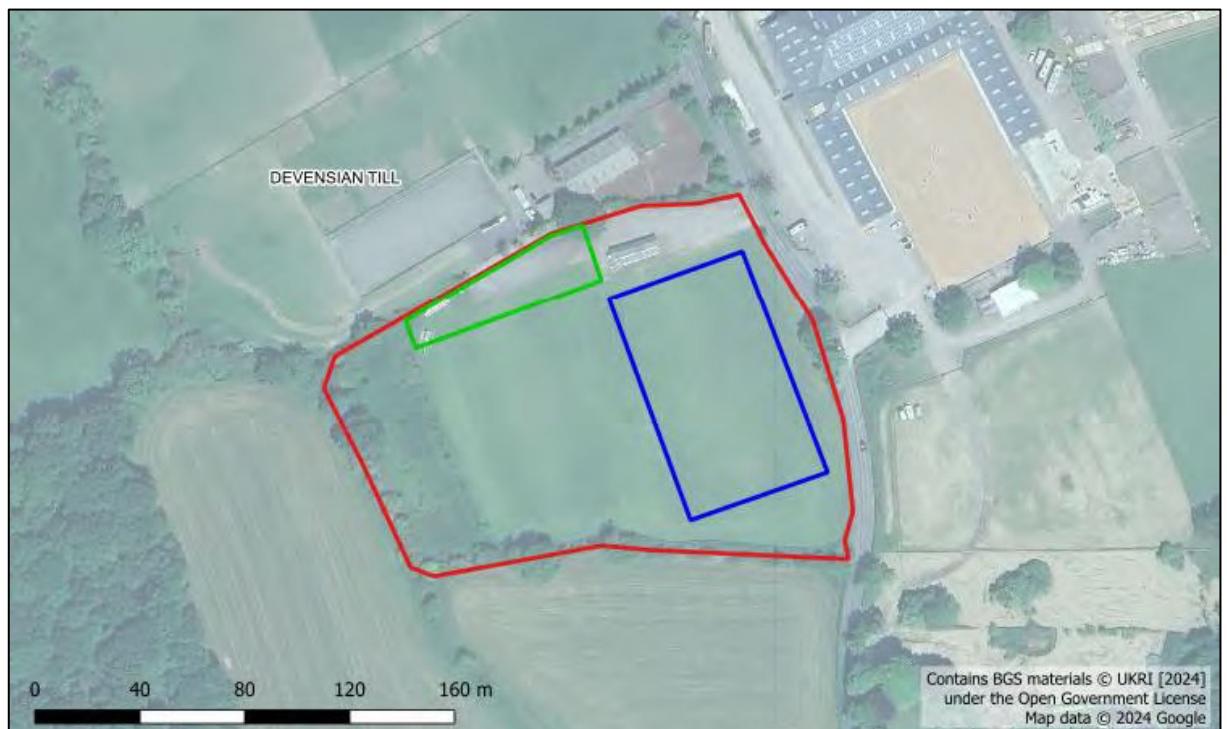
Figure 2-G: Extract from BGS showing superficial geology at the site

- 2.4.1 Based on a review of available records, the site is anticipated to be underlain by superficial deposits of Devensian Till, comprising clay with sand and gravel (refer to Figure 2-G below).
- 2.4.2 Based on a review of available records, artificial deposits are not anticipated to be present at the site. In addition, Made Ground is not expected across the development area based on history/current site use.
- 2.4.3 The underlying bedrock is recorded as the Rad Brook Mudstone Member, comprising mudstone across the entirety of the site, with the exception of the south-eastern corner of the wider site which comprises Bowland Shale Formation (mudstone) (refer to Figure 2-H below).

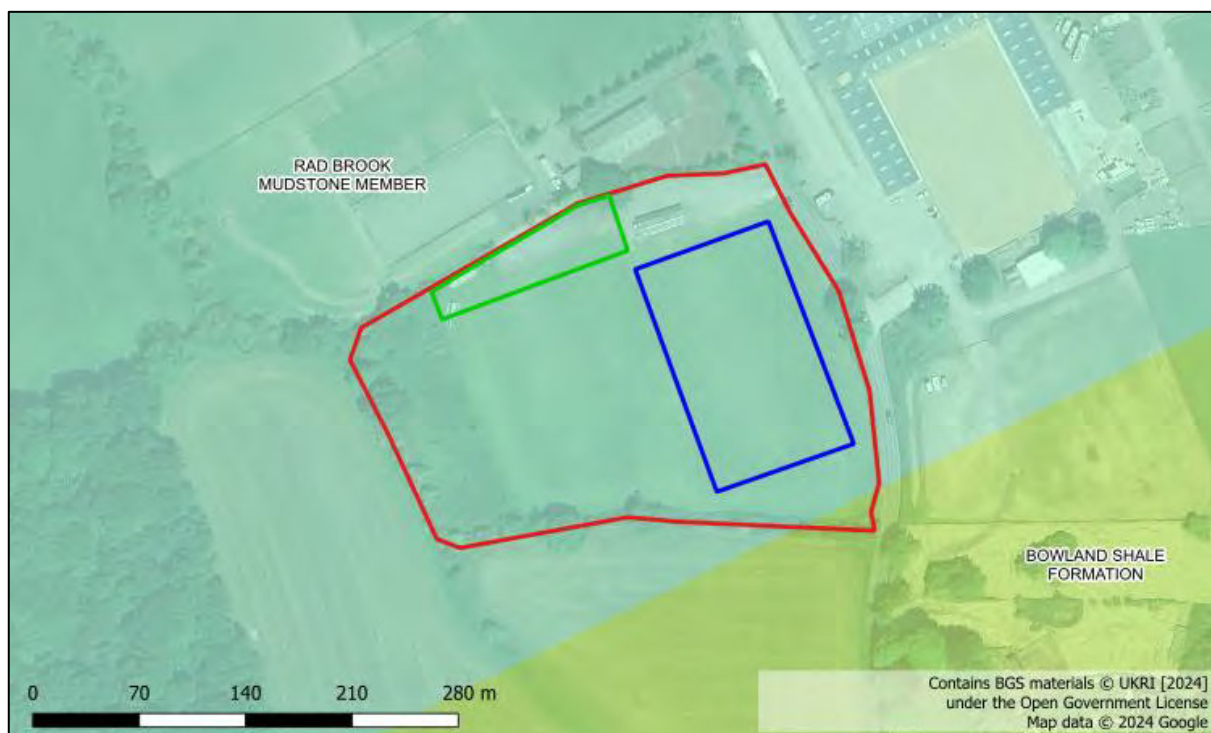
Figure 2-H: Extract from BGS showing bedrock geology at the site

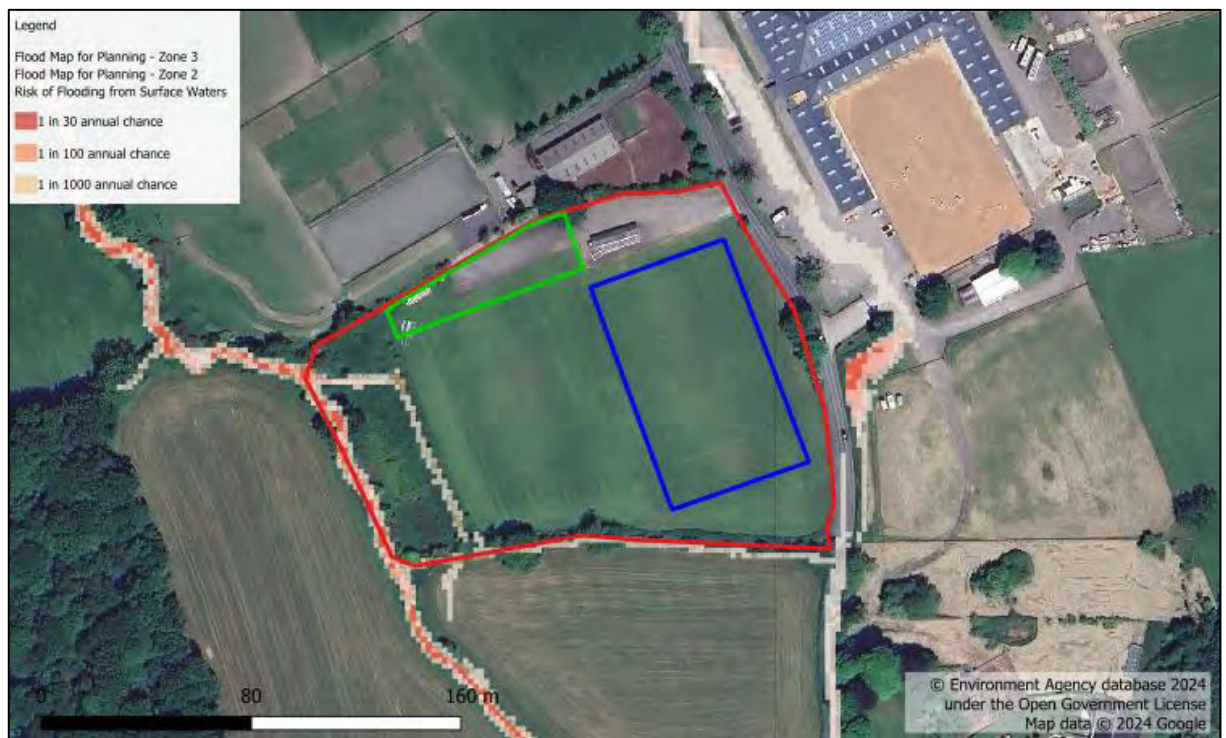
Figure 2-1: Extract of EA flood risk mapping for the site

2.5.1 The site falls within a Flood Zone 1 area. This designation indicates there is less than a 0.1% chance of flooding from rivers or the sea in any year (refer to Figure 2-I below).

2.5.2 The proposed AGP and parking area are not recorded in an area with potential for surface water flooding, however, the west of the wider site is recorded in an area with the potential for surface water flooding during a 1 in 1000 year flood event and a 1 in 30 year event is observed along the western boundary (refer to Figure 2-I below).

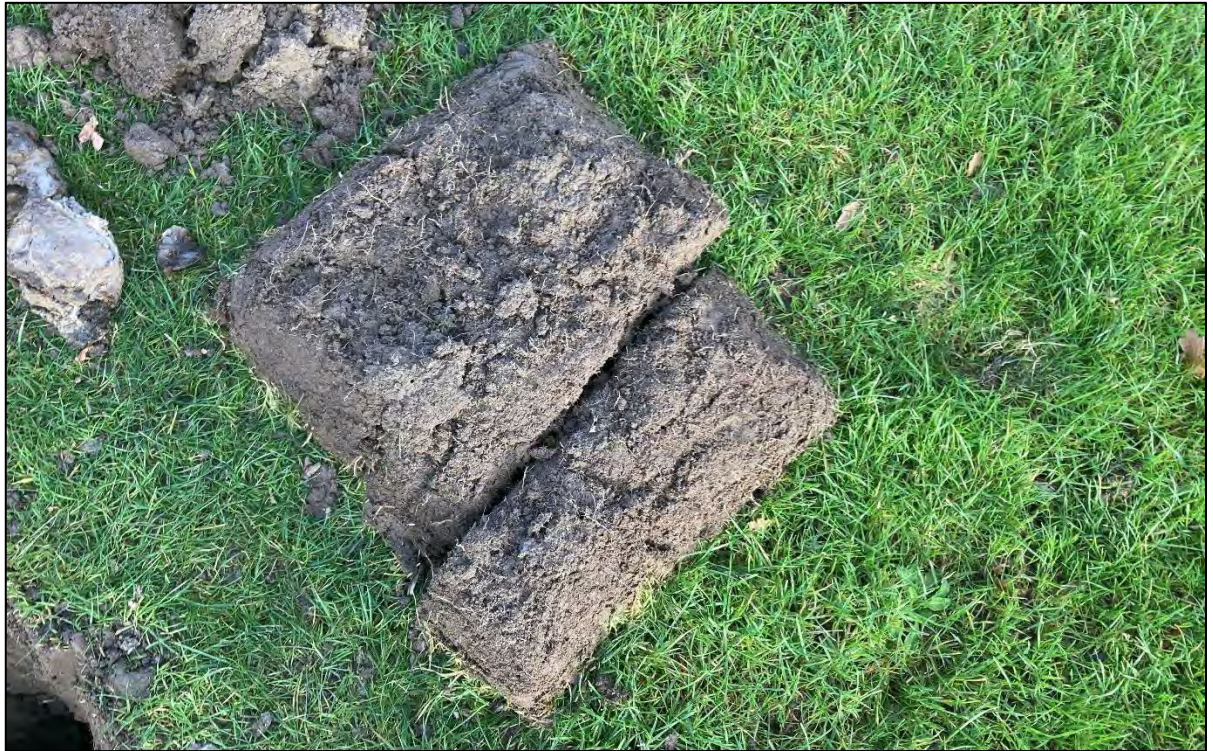
*Figure 5-A: Topsoil deposits extracted from HP02*

5.2.2 Topsoil ranged in thickness between 0.25 m to 0.35 m and comprised brown, slightly gravelly, sandy clay and clayey sand with frequent rootlets. The gravels generally comprised siltstone, concrete and occasional brick.

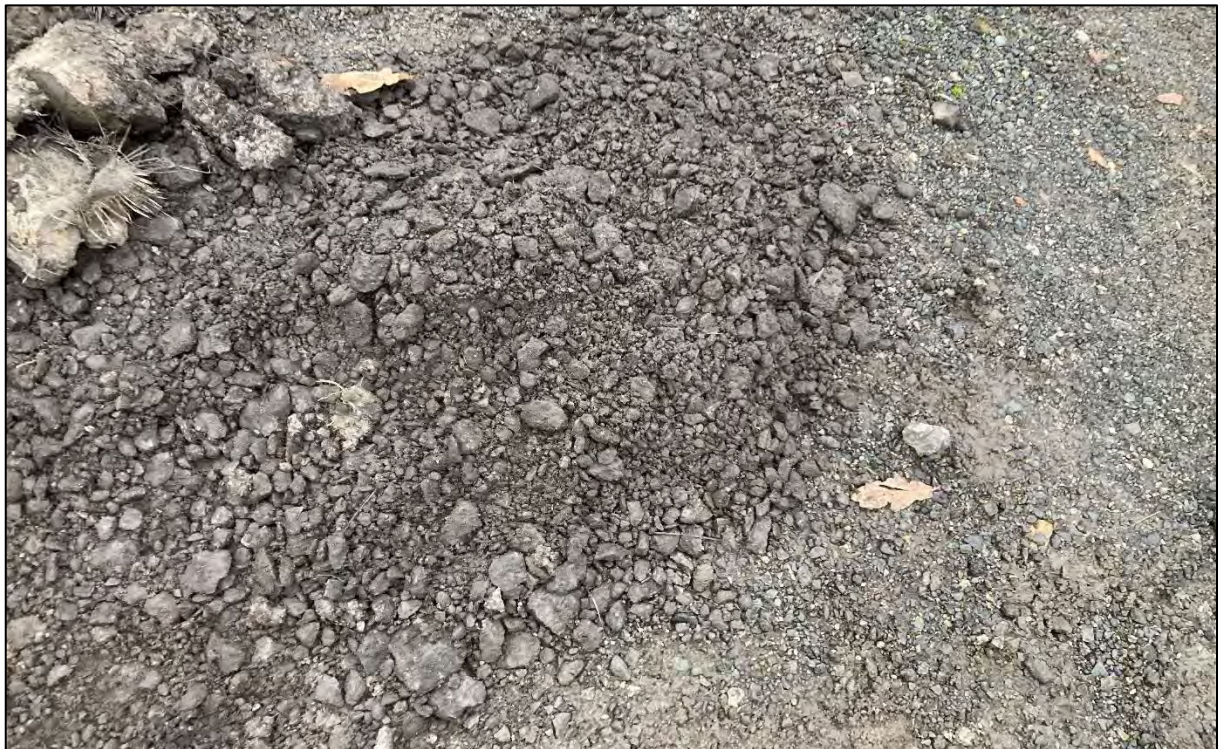
*Figure 5-B: Gravel surfacing (Made Ground) encountered in HP07*

5.2.1 Topsoil was encountered in all exploratory holes with the exception of HP07, which was located within a gravelled parking area. Gravel was noted to be 100mm thick at this location.

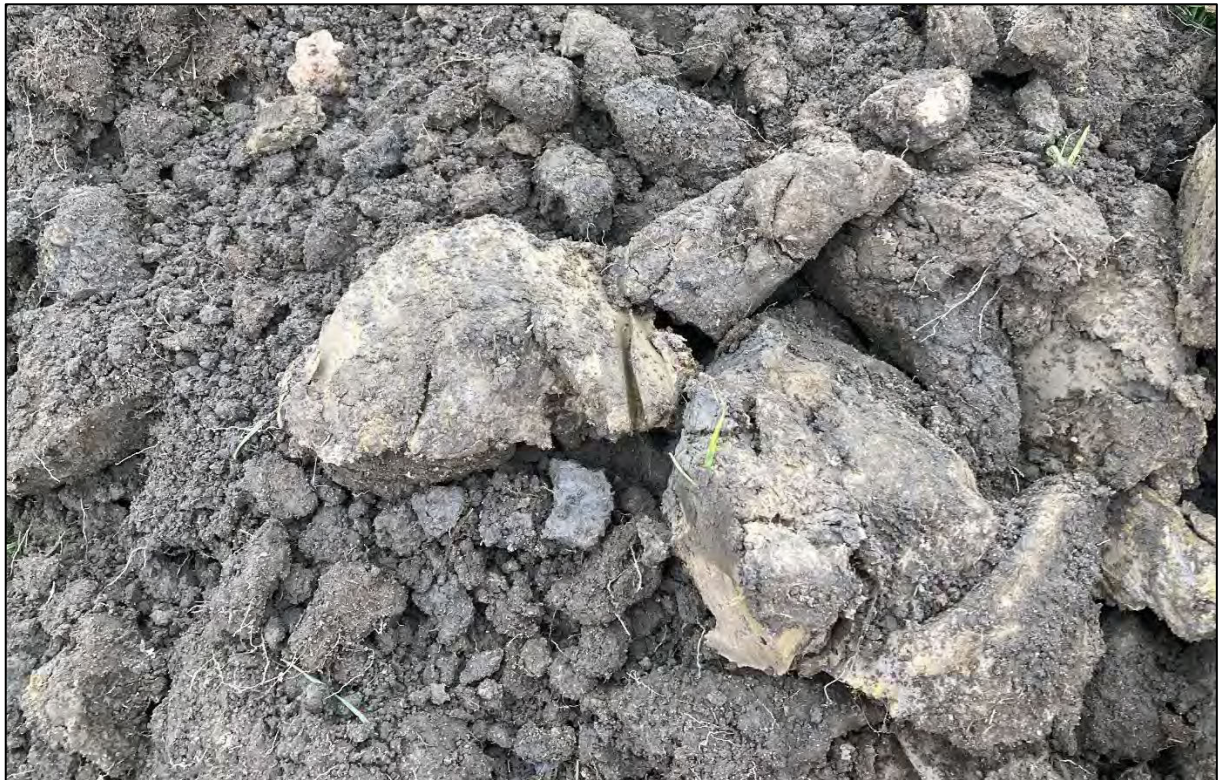
*Figure 5-C: Reworked Devensian Till extracted from HP05*

- 5.3.2 The base of the Devensian Till was not encountered with the maximum achieved depth of 1.20 m. The Devensian Till generally comprised firm, grey mottled orangish brown, slightly gravelly, clay. The gravels comprised sandstone and siltstone.
- 5.3.3 The Devensian Till was suspected to have been initially reworked in HP05 between depths of 0.25 m to 0.50 m.
- 5.3.4 Photographs of the Devensian Till encountered on site are presented below.

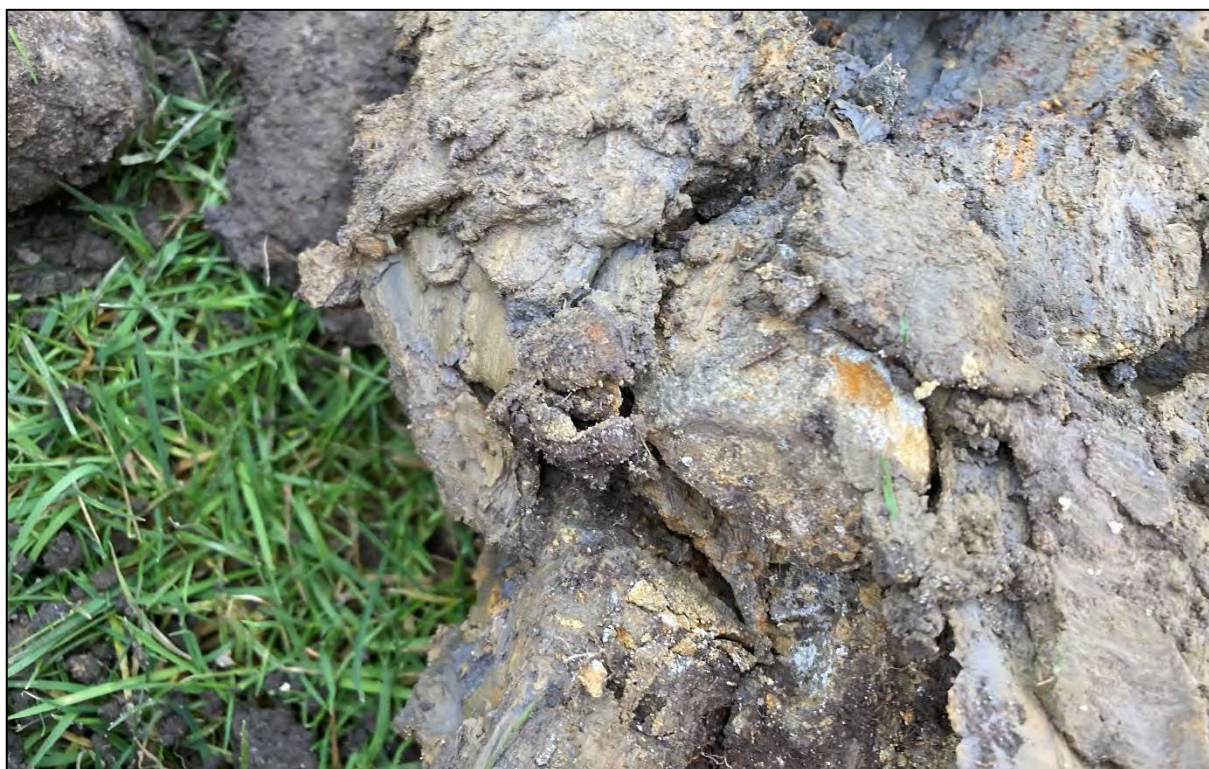
Figure 5-D: Devensian Till extracted from HP05

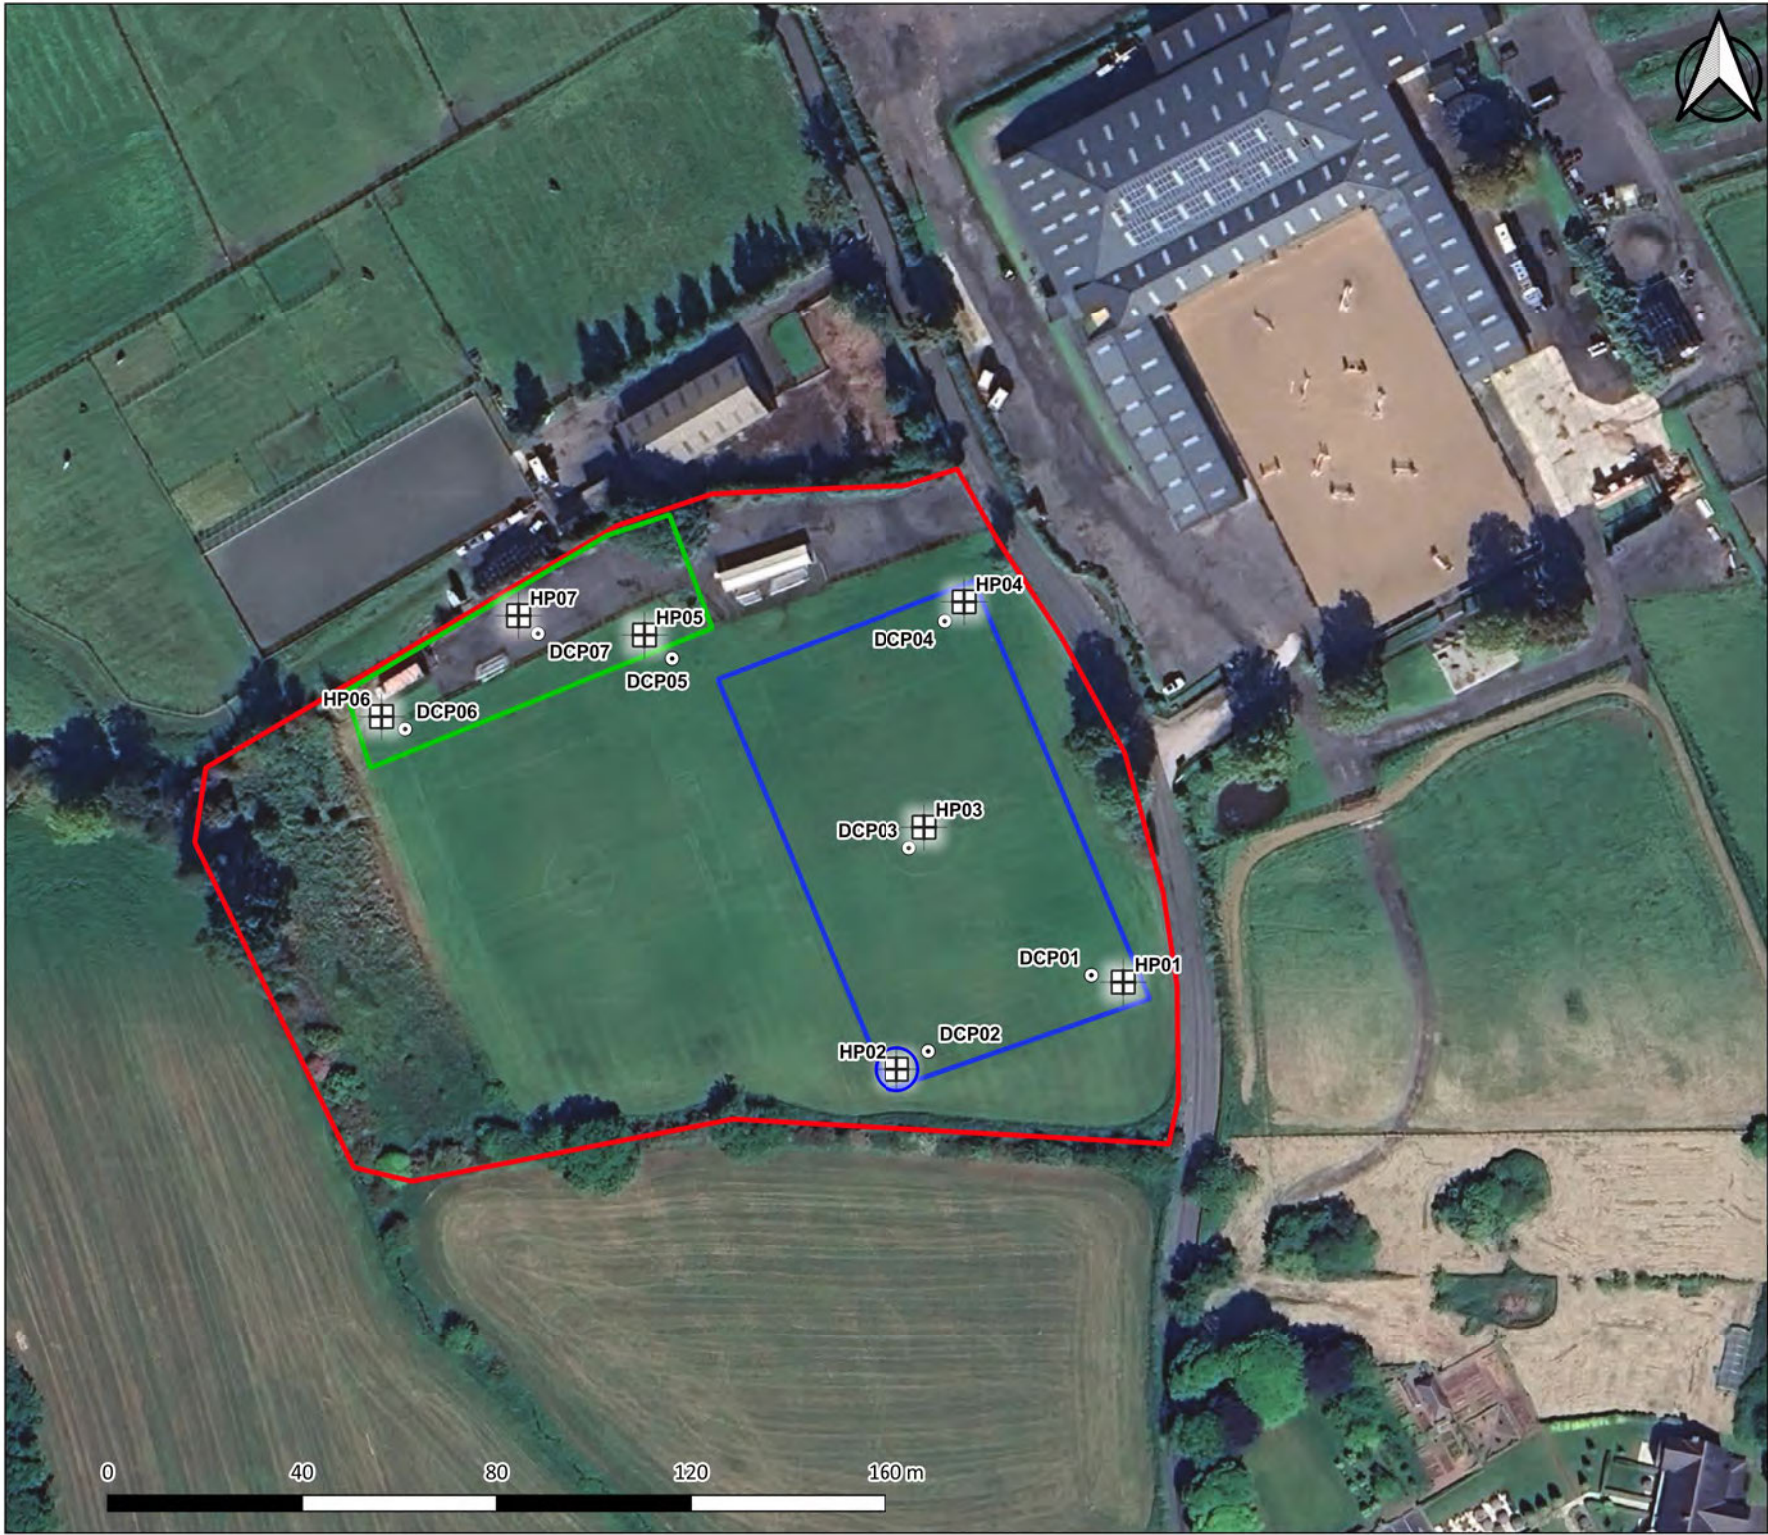
## Appendix A Drawings

- Key:
- Site Boundary
  - Proposed AGP Footprint
  - Proposed Parking
  - Hand Pit
  - Dynamic Cone Penetrometer (DCP) Test
  - Soakaway Testing
