# **Preliminary Bat Roost Assessment Report**

**Outbuilding at Rowan Cottage,  
Old Clitheroe Road,  
Hurst Green,  
PR3 2YU**

**18.07.2026**

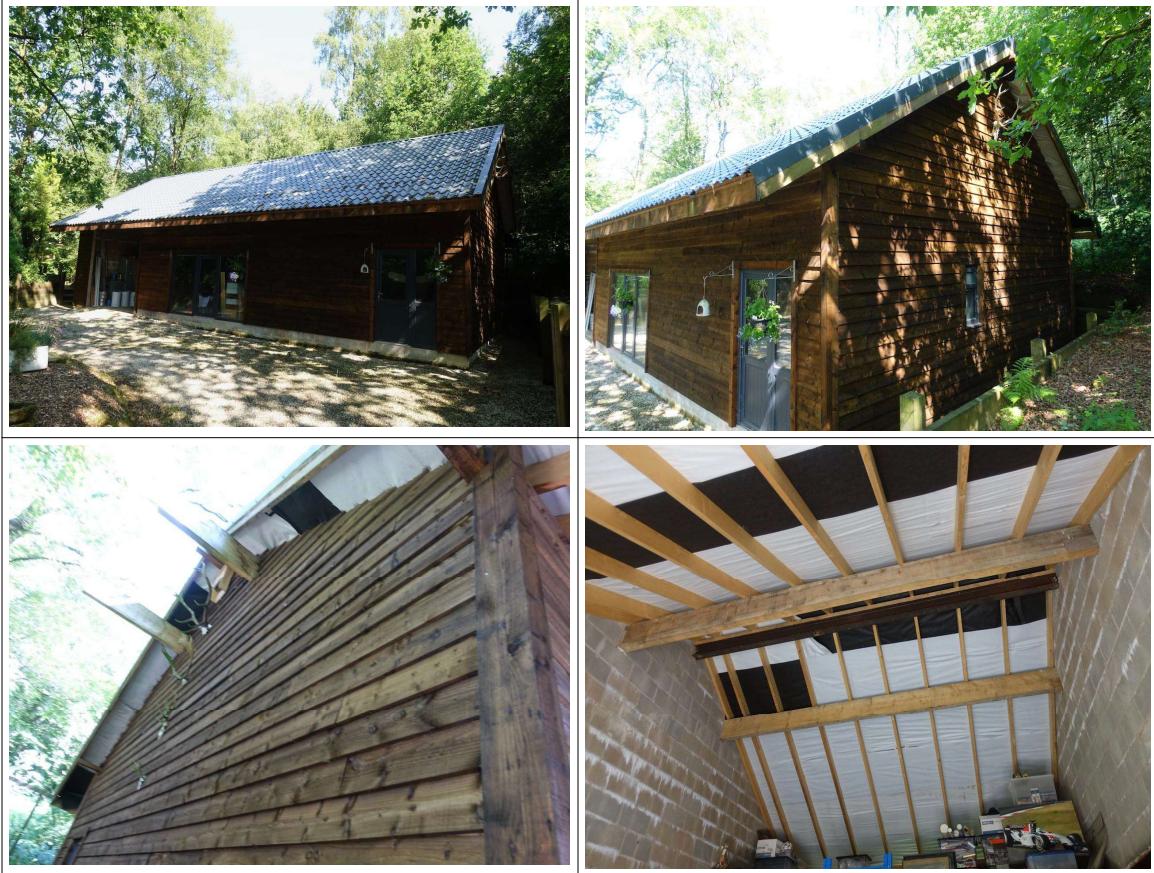
The property is a single storey detached outbuilding with a double pitched panelled roof.

The building is of a timber and concrete block construction. External timber walls are in good condition and close fitting with no obvious cracks, gaps or crevices. Internal walls were noted to have some crevices present.

Roof panels are close fitting and sealed. Panels are lined to the interior with a modern breathable membrane

The building can be considered to offer low bat potential.

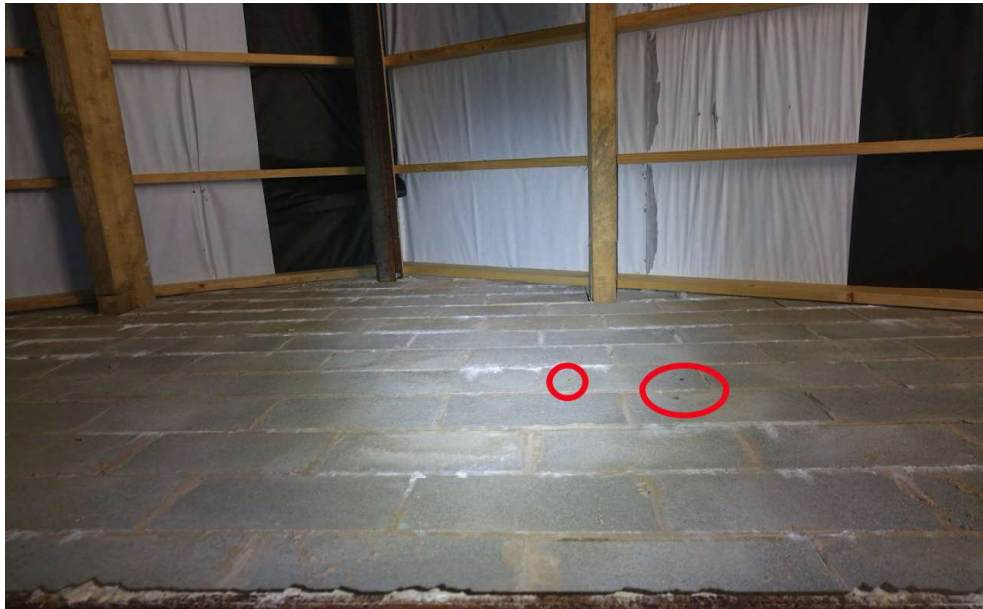
The building was observed to have some suitable roost features present. In particular a gaps in interior concrete block walls and bat boxes located on either gable end.

Evidence to suggest presence of roosting bats in the form of scattered droppings and droppings adhering to an interior wall below a gap in blockwork were observed.

*Location of bat droppings on interior wall*

It is recommended that a two emergence surveys are carried out between May and August, inclusive. Surveyors should be equipped with night vision aids given the potential for late emerging species to be present.
