# Spring House Farm, Pendleton Supplementary Bat Survey

June 2026

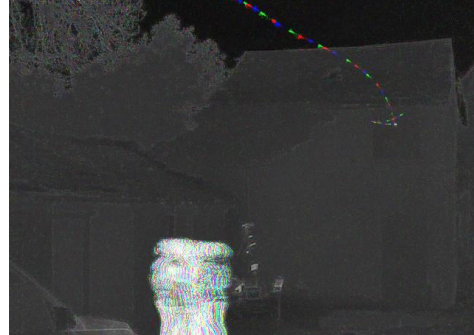
- 3.1.1 During the first nocturnal survey, two common pipistrelle bats were recorded emerging from barn 2 at 21:36 and 21:54. Both bats emerged from the unglazed first floor window on the east elevation of the barn (see image right). No bats were recorded emerging from any of the other farm buildings.
