# Spring House Farm, Pendleton Protected Species Survey

March 2026

**Dunelm Ecology**  
consultant ecologists

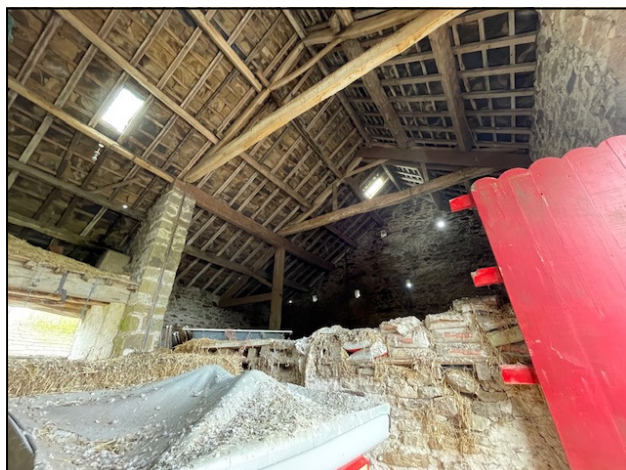
**Plate 1 Looking through barn 3**

| Building | Building Description | Roosting Opportunities & Signs of Bat Use | Roost Potential |
|---|---|---|---|
| Barn 3 | Large Grade II listed barn dating from early 19 <sup>th</sup> century and extending from the farmhouse. The walls comprise random sandstone and the pitched roof is clad with unlined stone slates. The roof is supported by three large dimension queen post trusses. The barn is open from floor to apex (7.3 m high) along half its length with a mezzanine level in the western half (animal stalls are present on the ground floor below), this having a floor to apex height of 5.4 m. The barn is used for storage including hay and is currently occupied by several pigeons. There is connectivity between the barn and farmhouse's roof space via an opening in the dividing wall. Several ventilation slots exist and together with skylights | No evidence of bats recorded but numerous gaps are present between roof slates, where mortar has perished at the western gable end wall, around internal gable wall tops and occasionally between stonework although the walls are generally well pointed. | Moderate |

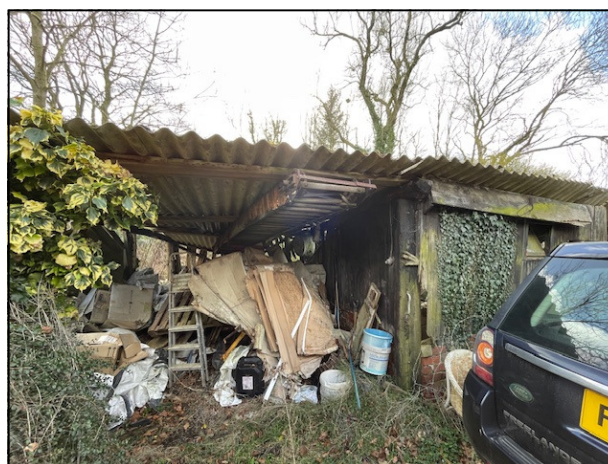
**Plate 4 Barn 5**

| Building | Building Description | Roosting Opportunities & Signs of Bat Use | Roost Potential |
|---|---|---|---|
| Barn 5 | Dilapidated timber post and panel lean-to structure (dating from mid 20 <sup>th</sup> century) with corrugated asbestos roof. | No evidence of bats was recorded and no potential roosting features were identified. | None |

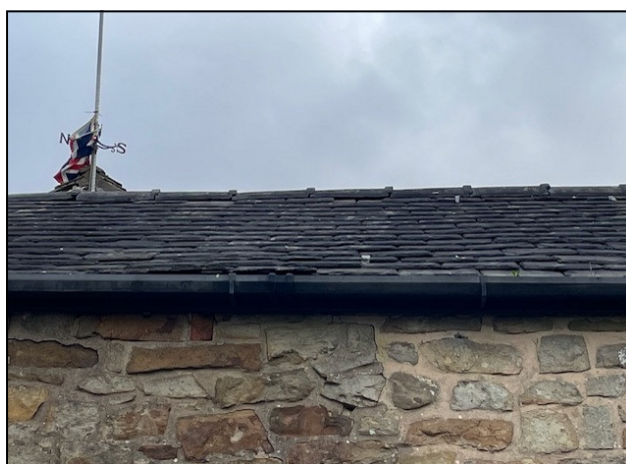
**Plate 5 Gaps under roof coverings**

- 4.1.2 Further survey effort in the form of two dusk emergence surveys is therefore recommended to give confidence in the initial negative survey result and to comply with best practice guidelines (Collins 2023). Such surveys can only be undertaken between May and August during suitable weather conditions i.e. warm ( $>10^{\circ}\text{C}$ ), light winds and dry, with at least three weeks between each survey. Should further survey confirm the presence of bats, then works would need to be completed under licence from Natural England. Roost sites for bats should be incorporated into the scheme whether bats are present or not, in accordance with the NPPF which seeks net gains in biodiversity. This could be achieved by installing bat boxes within the barns and providing ridge tile access points in the repaired roofs. Wall crevices can also be retained by inserting timber battens and pointing around these before removing once mortar has started to set.

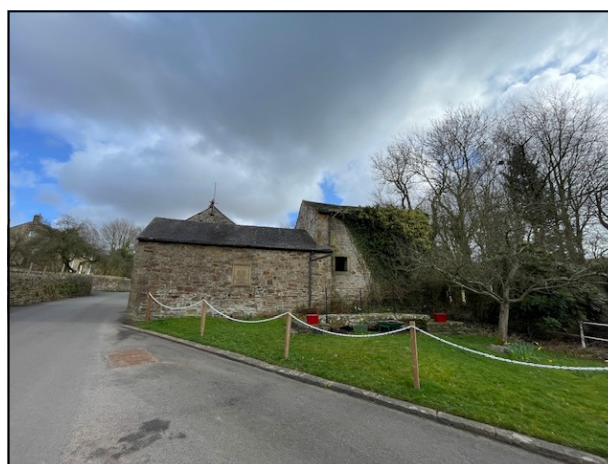
| Building | Building Description | Roosting Opportunities & Signs of Bat Use | Roost Potential |
|---|---|---|---|
| Barn 2 | Barn adjoins southern elevation of barn 1 and is of similar age and construction but built over two floors. The roof is covered with stone slates, with dense ivy growth covering part of the western pitch and most of the wall on this elevation. | No evidence of bats was recorded although it was not safe to inspect the first floor of the barn. Several potential roost features were identified, including: perished mortar around the northern gable verges and under roof slates on both roof pitches. Bats can access the interior of the building via unglazed widow openings on the east and west elevations. | Moderate |

**Plate 6 Barns 1 and 2 from the west. Note dense ivy growth.**
