**BAT SURVEY, AT -  
THE PENTRE  
PENDLE ROAD  
CLITHEROE**

REFERENCE NO 7336

In conjunction with the submission of an application for planning approval, this survey was commissioned to identify if bats are currently present in the building, to assess if it has been used in the past or if there is any potential for future use of the building.

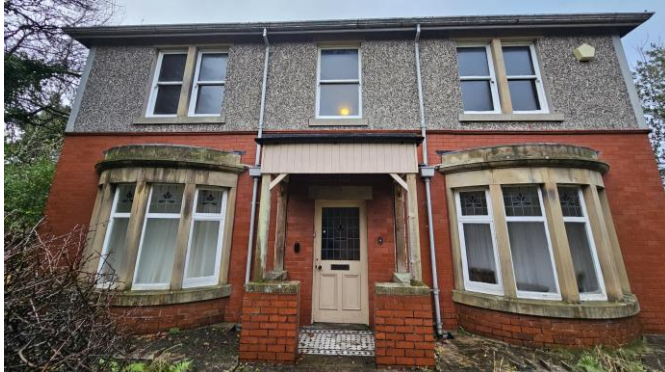
Front Northeast elevation.

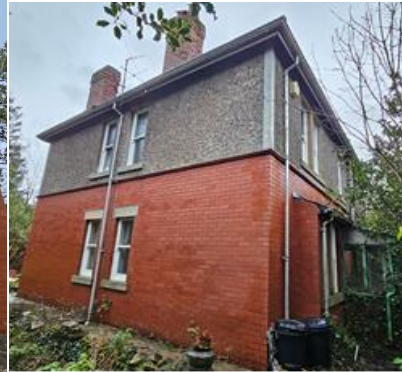
Northwest Side and part Rear Elevation

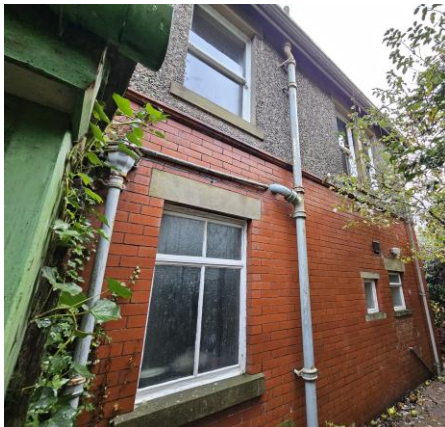
Part southwest rear extension

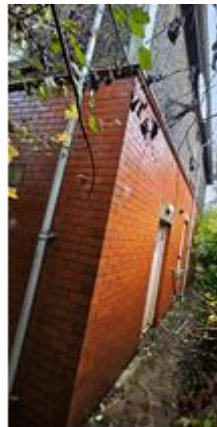
Southeast elevation

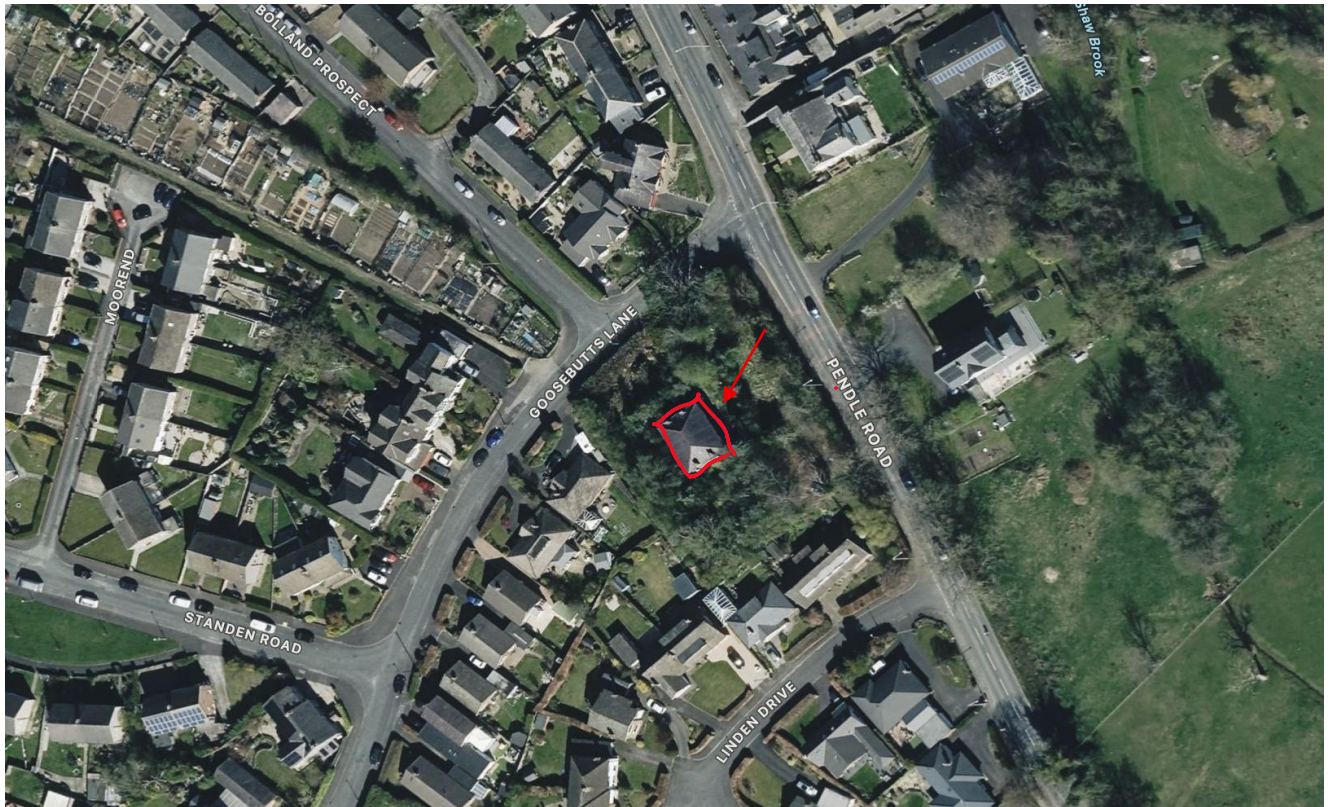
The house is in the centre of a very large garden which is completely surrounded on the boundary by dense trees and shrubbery. Pendle Road is adjacent to the northeast boundary and Goosebutts Lane is adjacent to the northwest boundary of the garden

The site is surrounded to the north, west and south by extensive well established residential housing estates all having gardens, containing mainly domestic planting. Some mature broad leaf trees form a broken line on the East side of Pendle Road further small groups of trees are present in the extensive gardens and some small acreage pastureland to the east.

The immediate locality provides optimal forage potential with some medium/ low potential to the east side of Pendle Road.

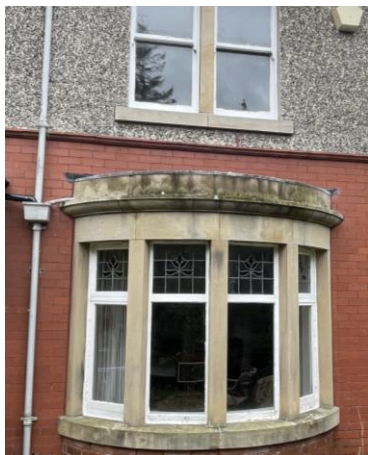
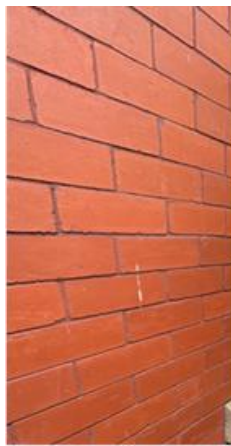
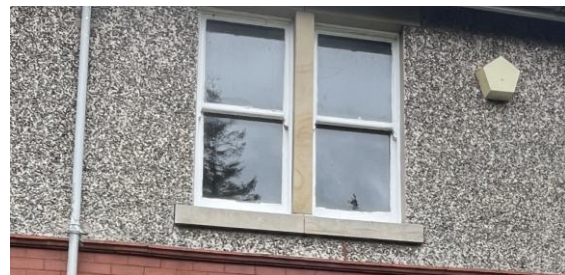
The main walls are brick, exposed up to first floor level, above a brick detail course is a rough stone chip render finish. The walls are in good condition.

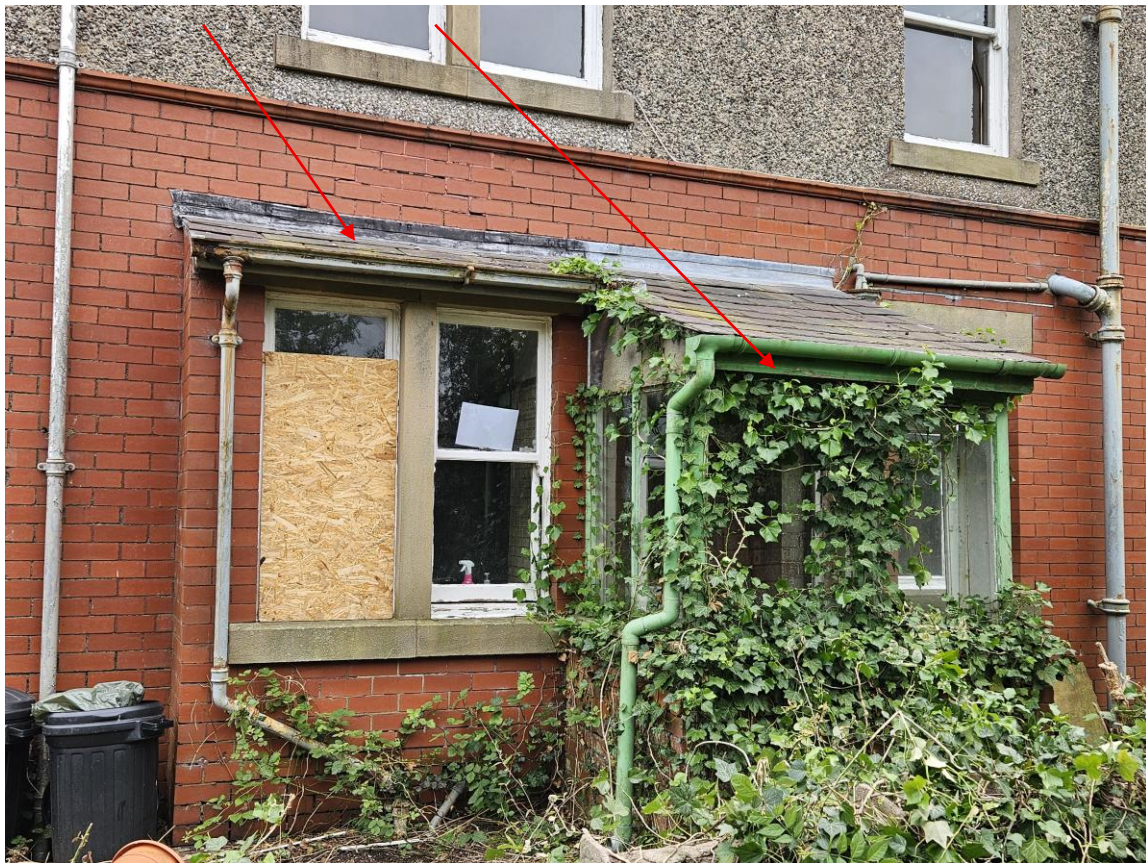
The bay window and attached rear porch have brick walls

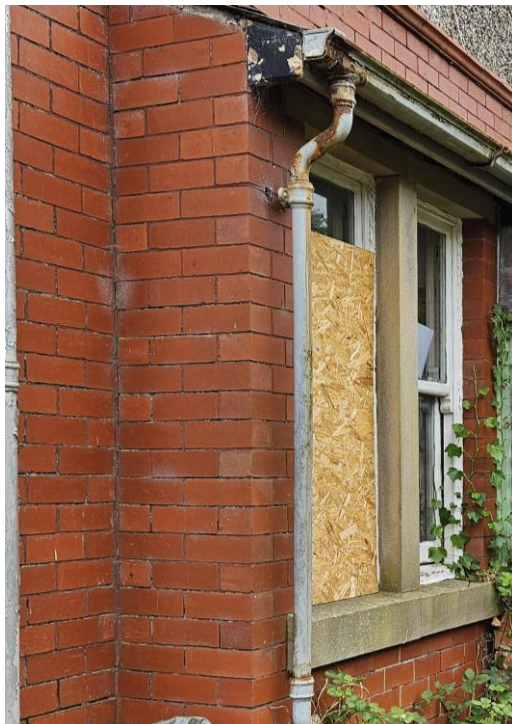
The walls to the bay window are in good condition, no sections of missing or cracked render.

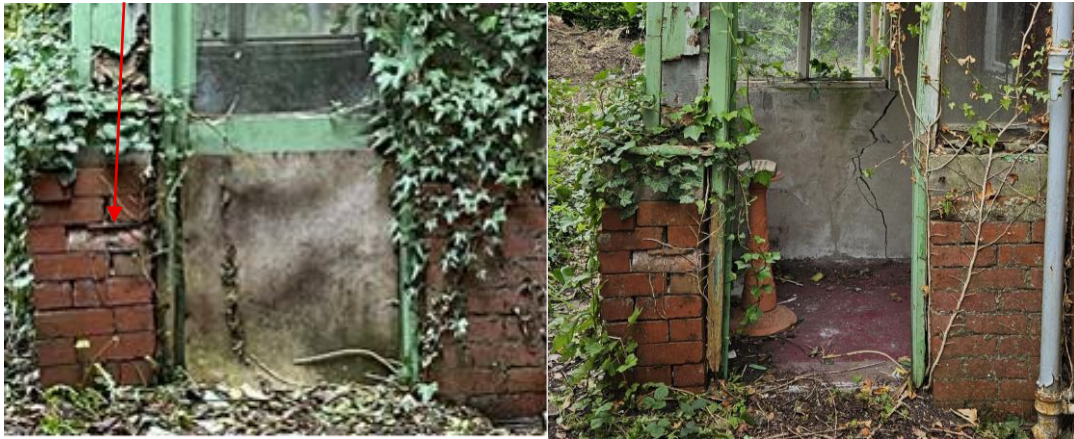
However the base wall of the rear porch is in a dilapidated condition, the wall has moved and a brick has been dislodged.

Due to the scale of the porch, it was possible to examine closely both potential access points. Neither had any signs of current or historic bat presence and were not found to provide high value roost potential.

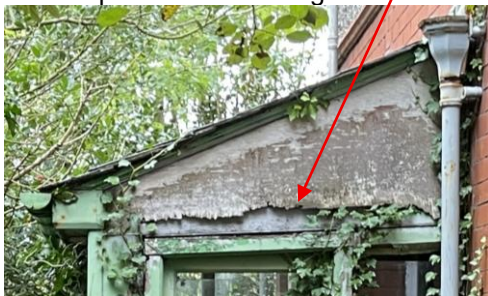
There is a boarded infill to the porch lean to roof which has laminated forming a crevice behind which has the potential for bat ingress.

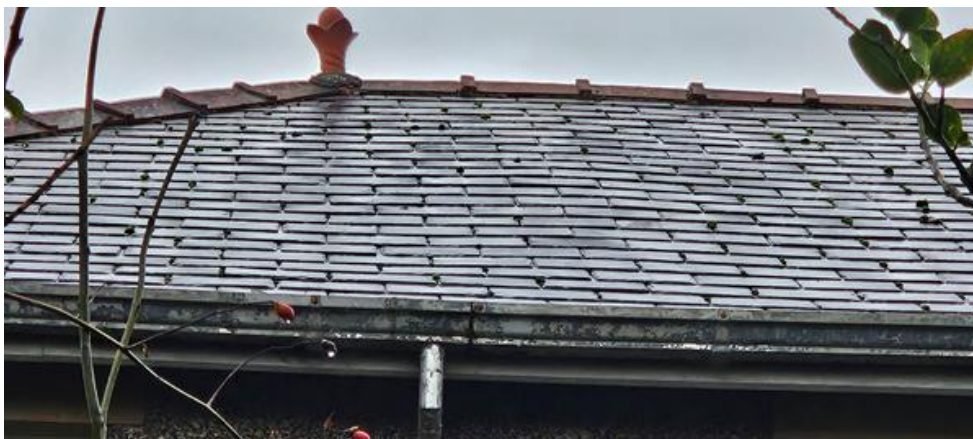
There is an overhang to the eaves with exposed rafter ends with board over. Timber fascia boards to the ends.

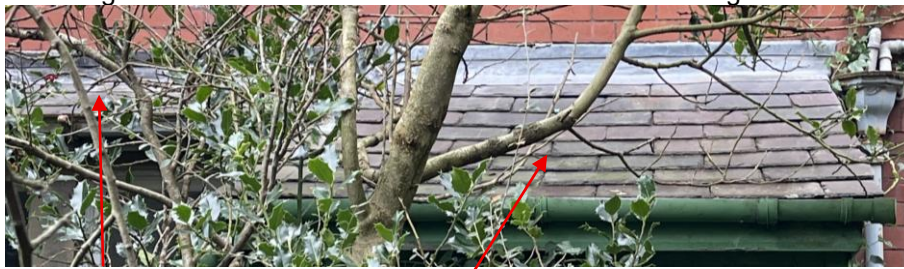
The porch roof and bay window roof is a lean-to structure with a blue slate finish. The eaves overhang has a boarded soffit and timber fascia. Lead flashing at the abutment with the main wall.

Bay window

Porch

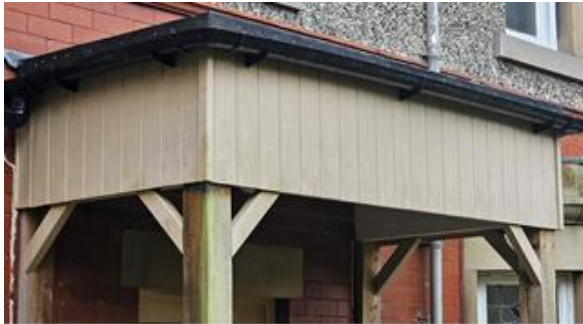
Front door Canopy

The canopy to the front door appears to be a relatively new flat roof timber structure, with boarded sides and a timber deck with felt finish nailed over.

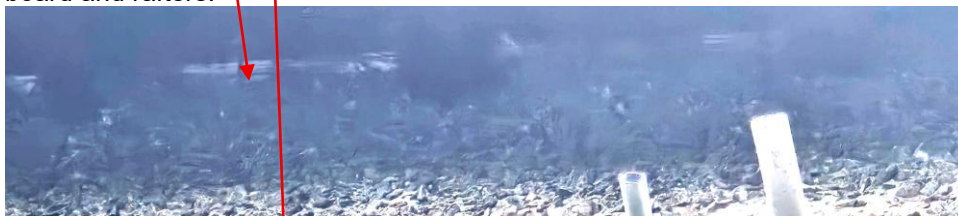
The abutment of the wall and the roof structure was very tight fitting the render finish flush to the board and rafters.

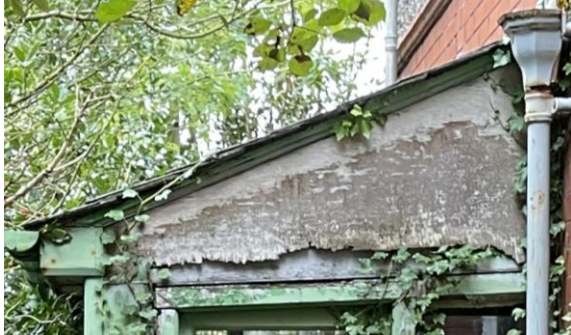
The porch roof verge has some gaps at the abutment with the side infill panel.

Both structures were small enough to enable close inspection of the identified crevices with the aid of an endoscope

There was no high value bat roost potential No current or historic bat presence was found.

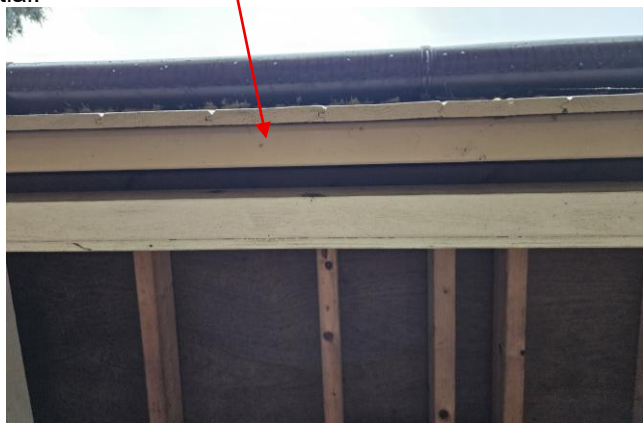
The front canopy is a relatively new structure of timber joists fixed to a frame supported by timber posts. A ply deck is fixed over with a felt finish flashed to the wall. A timber lining is present to the internal face of the boarded sides. Gaps were formed between the down stand boarding which were clear voids open at each end. No bats were found in the structure. The open nature of the structure did not provide any high value roost potential.

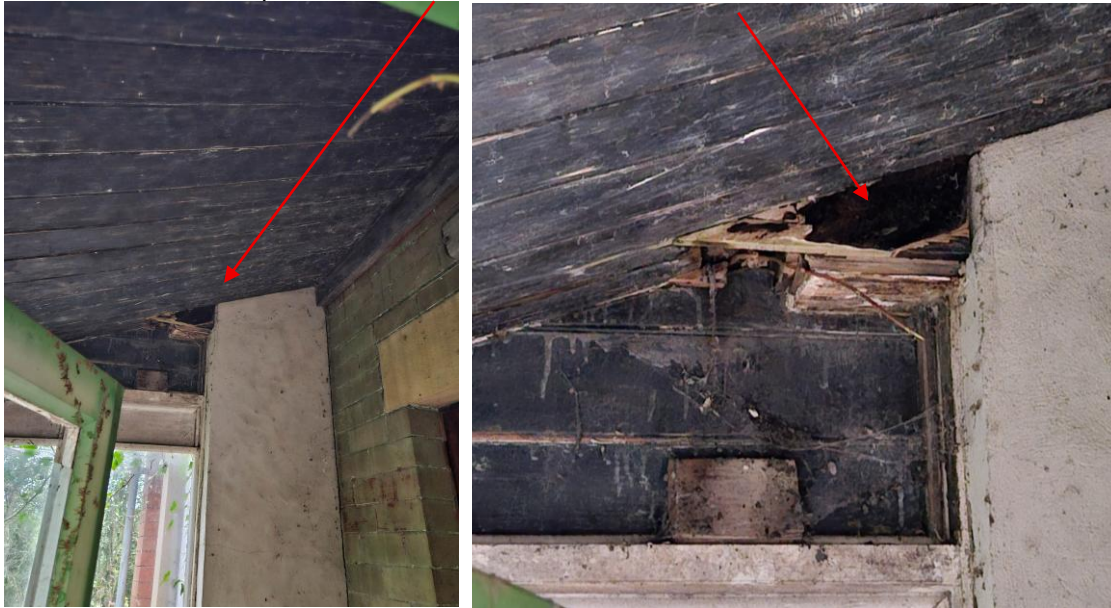
The interior of the rear porch roof is lined with timber boarding fixed to the underside of the rafters. There is a section of rotten timber forming a hole which could be examined with the endoscope. No current or historic bat presence was evident.

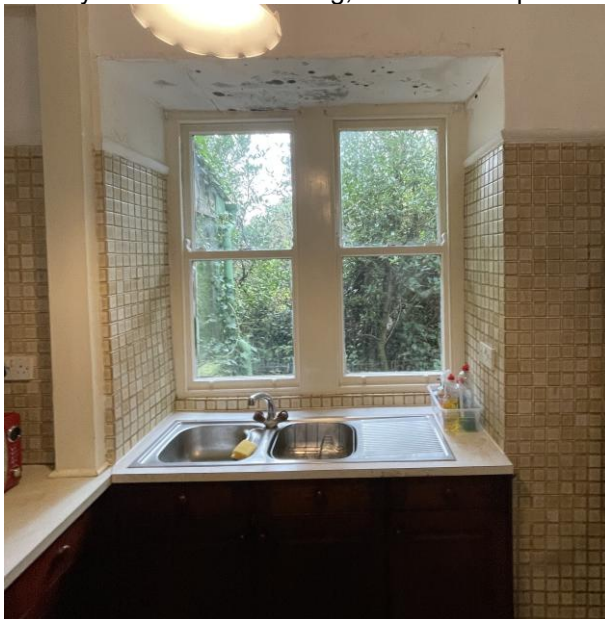
The bay window has a ceiling, no void to inspect.
